**SAFETY COMPLIANCE TESTING FOR
FMVSS NO. 214S
SIDE IMPACT PROTECTION (STATIC)**

**GENERAL MOTORS OF CANADA LTD.
2009 CHEVROLET IMPALA LS, PASSENGER CAR
NHTSA NO. C90100**

FINAL REPORT

1. Report No. 214-GTL-09-001	2. Government Accession No. N/A	3. Recipient's Catalog No. N/A
4. Title and Subtitle Final Report of FMVSS 214 Compliance Testing of 2009 CHEVROLET IMPALA LS, PASSENGER CAR NHTSA No. C90100		5. Report Date August 12, 2009

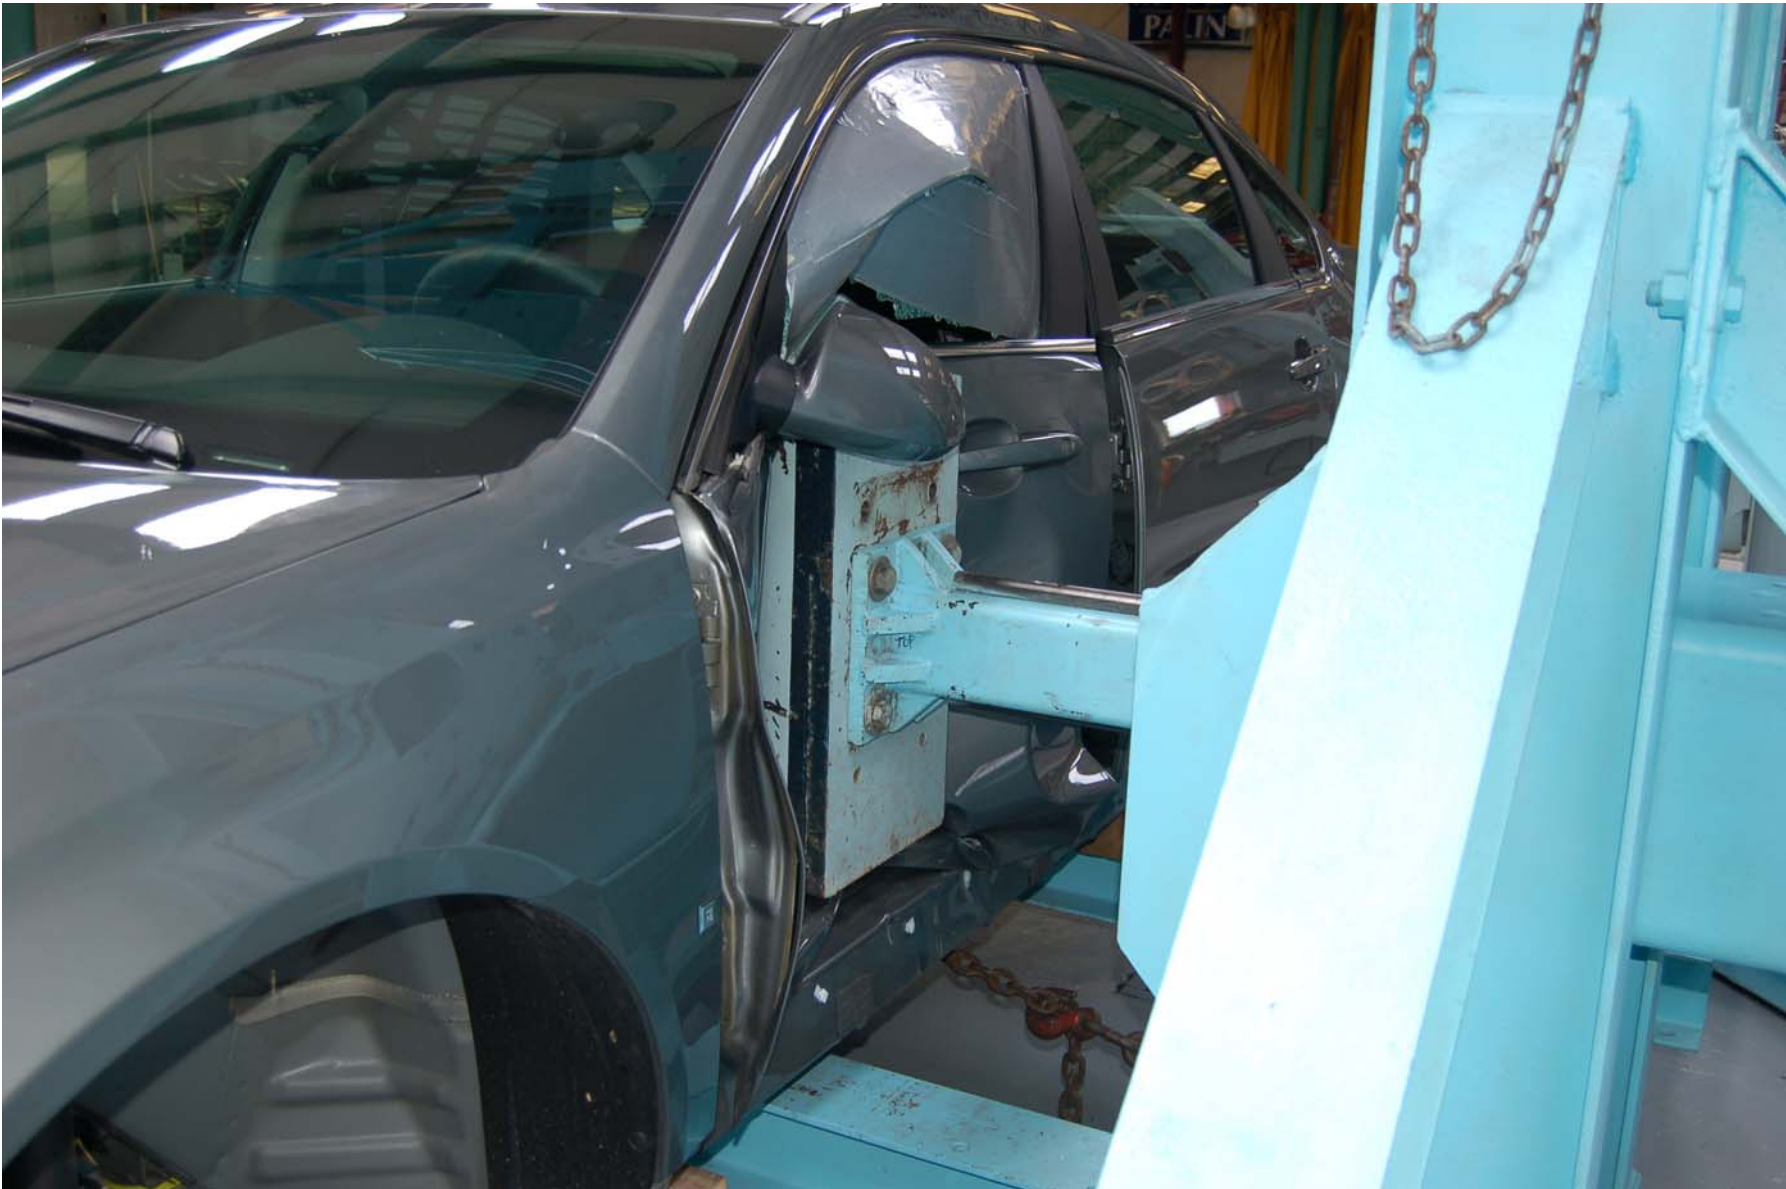
FIGURE 5.16
LOAD DEVICE AGAINST DOOR @ MAX LOAD – TEST 1

- A. The initial crush resistance was 3692 lbs.
 B. The intermediate crush resistance was 6395 lbs.
 C. The peak crush resistance was 11,367 lbs at 12.1 inches
 D. The rate of loading was .2"/sec

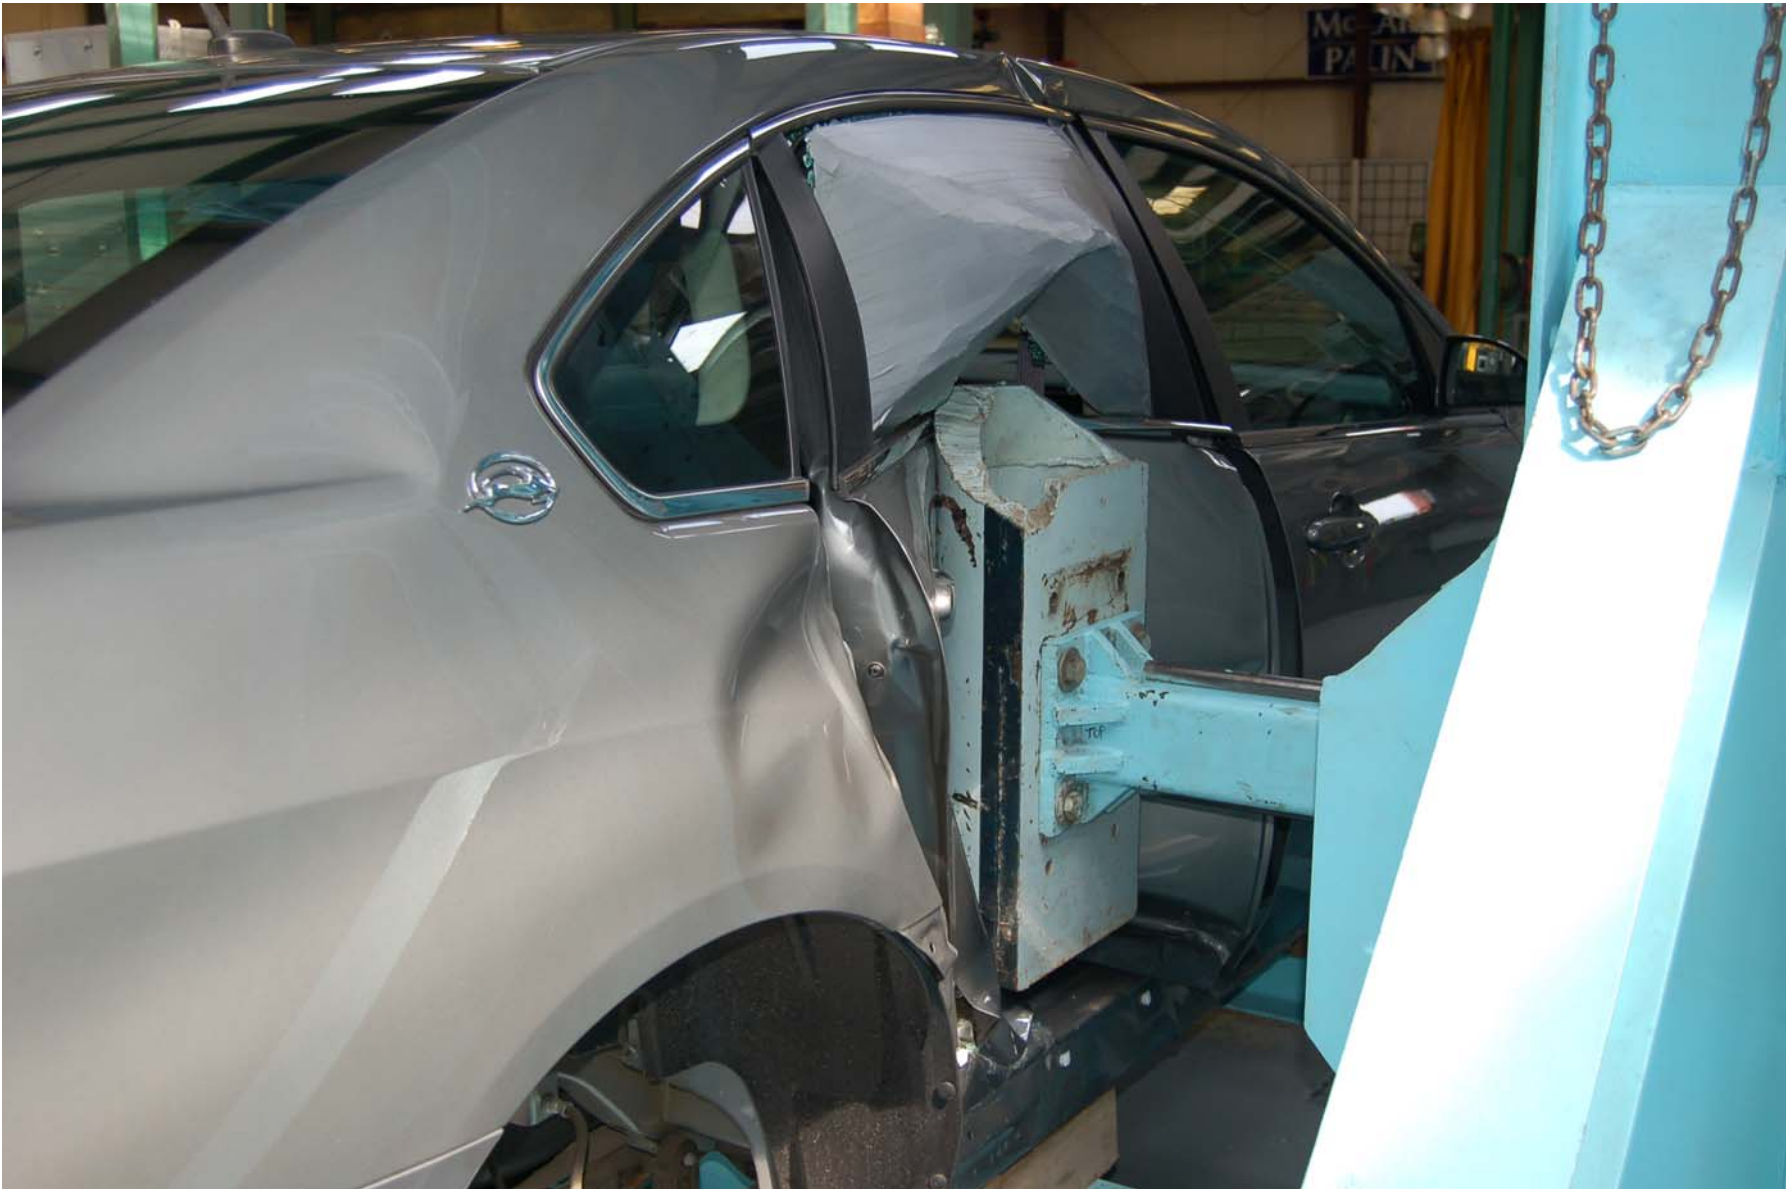
FIGURE 5.26
LOAD DEVICE AGAINST DOOR @ MAX LOAD – TEST 2

- A. The initial crush resistance was 4655 lbs.
 B. The intermediate crush resistance was 7816 lbs.
 C. The peak crush resistance was 13,318 lbs at 10.9 inches
 D. The rate of loading was .2"/sec

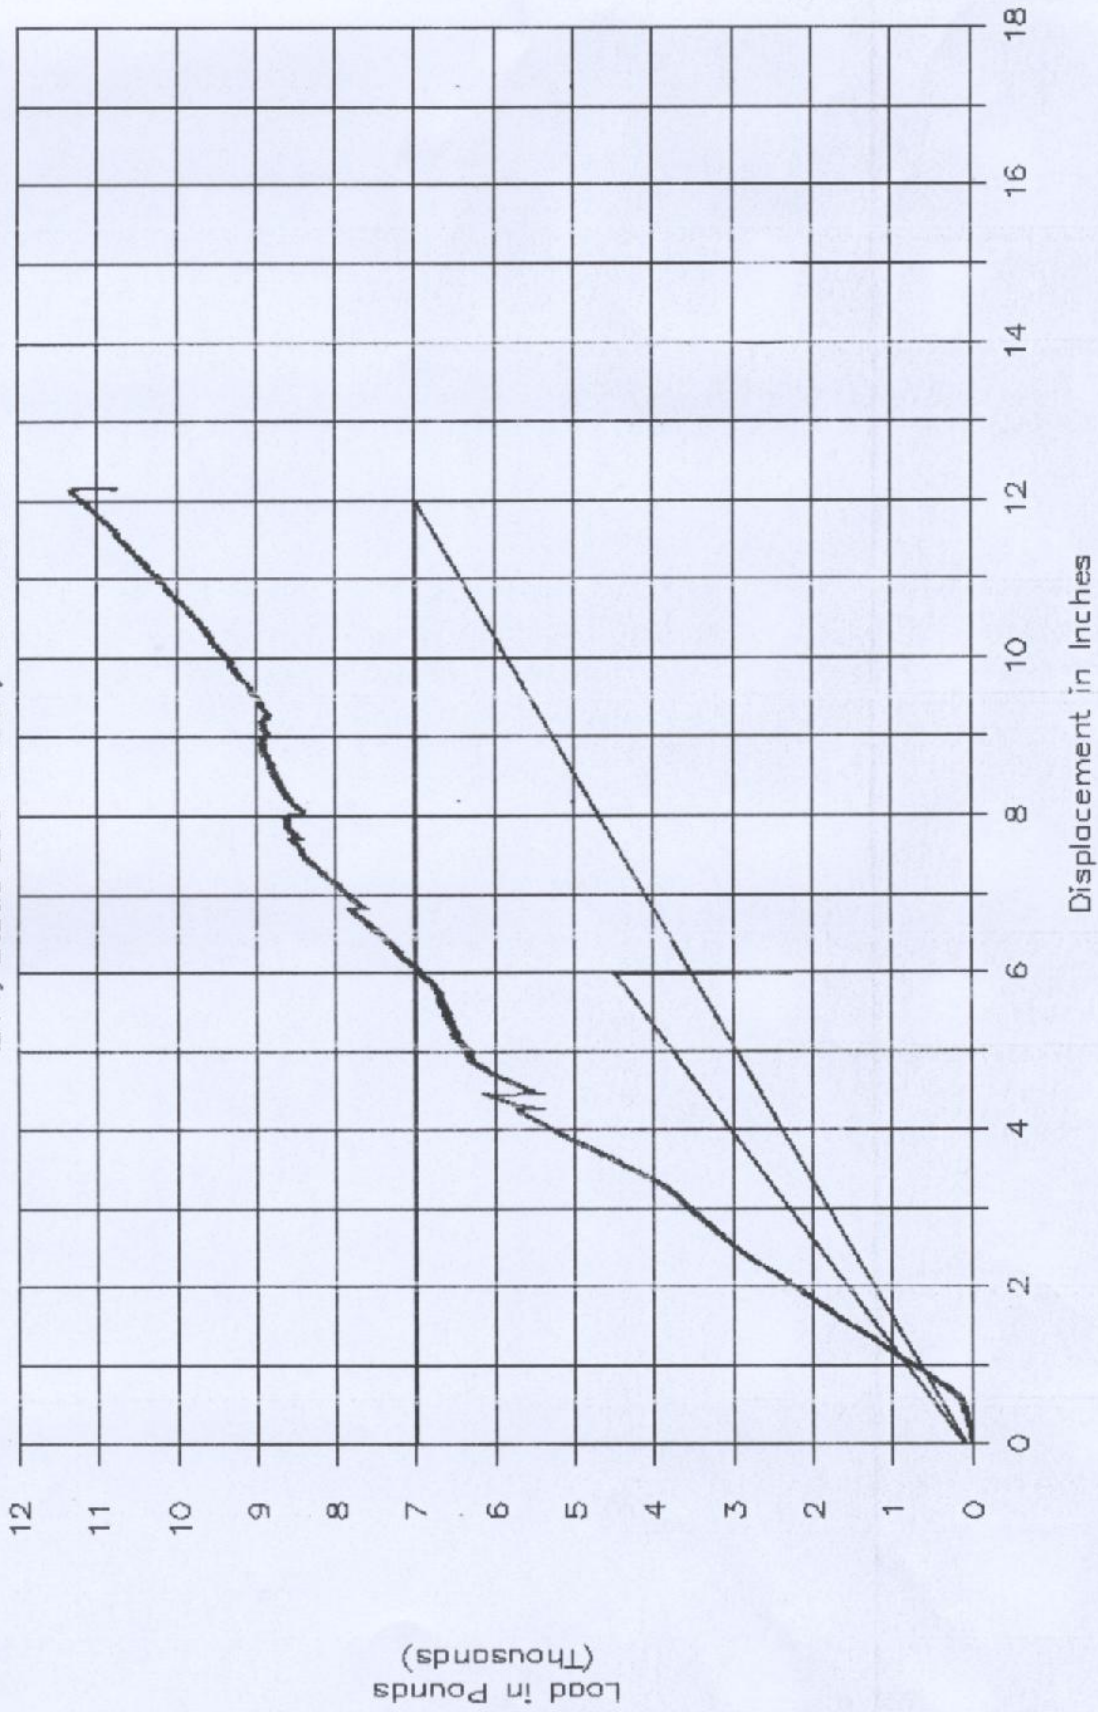
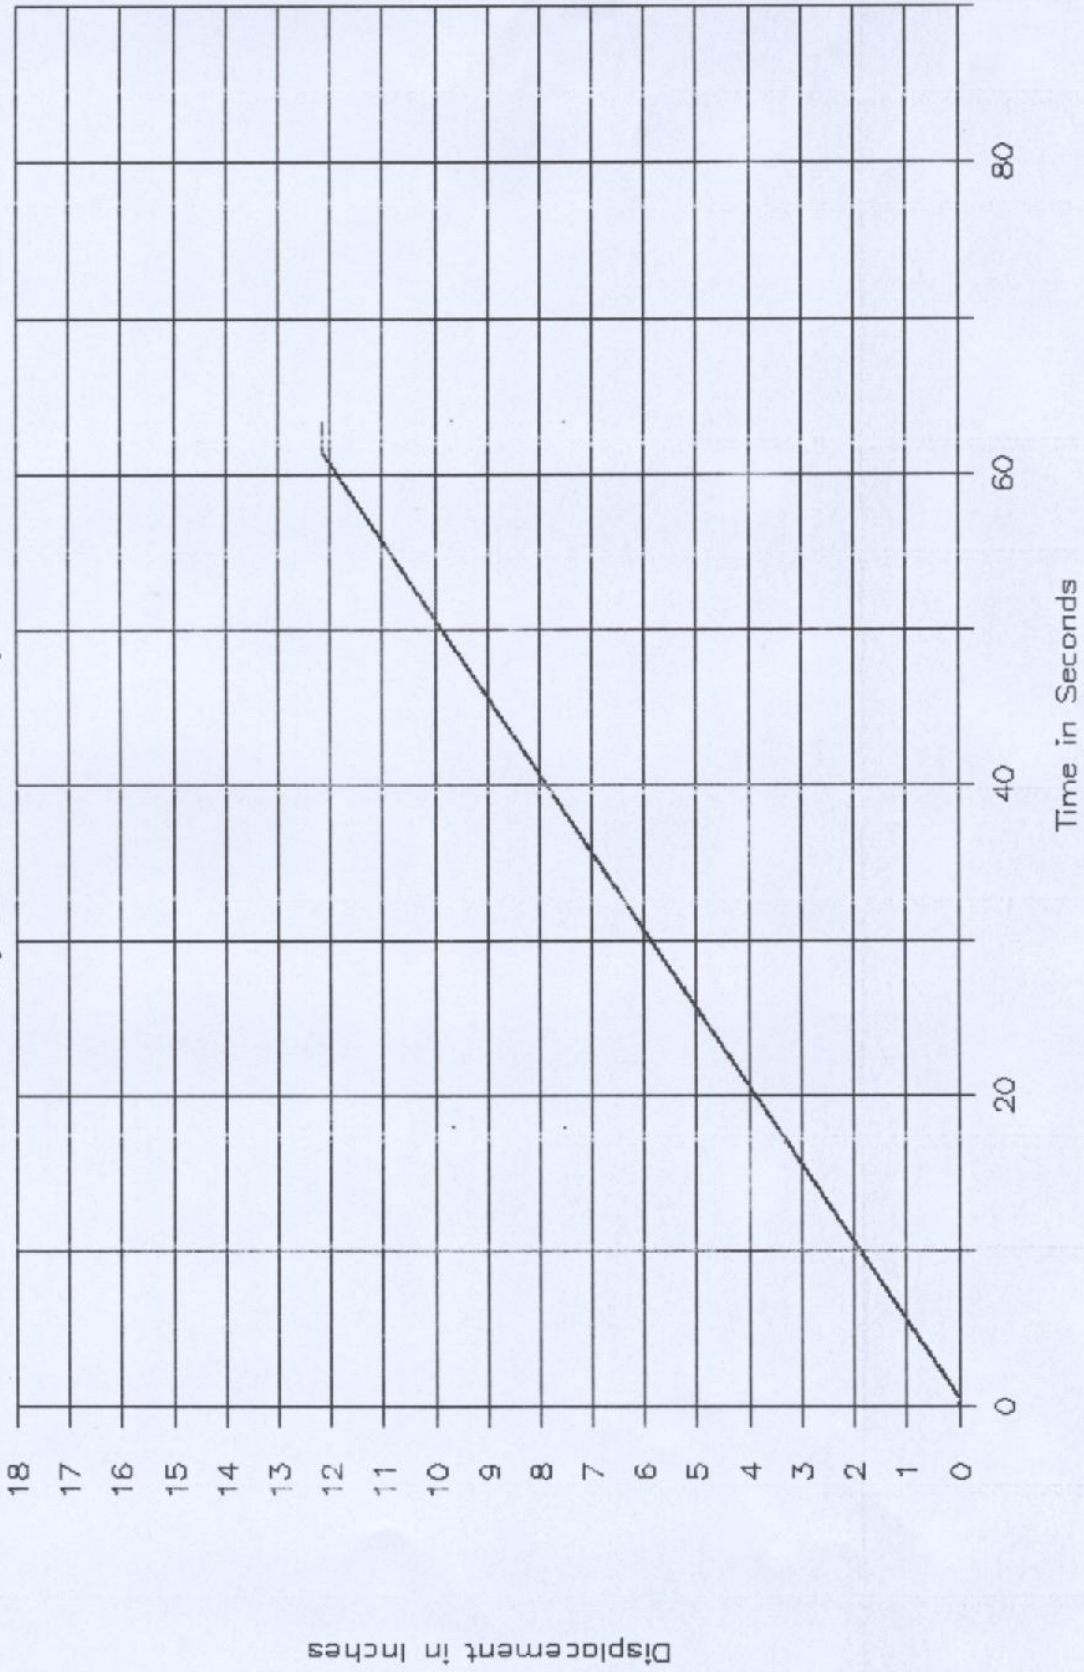
214, Static Door Crush, Left Front Door

- A. The initial crush resistance was 3692 lbs.
- B. The intermediate crush resistance was 6395 lbs.
- C. The peak crush resistance was 11,367 lbs at 12.1 inches

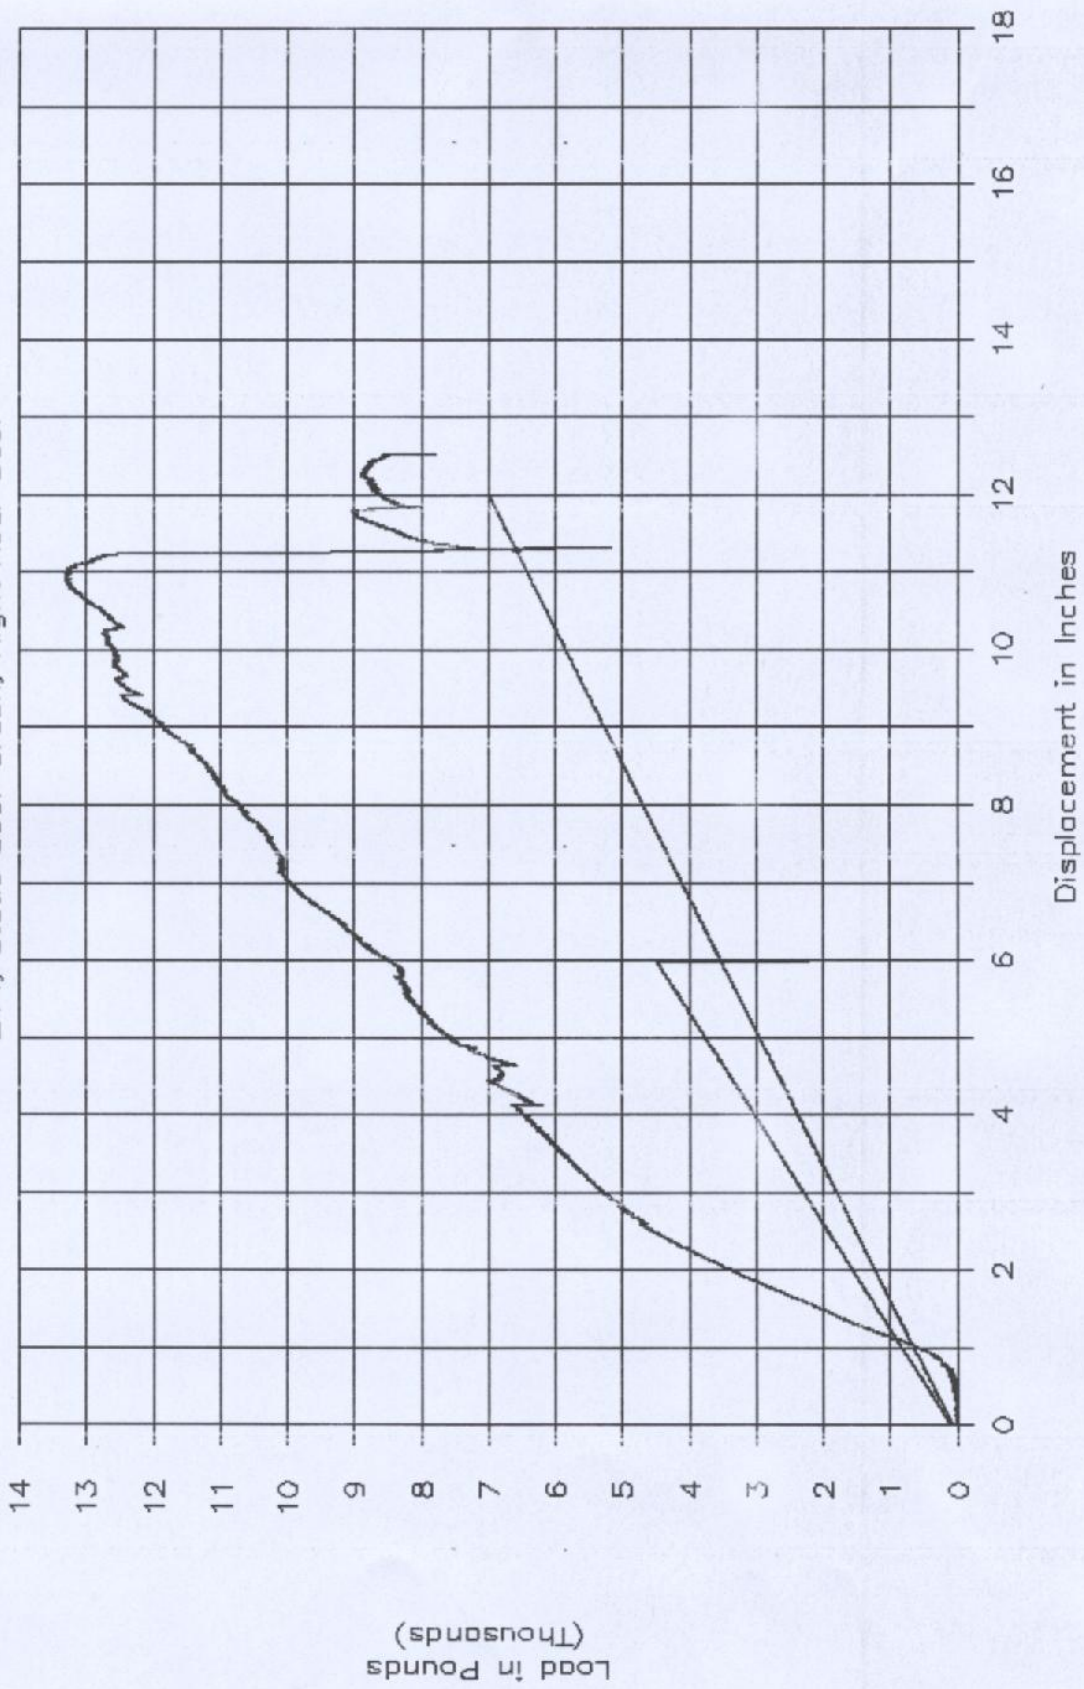
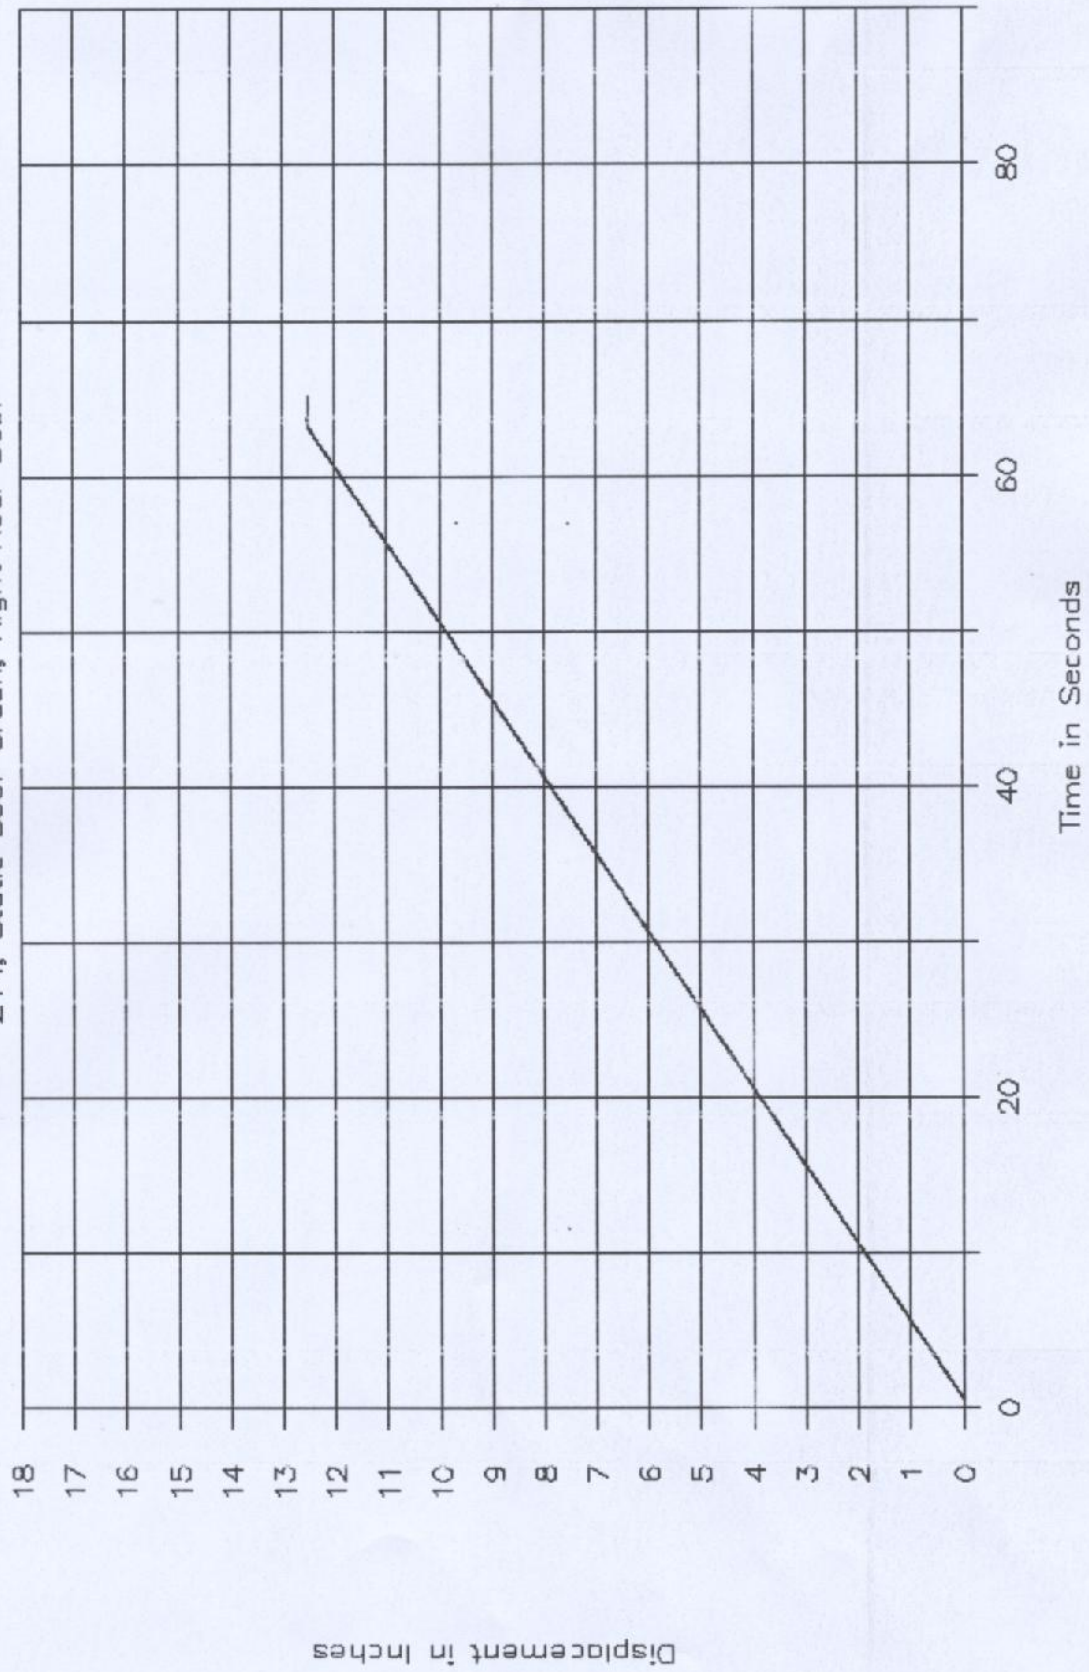
214, Static Door Crush, Right Rear Door

- A. The initial crush resistance was 4655 lbs.
 - B. The intermediate crush resistance was 7816 lbs.
 - C. The peak crush resistance was 13,318 lbs at 10.9 inches
- The time versus displacement plot showed that - -
