## SAFETY COMPLIANCE TESTING FOR FMVSS NO. 103 WINDSHIELD DEFROSTING AND DEFOGGING SYSTEMS

TOYOTA MOTOR CORPORATION 2009 LEXUS ES 350, PASSENGER CAR NHTSA NO. C95104

## GENERAL TESTING LABORATORIES, INC. 1623 LEEDSTOWN ROAD COLONIAL BEACH, VIRGINIA 22443

**FINAL REPORT**

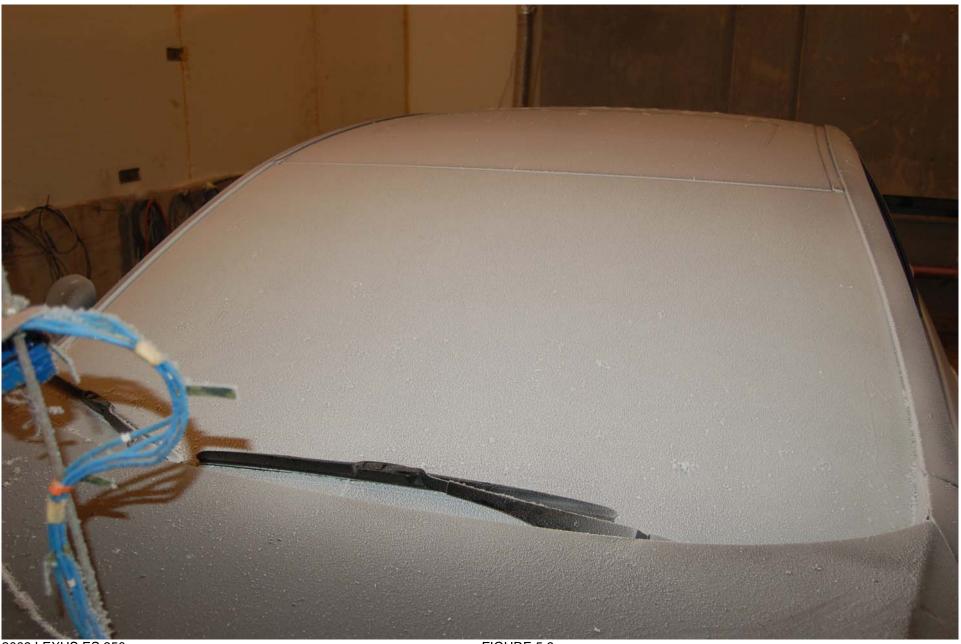
FIGURE 5.9 WINDSHIELD, PRE-TEST FROSTED STATE TEST #1

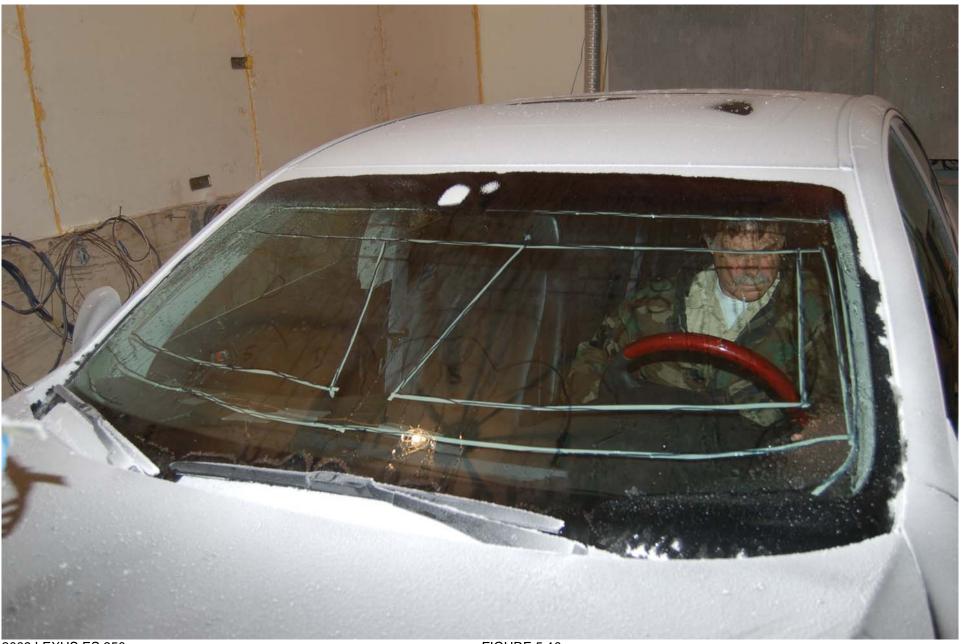
FIGURE 5.10 DEFROSTED AREA AT 15 MINUTES TEST #1

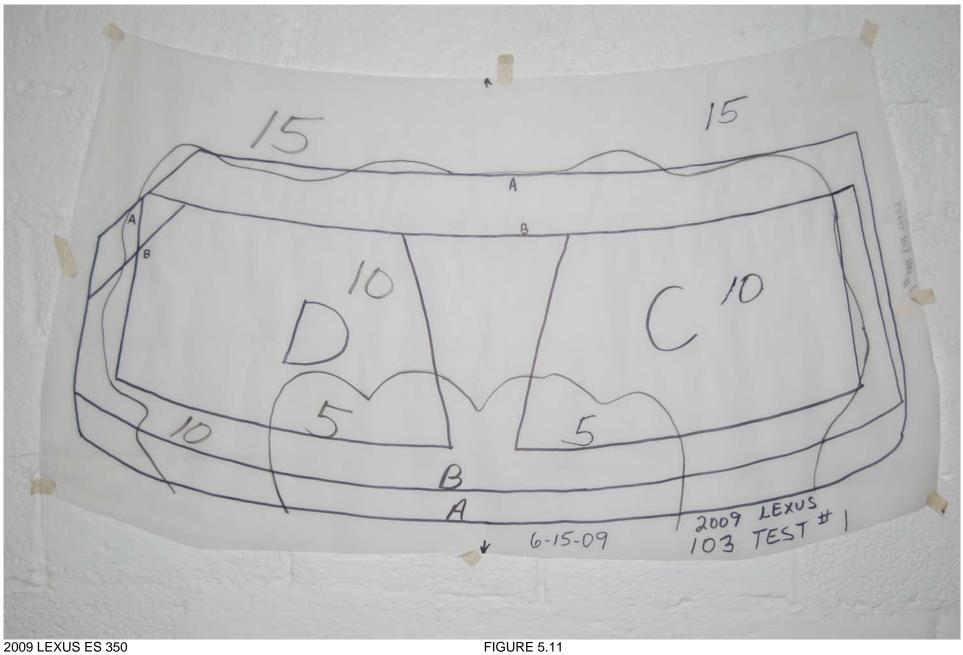
FIGURE 5.11 WINDSHIELD VELLUM PATTERN, POST TEST #1

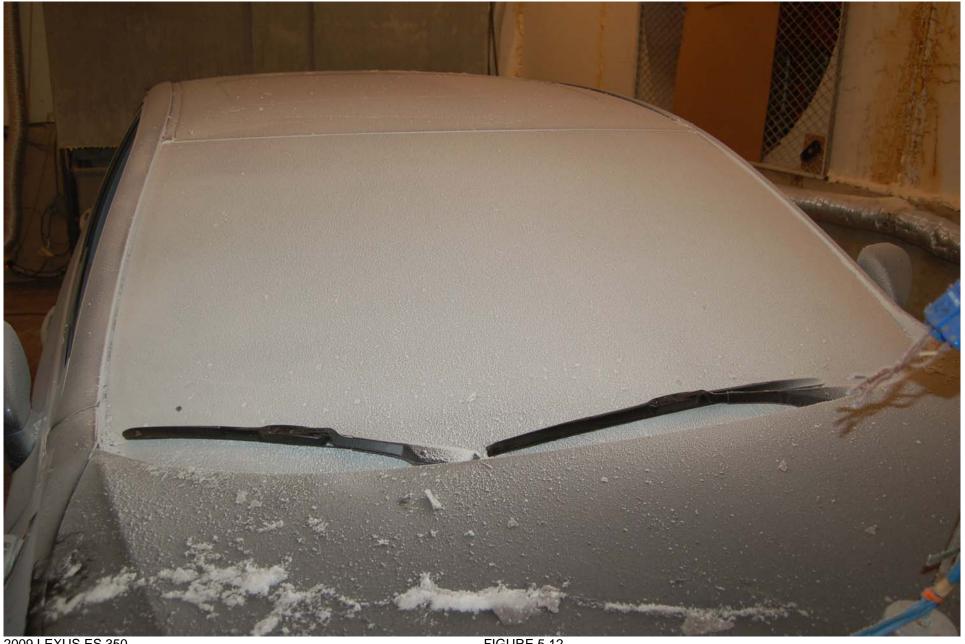
FIGURE 5.12 WINDSHIELD PRE-TEST FROSTED STATE #2

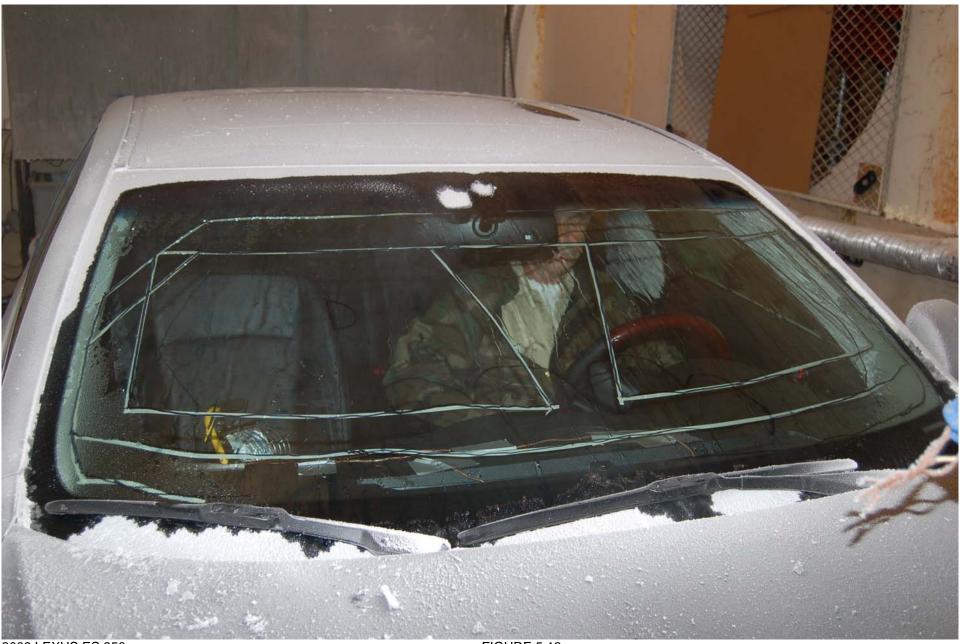
FIGURE 5.13 DEFROSTED AREA AT 15 MINUTES TEST #2

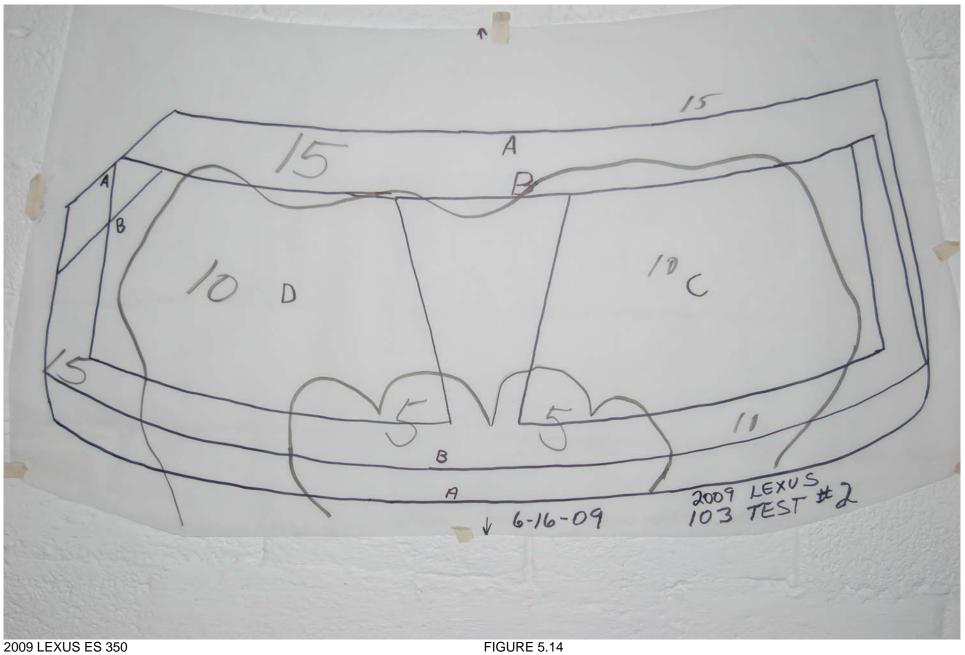
FIGURE 5.14 WINDSHIELD VELLUM PATTERN, POST TEST #2
