REPORT NUMBER: 201-CAL-09-06

**SAFETY COMPLIANCE TESTING FOR FMVSS 201
OCCUPANT PROTECTION IN INTERIOR IMPACT**

**GENERAL MOTORS DE MEXICO
2007 CHEVROLET HHR 4-DOOR**

NHTSA NUMBER: C70107
CALSPAN TEST NUMBER: 8884-01

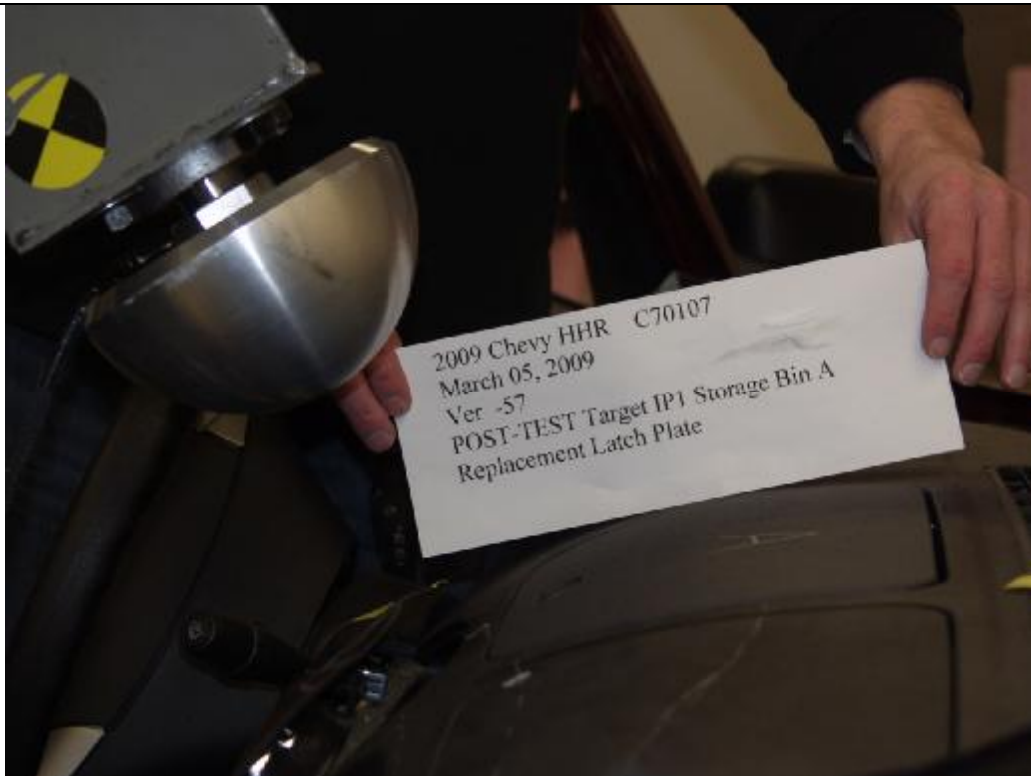
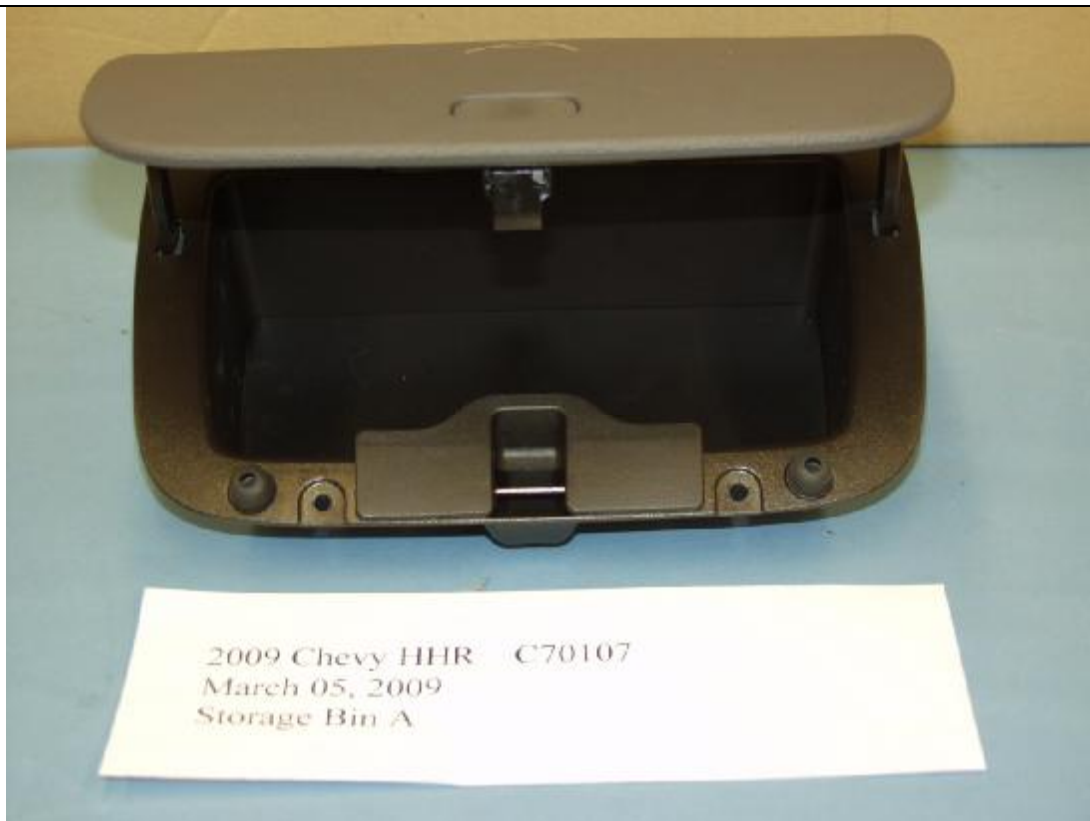
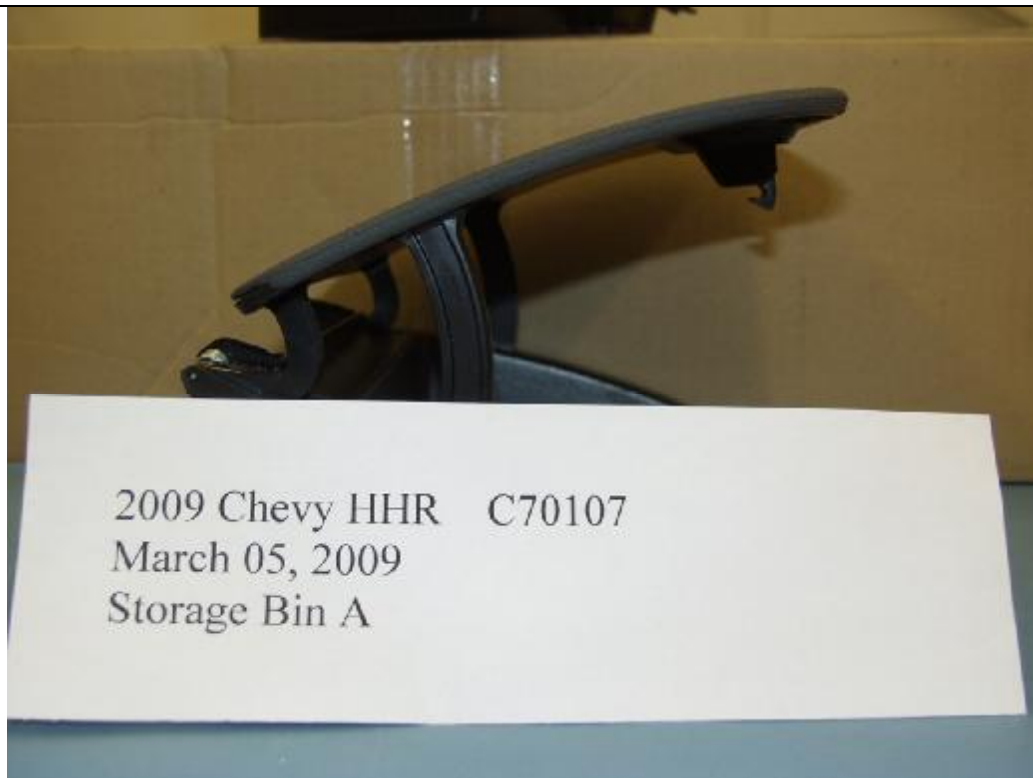
Figure A-16: INSTRUMENT PANEL STORAGE BIN A POST-TEST

Figure A-17: INSTRUMENT PANEL STORAGE BIN A POST-TEST

Figure A-18: INSTRUMENT PANEL STORAGE BIN A POST-TEST

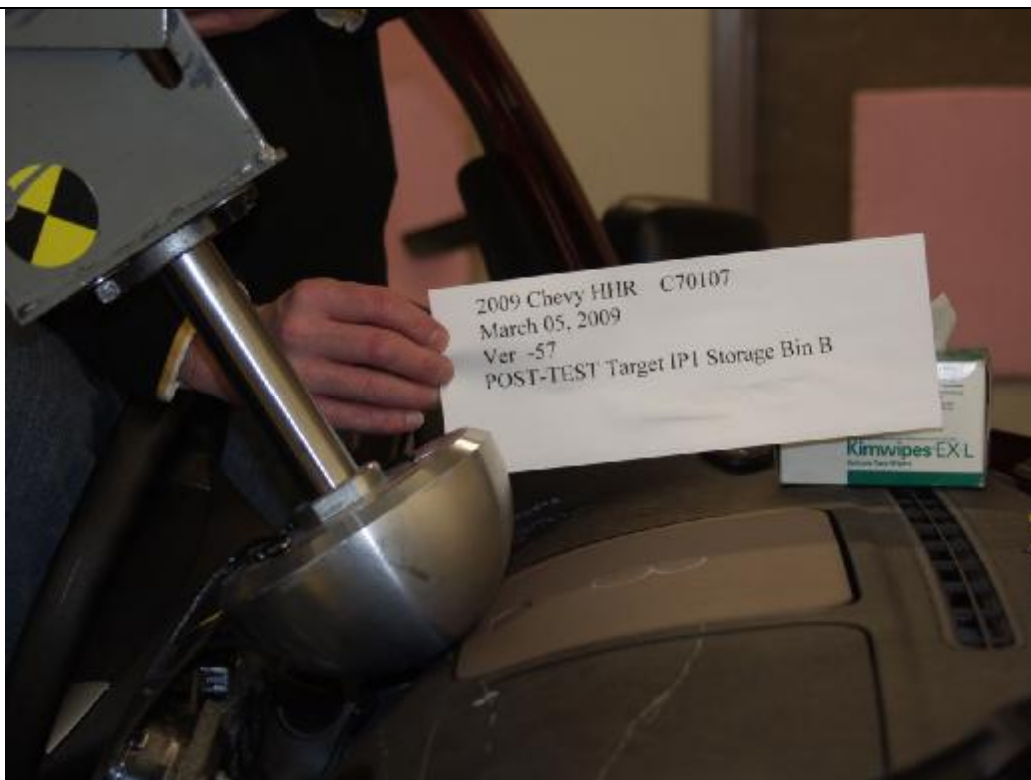
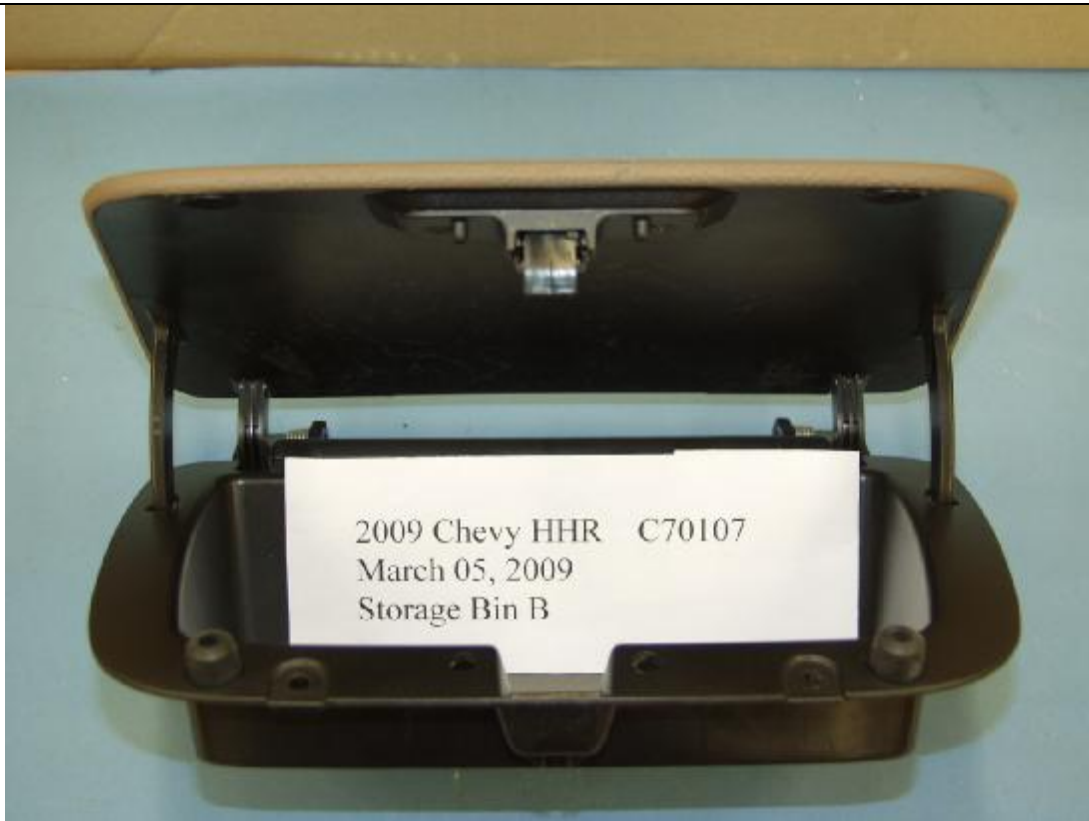
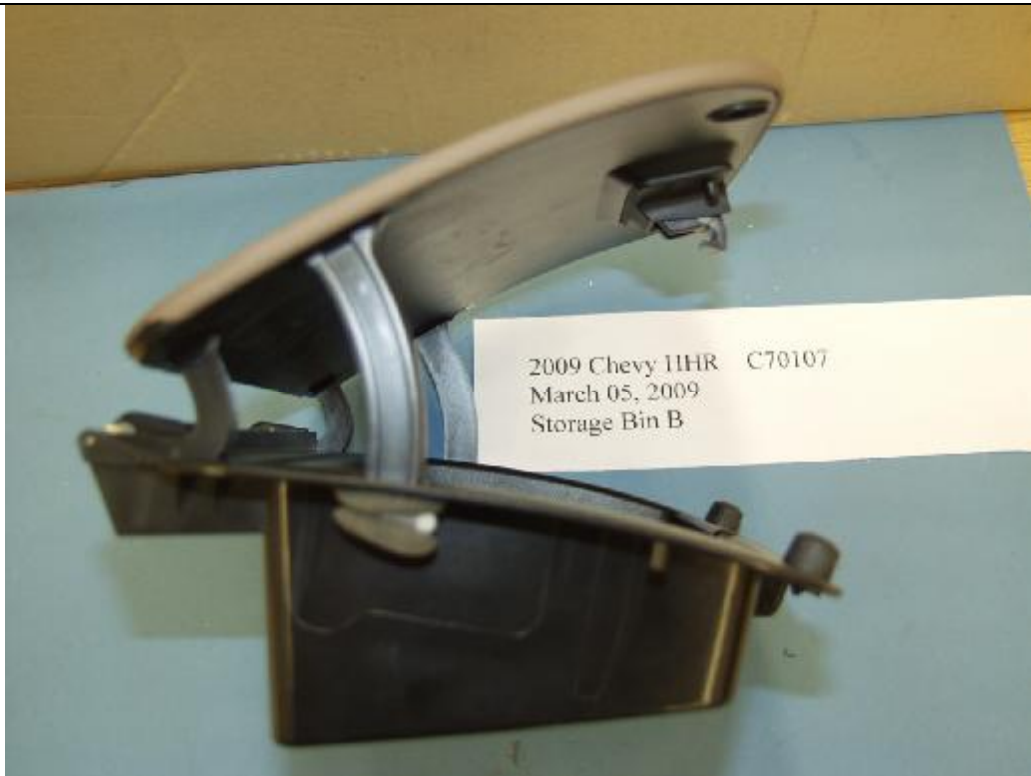
The instrument panel cover surrounding the air ducts, A/C and heating controls and radio separated along the upper perimeter.

Figure A-22: INSTRUMENT PANEL STORAGE BIN B POST-TEST

Figure A-23: INSTRUMENT PANEL STORAGE BIN B POST-TEST

Figure A-24: INSTRUMENT PANEL STORAGE BIN B POST-TEST

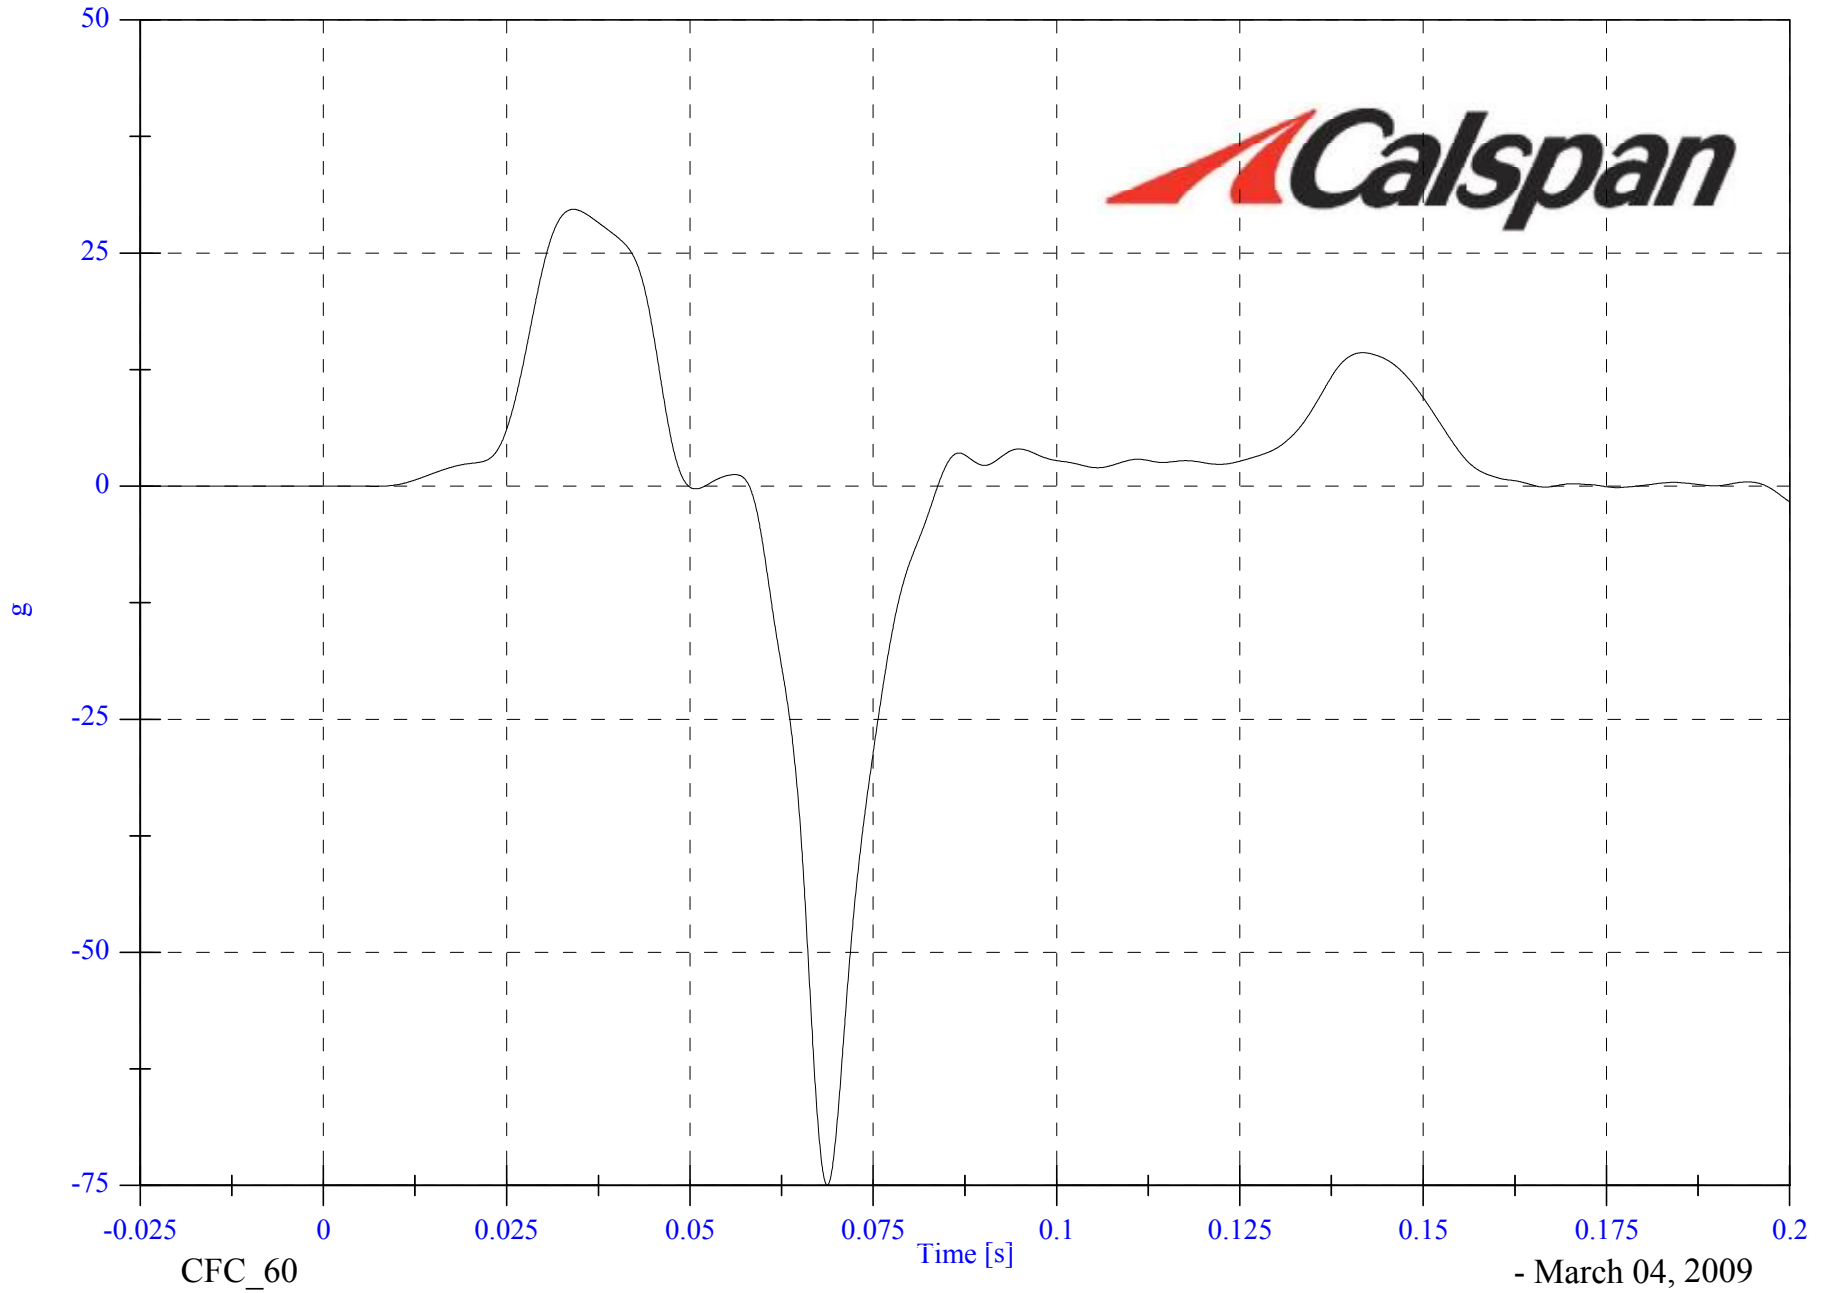
C70107 STORAGE BIN A WITH REPLACEMENT LATCH IMPACT PLOT #1

Max: 29.7 [g] at 0.034 [s]

Min: -75.0 [g] at 0.069 [s]

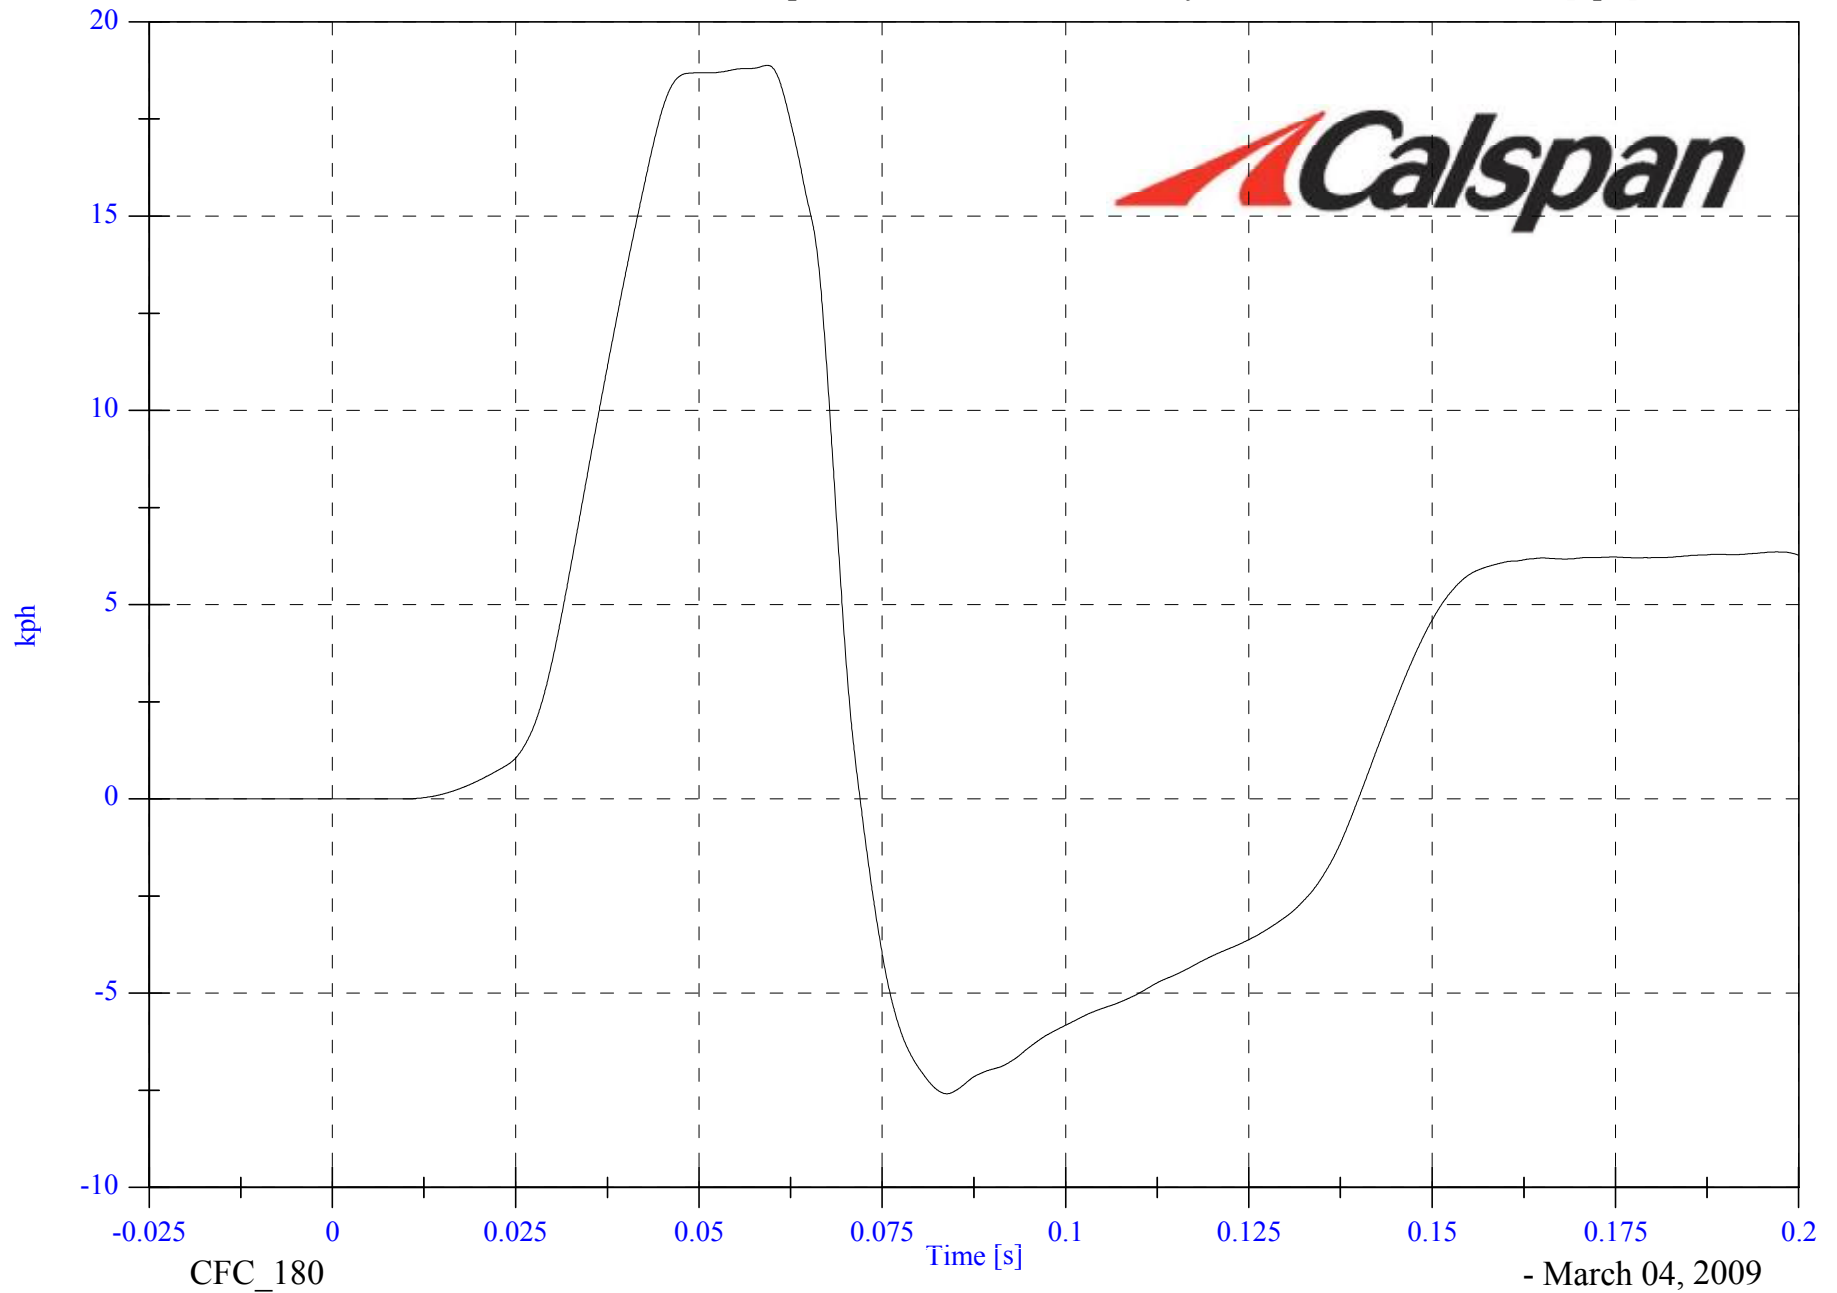
C70107 STORAGE BIN A WITH REPLACEMENT LATCH IMPACT PLOT #2

Max: 18.9 [kph] at 0.059 [s]

Min: -7.6 [kph] at 0.084 [s]

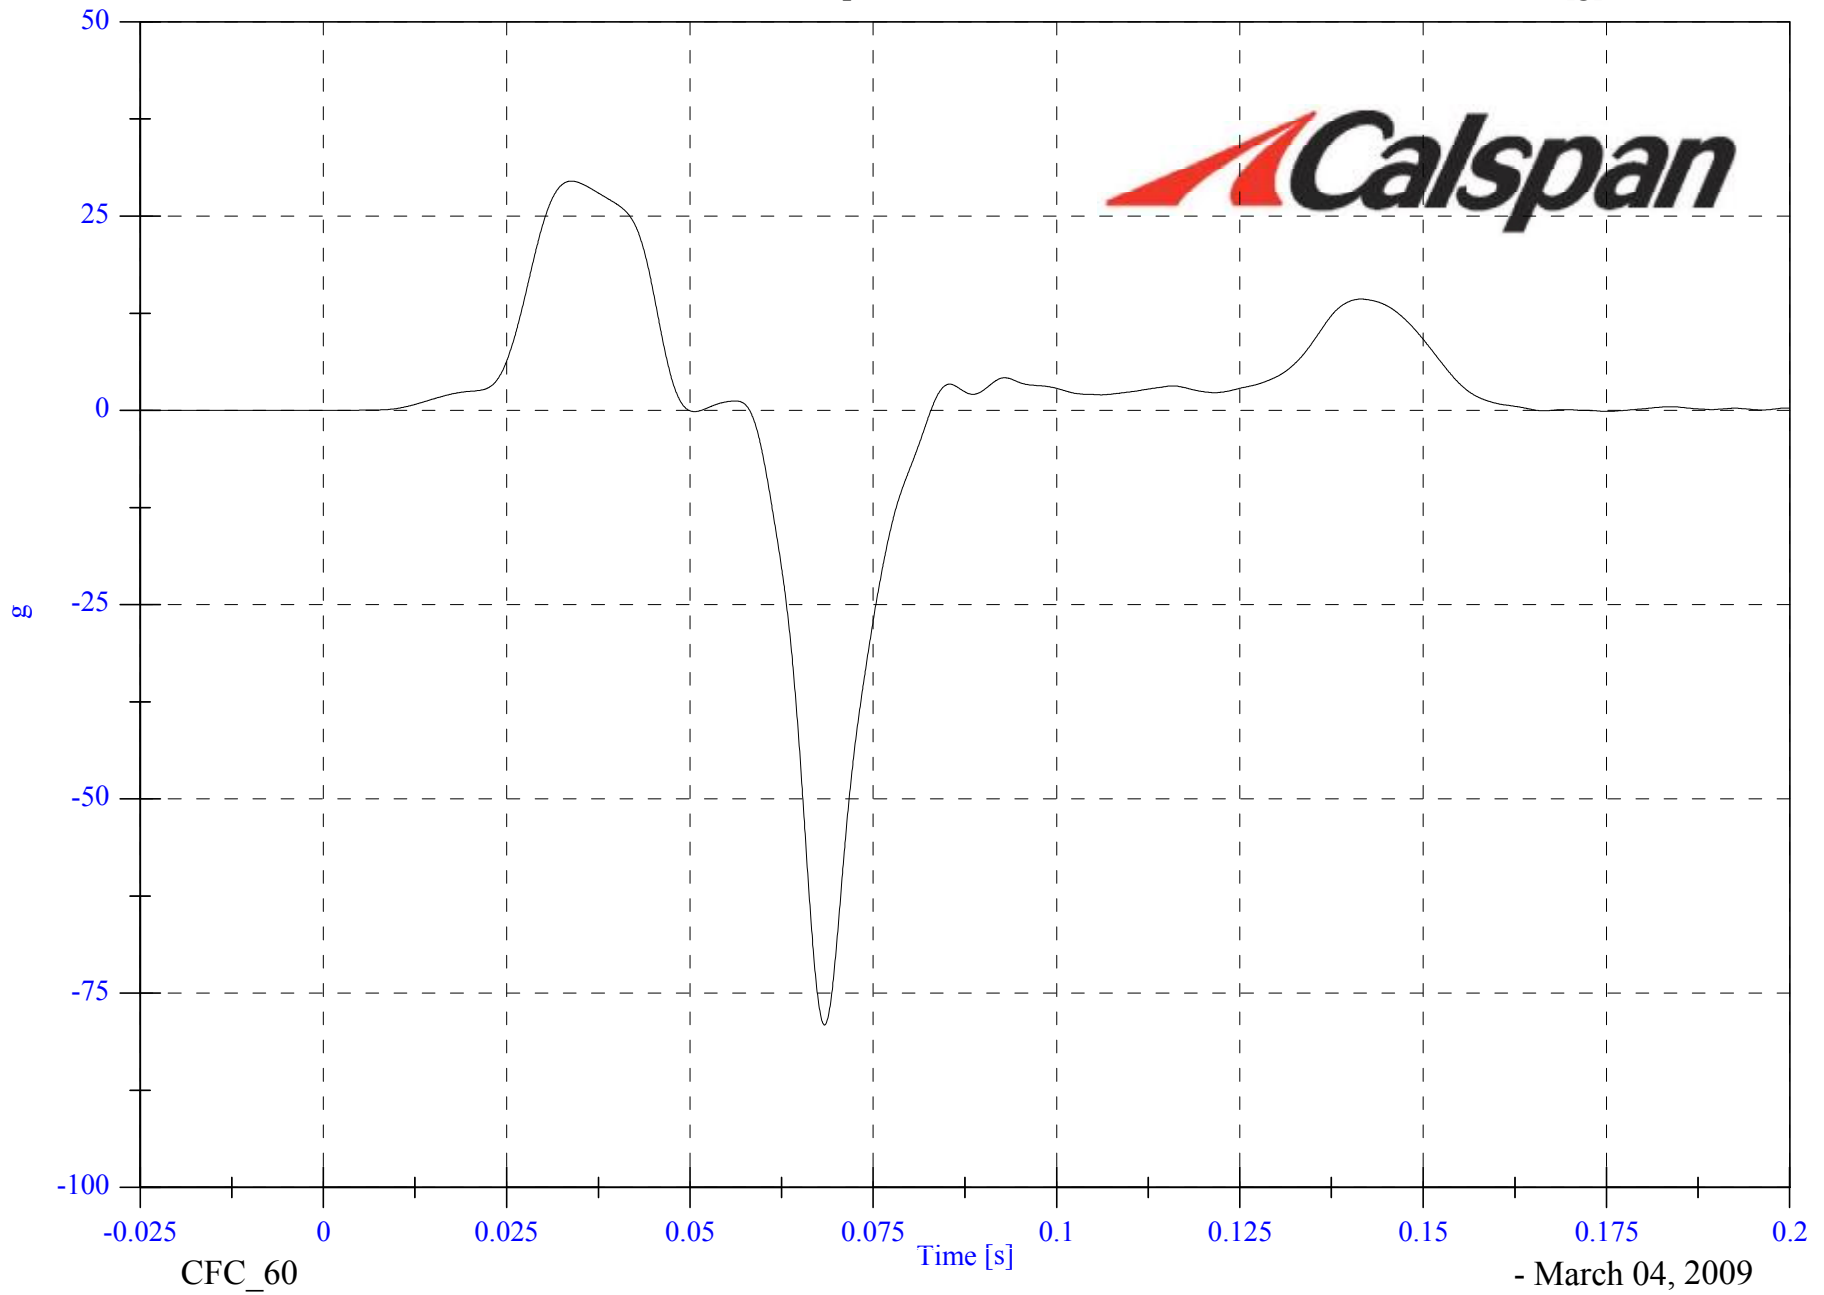
C70107 STORAGE BIN B IMPACT PLOT #1

Max: 29.5 [g] at 0.034 [s]

Min: -79.1 [g] at 0.068 [s]

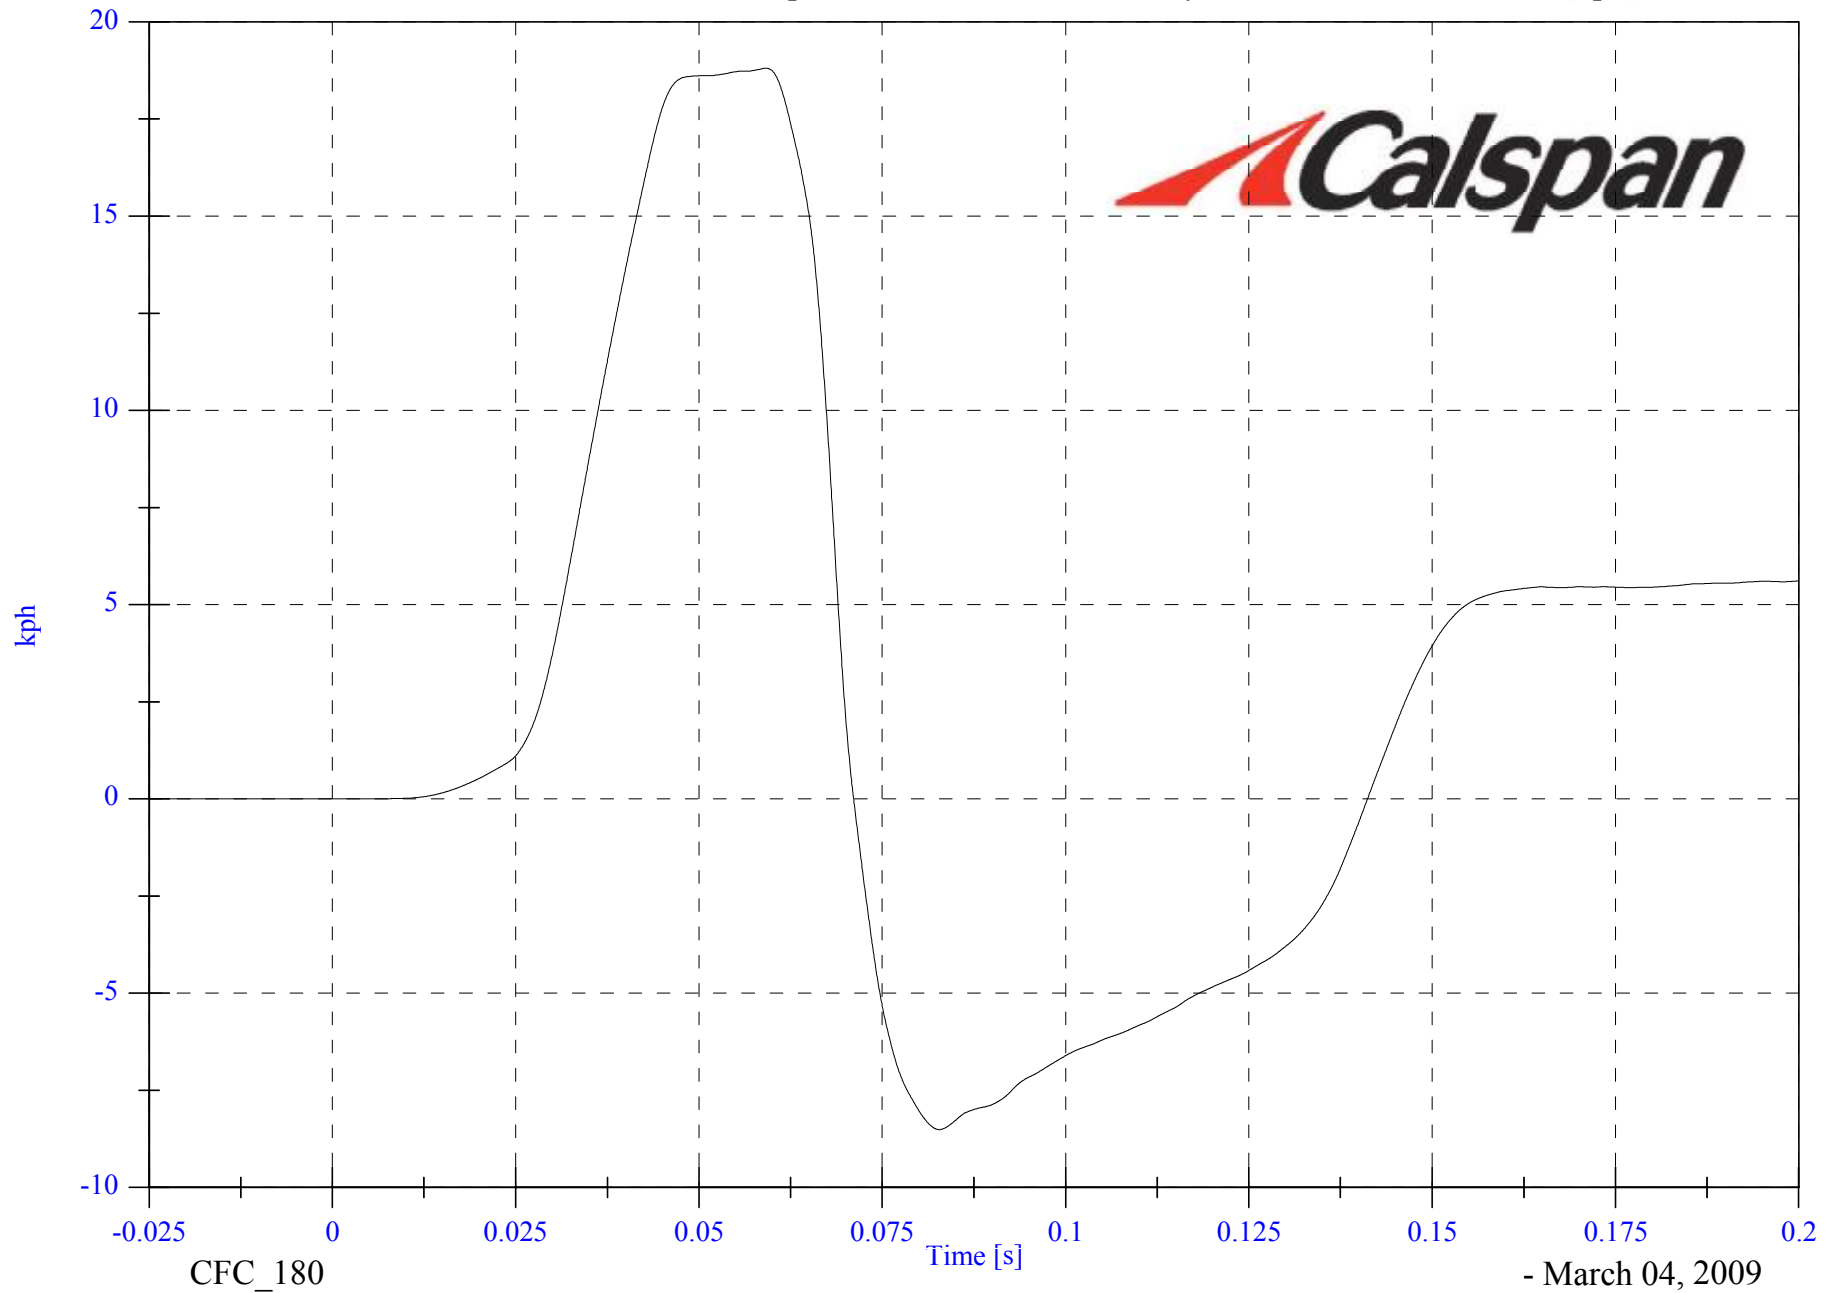
C70107 STORAGE BIN B IMPACT PLOT #2

Max: 18.8 [kph] at 0.059 [s]

Min: -8.5 [kph] at 0.083 [s]
