**REPORT NUMBER: 301-MGA-2010-005**

**SAFETY COMPLIANCE TESTING FOR FMVSS 301R  
FUEL SYSTEM INTEGRITY – REAR IMPACT**

**NISSAN MOTOR COMPANY LTD  
2010 NISSAN CUBE  
NHTSA NUMBER: CA5201**

**PREPARED BY:  
MGA RESEARCH CORPORATION  
5000 WARREN ROAD  
BURLINGTON, WI 53105**

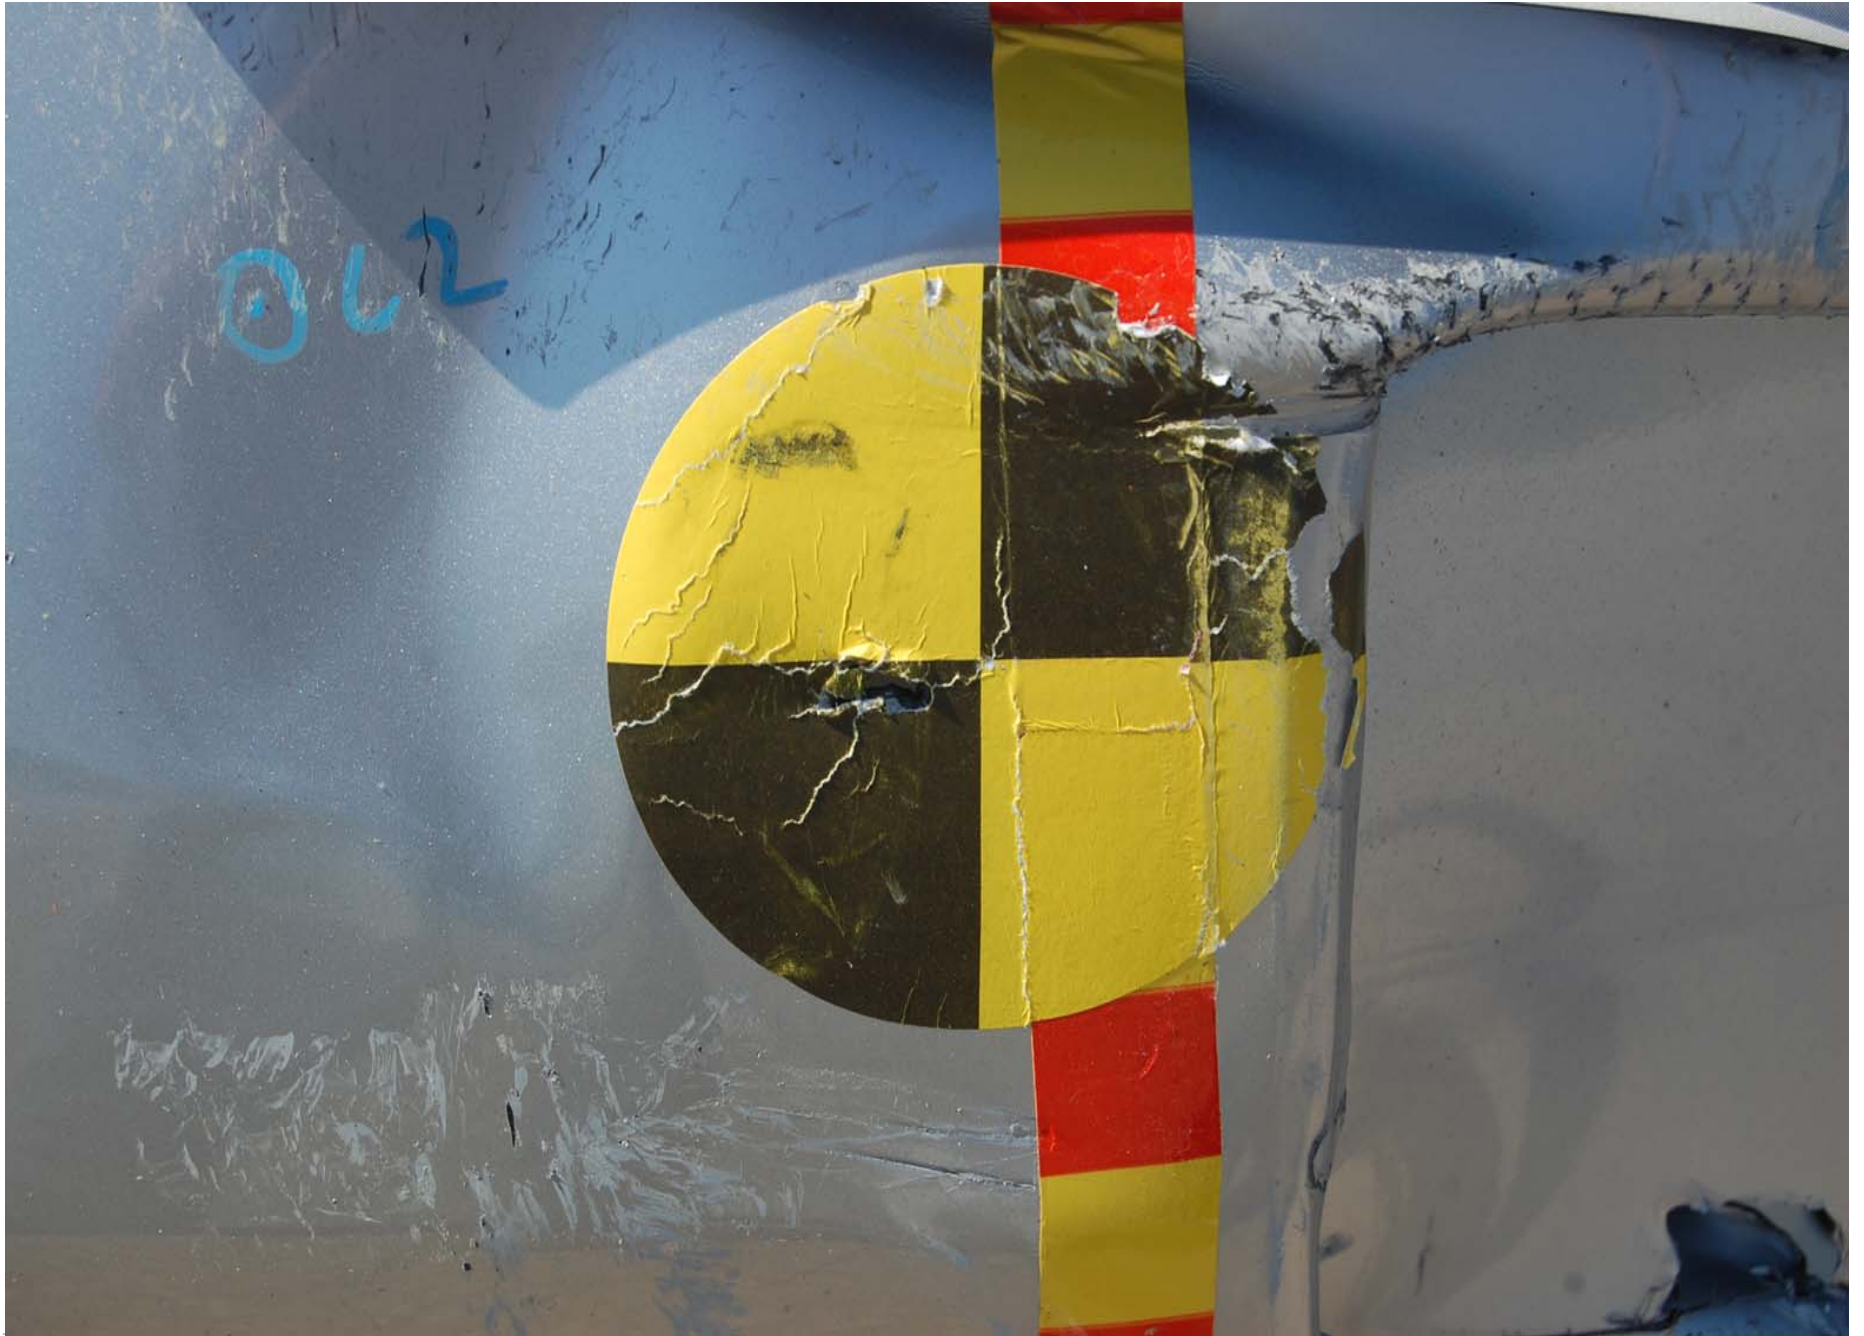
Units: mm
Vertical distance from target center (+ above target / - below target)	4 down
Horizontal distance from target center (+ to the right / - to the left)	8 left

Post-Test Impact Point

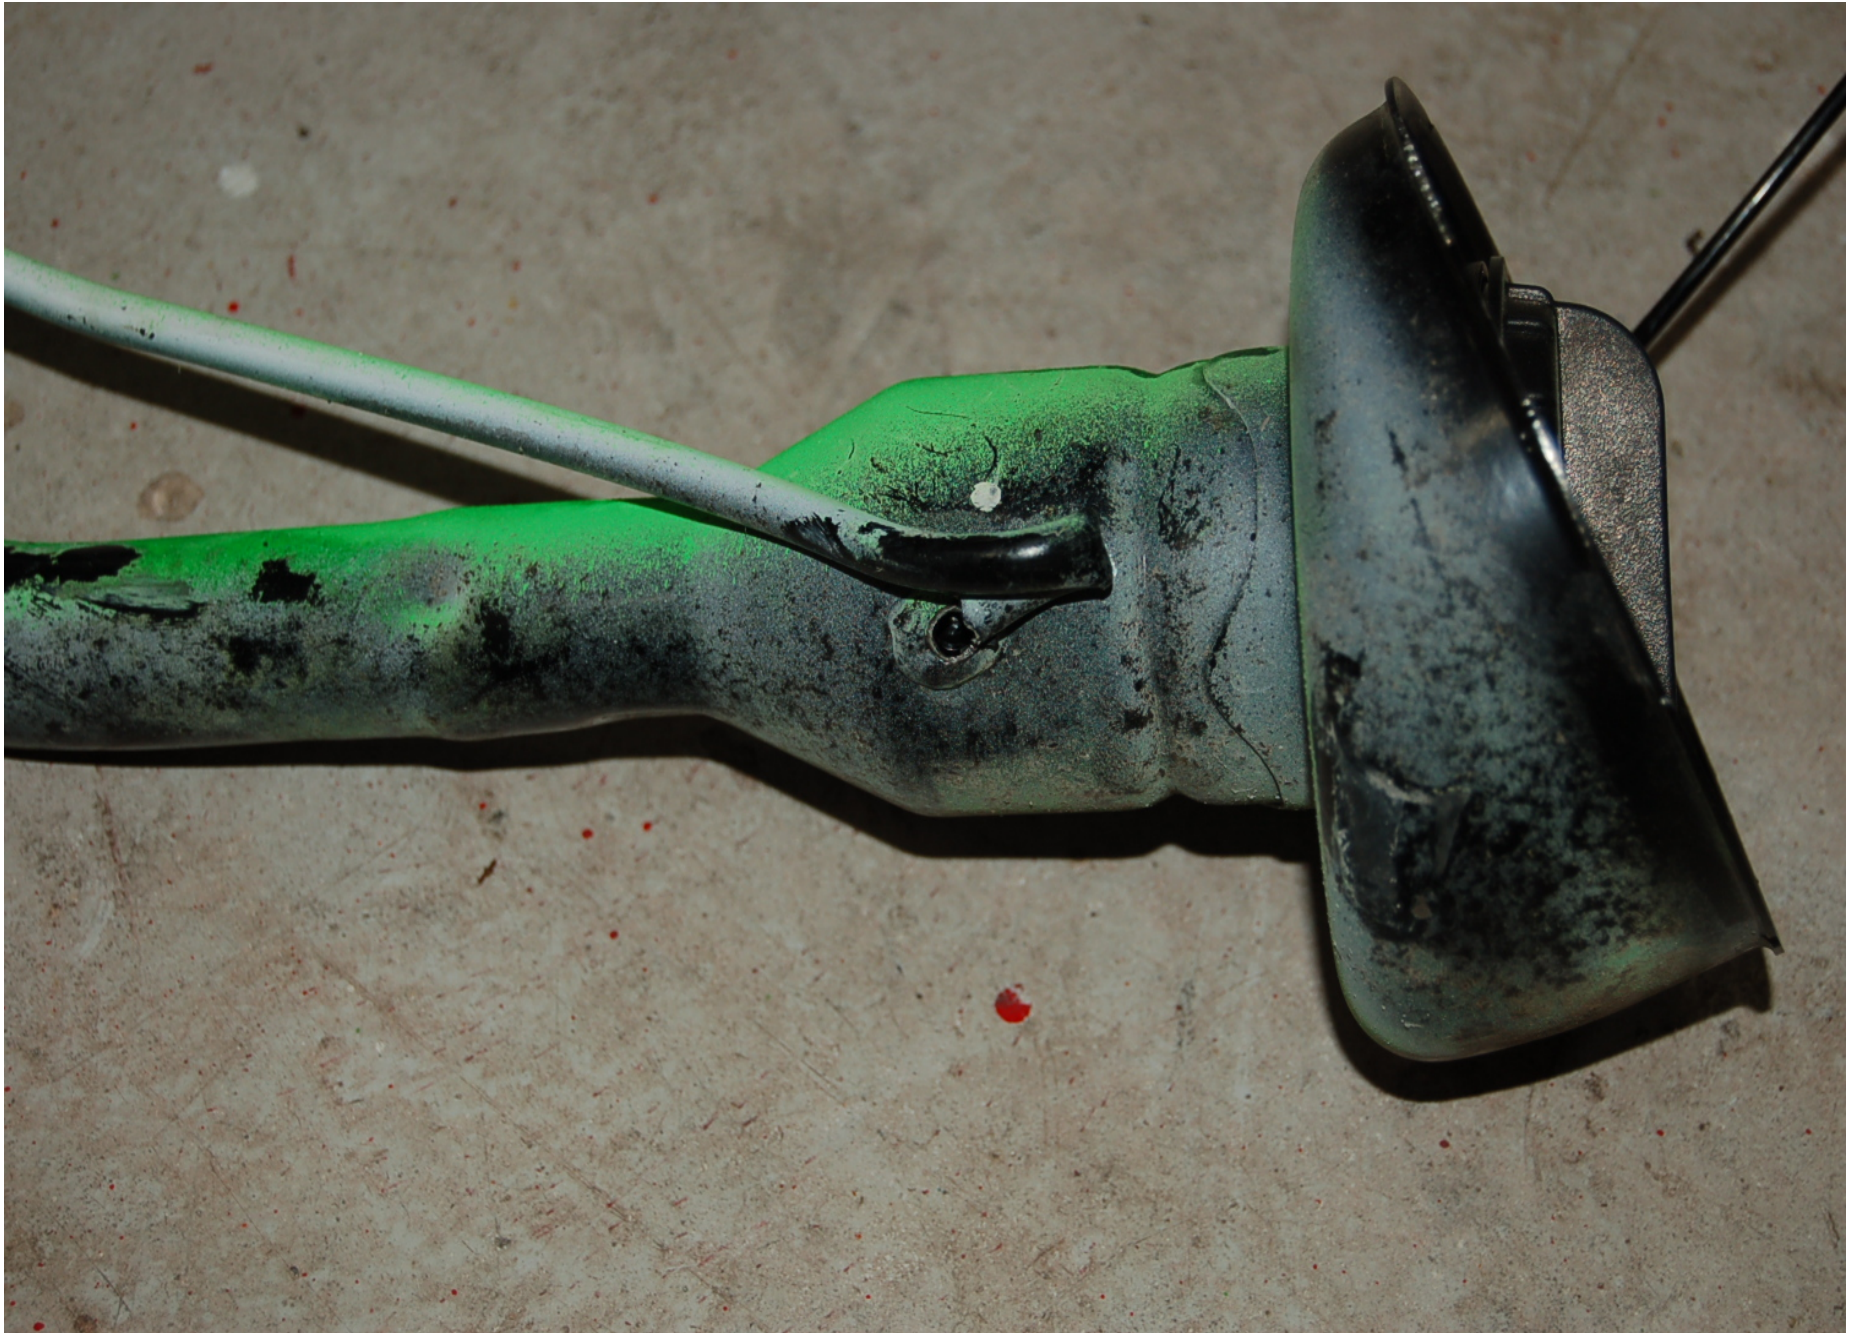
A-39.

There was Stoddard Solvent leakage during the static rollover, see page 11 at the end of this report for further details.

\*\* Due to Stoddard Solvent leakage the static rollover was not completed

Leak Point at 0°

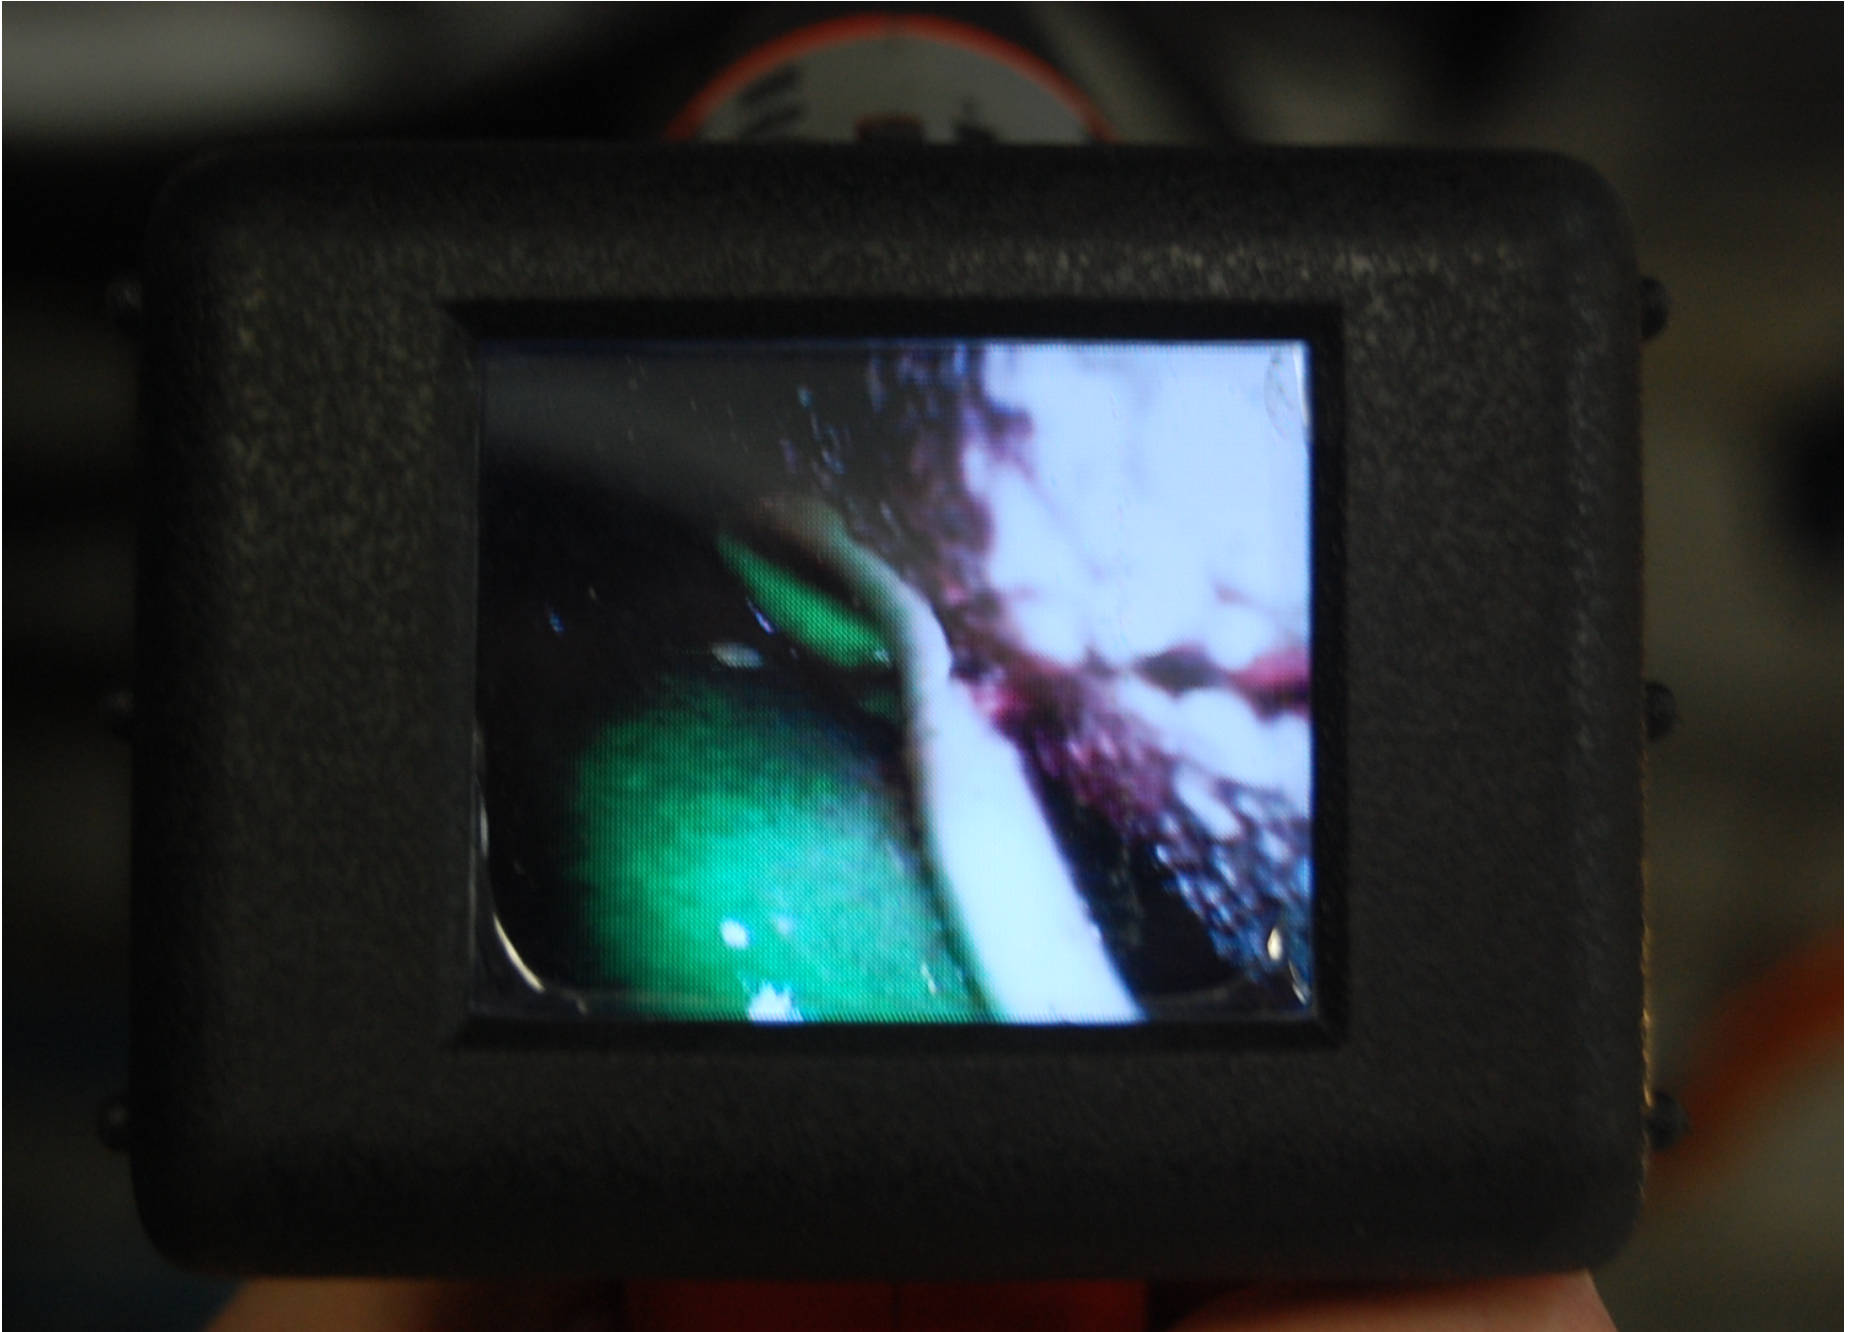
Leak Point Post Inspection
