REPORT NUMBER: 305-CAL-10-2

**SAFETY COMPLIANCE TESTING FOR FMVSS 305
ELECTRIC POWERED VEHICLES: ELECTROLYTE SPILLAGE
AND ELECTRICAL SHOCK PROTECTION**

Honda Motor Co., LTD.
Honda Insight
4-Door Sedan

NHTSA NUMBER: CA5302

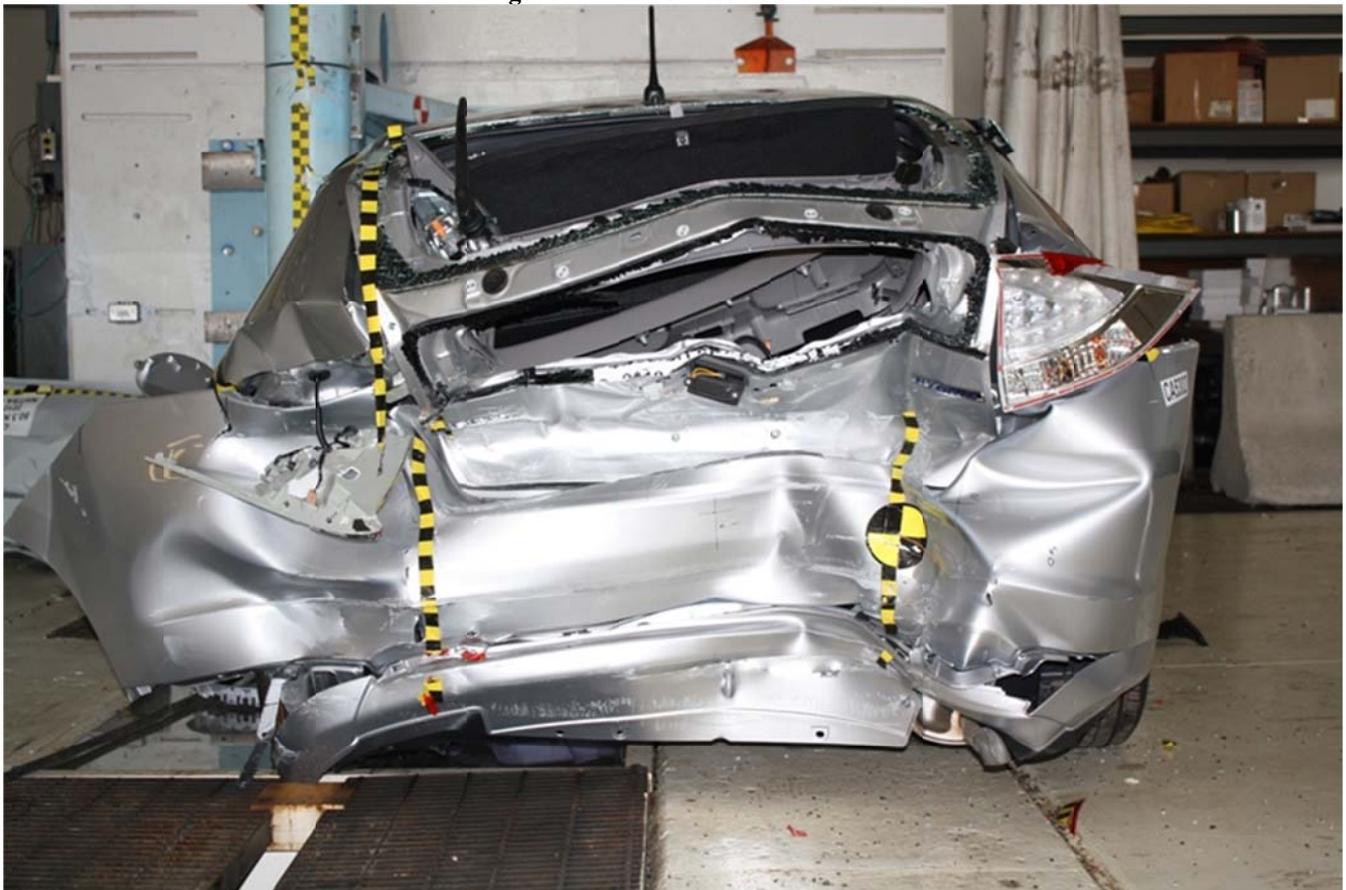
Figure A-22: Post-Test Rear View

Left Side	Centerline	Right Side
Pre-Test	4238	4378	4240
Post-Test	3802	3897	3948
Crush	436	481	292

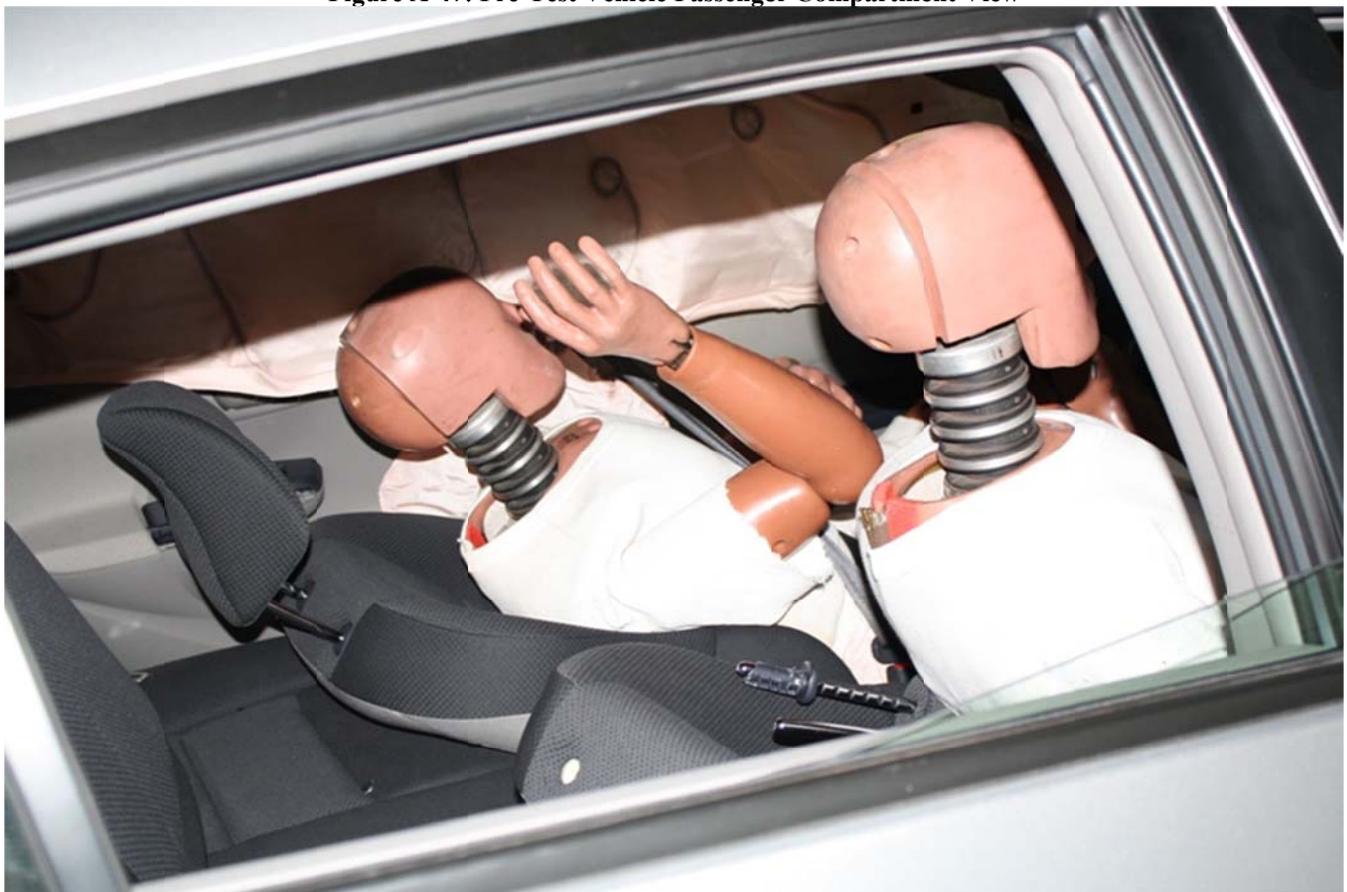
Figure A-48: Post-Test Vehicle Passenger Compartment View

LOCATION	SEAT MOVEMENT (mm)	SEAT BACK FAILURE
P1 (Left Front)	None	Slightly reclined
P2 (Right Front)	None	Slightly reclined

Curtain bag deployed on driver side.
