REPORT NUMBER: 301-MGA-2011-002

SAFETY COMPLIANCE TESTING FOR FMVSS 301R FUEL SYSTEM INTEGRITY – REAR IMPACT

VOLKSWAGEN DE MEXICO 2011 VOLKSWAGEN JETTA NHTSA NUMBER: CB5801

PREPARED BY:
MGA RESEARCH CORPORATION
5000 WARREN ROAD
BURLINGTON, WI 53105

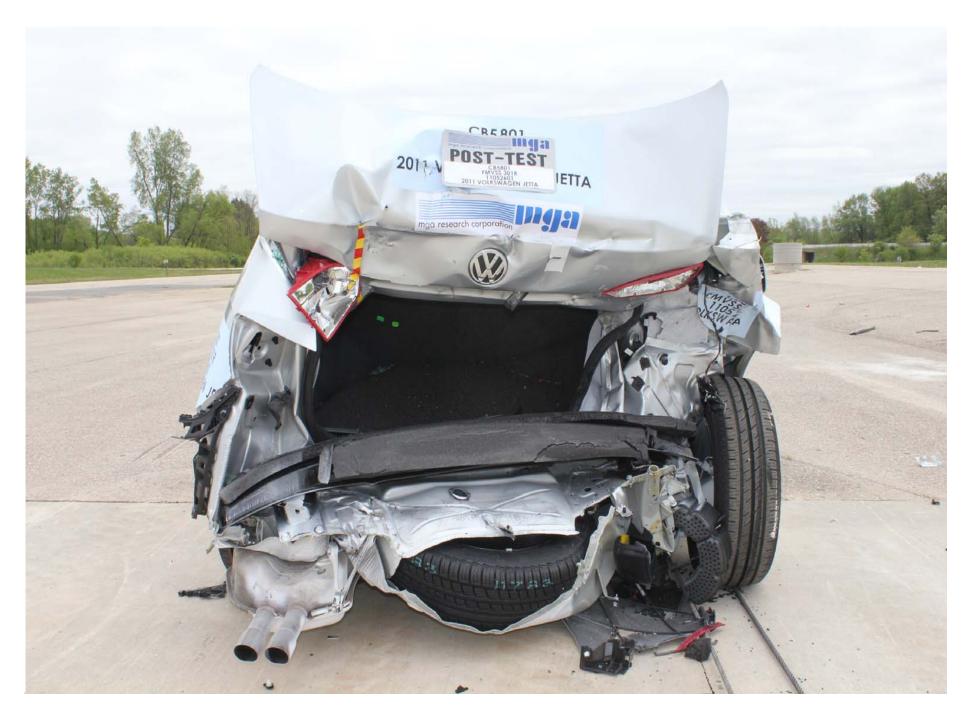
Post-Test Rear View of Vehicle

There was no Stoddard Solvent leakage after the event or during any phase of the static rollover.

The vehicle appeared to comply with all the requirements of FMVSS No. 301 "Fuel System Integrity."

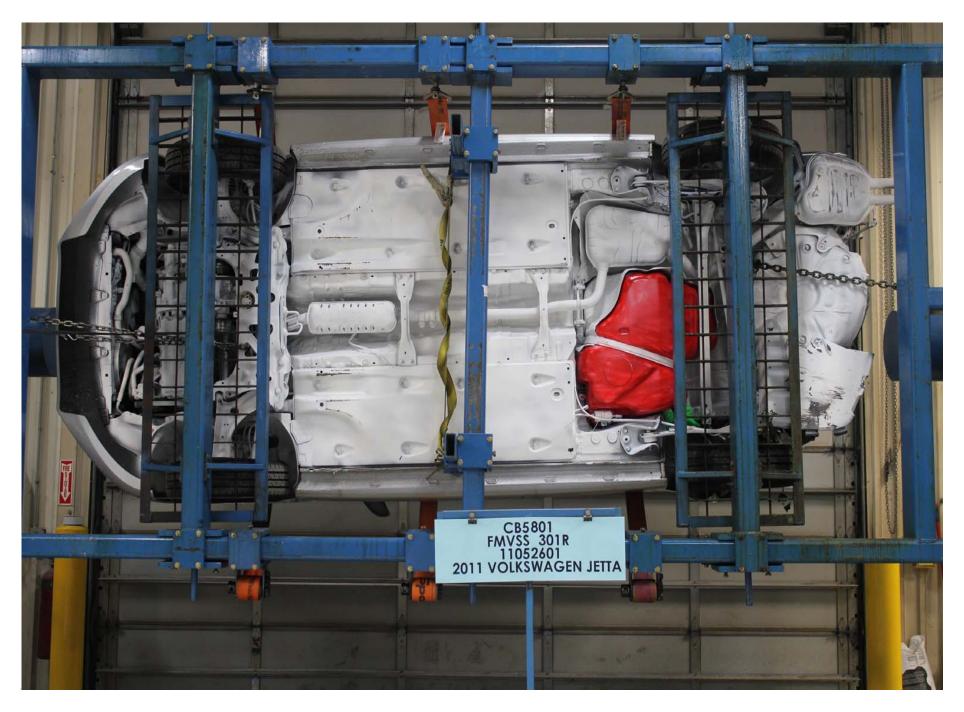
Static Rollover at 90 Degrees

Test Phase	Spillage (g)	Spillage Details
First 5 minutes from onset of rotation	0	
Sixth minute from onset of rotation	0	
Seventh minute from onset of rotation	0	
Eight minute if required	N/A

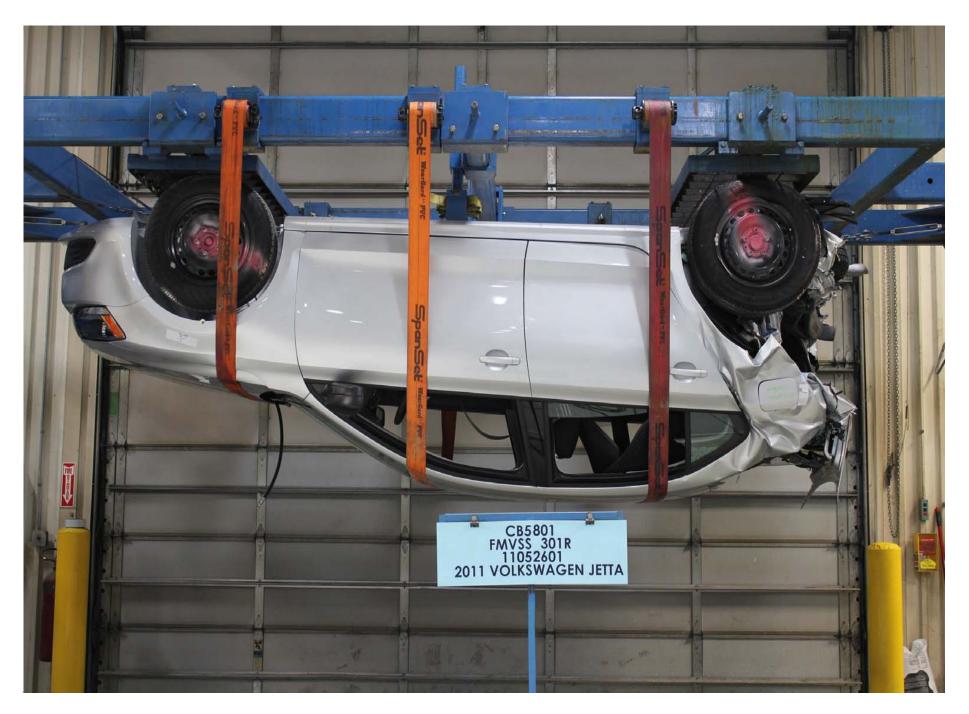
Static Rollover at 180 Degrees

Test Phase	Spillage (g)	Spillage Details
First 5 minutes from onset of rotation	0	
Sixth minute from onset of rotation	0	
Seventh minute from onset of rotation	0	
Eight minute if required	N/A

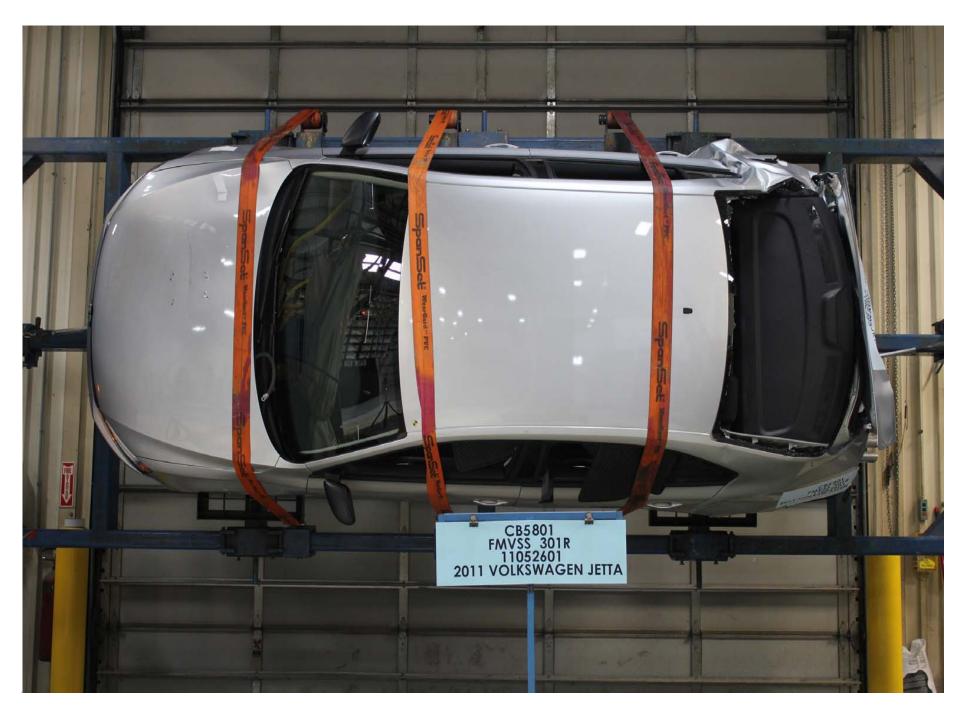
Static Rollover at 270 Degrees

Test Phase	Spillage (g)	Spillage Details
First 5 minutes from onset of rotation	0	
Sixth minute from onset of rotation	0	
Seventh minute from onset of rotation	0	
Eight minute if required	N/A

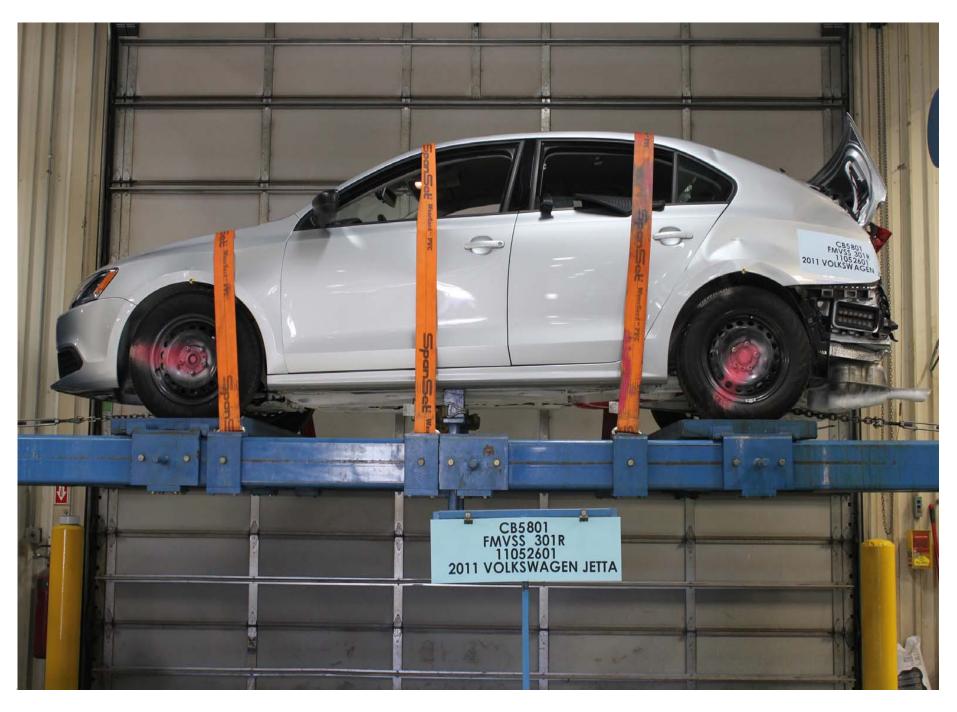
Static Rollover at 360 Degrees

Test Phase	Spillage (g)	Spillage Details
First 5 minutes from onset of rotation	0	
Sixth minute from onset of rotation	0	
Seventh minute from onset of rotation	0	
Eight minute if required	N/A
