DOT HS 812 560

Special Crash Investigations

On-Site Alleged Unintended

Vehicle: 2006 Jeep Grand

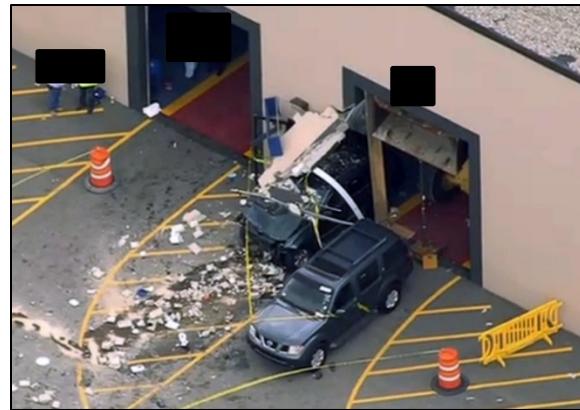
Figure 1: South-facing on-scene image showing the Jeep at its final rest position. A non-contact vehicle is located in the foreground. Image obtained from an Internet news media source.

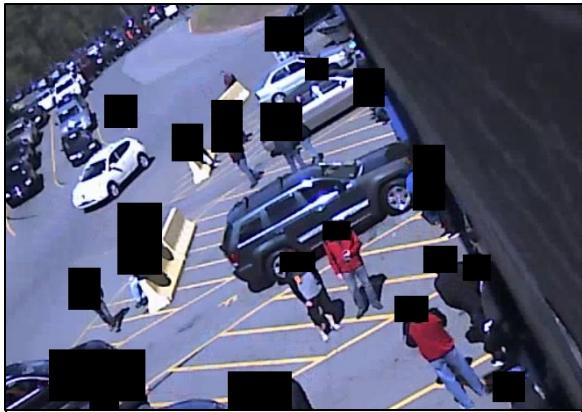
After the sedan entered the auction building, the Jeep slowly proceeded forward for approximately 22 seconds and stopped. The front plane of the Jeep was located approximately at the garage door opening (**Figure 5**). The vehicle remained stationary for approximately 18 seconds and then moved forward over the next 6 seconds such that its front wheels nested into the pavement transition at the building's threshold. On the surveillance video, the Jeep can be seen rolling slightly rearward (due to transmission backlash) as it came to rest at the threshold (**Figure 6**).

Figure 5: West-looking image showing the stopped position of the Jeep with its front plane at the building entrance. Image taken from the surveillance footage at Time - 10:10:03.

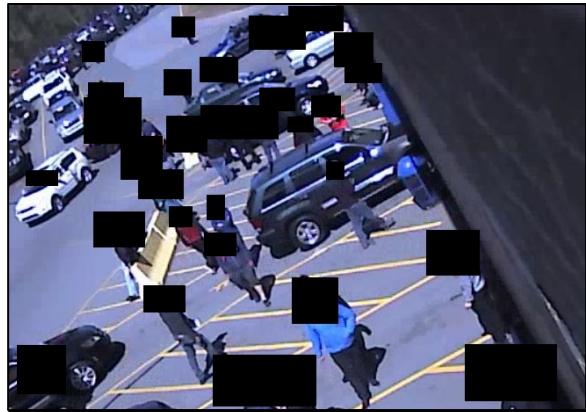
Figure 6: West-looking image showing the stopped position of the Jeep with its front tires nested at the building threshold. Image taken from the surveillance footage at Time - 10:10:33.

The change in the pavement's elevation at the transition was an estimated 3 cm (1 in) over a 30 cm (12 in) distance. The driver reported in his interview with the police that he typically had to press on the accelerator ("give it a little gas") to get a vehicle over the transition and into the building. The Jeep was stationary at this third stop for the next 72 seconds. During this time, a potential buyer approached the Jeep from Lane #7. The buyer walked up to the Jeep and completely around the vehicle, visually inspecting the Jeep over a 30-second period. The buyer then talked to the driver and opened the left front door.

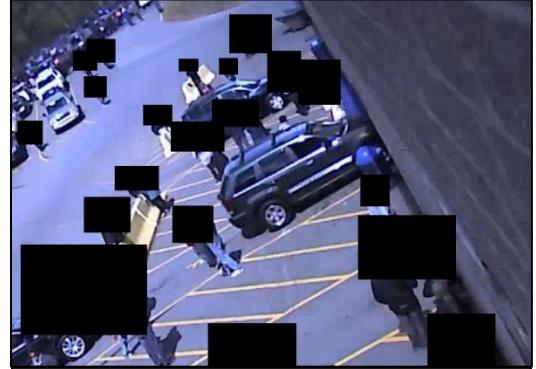
The buyer passed the cable scan tool and umbilical cable through the left front window opening and the left front door closed approximately 65 seconds after the Jeep came to its third stop. Based on the time stamp associated with this camera view, the Jeep accelerated away approximately 7.1 seconds after the left front door closed. Although partially masked by the Jeep relative to the camera's perspective, an analysis of the camera footage indicated that the buyer's focus initially appeared to be directed to his left toward Lane #7 (**Figure 7**). The buyer's attention appeared to return to the scanner approximately 2 seconds prior to the Jeep acceleration. The following table summarizes the timeline of the Jeep actions and the surrounding activity:

Figure 7: West-looking view of the Jeep at the building threshold with the buyer at the left front window. Image taken from the surveillance footage at Time - 10:11:25.

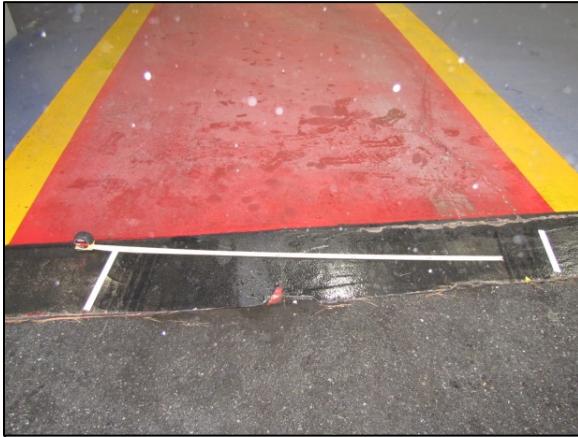
Figure 8: North-facing image of the tire marks at the entrance to Lane #6. Note the angled orientation of the marks relative to the travel lane.

The Jeep accelerated forward out of the driver’s control and into the building. The scan tool remained attached to the vehicle and was pulled from the buyer’s hand. Two short (acceleration) tire marks were identified at the scene during the police investigation and were also observed during the SCI scene inspection. The marks were located at the threshold to the building at the Lane #6 entrance in the pavement transition (**Figure 8**). The tread pattern and track width of the marks were consistent with the tread pattern and track width of the Jeep’s tires. The left front tire mark measured 38 cm (15.0 in) in length and the right tire mark measured 33 cm (13.0 in). Due to its initial orientation, angled slightly to the right with respect to the side plane of the building, the Jeep departed the (red) travel path of Lane #6 and entered the (blue) pedestrian zone as it accelerated forward. The vehicle traveled along a nearly straight path at a reconstructed heading angle approximately 3 degrees to the right of the lane marking. As the Jeep traversed the 38.0 m (124.7 ft) interior width of the structure, 13 pedestrians were injured either due to direct contact with the Jeep, by ground contact, or pedestrian interaction. Five people struck by the front plane of the Jeep (Events 1-5) resulted in fatalities. The front plane of the vehicle then struck and fractured the cement block-construction of the exit wall (Event 6 - **Figure 9**). The Jeep penetrated approximately 3 m (10 ft) through the wall and came to rest. A crash diagram is included at the end of this report on Page 16.

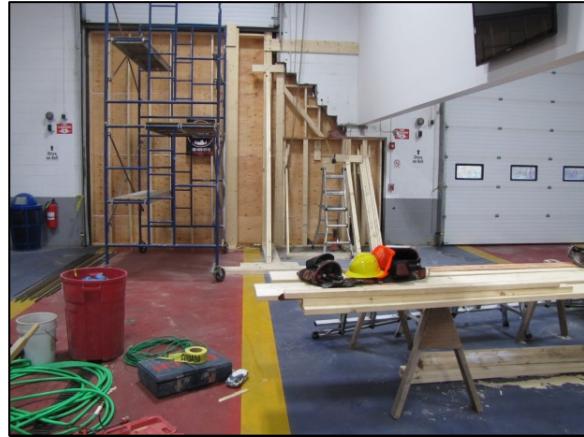
Figure 9: North-facing image of the fractured exit wall at the point of impact (under repair at the time of the SCI inspection).

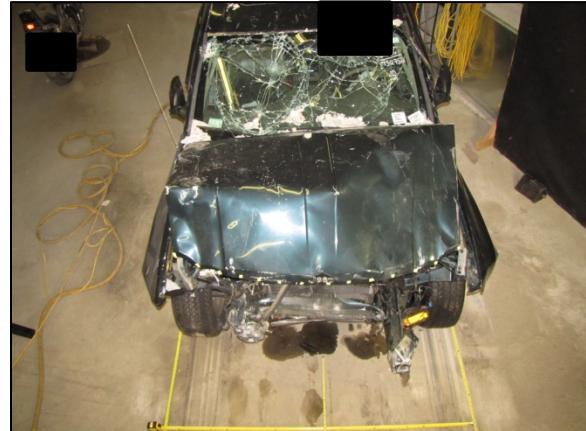
The exterior of the Jeep (**Figure 11**) sustained damage to the front, right and top planes from the impact events with the pedestrians and the building wall. Five pedestrian impacts involved the front plane with wrapping onto the hood as the pedestrians were carried forward by the Jeep. The specific location of each pedestrian impact event was masked by the subsequent impact with the concrete block wall. Two distinct pedestrian impacts to the laminated windshield were present, located forward of the driver and front row right occupant positions. Based on the surveillance footage, the estimated Collision Deformation Classification (CDC) of the pedestrian impacts (Events 1-5) were 12FREN1, 12FREN1, 12FCAN6, 12FLAN6, 12FLEN1, respectively.

Figure 11: Overhead view of the Jeep's frontal damage.

The residual frontal damage that occurred from the building wall impact was distributed across the entire 152 cm (60.0 in) front end width. The direct contact damage measured 148 cm (58.2 in) and extended across the hood face and the leading edges of the front fenders. The bumper fascia and reinforcement bar deformed and separated from the vehicle. The left frame rail was not crushed while the right frame rail crushed 27 cm (10.5 in) and deformed slightly to the left. The residual crush profile was documented at the level of the hood face and was as follows: C1 = 20 cm (7.9 in), C2 = 21 cm (8.3 in), C3 = 18 cm (7.1 in), C4 = 18 cm (7.1 in), C5 = 21 cm (8.3 in), C6 = 23 cm (9.1 in). The CDC associated to the wall impact (Event 6) was 12FDEW2. A delta-V was not calculated due to the yielding properties of the impact.

The leading edges of both front fenders were displaced rearward and outward with respect to the body profile. The upper radiator support was displaced rearward. Concrete block fragments fell onto the Jeep resulting in isolated dents and scratches to the hood, fenders, upper A-pillars, and roof.

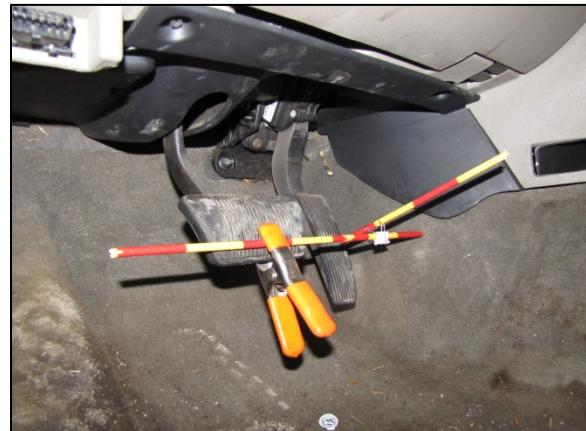
The Jeep brake pedal was directly linked to the brake master cylinder via a mechanical linkage and an accelerator pedal linked to the throttle body by a cable routed through the front cowl (**Figure 12**). The brake pedal was trapezoidal with a top dimension of 13 cm (5.0 in), a bottom width of 10 cm (4.0 in), and a height of 7 cm (2.8 in). The accelerator pedal was rectangular (vertically oriented) with a length of 15 cm (6.0 in) and a width of 6 cm (1.5 in). The OEM rubber non-slip pads were in place over the steel pedals. The lateral offset from the center of the brake pedal to the center of the accelerator pedal was 15 cm (5.8 in).

Figure 12: View of the Jeep's foot controls.

The accelerator pedal was a suspended pedal with the pivot point located above the top of the pedal. The bottom aspect of the pedal was not supported and was 9 cm (3.5 in) above the floor pan. The static position of the accelerator pedal was 5 cm (2 in) below the height of the brake pedal. There was no interference or trapping of the accelerator pedal by the OEM carpet or floor/toe pan of the Jeep. At the time of this crash, the Jeep was not equipped with floor mats. Both pedals and their associated linkages operated smoothly without binding. The SCI investigator inspected and manually opened the engine compartment-mounted throttle body and found no evidence of binding; the mechanism operated smoothly.

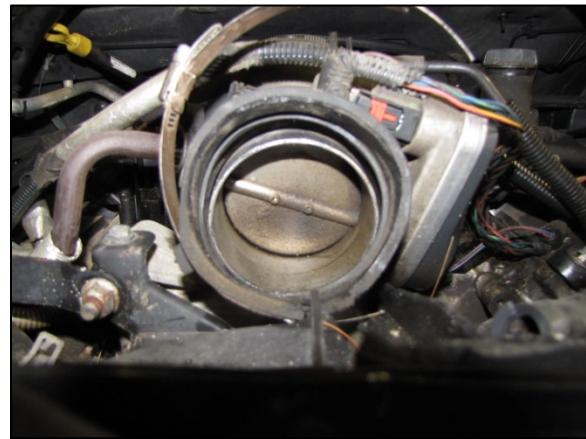
During the SCI inspection, the engine's air intake plenum was removed and the throttle body was inspected (**Figure 13**). At initial observation, the throttle plate was in a closed position (as expected). The throttle plate operated freely without binding. Electrical power was connected to the vehicle and upon rotation of the ignition key to the Run position the throttle body conducted a self-check of its operation. The vehicle's manufacturer reported that software programming in the powertrain control module (PCM) was designed to conduct this check. If the time duration and rotation of the throttle plate fell in designed parameters, the vehicle was then allowed to start. The vehicle's engine would not be permitted to start if the self-check fell outside of the envelope of required parameters. With the air intake removed, it was possible to observe the movement of the throttle plate during the self-check and this procedure was video-taped by SCI, the police investigators and the manufacturer. The engine was then started. The engine operated normally, despite leaking fluids due to crash-related damages.

Figure 13: Image of the Jeep's throttle body showing the closed position of the throttle plate at the time of the SCI inspection.

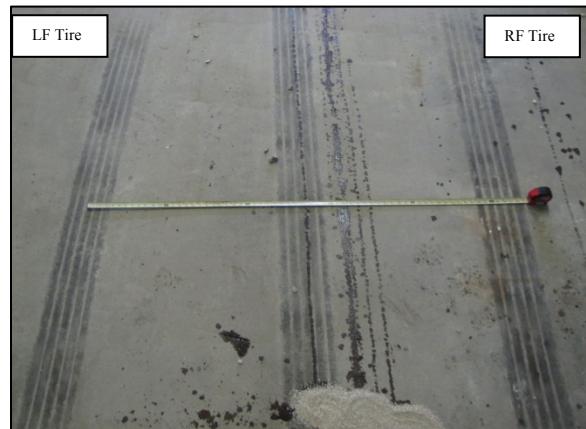
The second pair of tests was conducted with the transmission initially in neutral. The accelerator was then applied to high RPM and the transmission was shifted (dropped) into "Drive." It was noted that the initial wheel spin was primarily at the front axle as the Jeep accelerated forward (**Figure 14**). As the transmission was shifted to "Drive" an audible "clunk" was heard, in addition to the sound of the racing engine.

Figure 14: Image showing the front tire acceleration marks from the "Neutral-Drop Test" of the Jeep.

Everyone in attendance at the SCI inspection was in agreement that this “Neutral-Drop Test Scenario” most-likely duplicated the incident under investigation. It was theorized that the driver placed the transmission into neutral as he waited at the building entrance. The driver (potentially distracted by the buyer) then applied the accelerator to advance the Jeep into the building. When the Jeep did not respond, the driver continued to apply the accelerator further. He then realized the vehicle’s transmission was in neutral and shifted the transmission into drive without first releasing the accelerator.
