Case 352 : Narrative

Case Vehicle (A): 2001 Pontiac
Type: Firebird, 2-door coupe
Driver: 22-year-old female
CDC: 12-FZEW-3

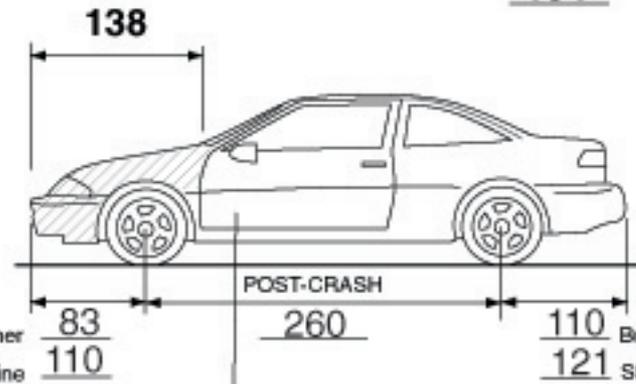
Both exterior door panels knocked off

Max. crush to right front bumper corner

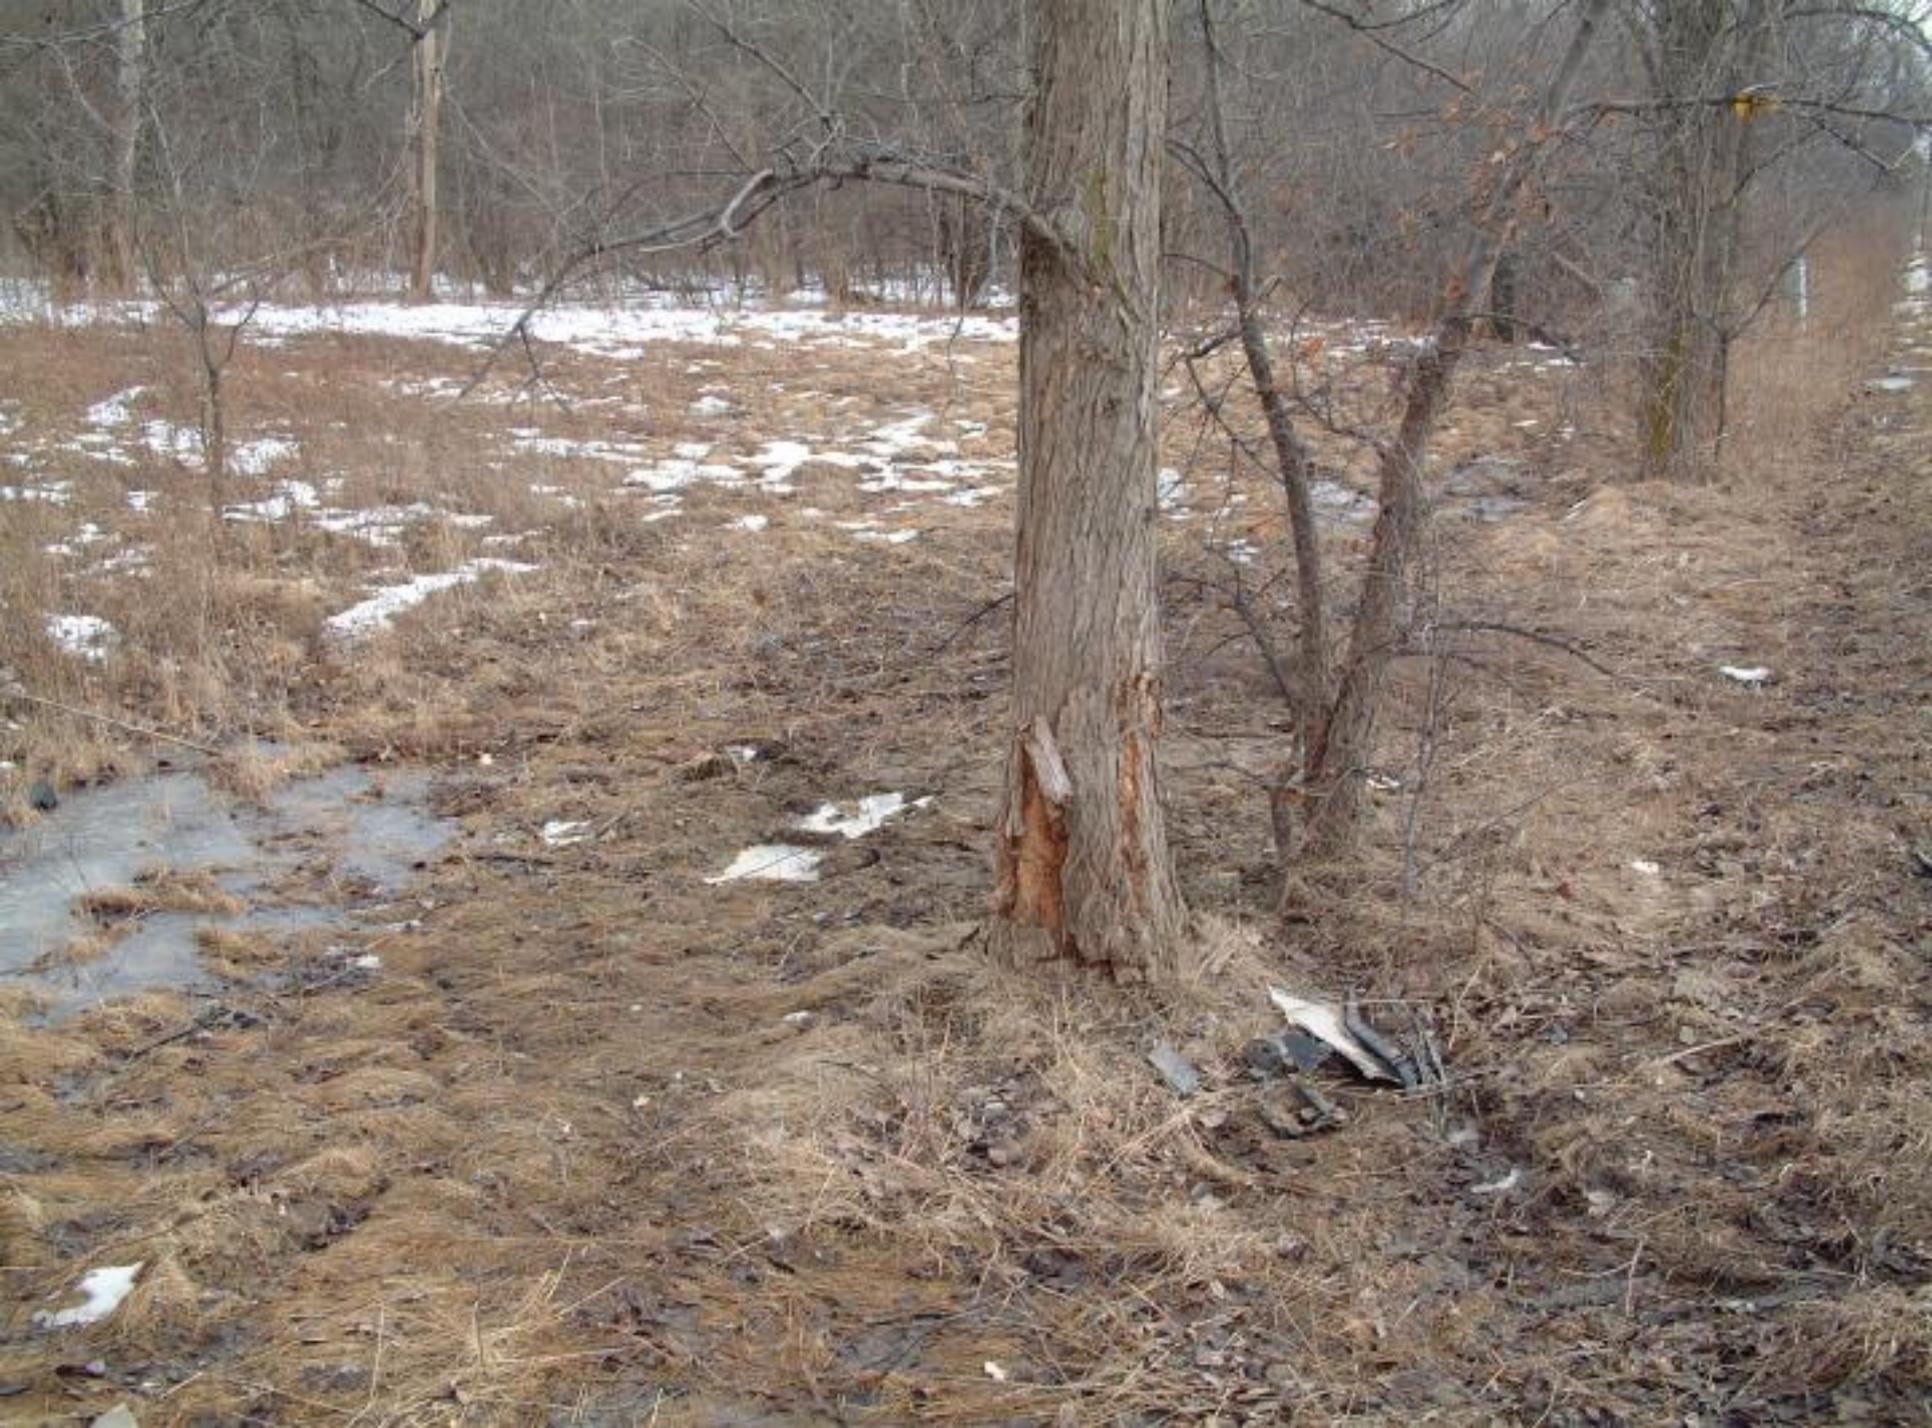
[22](#) On the right side, the fender was missing, and the upper section of the A-pillar, the [23](#) forward portion of the roof siderail, and the T-top were deflected up. [24](#) [25](#) Also, the exterior door panel was removed, the right-side door was jammed closed, and the T-top glazing on the right side of the roof was broken out, [26](#) but the right side glazing was intact. The right-front wheel and the lower section of the A-pillar were displaced to the rear, [27](#) slightly buckling the lower section of the B-pillar and reducing the right wheelbase by 18 cm.

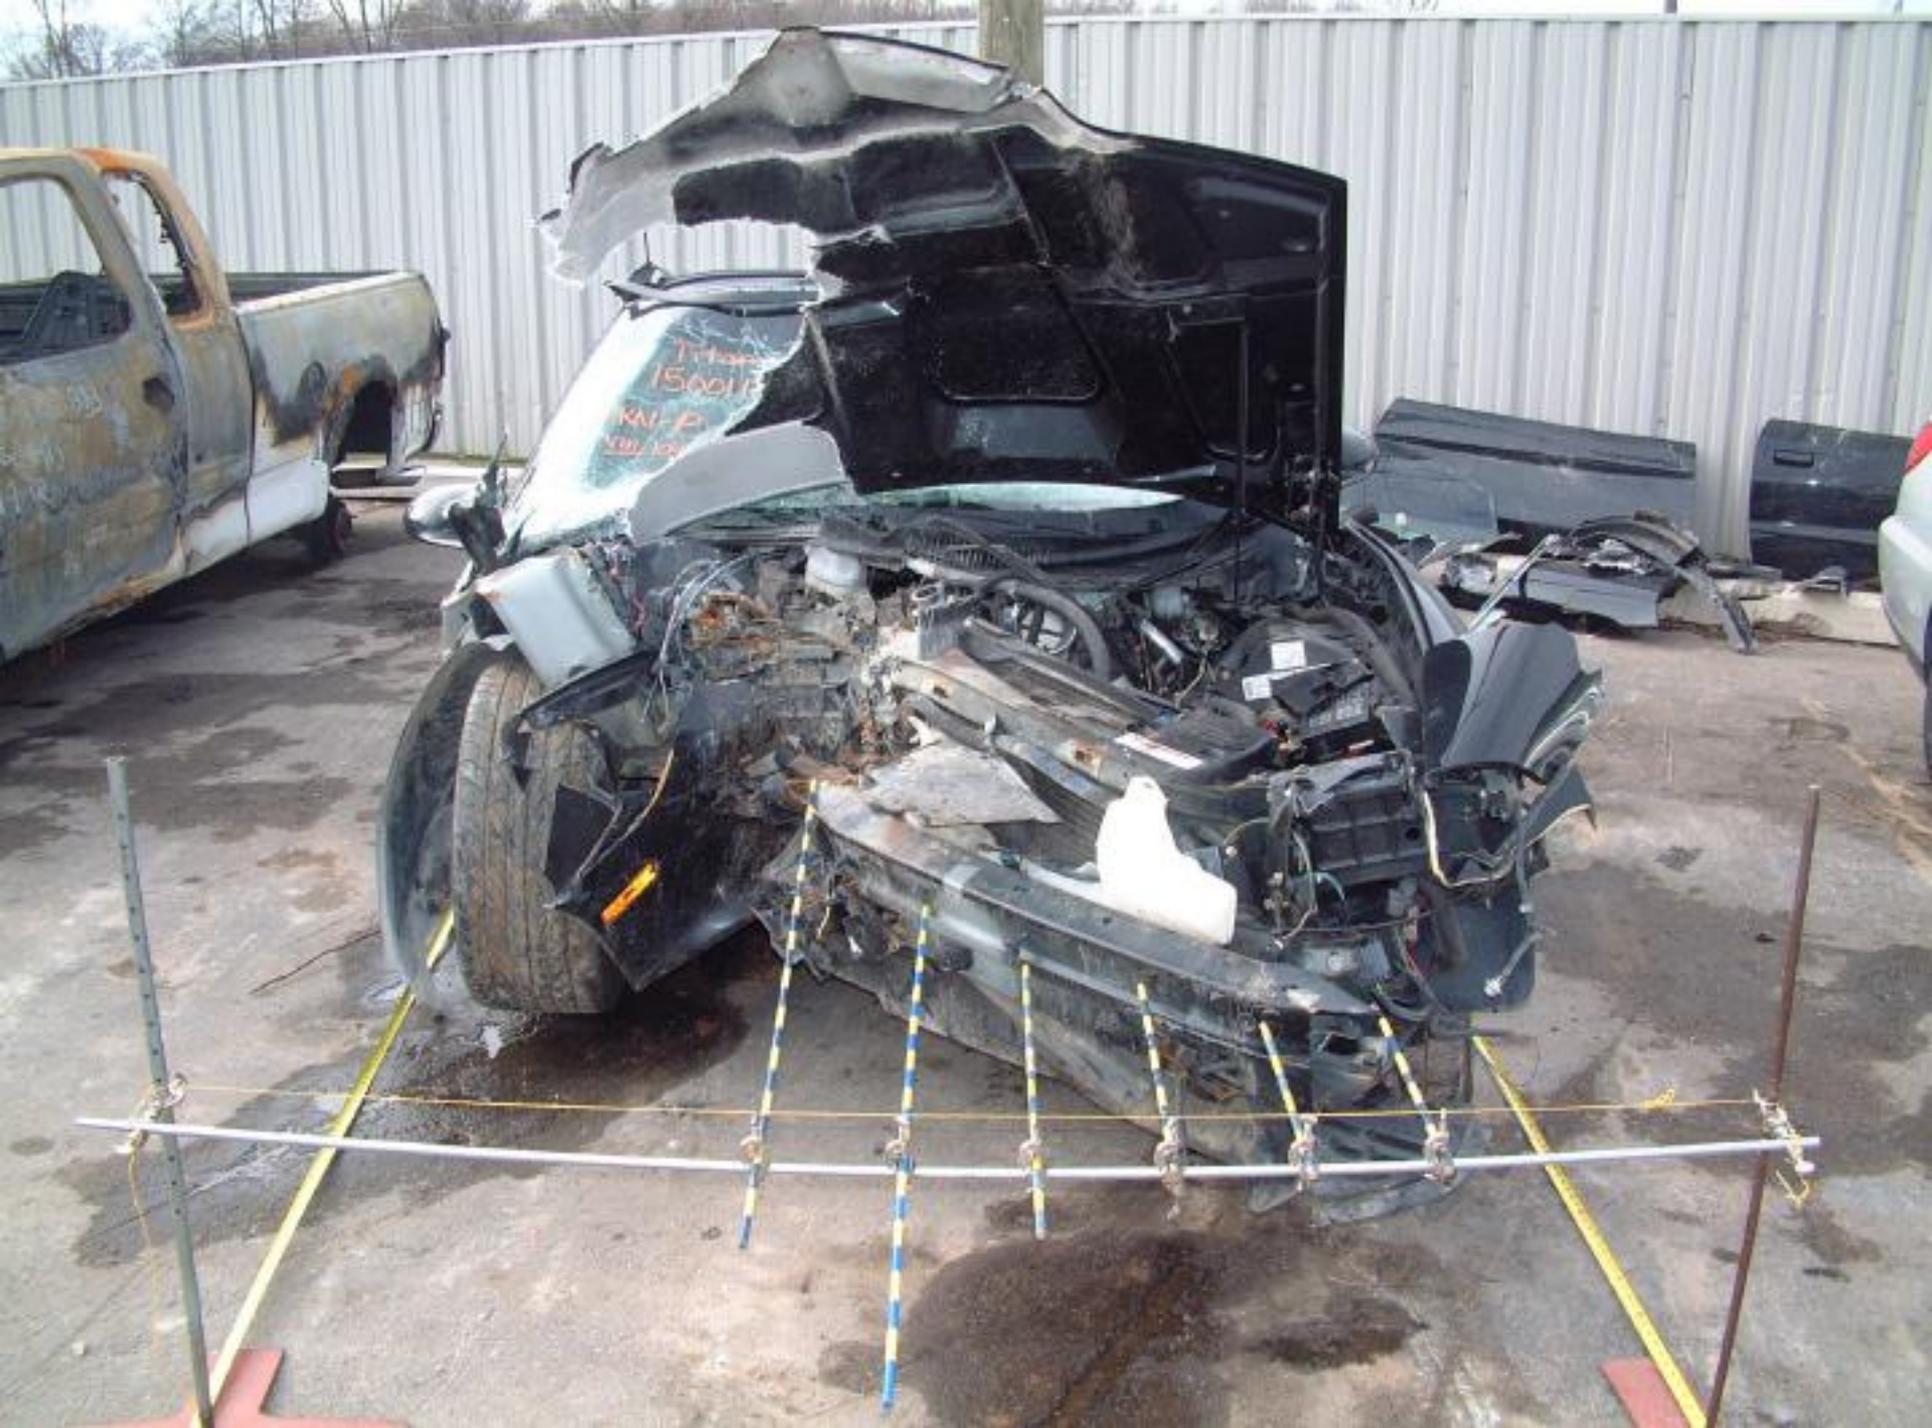
[28](#) There was no damage to the rear of the vehicle. [29](#) On the left side, the forward portion of the composite fender was broken and deflected to the left, [30](#) [31](#) the exterior door panel was removed, and the left-side glazing was broken out. The left-side door was closed but operational. [32](#) There was no other left-side damage and there was no significant change in the left wheelbase.

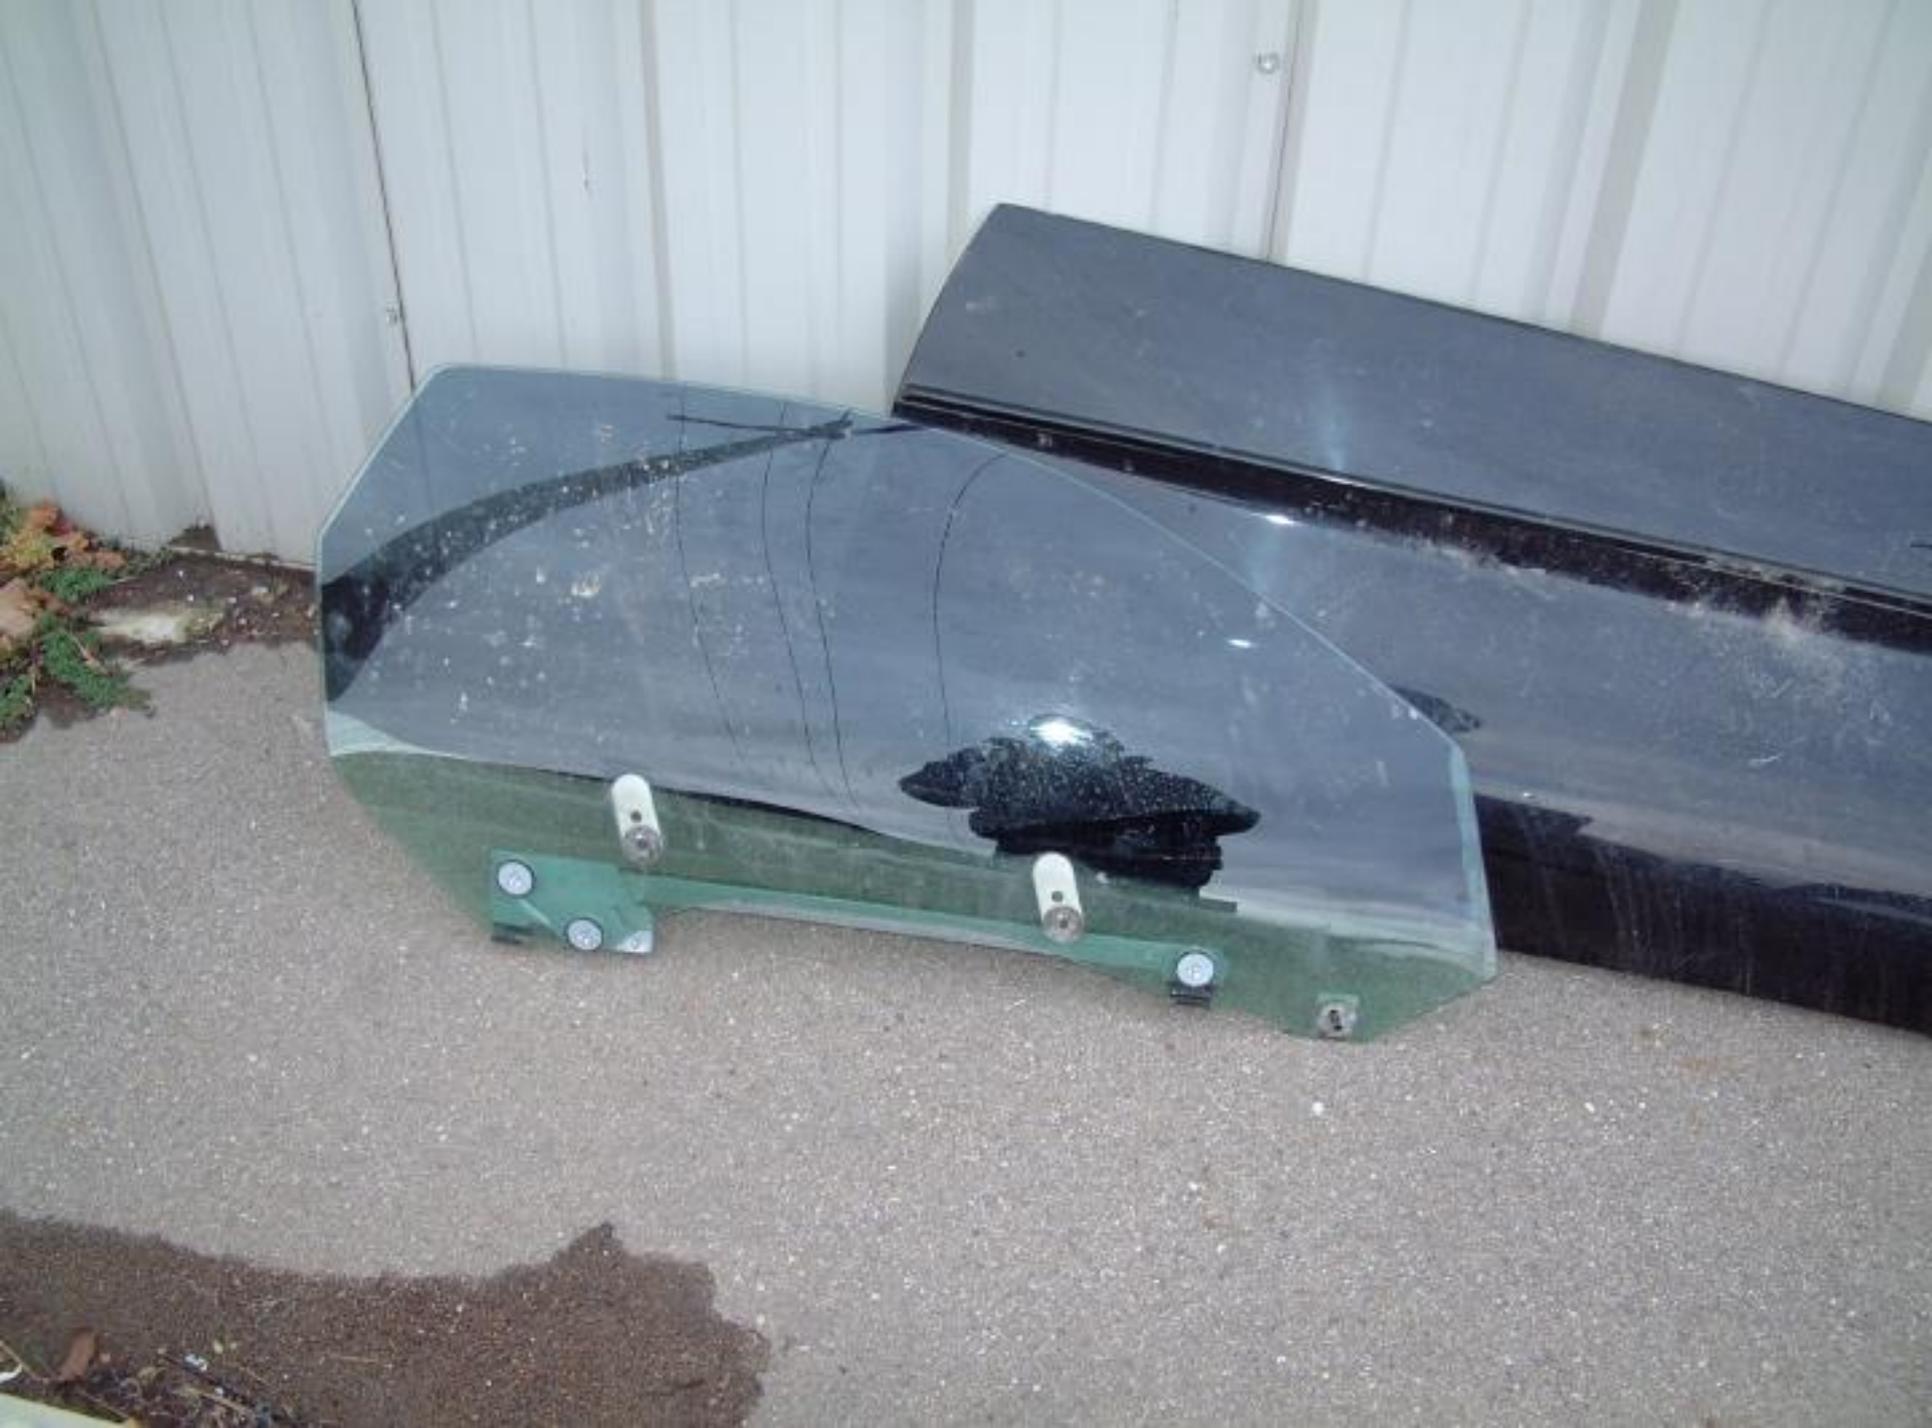
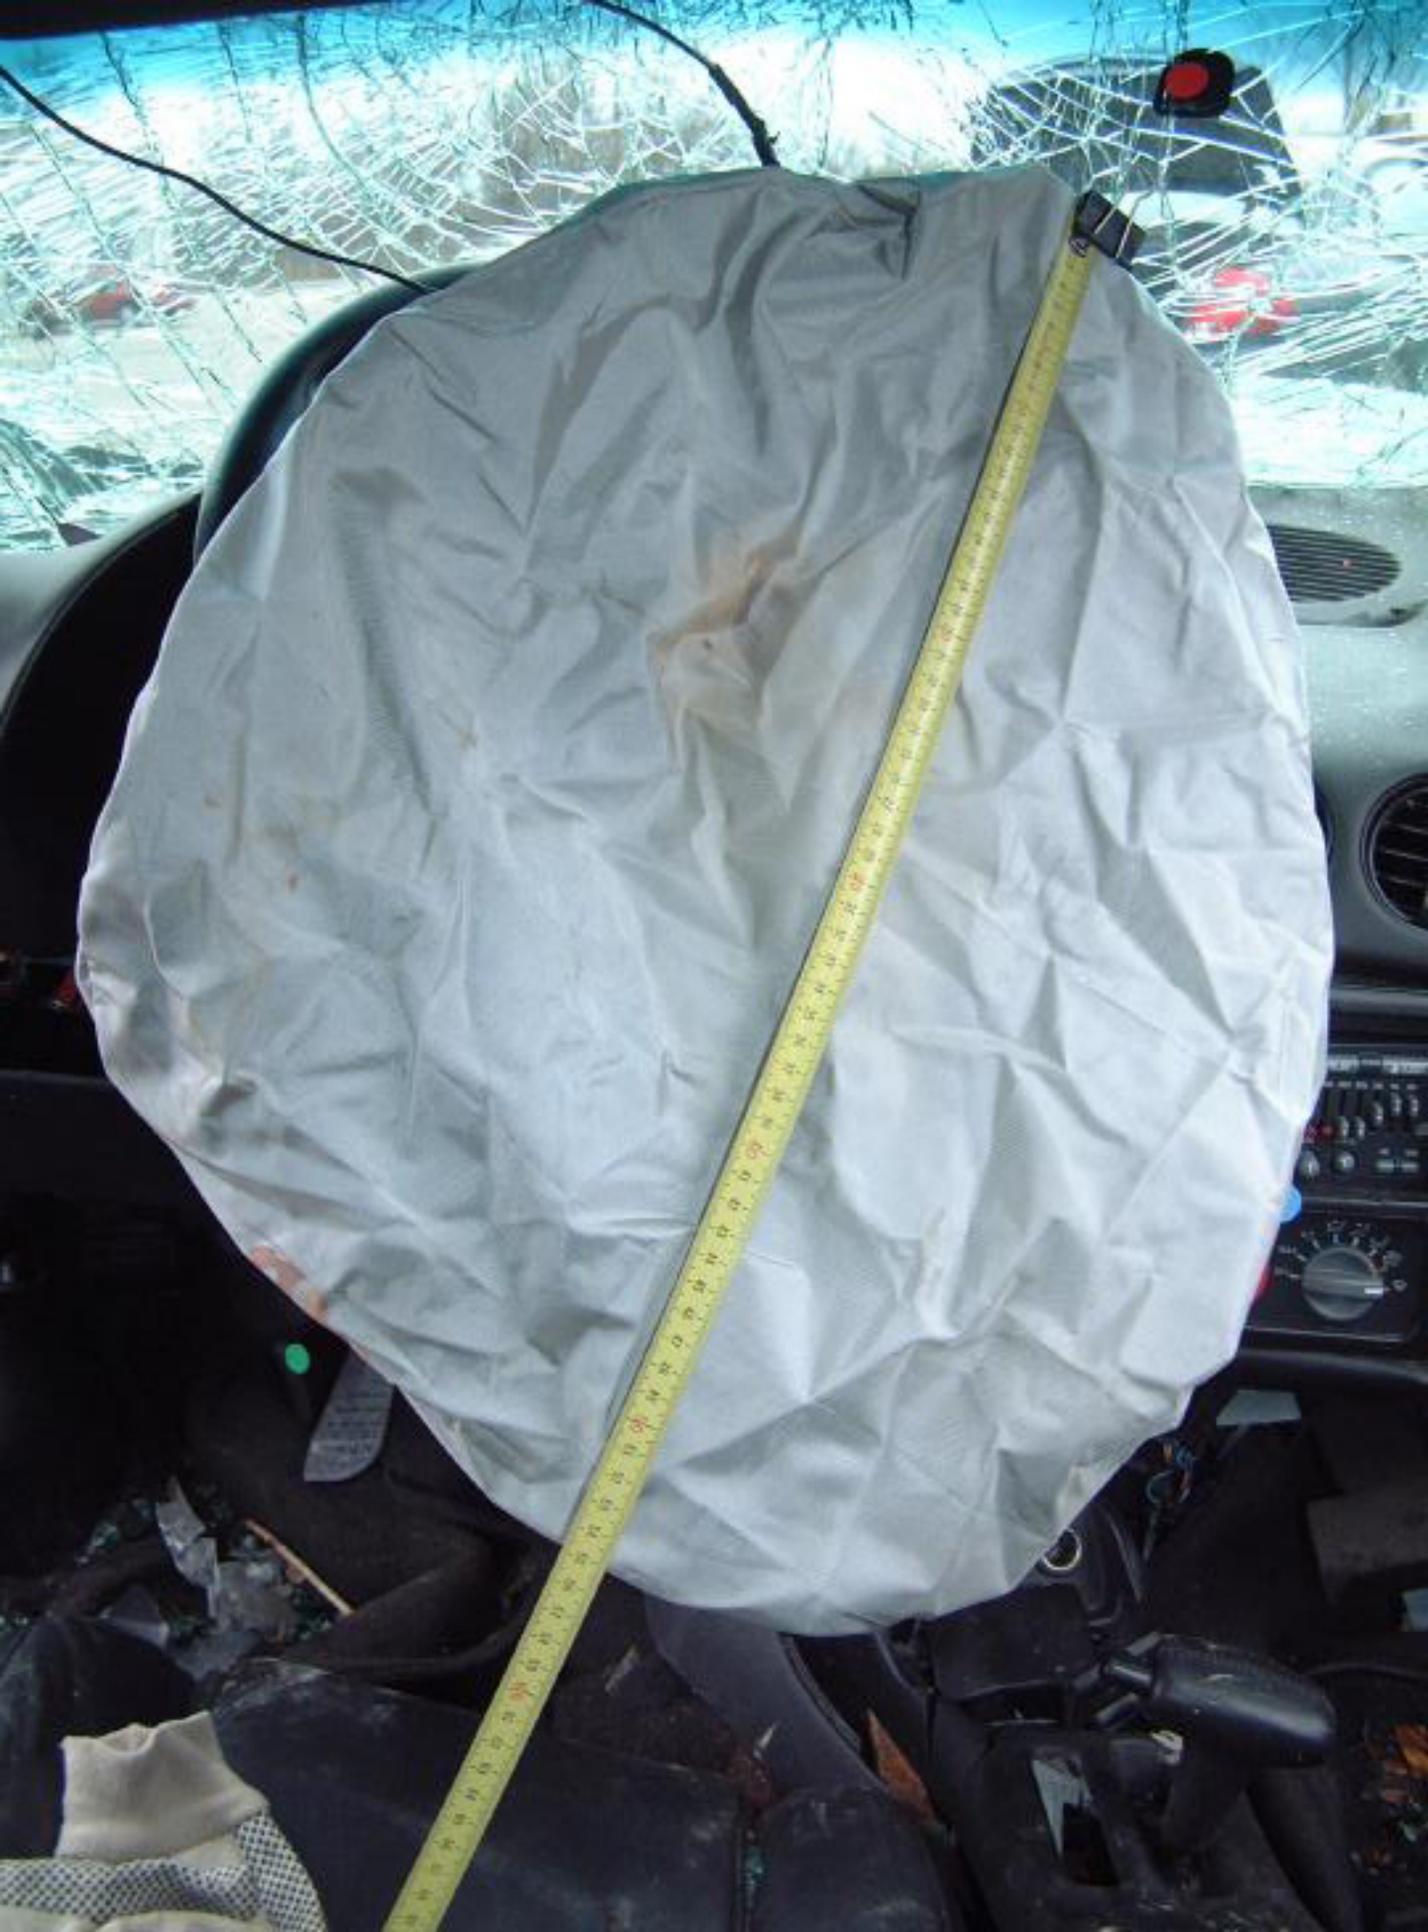
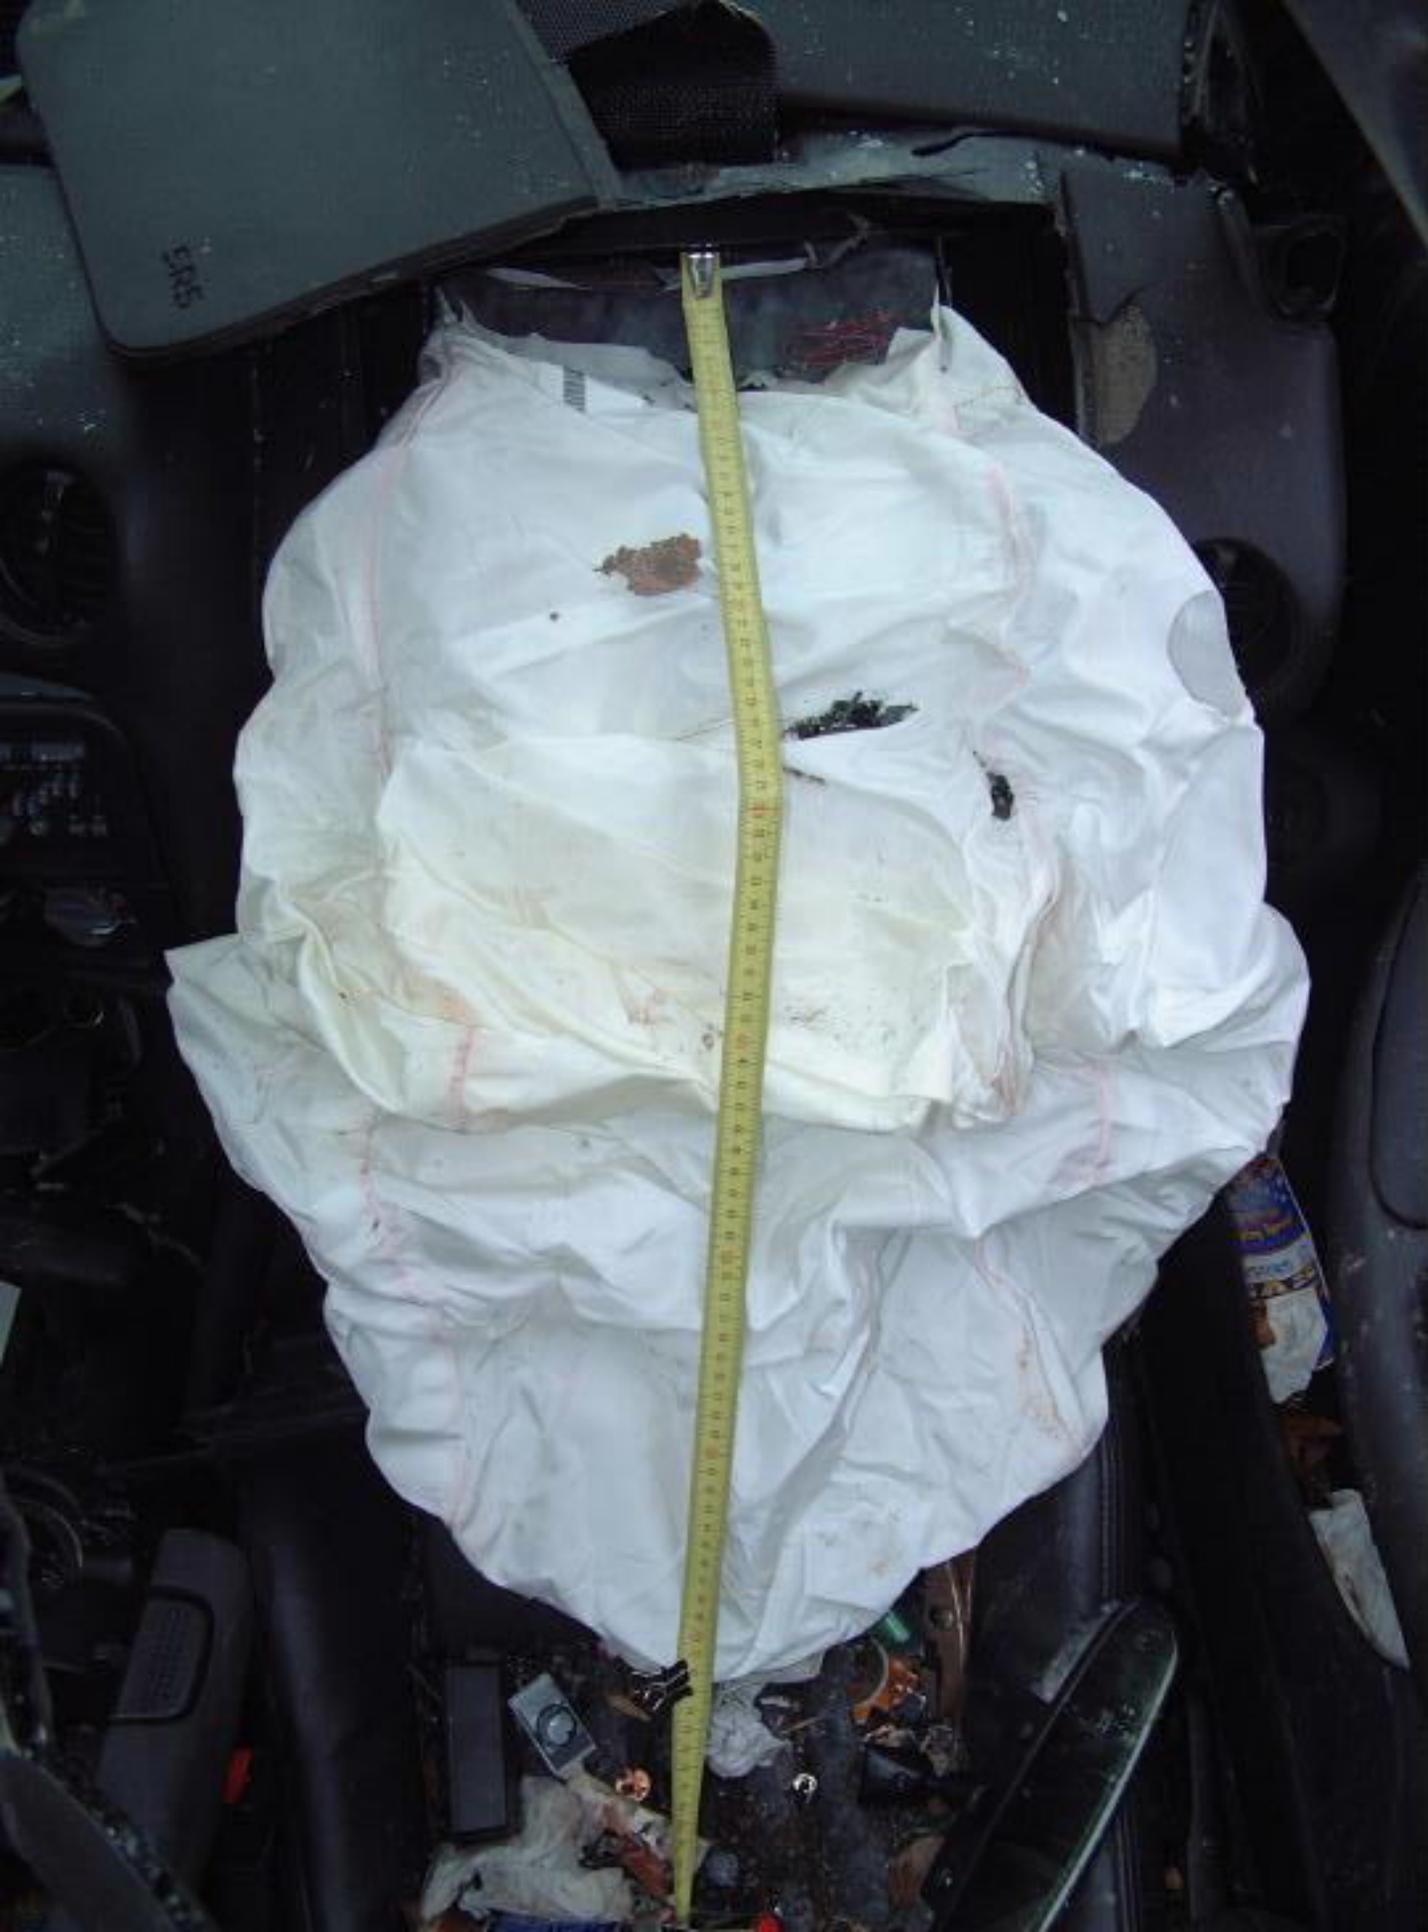
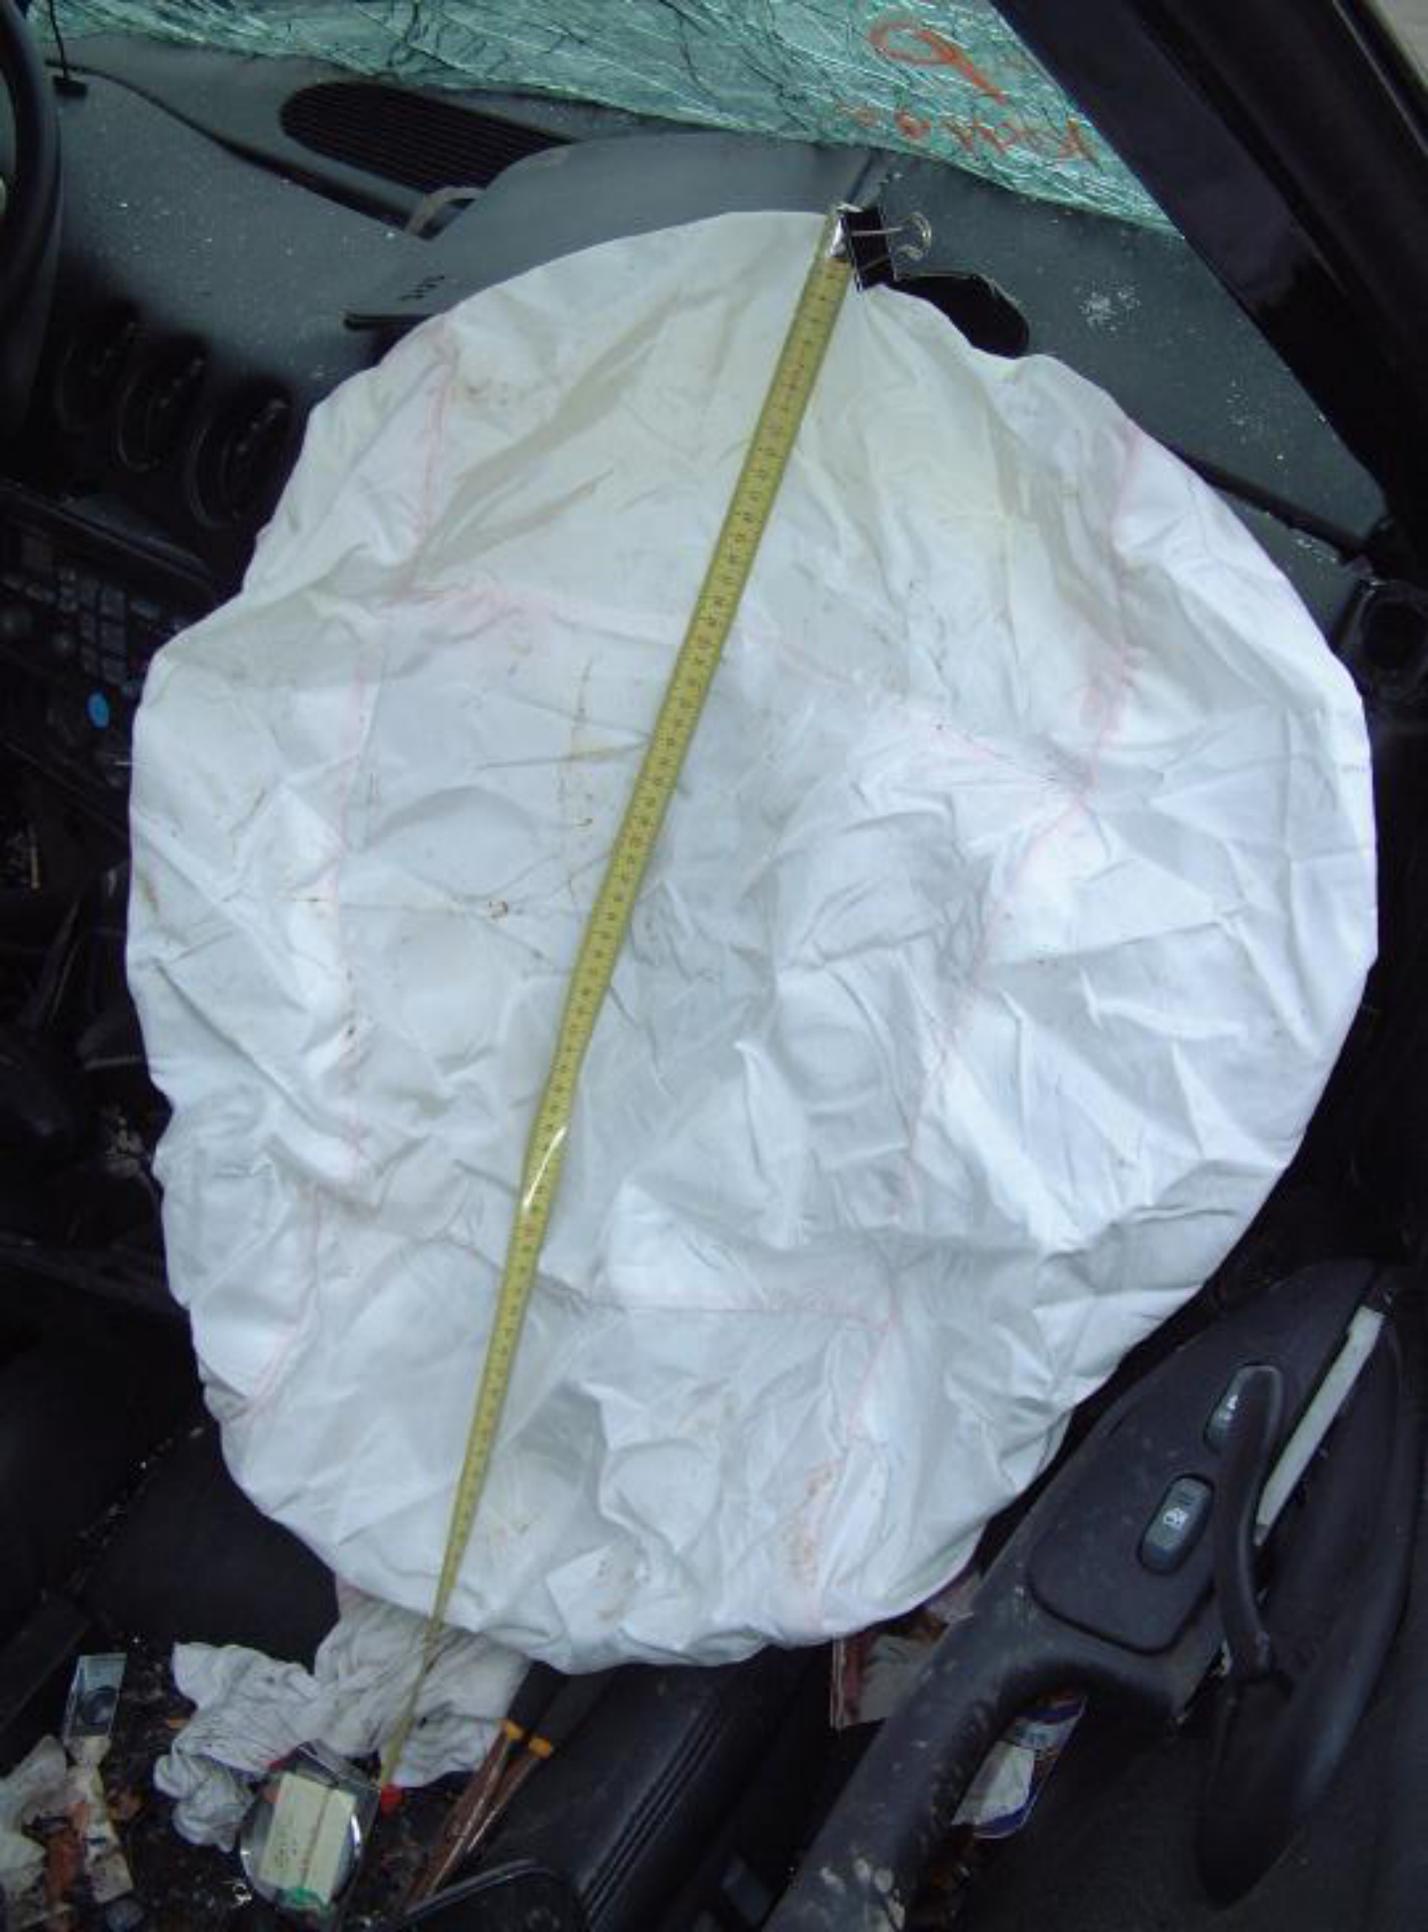
This vehicle was equipped with steering-wheel and dash-mounted frontal-impact airbags and [33](#) [34](#) [35](#) [36](#) both deployed in the frontal impact with the tree. [50](#) There was no damage to the driver airbag, but the upper portion was stained with makeup. [37](#) [38](#) [39](#) [40](#) There was no damage to the flaps/covers of the steering-wheel airbag module and [42](#) [43](#) there was no damage to the steering-wheel rim or spokes, but the steering column and steering wheel were deflected up and to the right. [44](#) The plastic covers on the mid and upper instrument panels were dislodged, the plastic cover over the instruments was cracked, and the knee-bolster cover was loose and displaced down. [45](#) The plastic steering column cover was scuffed and the metal steering column bracket was bent. [46](#) The gas and brake pedals were deflected to the right, the brake pedal pad was separated from the brake-pedal linkage, and the heater/ac duct was crushed. [47](#) The plastic shoulder-belt guide separated from the driver-seat headrest and the driver-seat fore/aft adjuster was jammed in a forward seat-track position. [41](#) [48](#) [49](#) There was no other damage to the driver area.

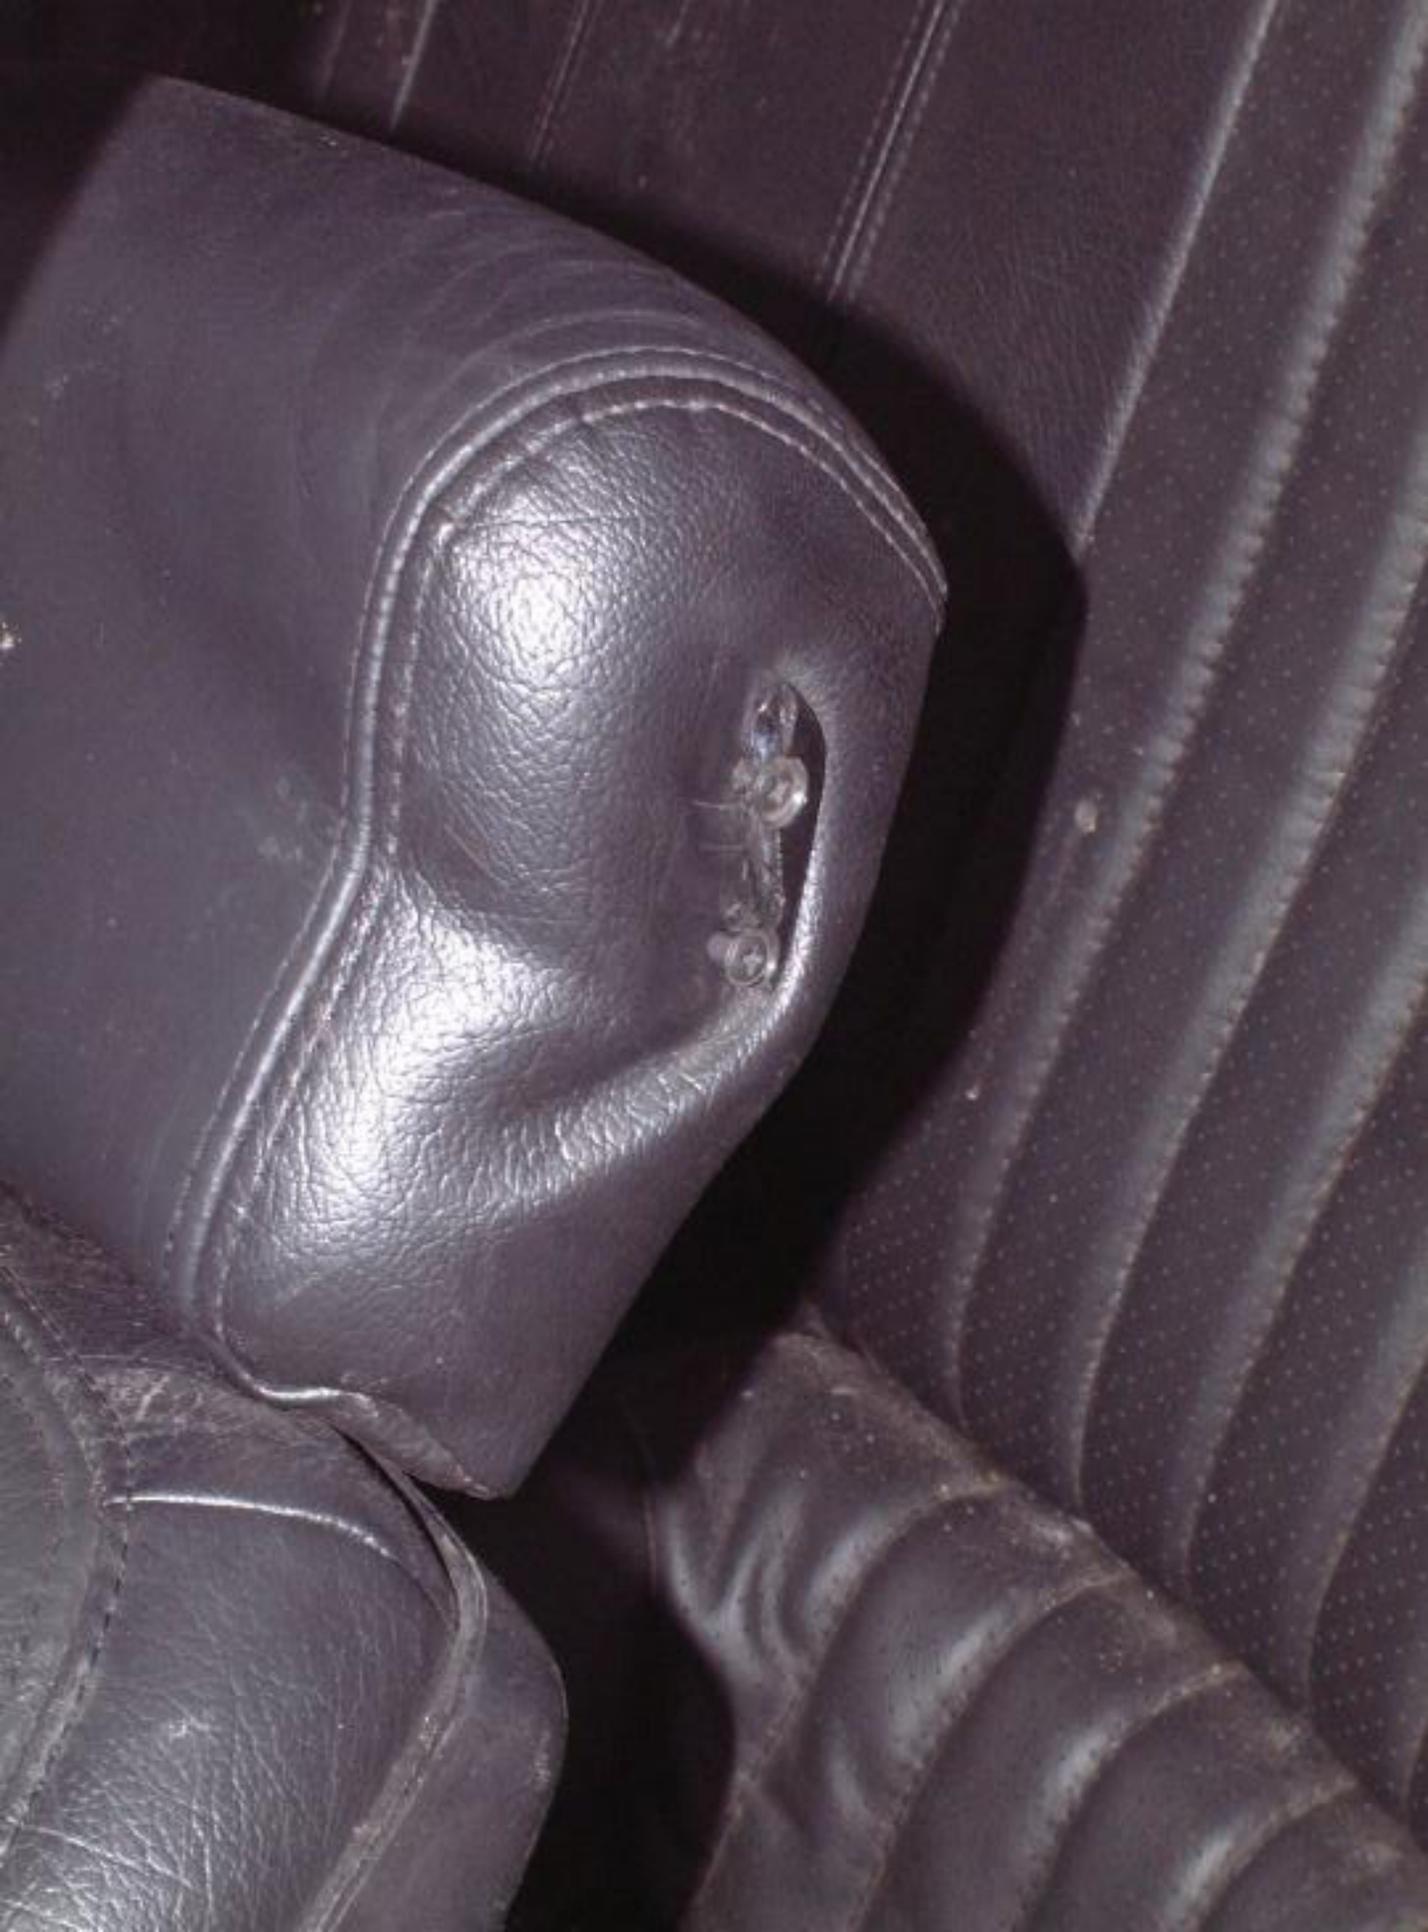
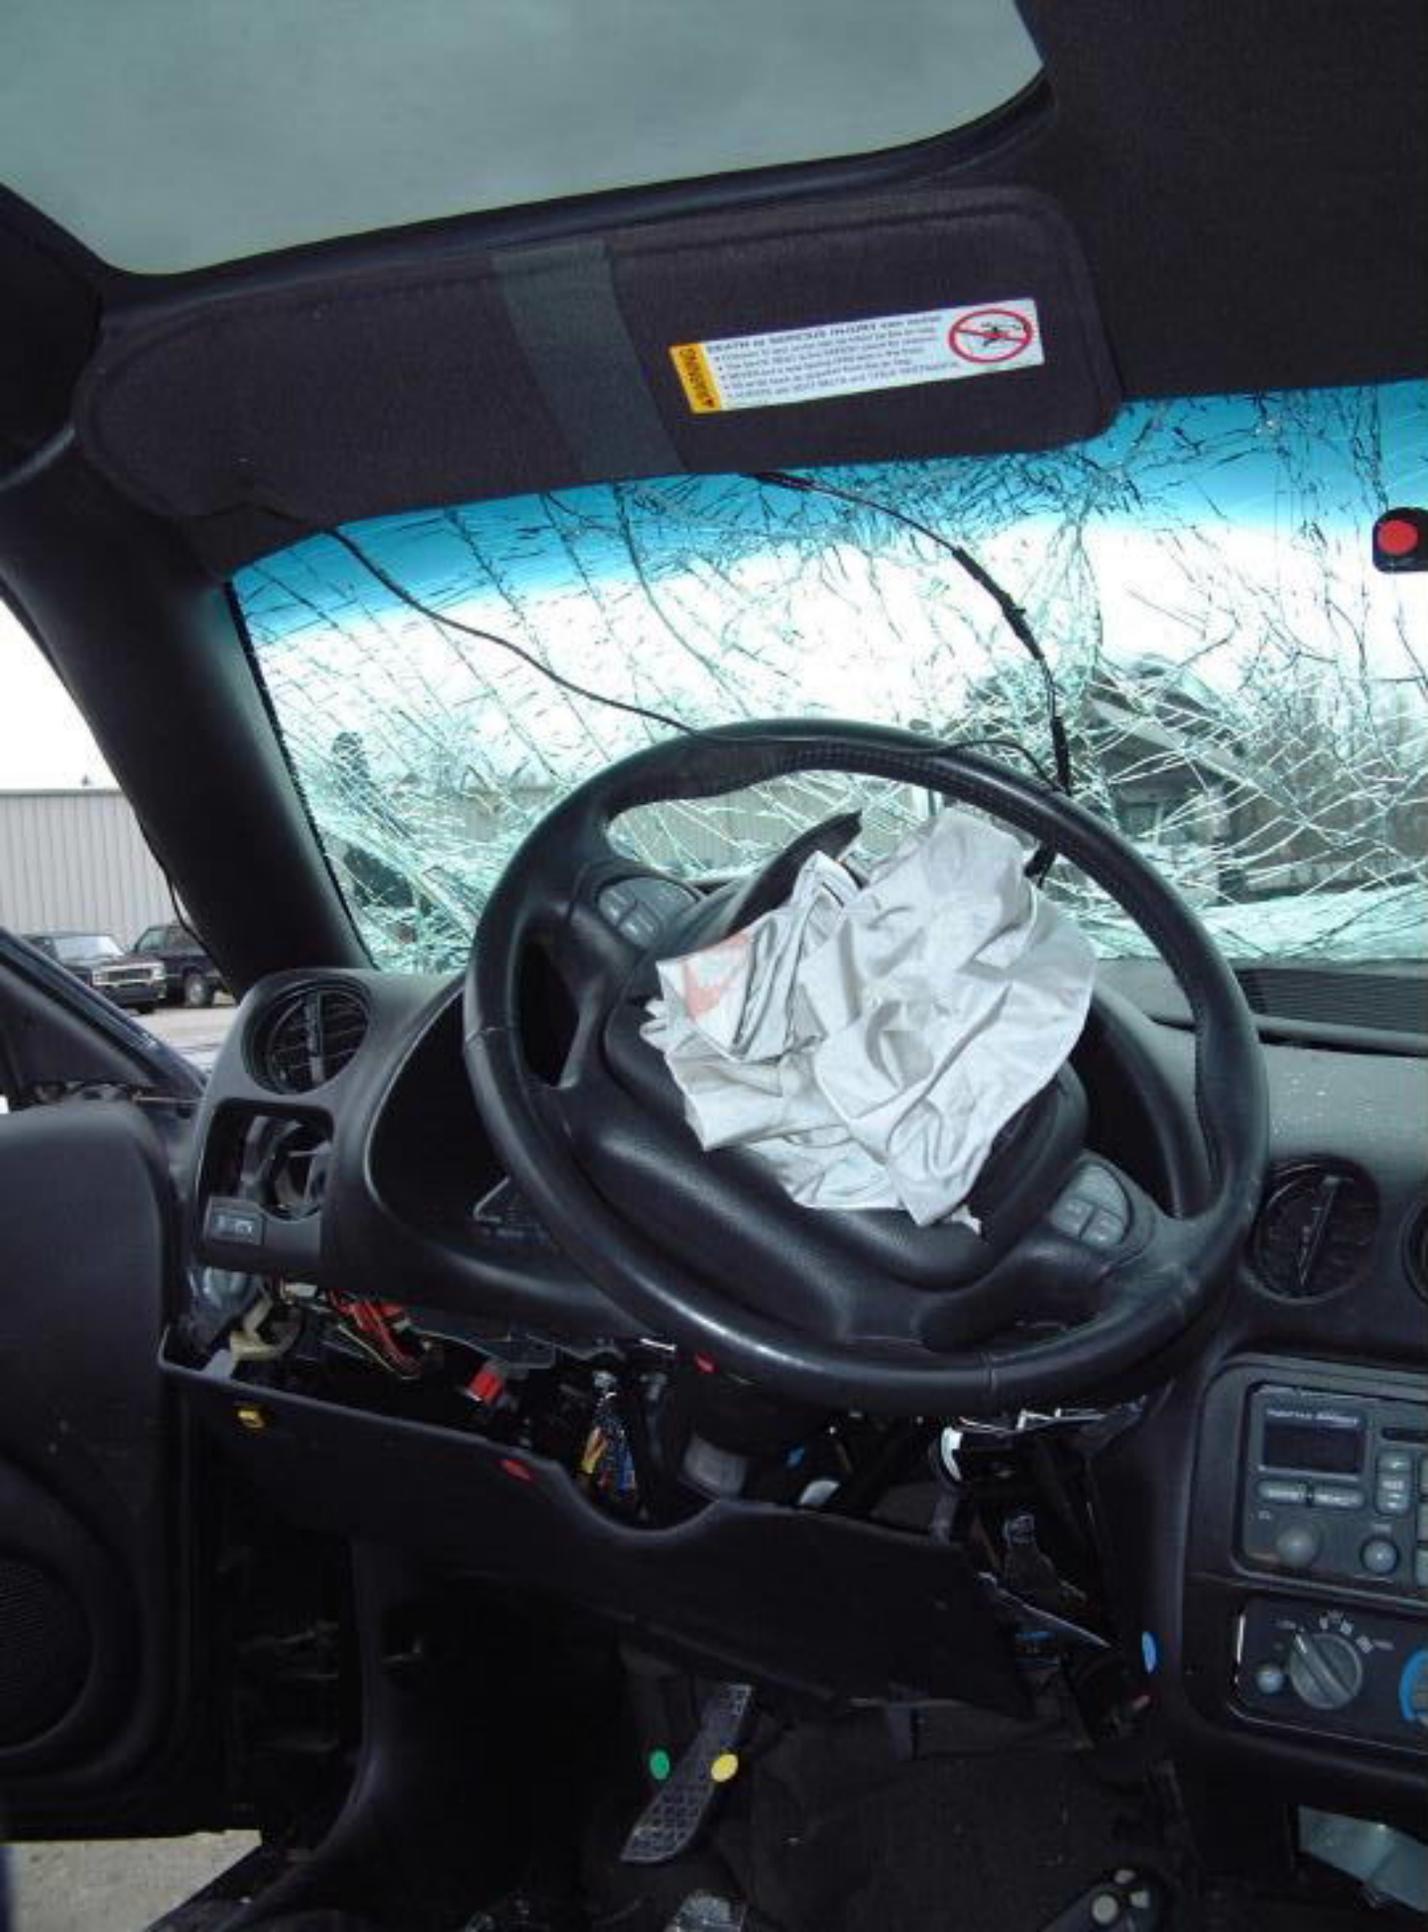
Location	Component	Distance (cm)	Direction
Driver	toe pan at gas pedal 62	19	to rear
	transmission tunnel	19	to left
	instrument panel 63	8	to rear
Center front	vertical console 64	11	to rear
Right front	toe pan 65	9	to rear
	windshield header 66	9	to rear
	instrument panel	9	to rear
