Case 352 : Narrative

Case Vehicle (A): 2001 Pontiac
Type: Firebird, 2-door coupe
Driver: 22-year-old female
CDC: 12-FZEW-3

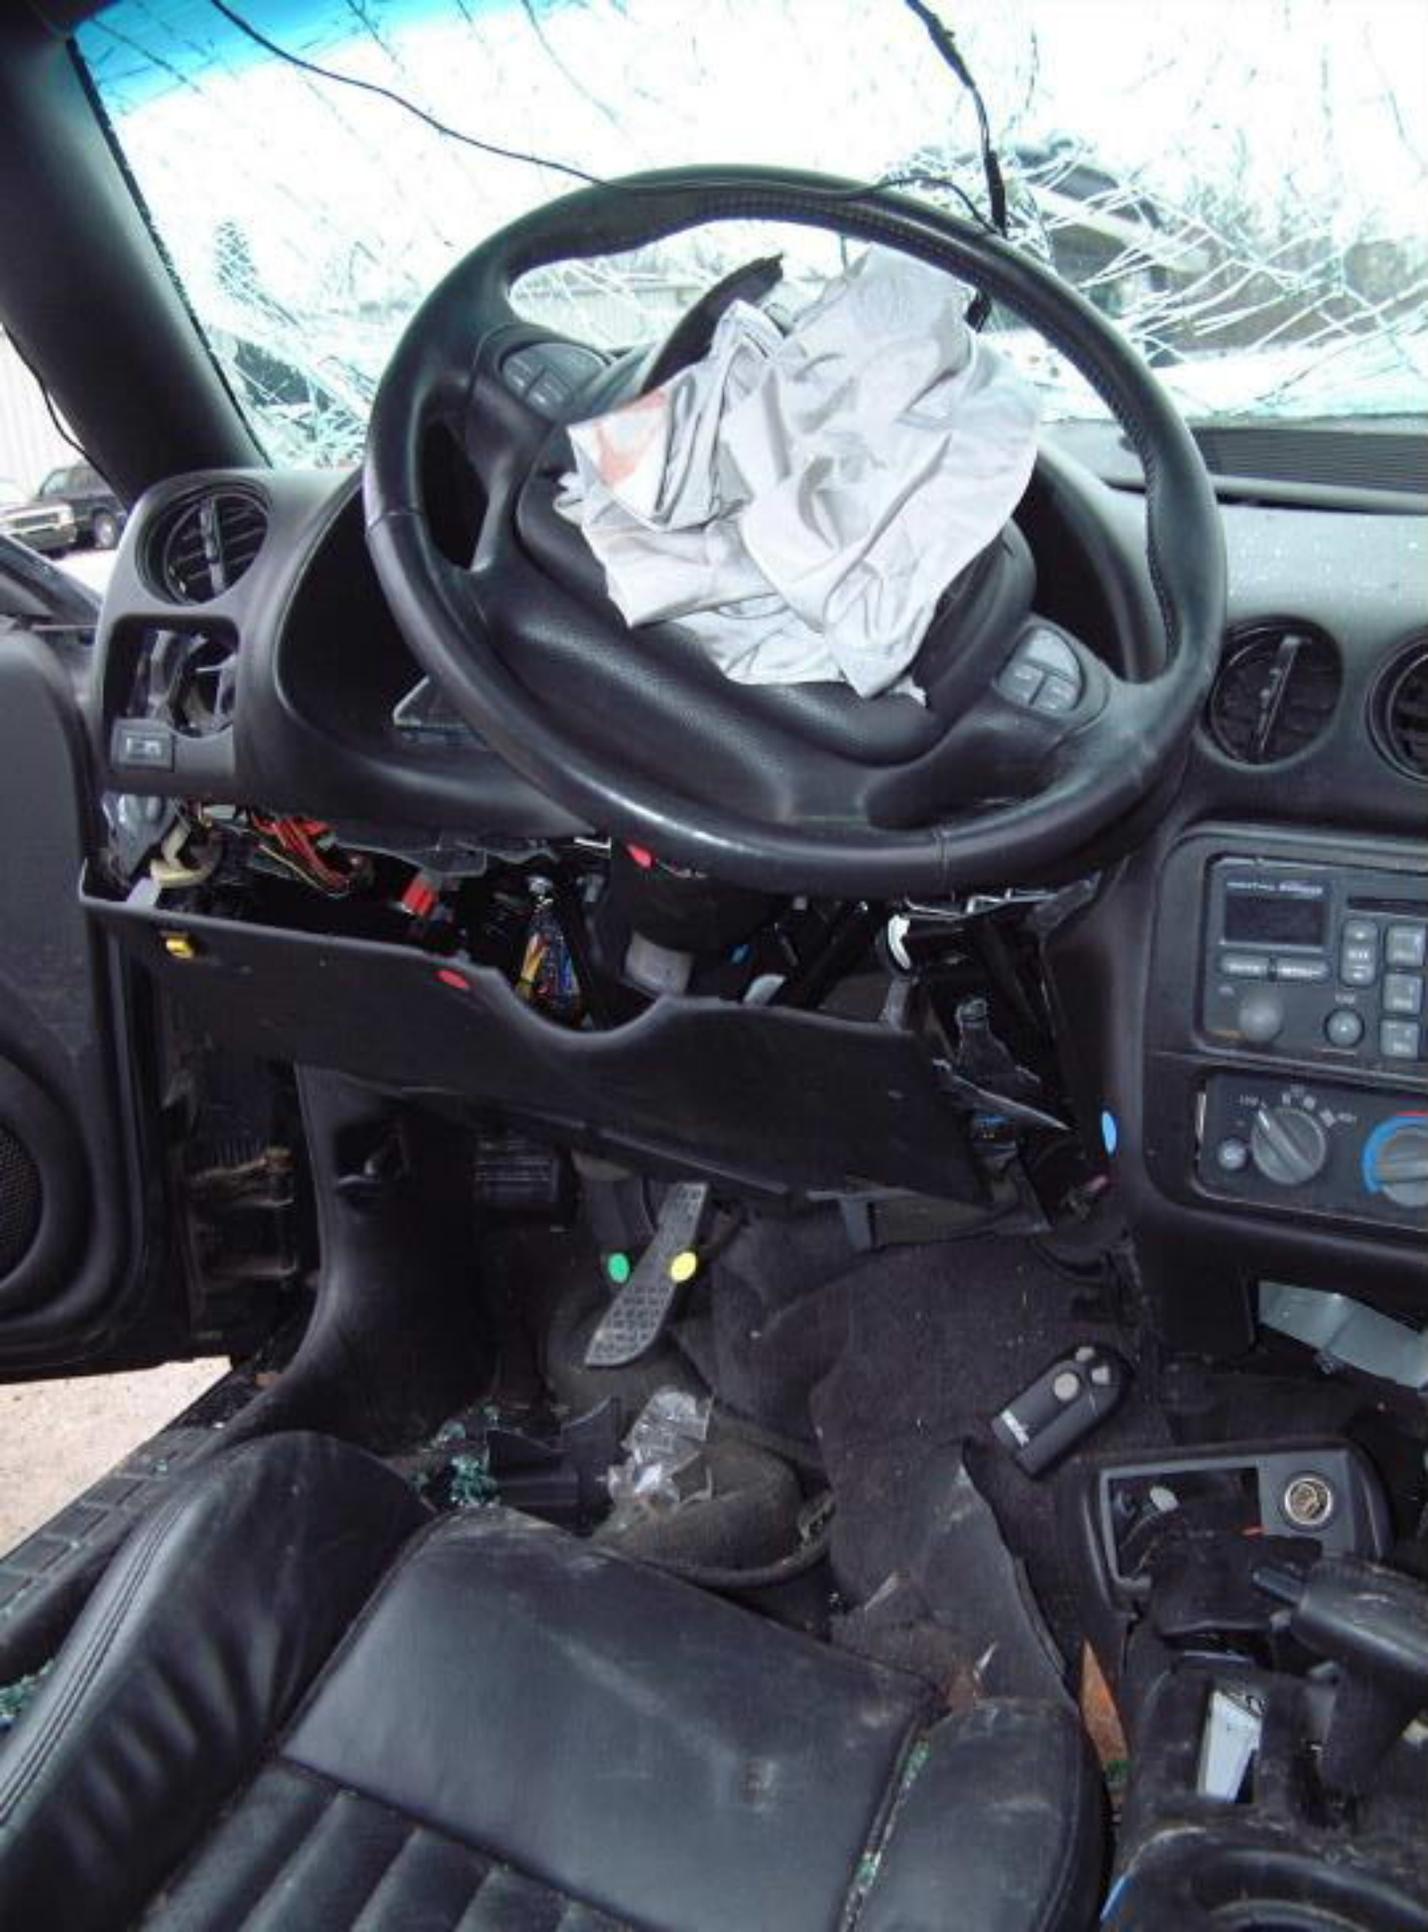
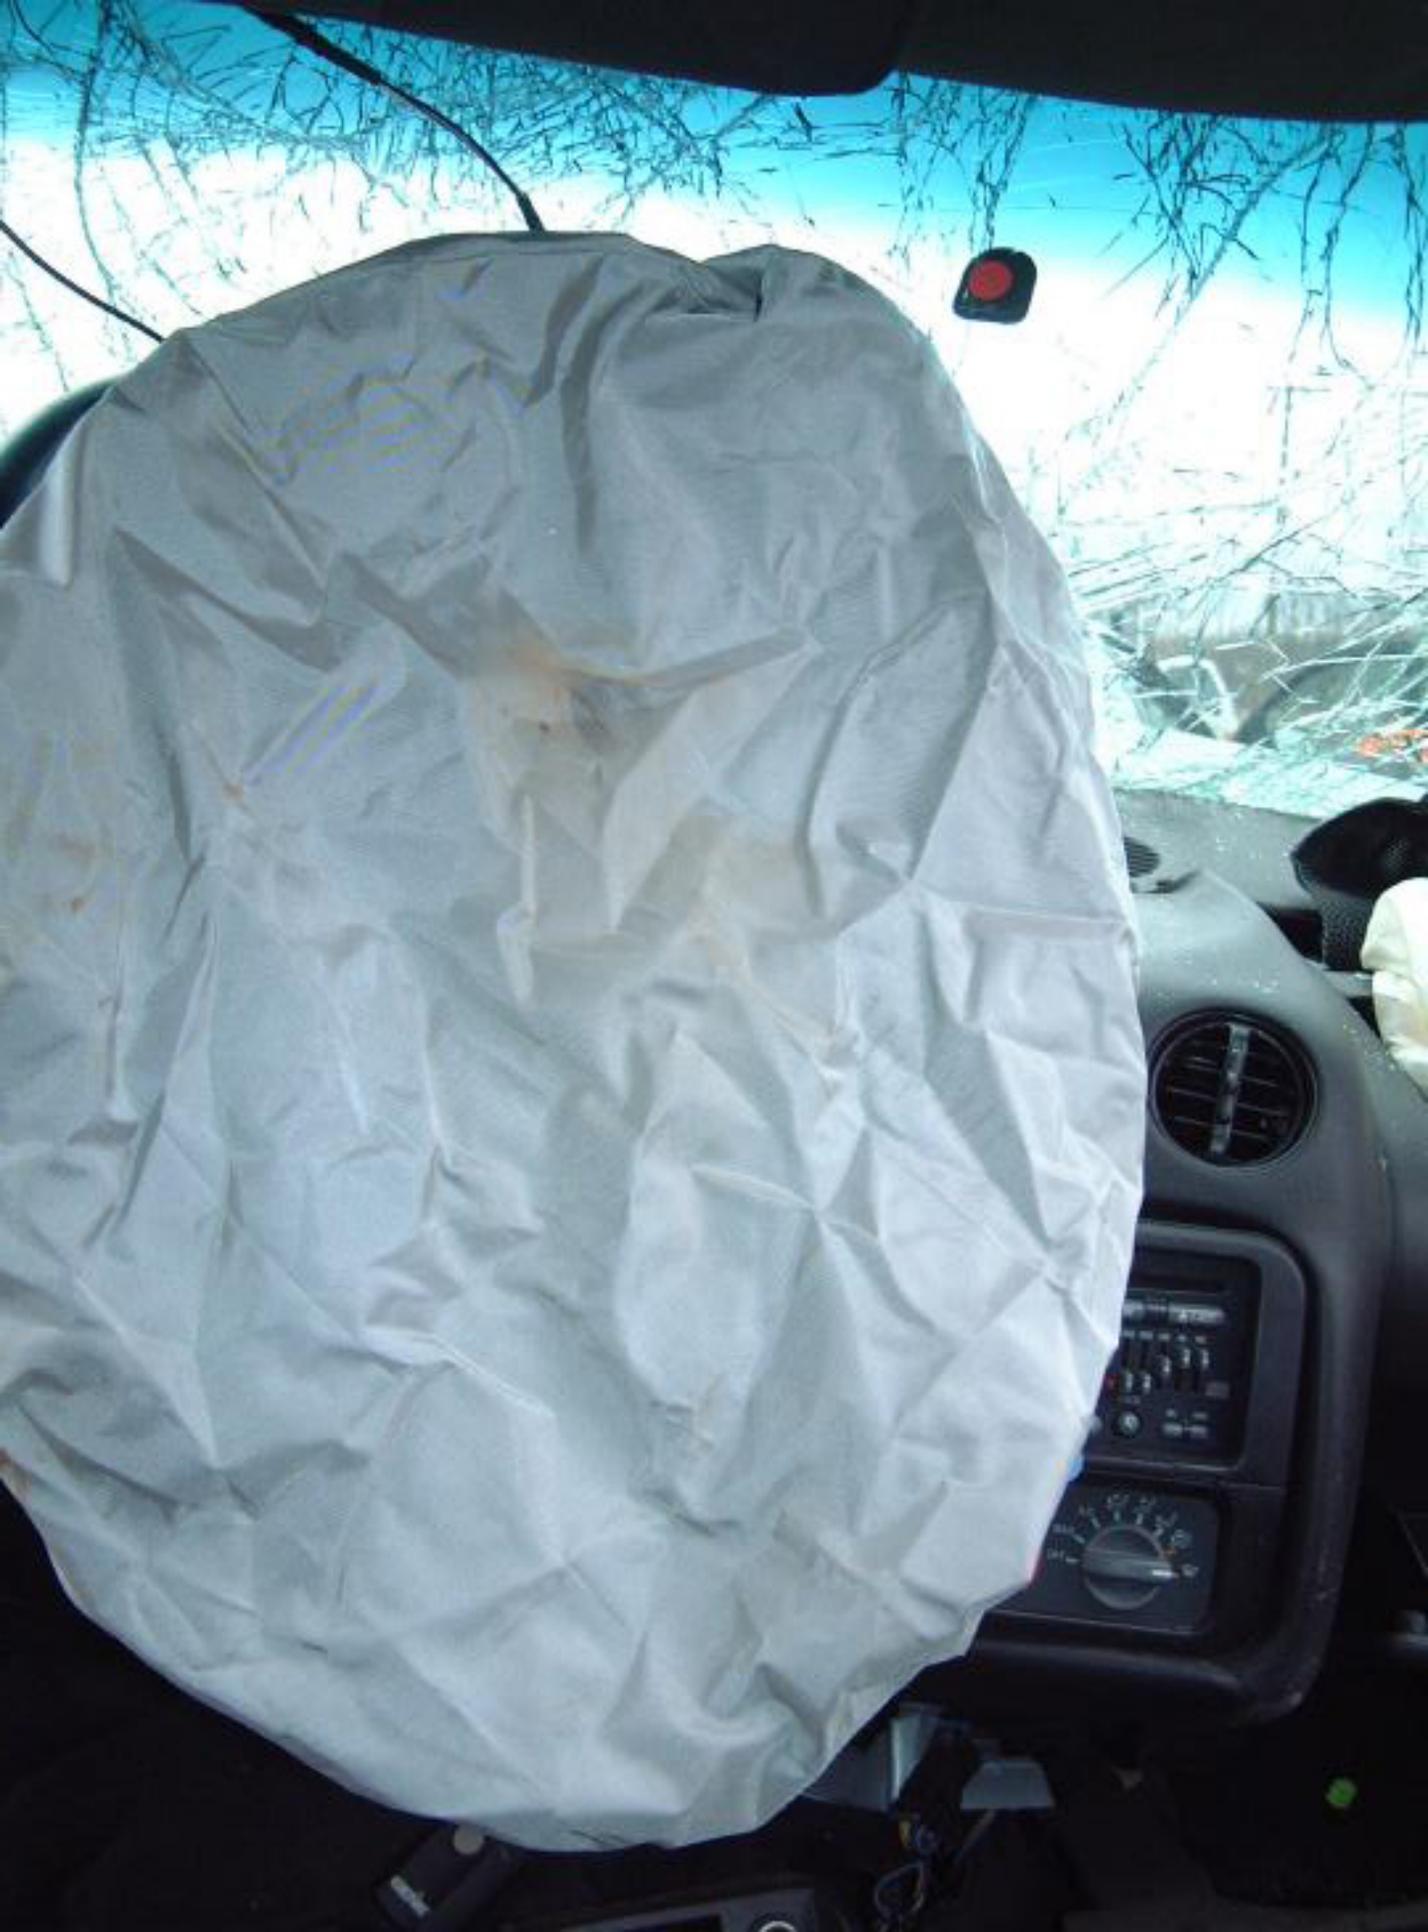
Location	Component	Distance (cm)	Direction
Driver	toe pan at gas pedal 62	19	to rear
	transmission tunnel	19	to left
	instrument panel 63	8	to rear
Center front	vertical console 64	11	to rear
Right front	toe pan 65	9	to rear
	windshield header 66	9	to rear
	instrument panel	9	to rear

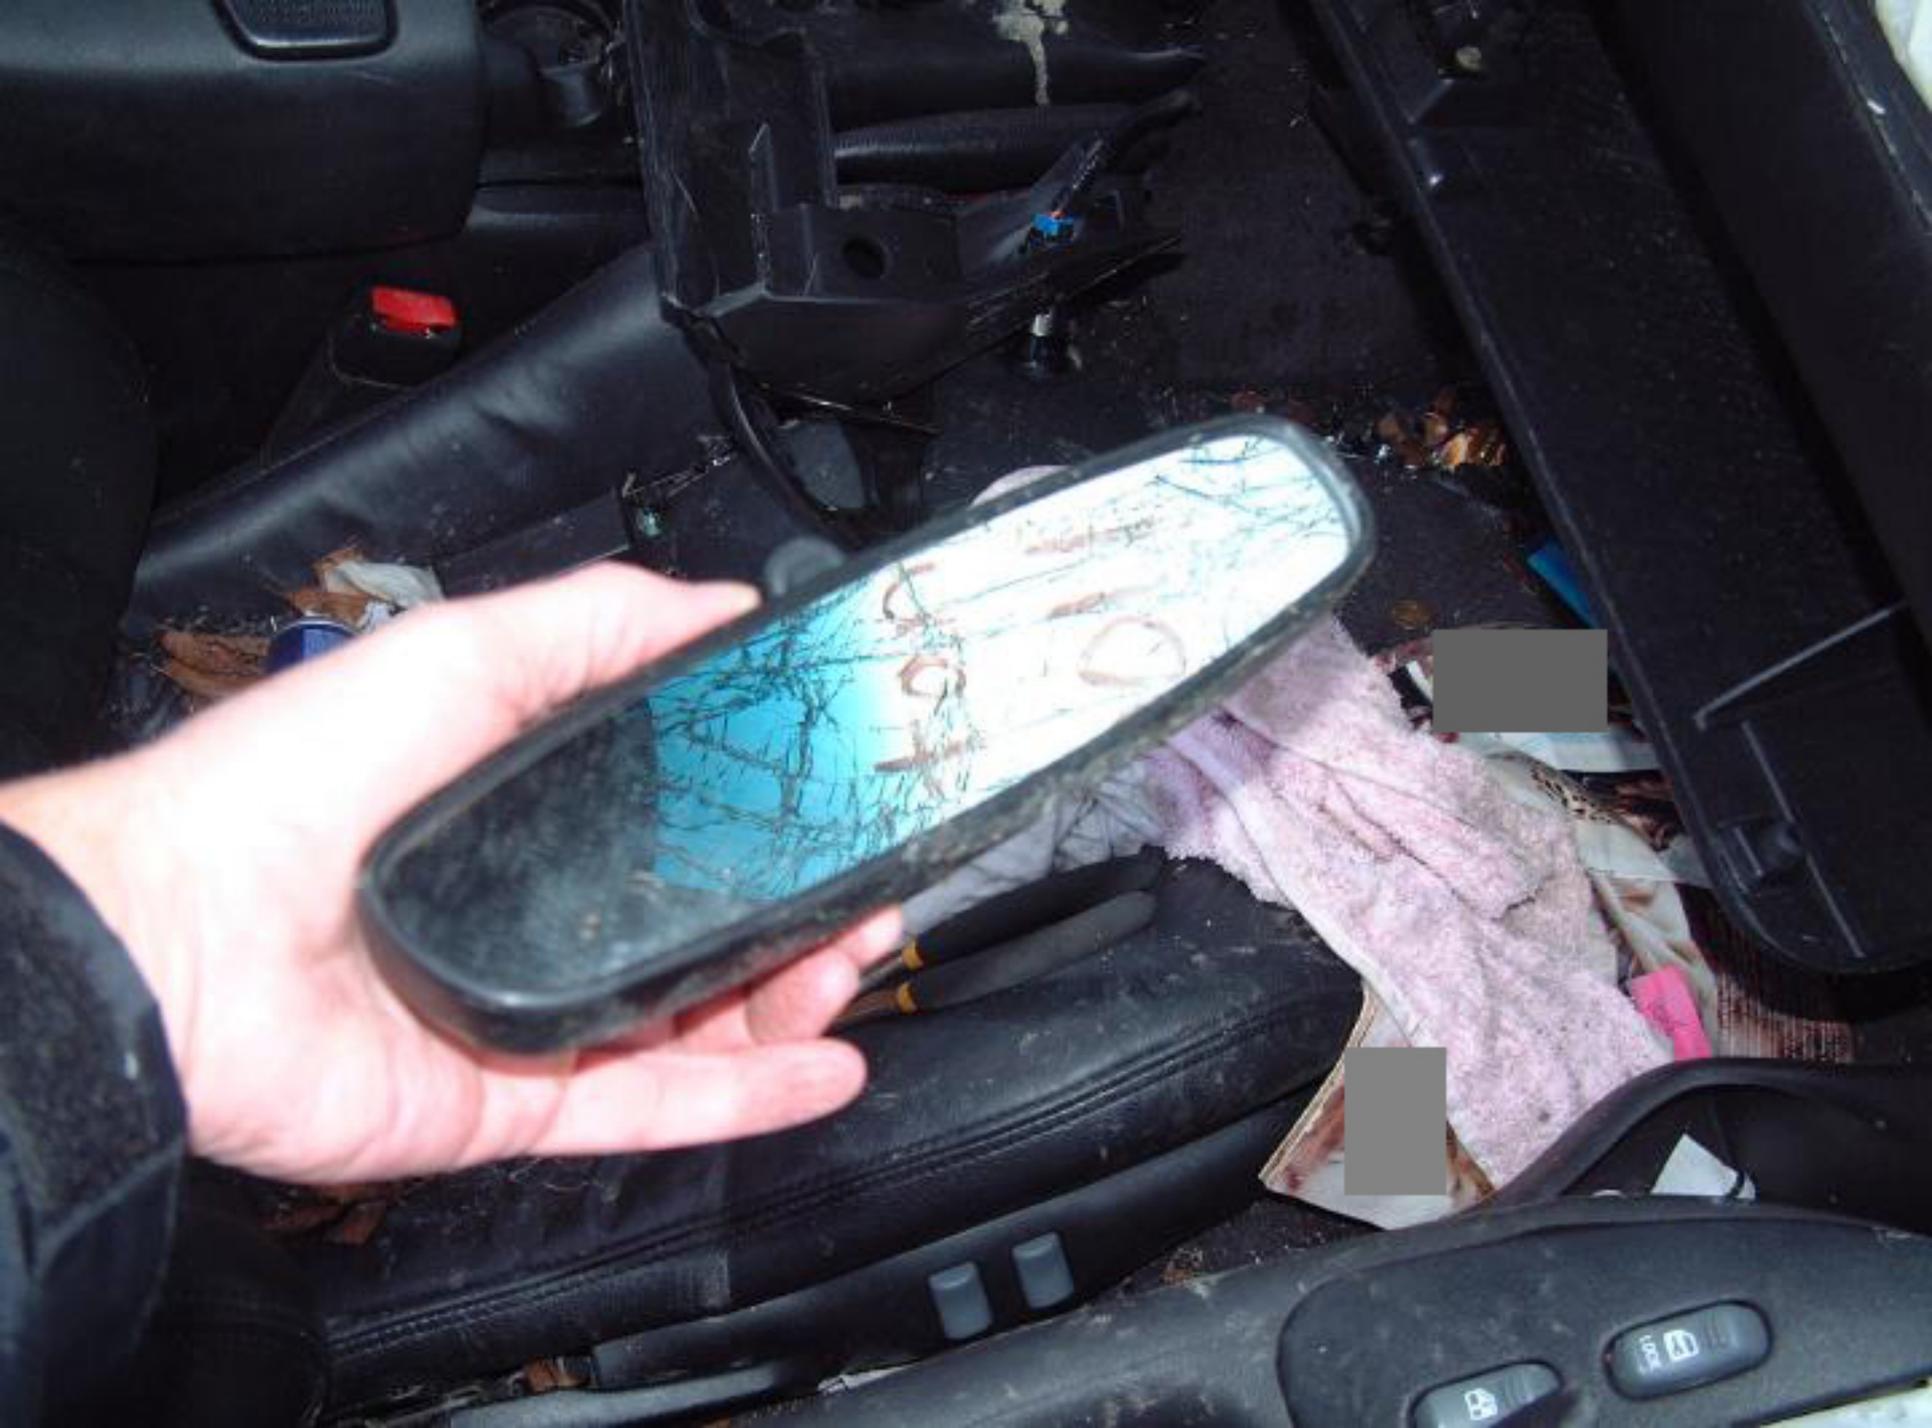
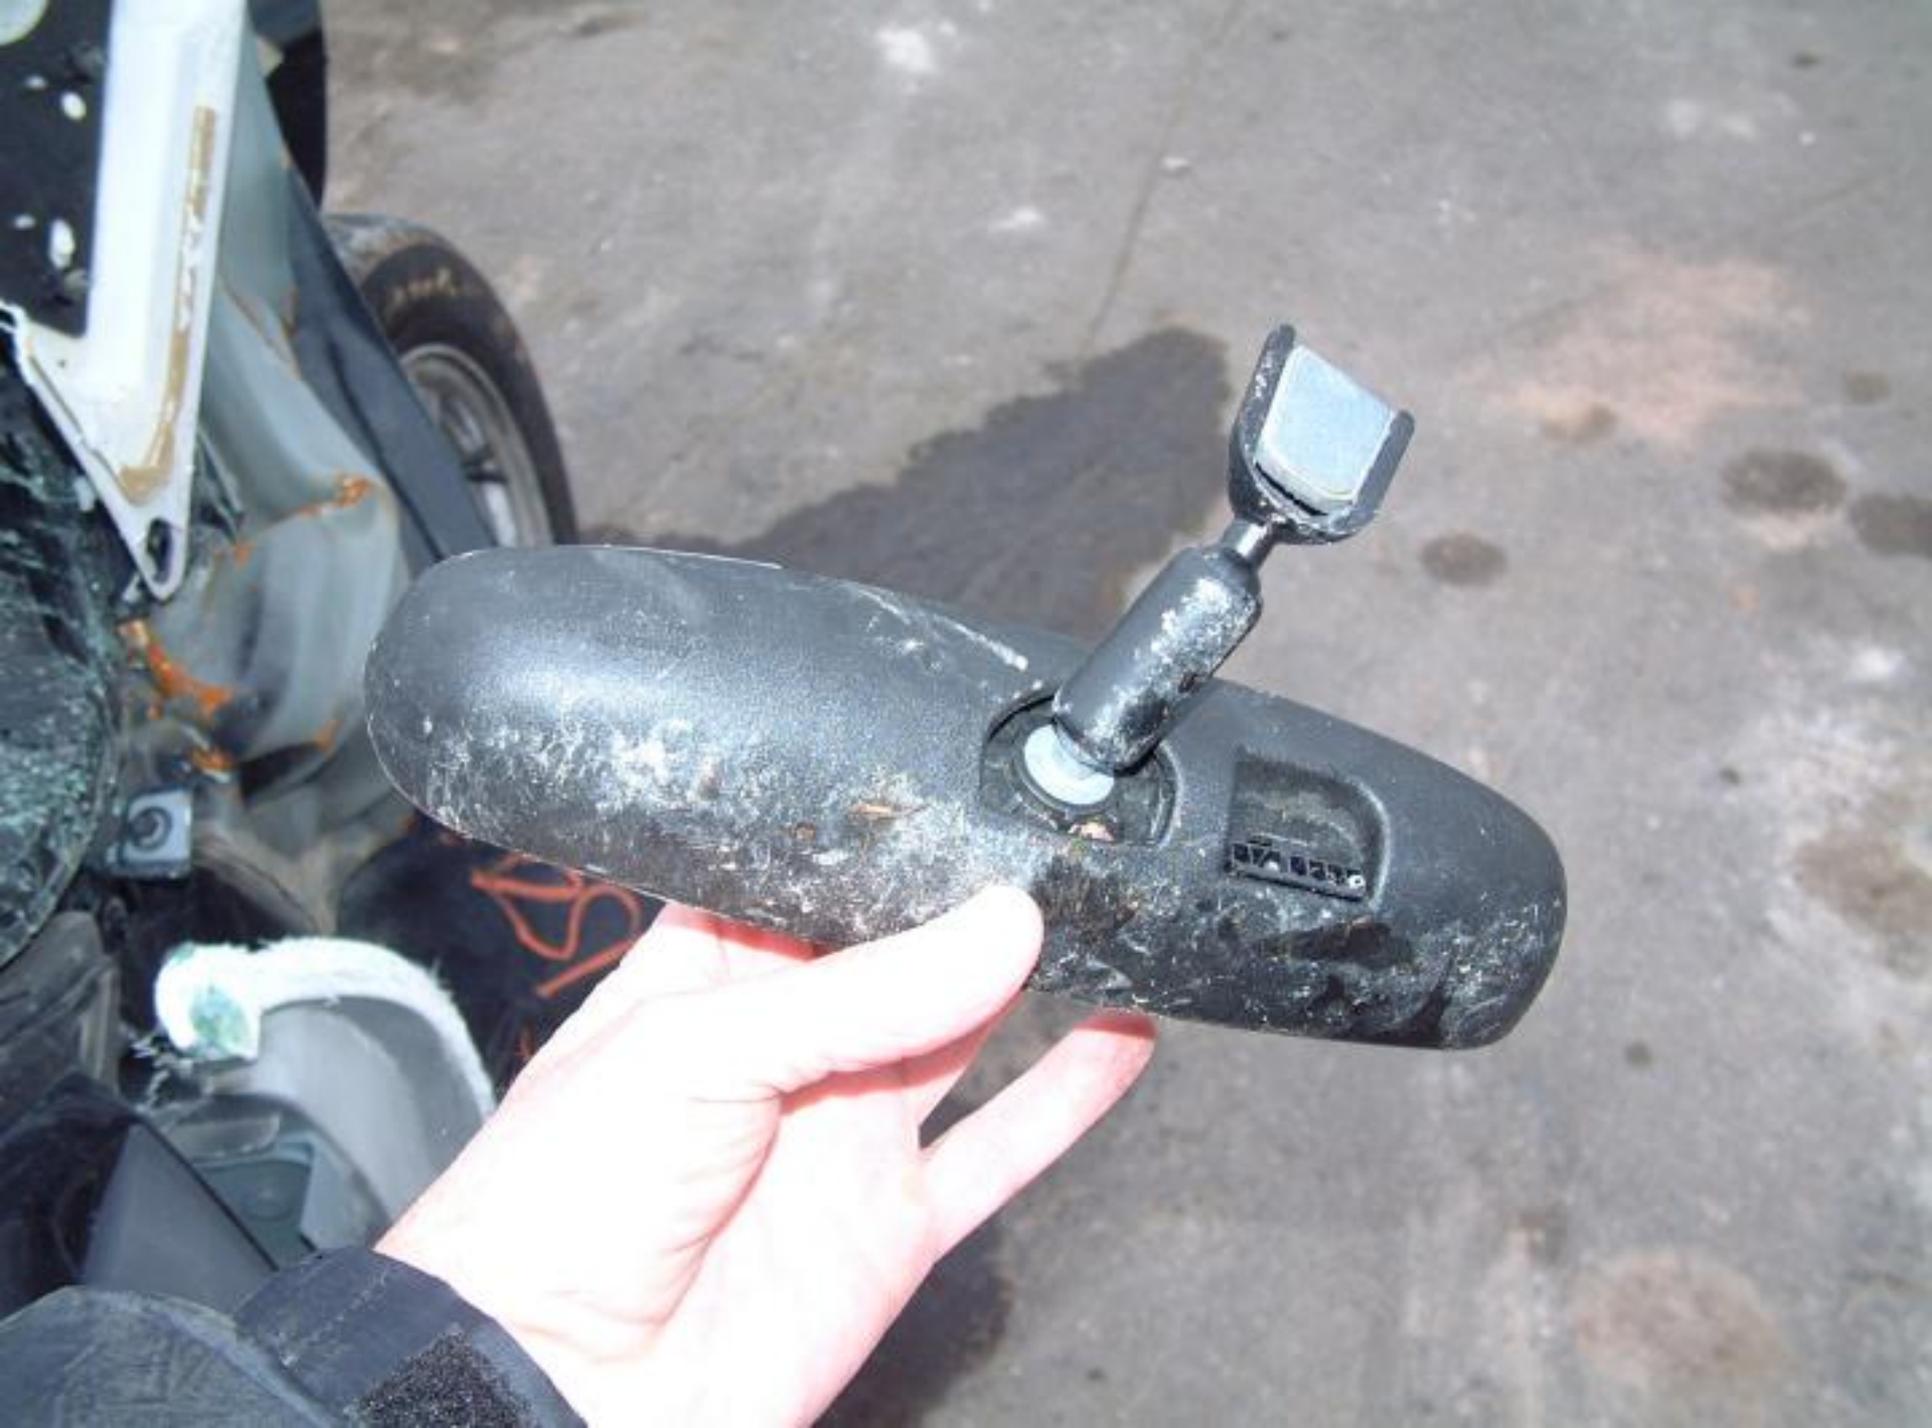
[67](#) [68](#) There was no other interior damage.

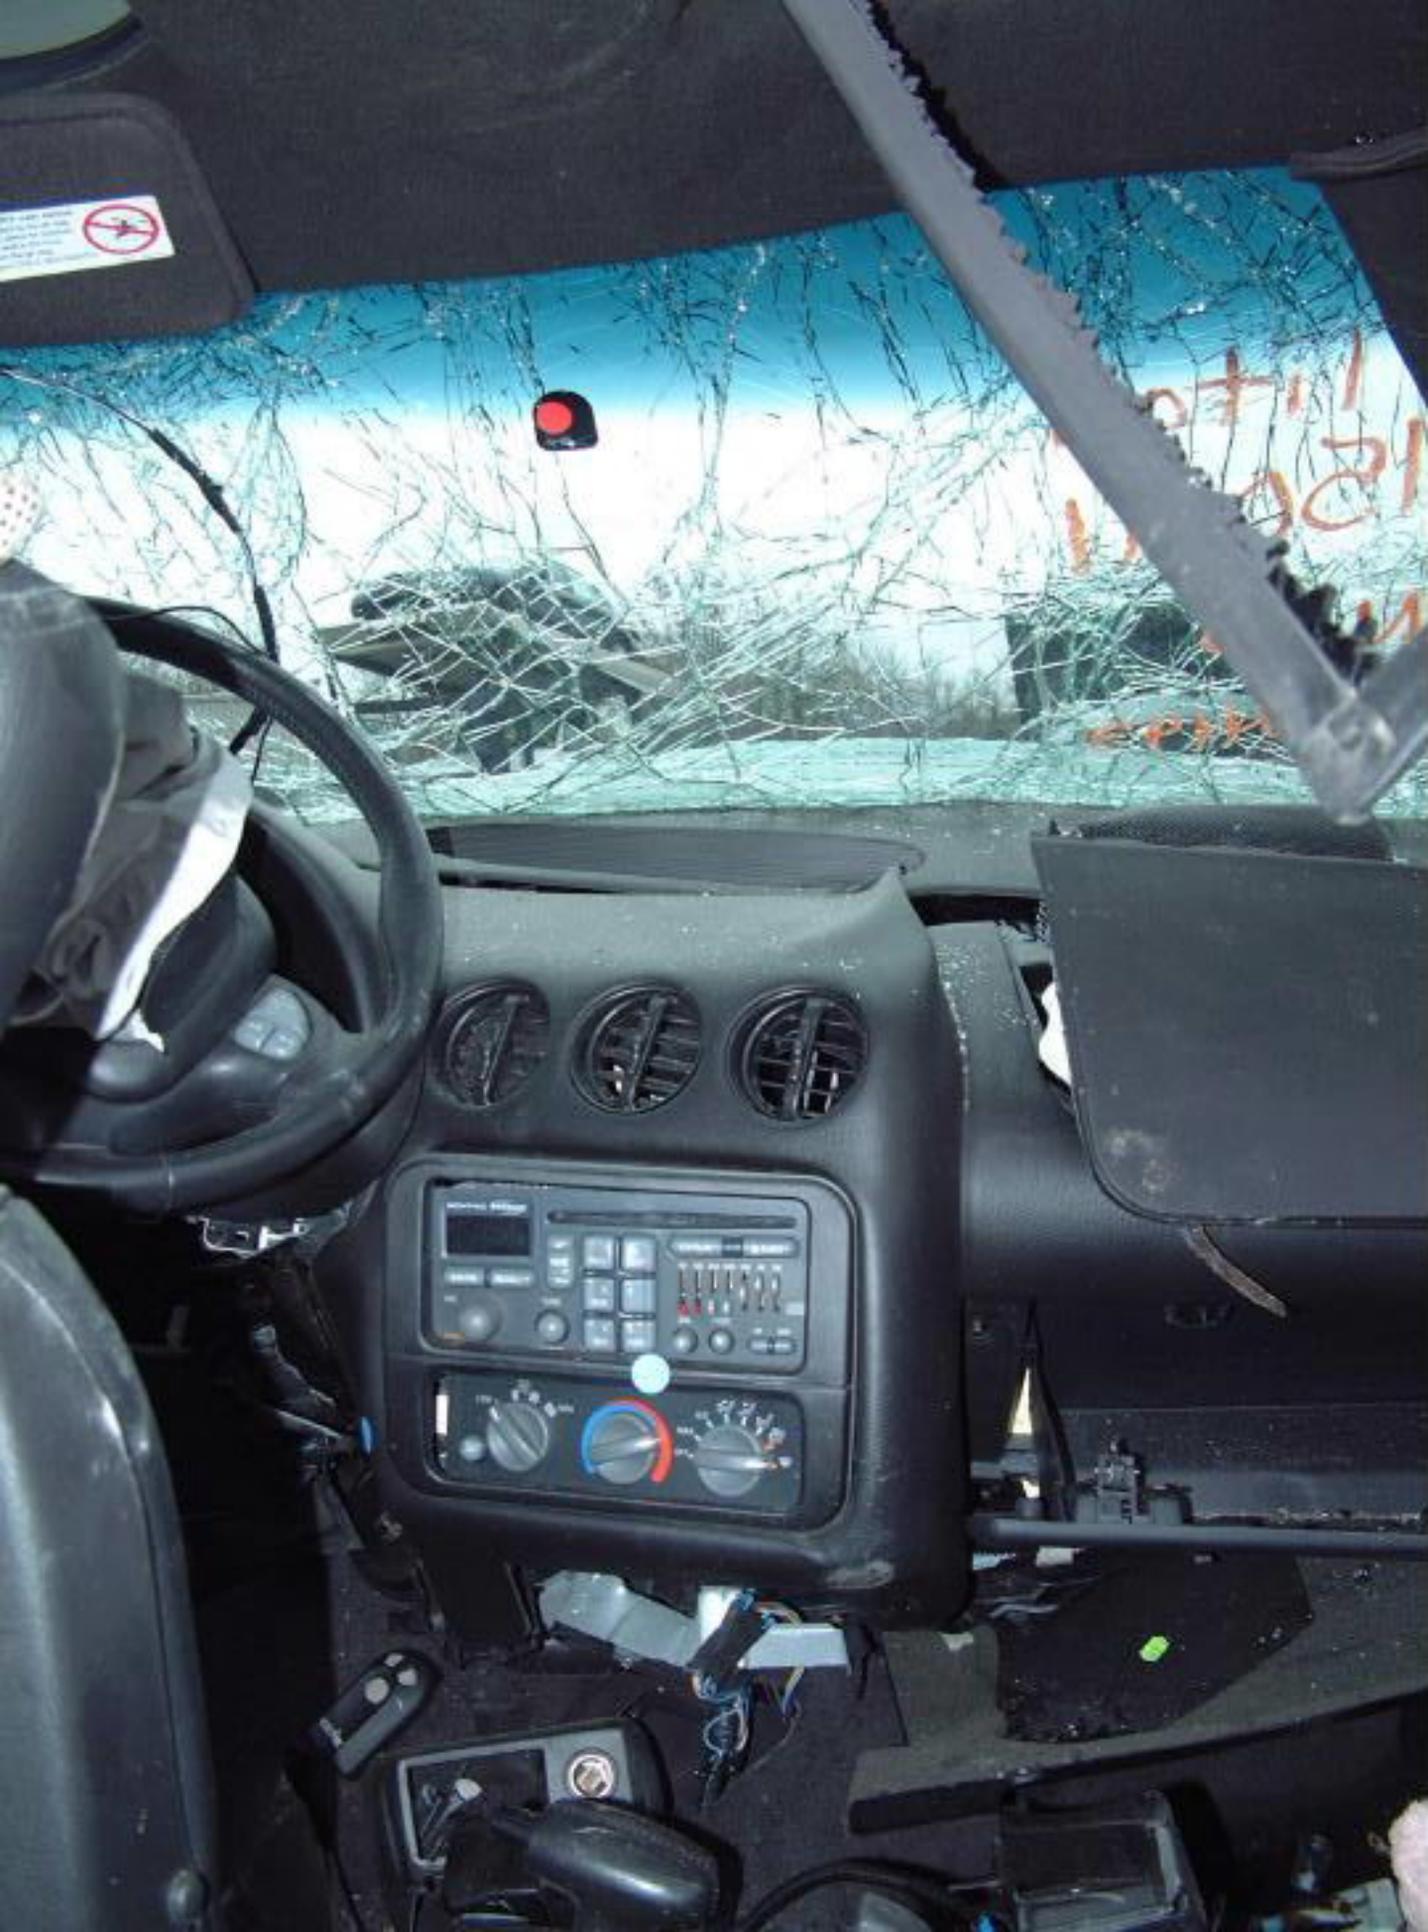
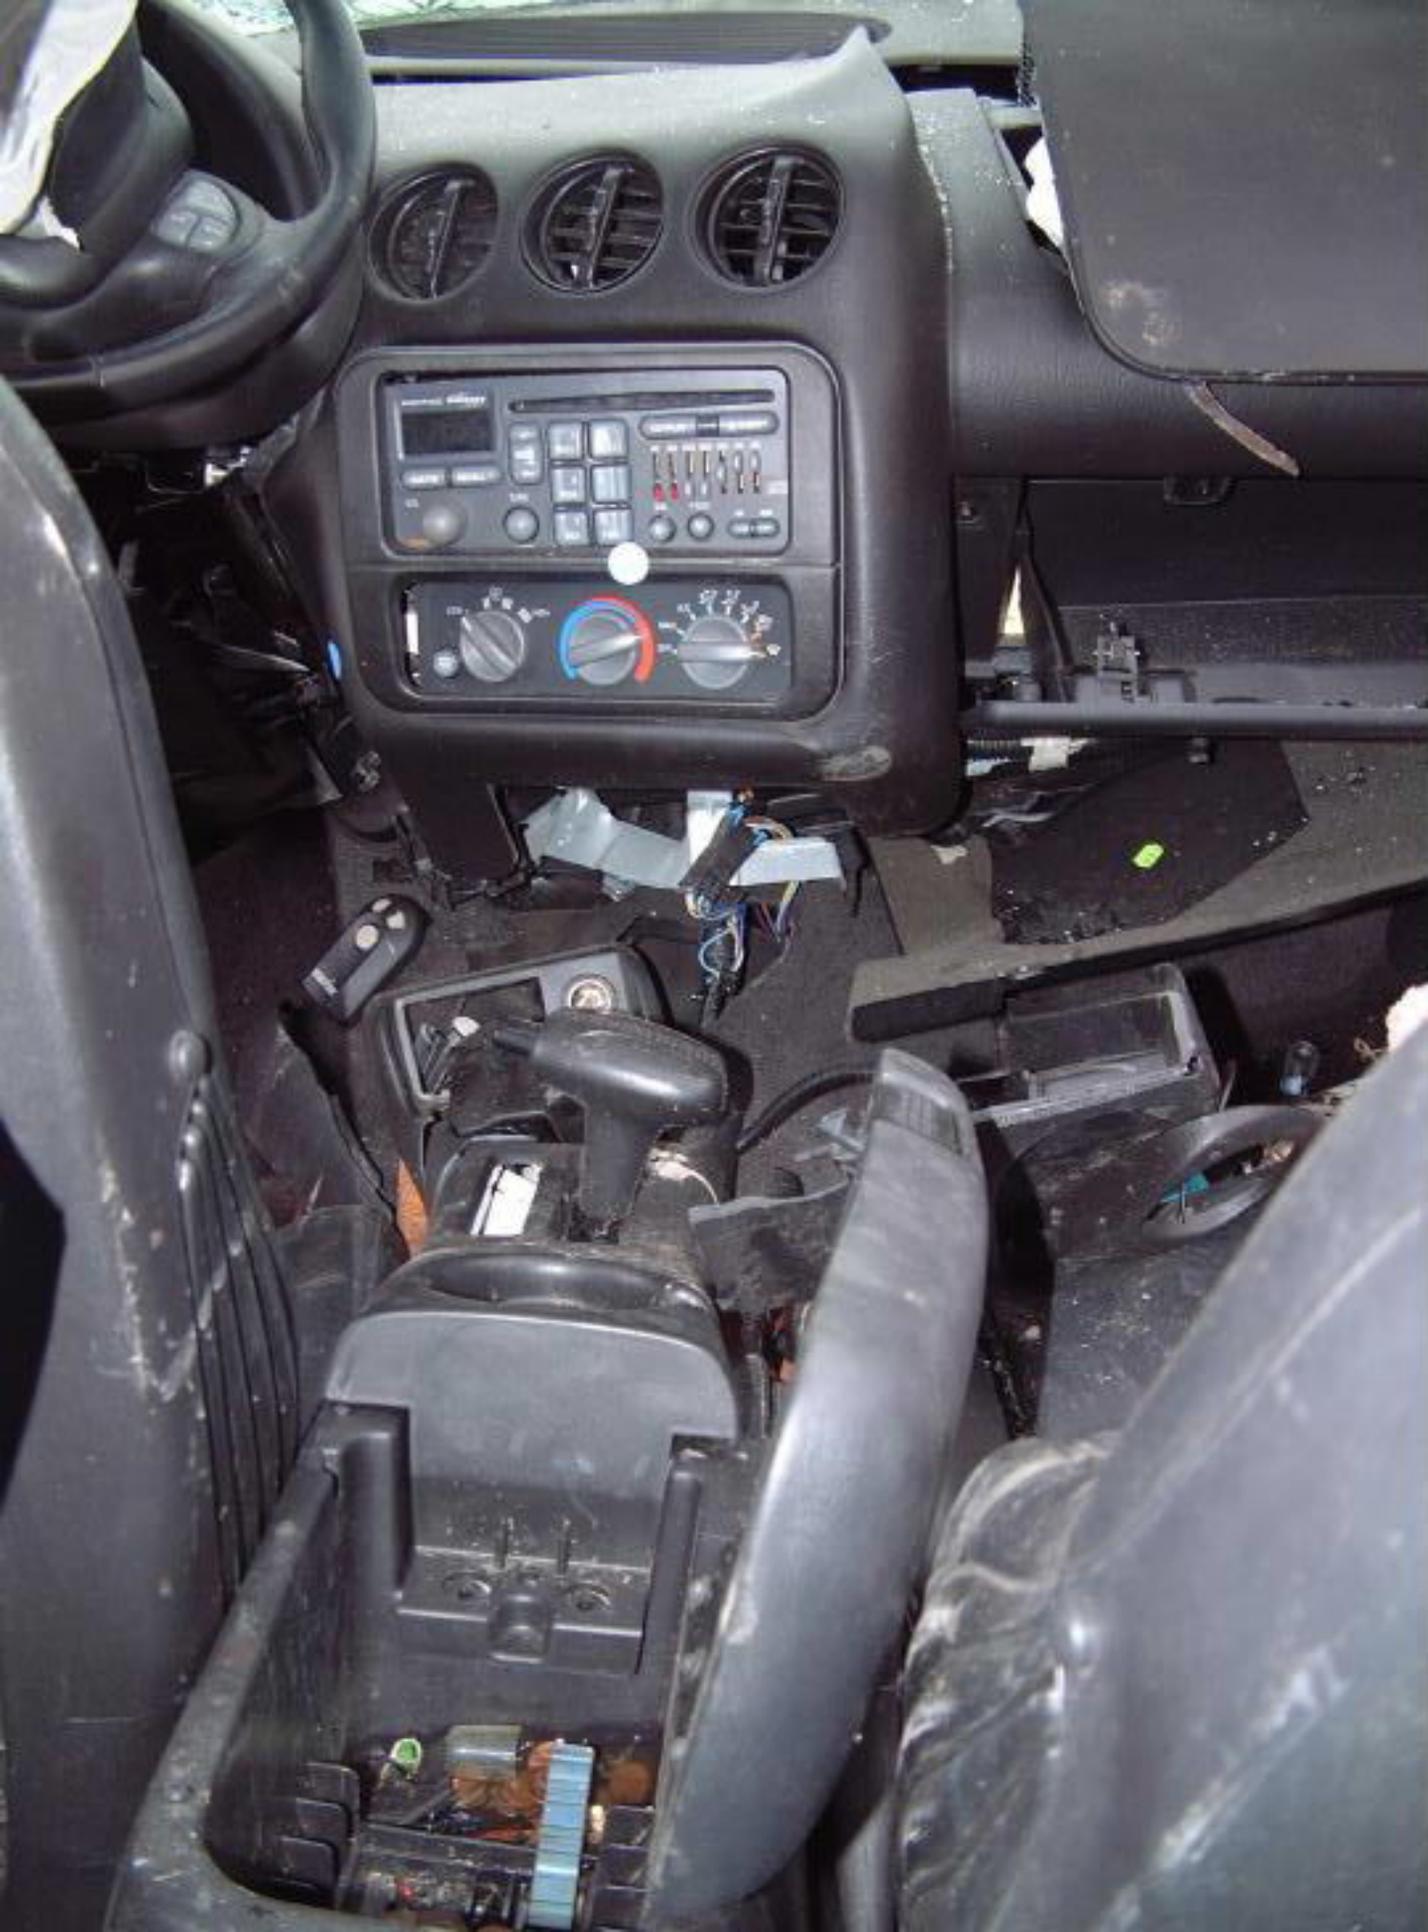
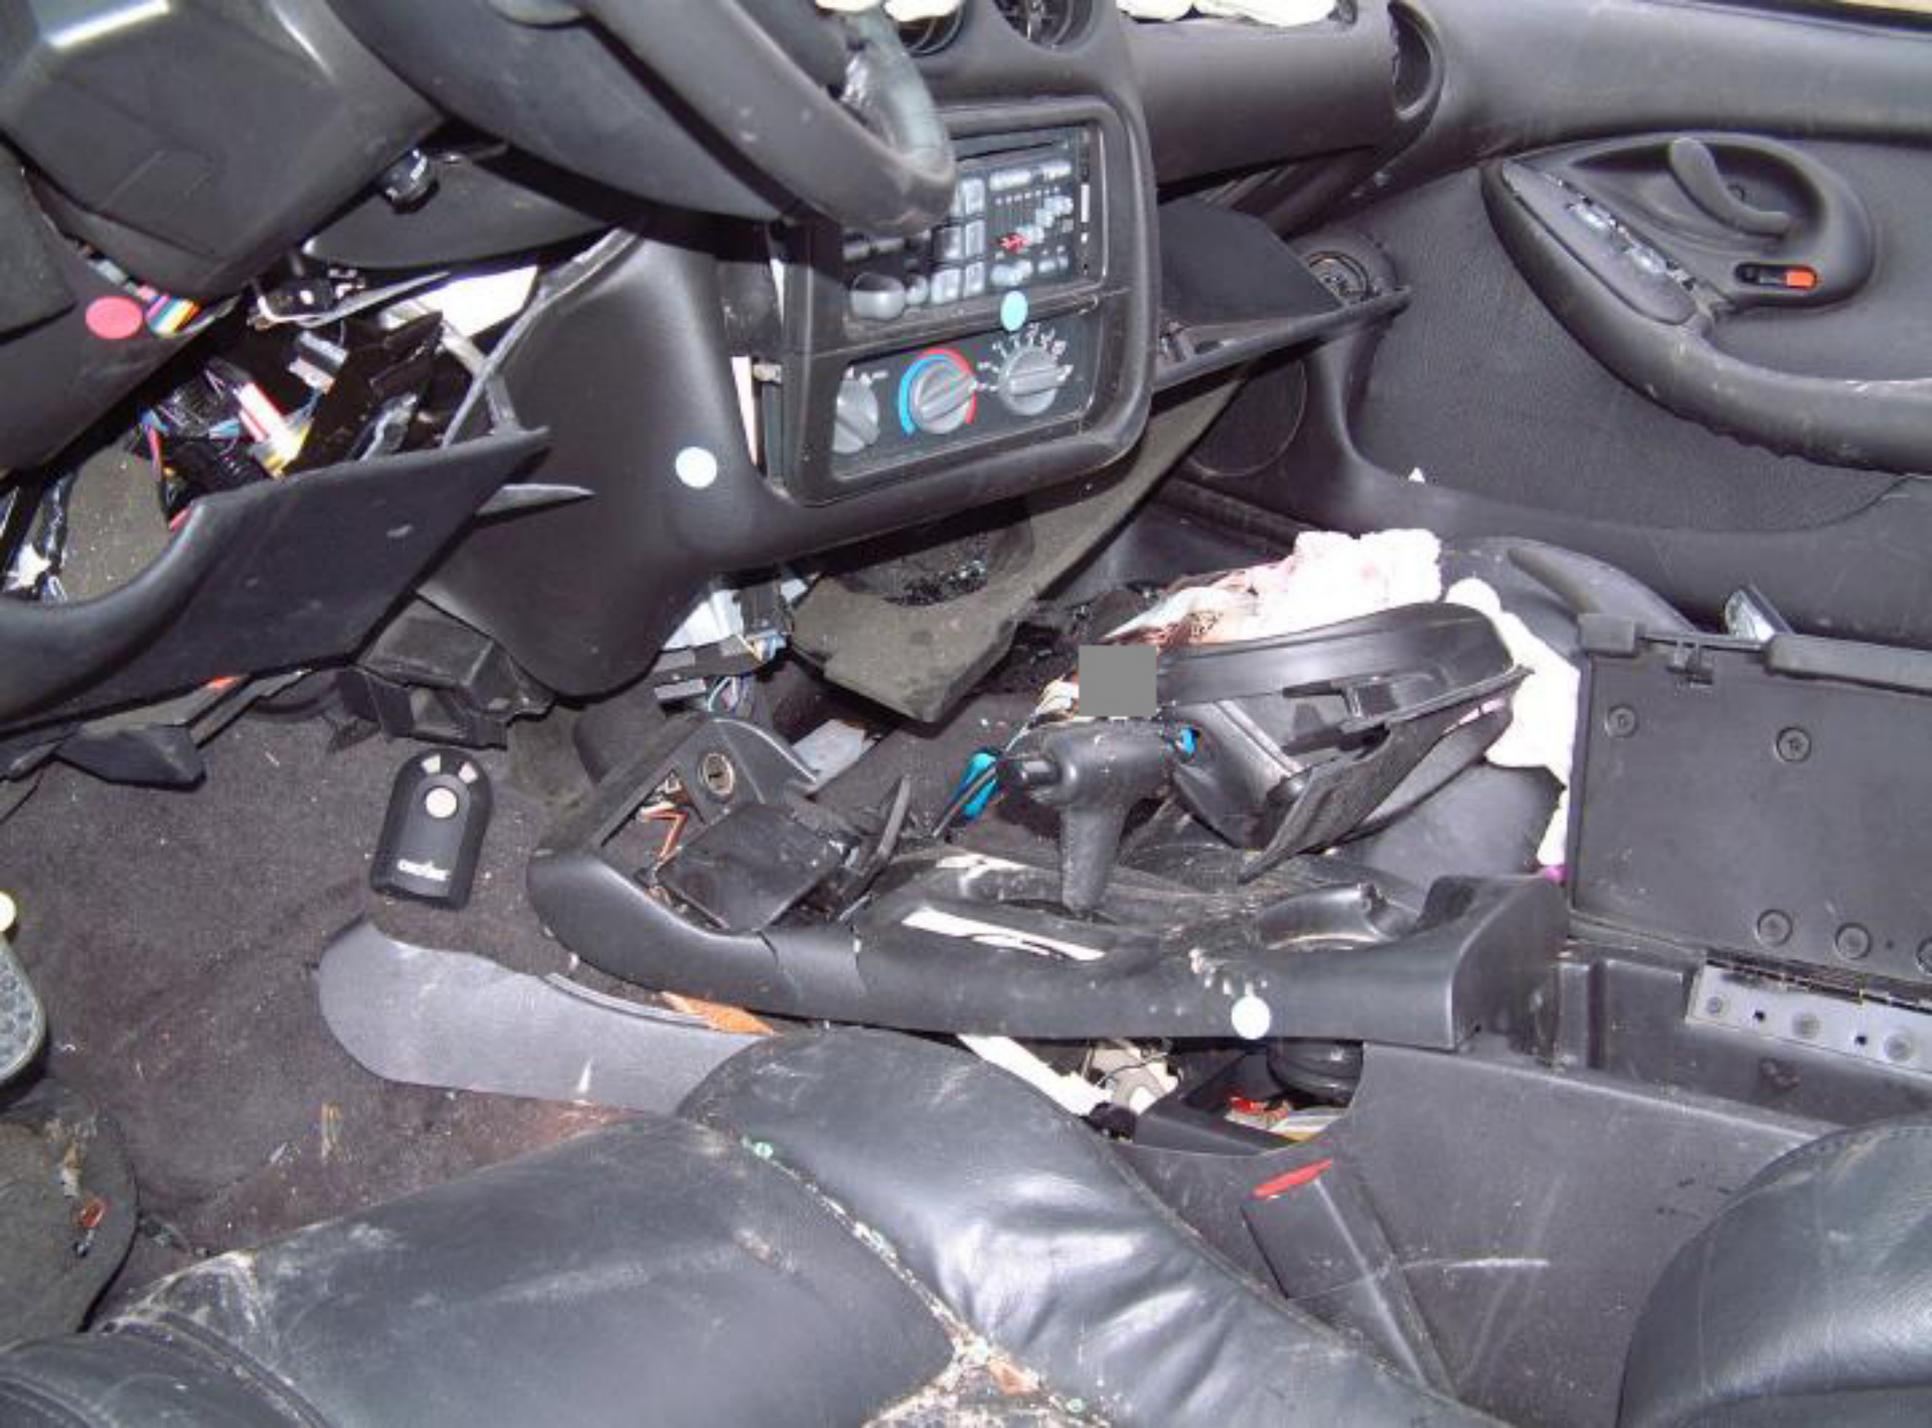
[69](#) [70](#) The 5-ft, 5-in, 120-lb, 22-year-old female driver was using the three-point belt improperly with the shoulder belt behind her back, [71](#) and the steering-wheel
