**Special Crash Investigations:
On-Site Rollover and Child Restraint
System Crash Investigation;
Vehicle: 2009 Honda Odyssey;
Location: Ohio;
Crash Date: November 2022**

Special Crash Investigations
On-Site Rollover and Child Restraint System Crash Investigation
Case Number: CR22019
Vehicle: 2009 Honda Odyssey
Location: Ohio
Crash Date: November 2022

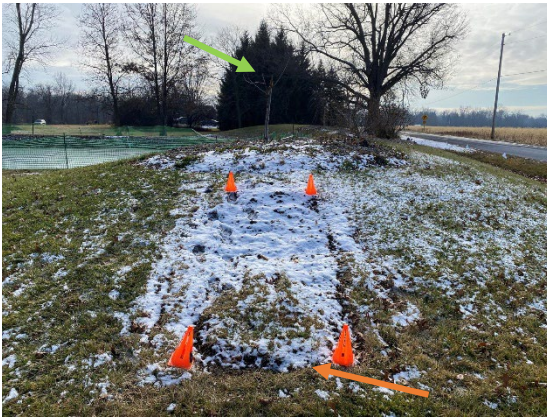
Figure 3. South view of the Honda's area point of impacts to the landscape embankment (Event 1) and tree (Event 2)

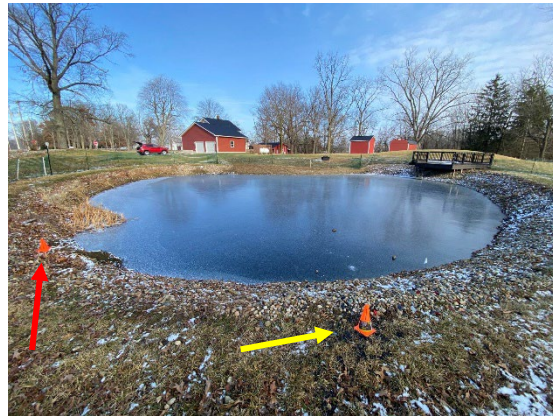
Figure 4. Northeast view of the Honda's area point of impacts to the ground for Events 3 and 4

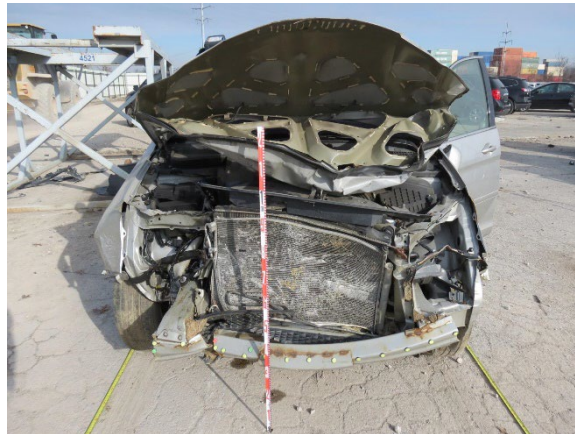
The direct damage from the pond embankment (Event 3), shown in Figure 6, began 62 cm (24.4 in) right of the front center point extending left 62 cm (24.4 in). The field-L was 130 cm (51.2 in). The crush measurements, taken at bumper level, were C1= 6 cm (2.4 in), C2 = 11 cm (4.3 in), C3 = 17 cm (6.7 in), C4 = 23 cm (9.1 in), C5 = 26 cm (10.2 in), and C6 = 10 cm (3.9 in).

Maximum crush was located 39 cm (15.4 in) right of the front center point and measured 27 cm (10.6 in). The CDC assigned to this damage profile was 00FZEW2.

Figure 6. View of the front-plane damage of the Honda Odyssey

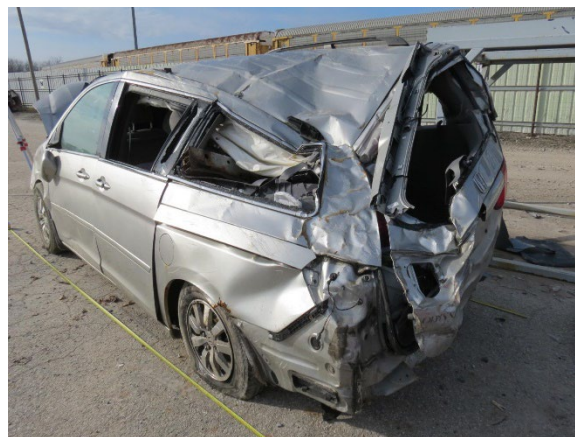
The rollover event (Event 4) resulted in a maximum vertical crush of 30 cm (11.8 in) and maximum lateral crush of 30 cm (11.8 in) located at the left D-pillar (Figure 7). The assigned CDC for this damage was 00TDDO4.

Figure 7. Left-rear oblique view of the Honda Odyssey

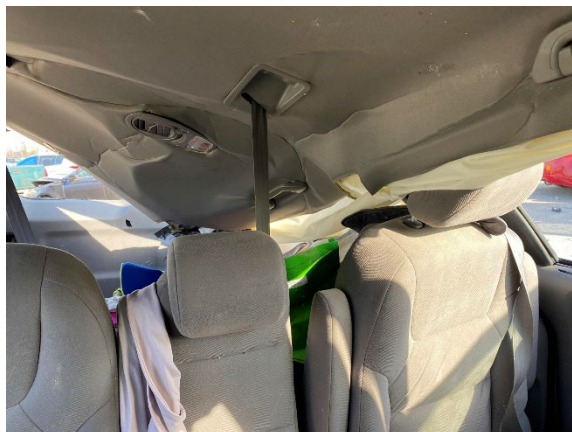
panel in the first row. This contact point was attributed to the driver's left knee striking the instrument panel during the crash sequence. Vertical and lateral intrusions were observed in the second and third rows (Figure 8). In the second row, the estimated maximum vertical intrusion was 30 cm (11.8 in) located at the C-pillar. In the third row, the estimated maximum vertical intrusion was 45 cm (17.7 in) at the left D-pillar.

Figure 8. View of the interior of the Honda depicting the left-side intrusions at the C and D-pillars

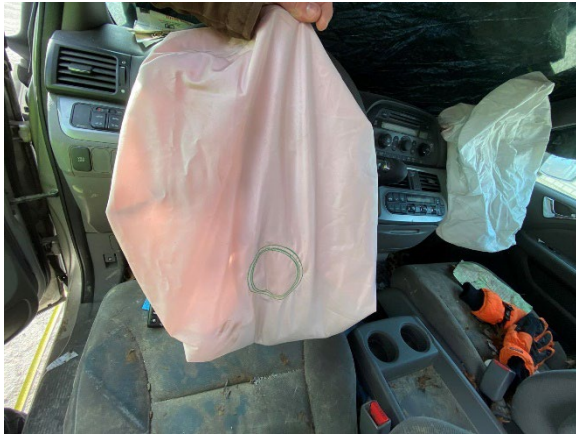
Figure 9. View of the driver's deployed frontal air bag in the Honda

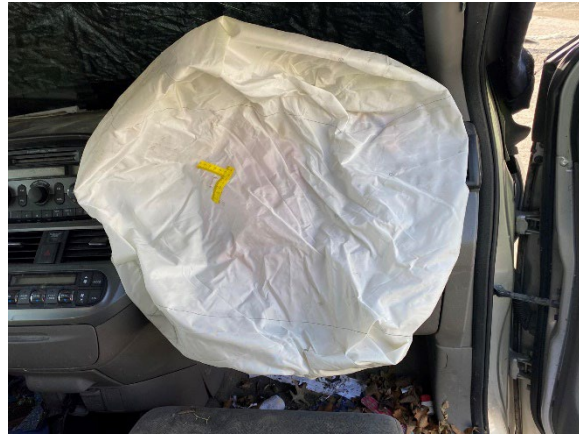
Figure 10. View of the passenger's deployed frontal air bag in the Honda

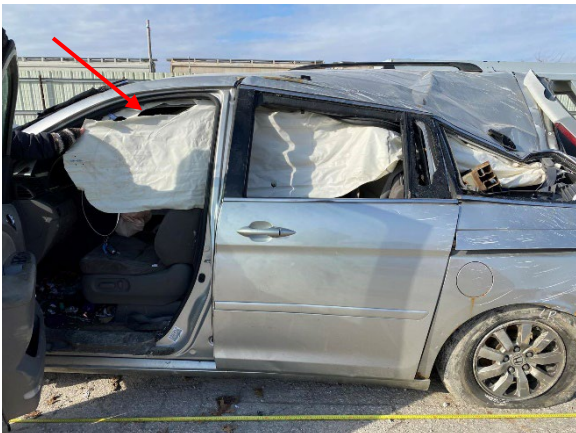
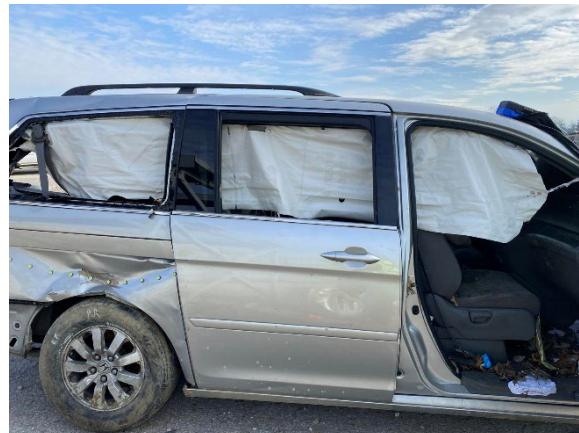
Figures 11 and 12 show both IC air bags as they were found at the time of the inspection. The left IC was cut by emergency personnel, indicated in Figure 11 by the red arrow, after the vehicle was removed from the pond to assist with the removal of the 4-year-old female. It should be noted that it is likely the driver and front passenger contacted them at some point during the crash sequence. However, due to the vehicle being submerged in water, there was no physical contact evidence found.

Figure 11. View of the left IC air bag in the Honda

Figure 12. View of the right IC air bag in the Honda

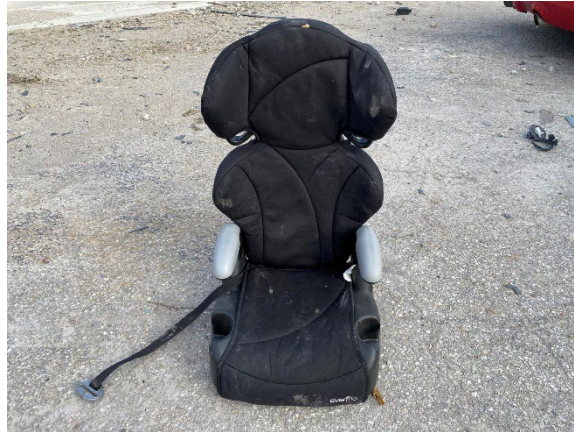
The first child restraint system found was an Evenflo Amp No Back booster seat (Figure 13). It was found in the cargo area during the inspection. The removeable back rest was separated from the base. This CRS was occupied by the 4-year-old female in the second-row-left seating position. The manufacturer label (Figure 14) on the CRS stated that it was produced on August

21, 2017, with an expiration date of August 20, 2023. There was no sign of damage to the CRS at the time of the inspection.

Figure 13. Child restraint system that was secured in the second-row-left seating position of the Honda

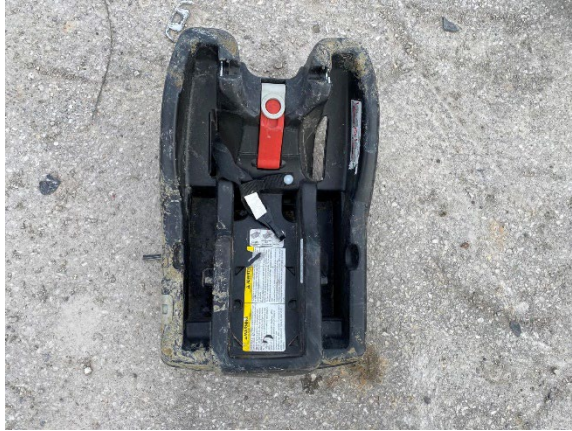
A Graco Click Connect universal base (Figure 15) was also found in the cargo area. The base could be used with a number of different Graco CRS models. The exact Graco model could not be determined. It was determined by process of elimination that this CRS base was originally used by the 2-year-old male in the second-row-right seating position. The manufacturer label (Figure 16) on the CRS base stated it was produced on August 26, 2016. Graco Click Connect CRS lifespan is 7 years after the date of manufacture, which would indicate that the base expired on August 25, 2022. The CRS that would secure into this base was discovered through dashcam footage received by local first responders to have been thrown into the pond during the extrication process. It was determined that the CRS make had to be Graco in order for the base to connect properly to the CRS. However, the model is undetermined due to not having the CRS to inspect.

Figure 15. Child restraint system base that was found in the Honda's cargo area
