ON-SITE AIR BAG RELATED CHILD FATALITY INVESTIGATION

VERIDIAN CASE NO: CA98-070

VEHICLE: 1995 PONTIAC SUNFIRE

CRASH DATE: DECEMBER 1998

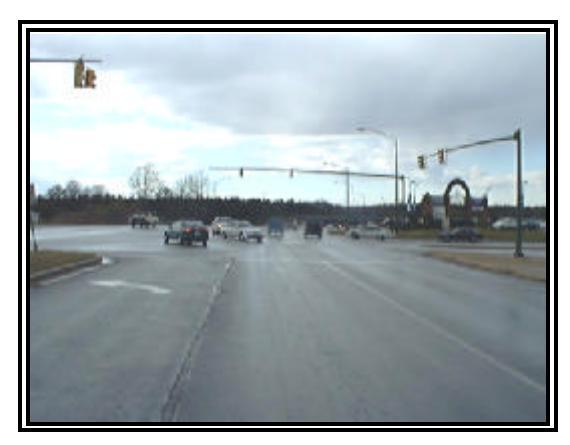
Figure 1. Precrash trajectory of the Pontiac Sunfire

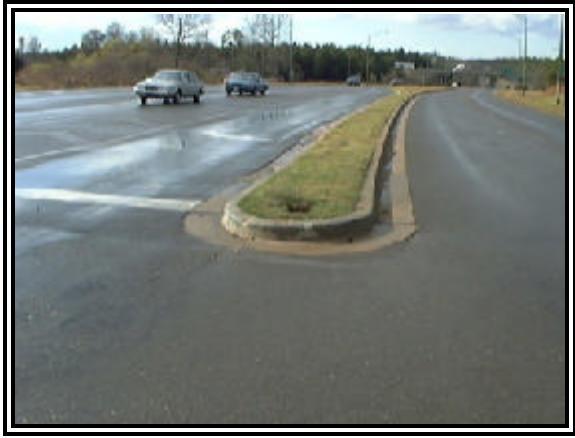
The Pontiac continued on its westward trajectory after separating from the Volkswagen. The front undercarriage of the Pontiac then impacted and overrode the barrier curb protecting the center median located west of the intersection. Inspection of the curb face identified contact damage which was subsequently linked to the Pontiac's undercarriage damage. The vehicle then came to rest straddling the median approximately 24 m (79 ft) from the POI. **Figure 2** is a view of the median and the area of the vehicle's final rest.

Figure 2: View of the barrier curb and the area of the Pontiac's final rest.

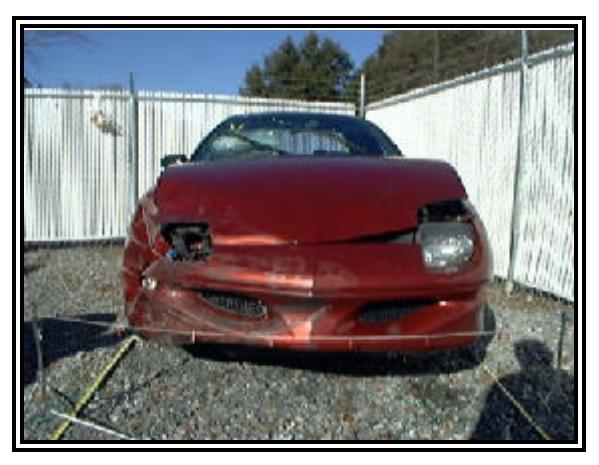
Figures 3 through 5 are the front, right side and right lateral views depicting the Pontiac's damage. The front plane of the vehicle sustained 80.0 cm (31.5 in) of direct contact damage. The direct contact began 15 cm (6 in) left of center and extended to the right corner of the front bumper. The combined width of the direct and induced damage extended across the full 125 cm (49 in) frontal end width of the Pontiac. The crush profile measured along the bumper was follows: C1 = 6.0 cm (2.4 in), C2 = 6.0 cm (2.4 in), C3 = 7.0 cm (2.8 in), C4 = 10.0 cm (3.9 in), C5 = 15.0 cm (5.9 in), C6=20.0 cm (7.9 in). There was no measurable change in the either wheelbase

Figure 3: Pontiac front view.

dimension. The hood and right front fender were buckled. All the doors remained shut during the crash and were operational upon inspection. The Collision Deformation Classification was 11-FZEW-1. The total delta V calculated by the damage algorithm of the WINSMASH model was 17.0 km/h (10.6 mph). The longitudinal and lateral delta V components were -16.0 km/h (9.9 mph) and 5.8 km/h (3.6 mph). The Principle Direction of Force (PDOF) was an estimated 20 degrees. The vehicle's impact speed calculated by the trajectory model was 40.0 km/h (24.9 mph). The WINSMASH analysis was a borderline speed reconstruction because of the violation of the common velocity assumption.

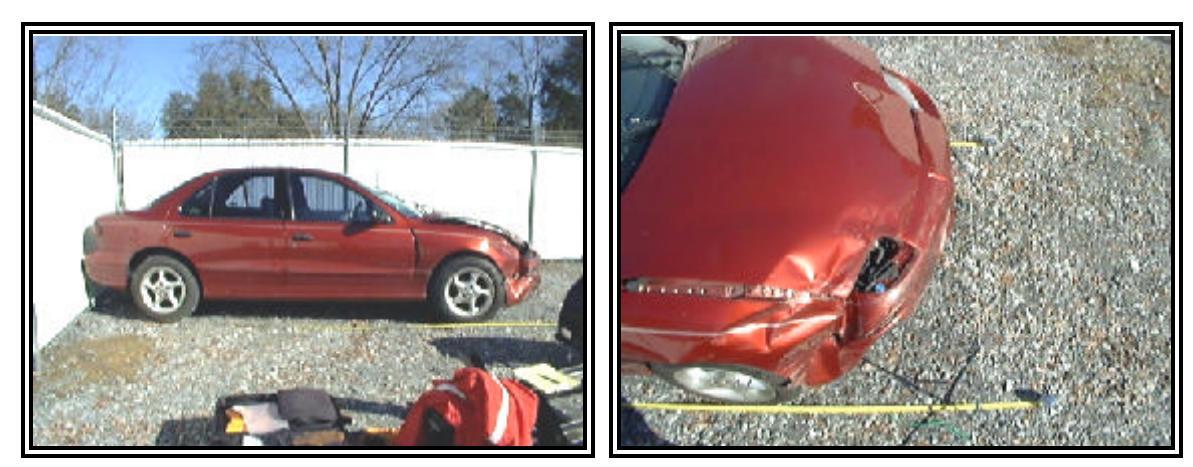
Figure 4: Pontiac right side view.

Figure 5: Right lateral view of the frontal damage.

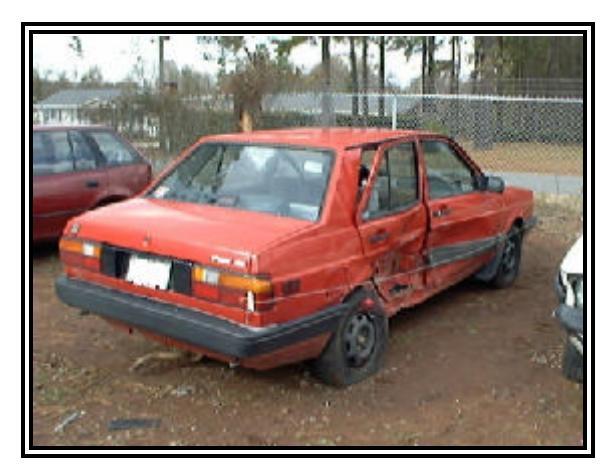
The right side of the Volkswagen sustained a combined width of direct contact and induced damage that measured 196.3 cm (77.3 in), **Figure 6**. The induced damage began 58 cm (23 in) rear of the right front axle location and extended rearward. The direct contact damage width measured 146.1 cm (57.5 in) and began 89 cm (35 in) rear of the right front axle (in the area of the right B-pillar). The maximum crush

measured 29.2 cm (11.5 in) and was located 155 cm (61 in) rear of the right front axle on the mid-aspect of the right rear door. The crush profile measured along the trim elevation was as follows: C1 = 0, C2 = 17.8 cm (7.0 in), C3 = 26.7 cm (10.5 in), C4 = 16.5 cm (6.5 in), C5 = 8.9 cm (3.5 in), C6=1.0 cm (0.4 in). The right doors were jammed shut due to deformation. All the side window glazings were intact. The right rear wheel rim was bent due to impact damage. However, there was no measurable change in the wheelbase dimension. The Collision Deformation Classification (CDC) of this vehicle was 02-RPEW-03. The total delta V calculated by the damage

Figure 6: Right rear view of the Volkswagen Fox.

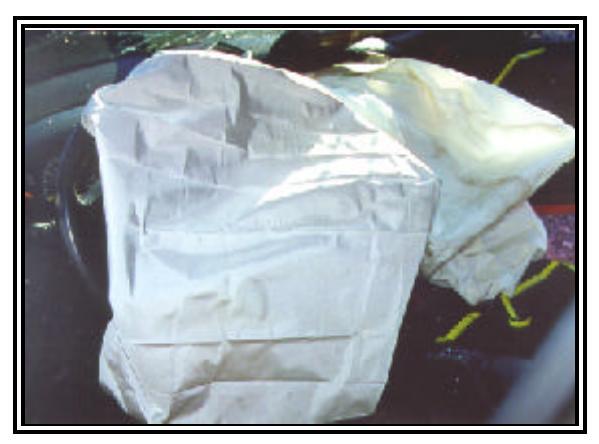
The driver air bag module was located in the center of the steering wheel. The I-configuration module cover flaps opened as designed along the tear seams. The flaps were symmetrical and measured 8 cm x 10 cm (3 in x 4 in), width by height. The deployed driver air bag, **Figure 7**, measured 66 cm (26 in) in diameter and was not tethered. The bag was vented by two 1.3 cm (0.5 in) diameter ports located in the

3/9 o'clock sectors on the back side. On the face of the air bag, three areas of vinyl transfers were noted in the 12 o'clock, central, and 6 o'clock aspects. The transfers measured approximately 20 cm (8 in) in length and were attributed to contact with the cover flaps during the deployment. These transfers were considered typical for this air bag. No evidence of occupant contact was observed on the driver air bag. The driver air bag was identified by the following manufacturers nomenclature:

Figure 7: Driver air bag.

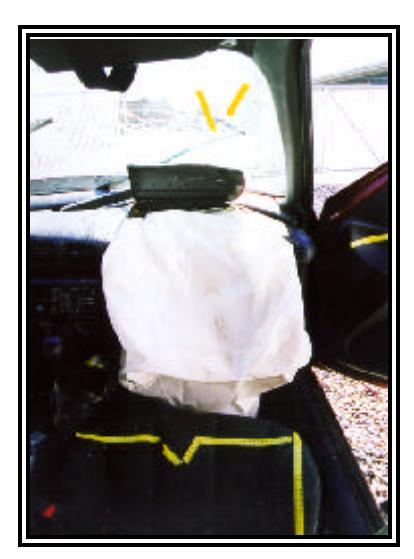
The face of the passenger air bag measured 48 cm x 56 cm (19 in x 22 in), width by height and extended rearward 56 cm (22 in) in its deflated state, **Figure 8**. The air bag was tethered by a 46 cm (18 in) wide strap sewn to the mid to upper aspect of the face of the bag. The membrane was not externally vented. The following nomenclature identified the passenger air bag:

Figure 8: Front right passenger air bag.

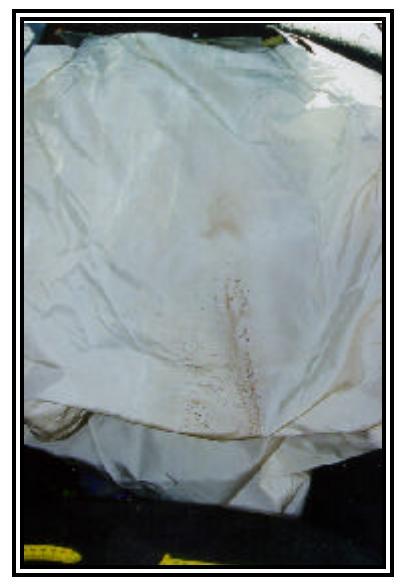
The deploying passenger air bag contacted and abraded the face and neck of the lap seated child early in the deployment sequence. This contact resulted in a large tissue transfer to the horizontal top surface and vertical face of the bag, **Figures 9 and 10**. The tissue transfer measured $43.2 \text{ cm} \times 12.2 \text{ cm} (17.0 \text{ in } \times 4.8 \text{ in})$, length by width, and

was located within the central aspect of the bag's width. The transfer began on the air bag's top surface approximately 25 cm (10 in) from the inflator, extended rearward 30 cm (12 in) and wrapped 12 (5 in) onto the face of the bag.

Figure 9: View of the tissue transfer to the top surface of the PAB.

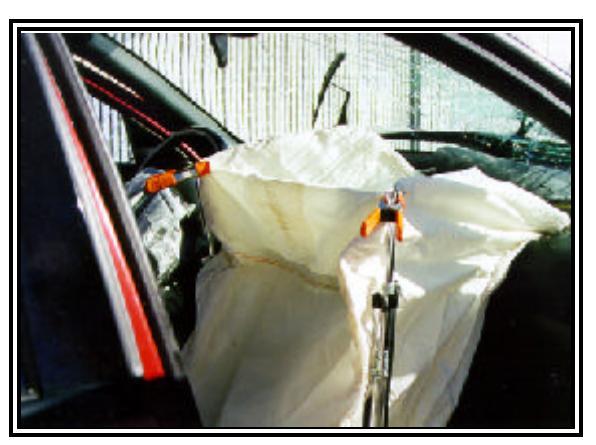
Figure 10: Profile view of the PAB and tissue transfer.

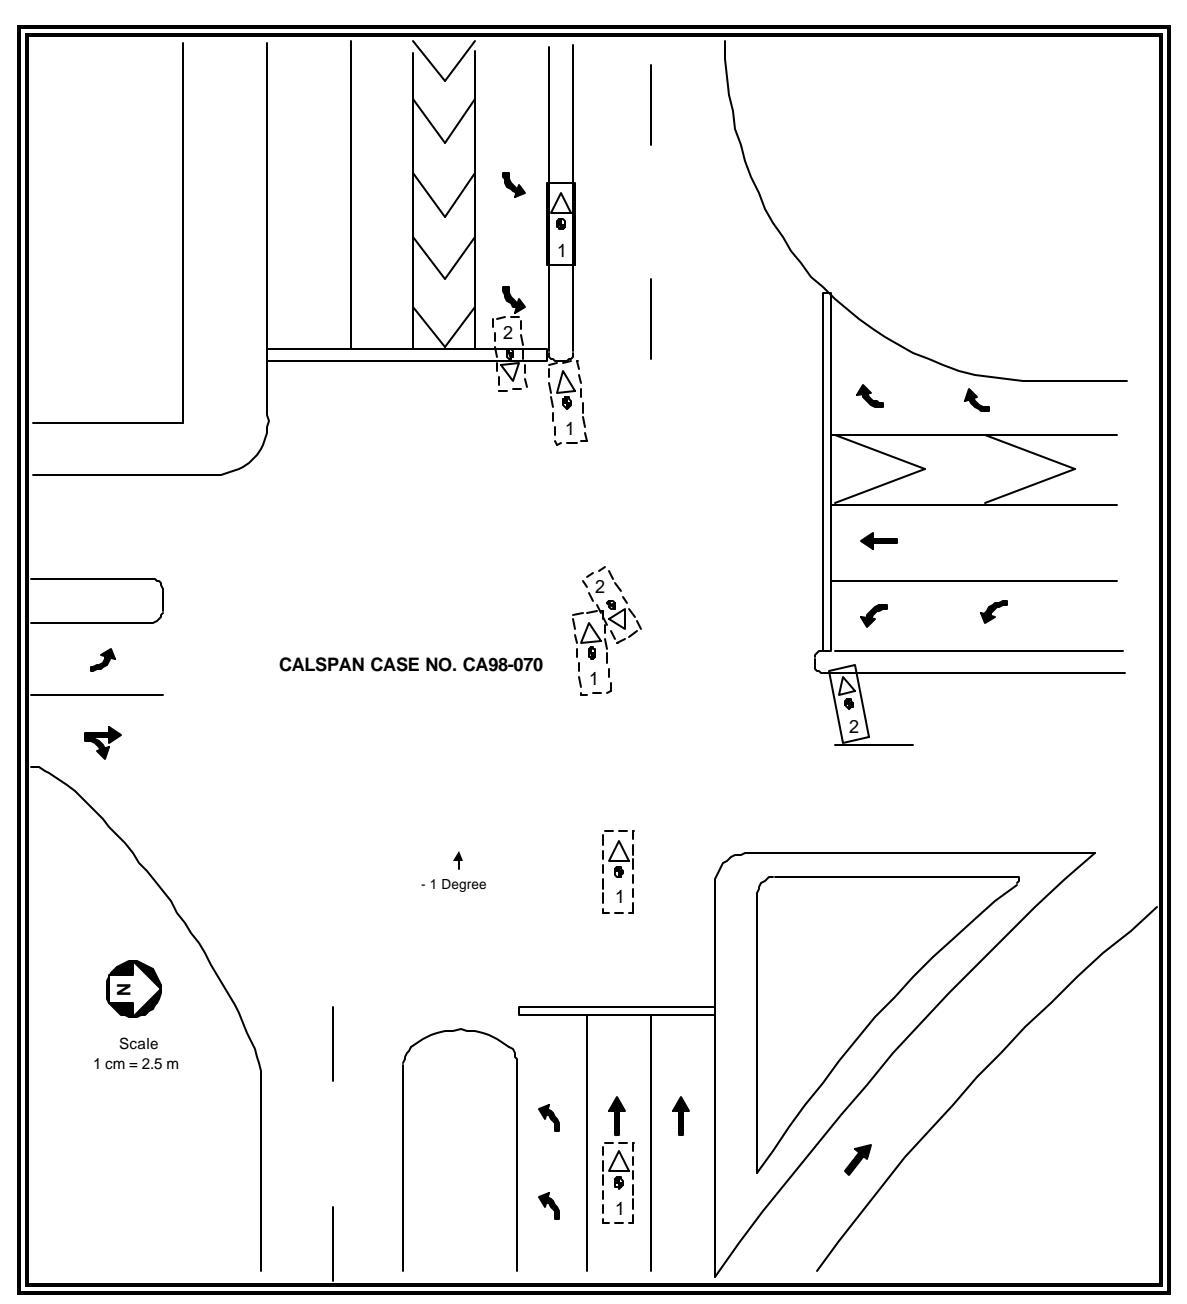
The central and right aspects of the Pontiac front plane struck the right side of the Volkswagen in an 11/2 o'clock impact configuration. The impact damage to the Volkswagen began at the right B-pillar location and extended rearward into the right rear suspension. The force of the impact caused the frontal air bags on the Pontiac to deploy. **Figure 11**, page 11, is a schematic of the crash.

Figure 11: Crash Schematic.
