U.S. Department
of Transportation

**National Highway
Traffic Safety
Administration**

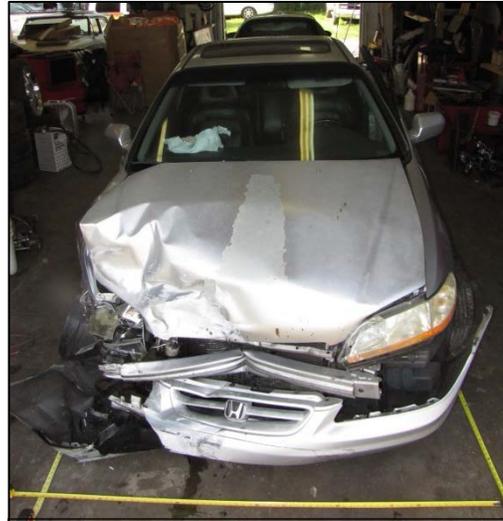
Figure 1: Front view of the Honda taken at the time of the SCI inspection.

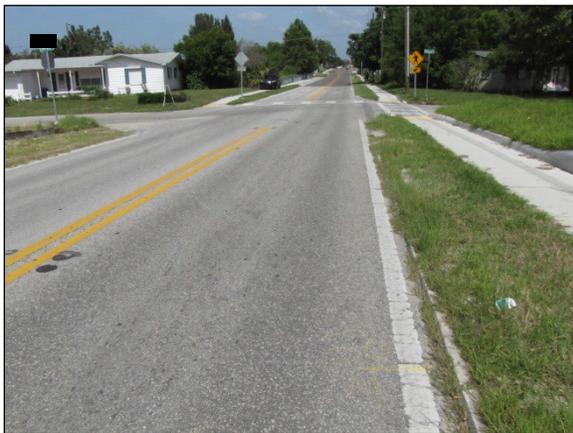
Figure 2: Eastbound trajectory view of the Honda approximately 30 m (98 ft) from the intersection.

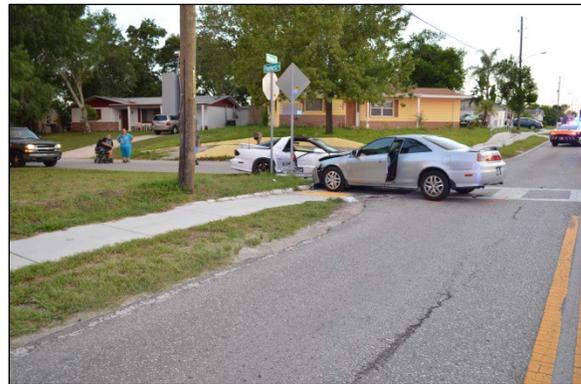
Figure 4: Southwest-looking on-scene police image depicting the vehicles at final rest. Image supplied by the police investigation.

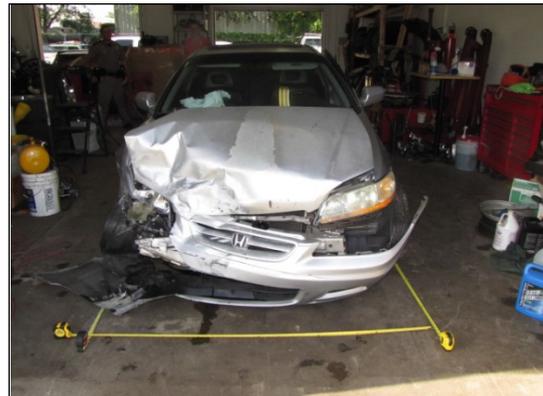
Figure 5: Front view of the Honda Accord.

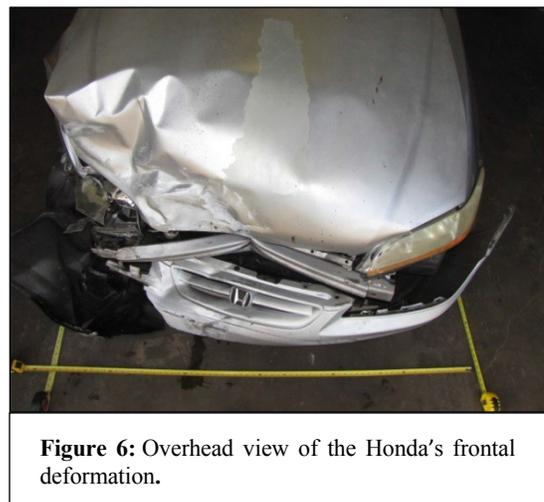
Figure 6: Overhead view of the Honda's frontal deformation.

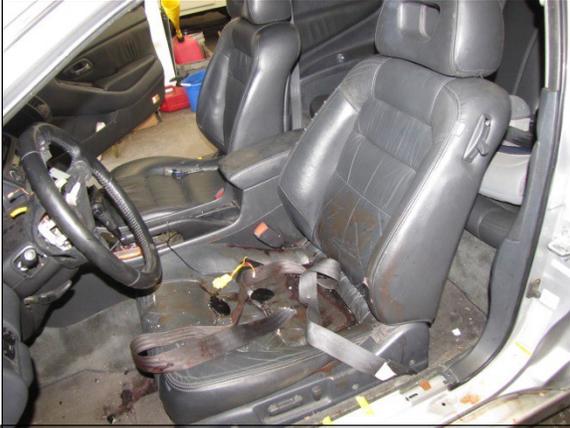
Figure 7: Left interior view of the Honda depicting the driver seat.

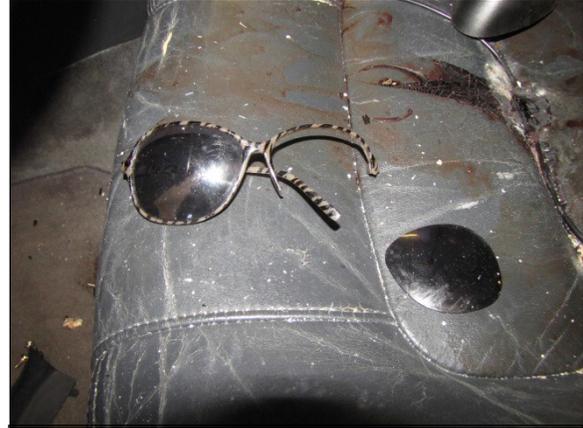
Figure 8: Image depicting the fractured sunglasses in the Honda.

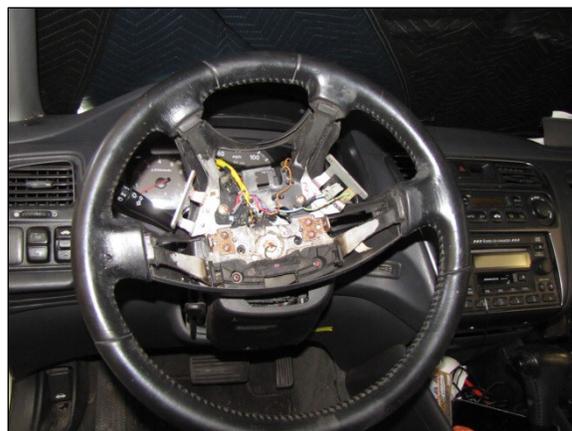
Figure 9: Interior image depicting the steering wheel of the Honda (driver's frontal air bag module removed).

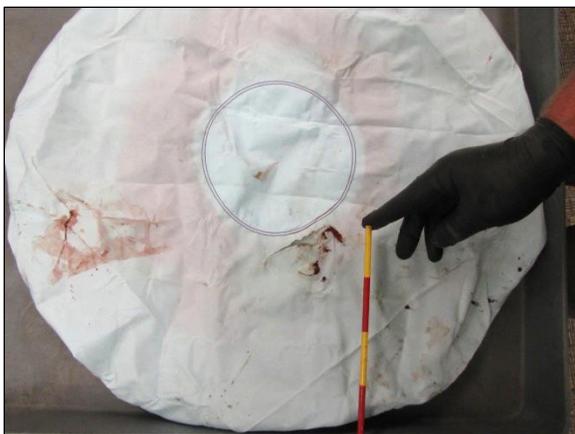
Figure 10: Honda driver's frontal air bag fabric face.

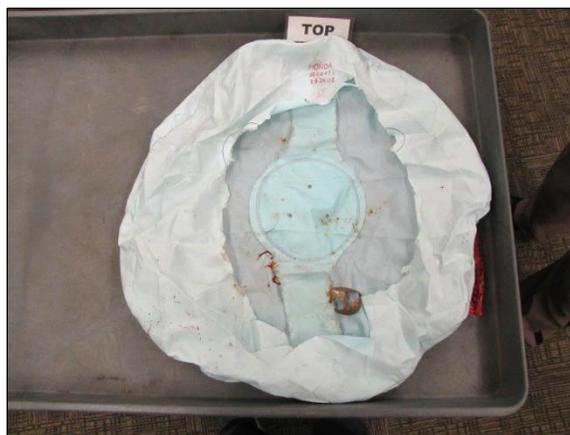
Figure 11: Honda driver's frontal air bag fabric interior.

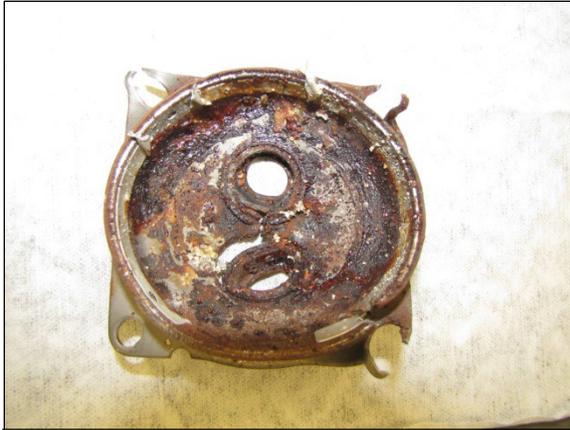
Figure 12: Interior surface of the ruptured Honda driver's frontal air bag inflator housing.

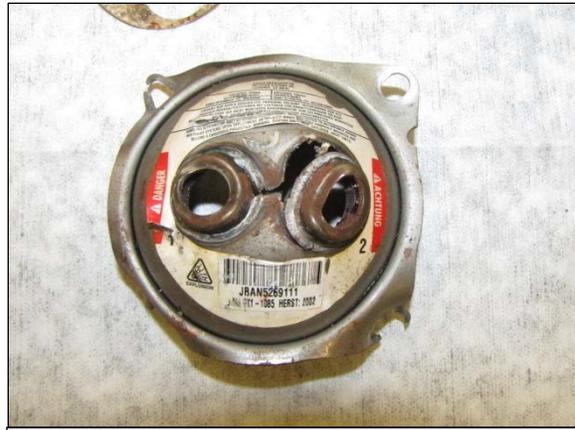
Figure 13: Back view of the ruptured Honda driver's frontal air bag inflator housing.

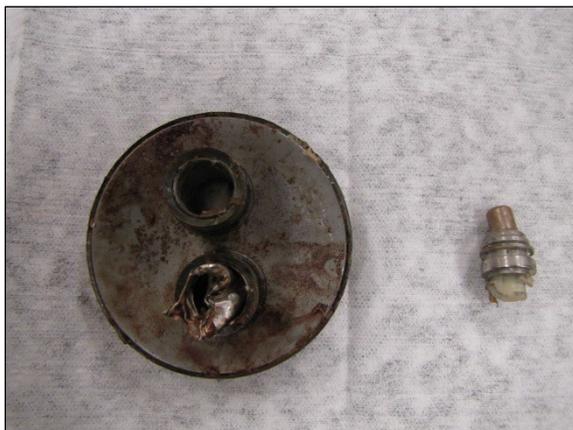
Figure 14: Back view of the separated Stage 2 housing of the Honda driver's frontal air bag inflator.

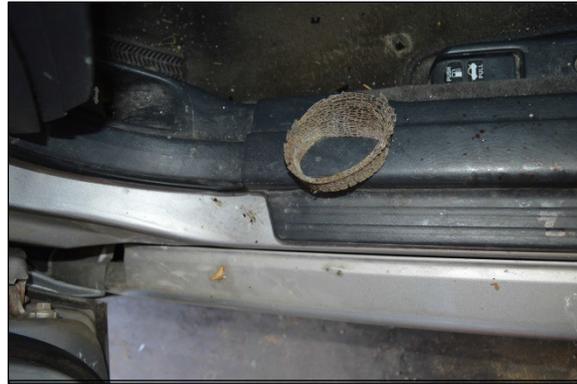
Figure 17: Interior image of the separated wire mesh filter of the inflator. It was adhered to the left sill trim of the Honda. Police investigation image.

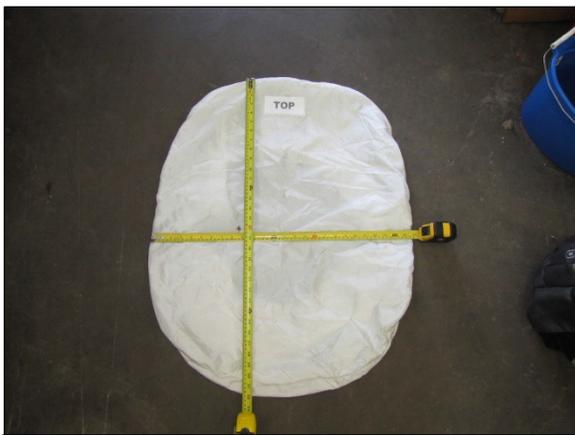
Figure 18: View of the Honda passenger's frontal air bag at the time of the SCI inspection.

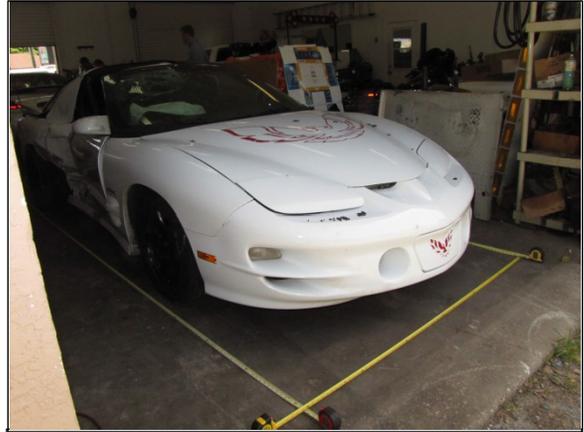
Figure 20: Front right oblique view of the Pontiac.

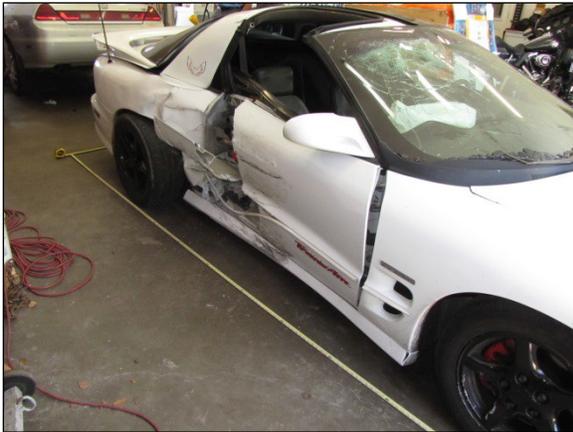
Figure 21: Right front oblique view of the Pontiac's impact damage.

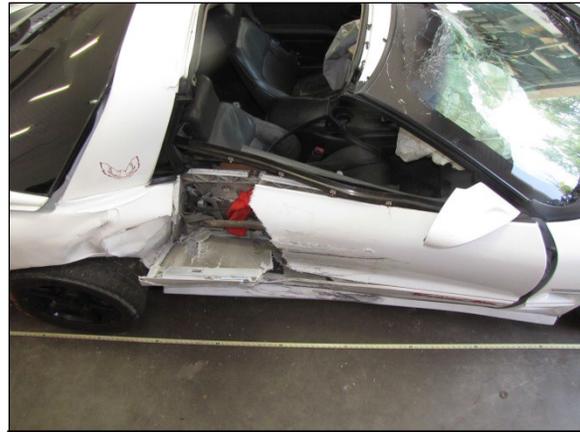
Figure 22: Overhead view of the Pontiac's impact damage.
