CALSPAN REMOTE SIDE IMPACT OCCUPANT PROTECTION SYSTEM CRASH INVESTIGATION

NASS/SCI CASE NO: 2007-41-174J VEHICLE: 2005 HYUNDAI ACCENT LOCATION: FLORIDA CRASH DATE: OCTOBER, 2007

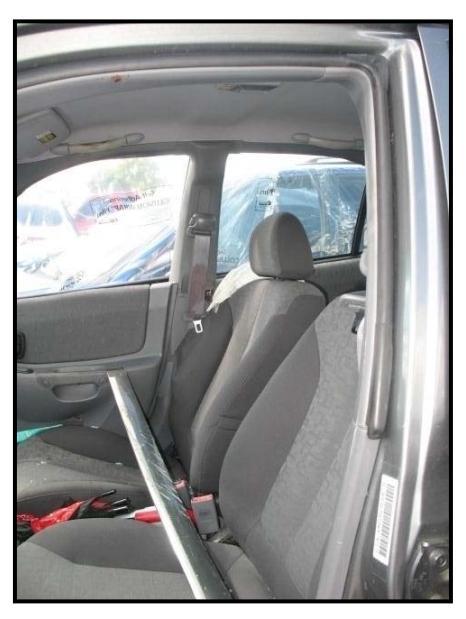
The impact crushed the right side of the Hyundai and caused the right B-pillar to intrude into the

outboard aspect of the front right seat. The force of the impact caused the front right seat back mounted side air bag The side air bag deployed after the B-pillar to deploy. intrusion as evidenced by the captured air bag. The intruded B-pillar altered the deployment path of the air bag. The deflated air bag was found captured behind the B-pillar and front right seat. The impeded air bag appeared to have deployed vertically and rearward (rather than forward). The driver responded to the 2 o'clock direction of the impact force with a rightward trajectory across the front right seat. The driver's torso slipped out from under the shoulder belt and he loaded the lap portion of the safety belt with his pelvis. The restrained driver impacted the right B-pillar area with his head resulting in severe brain trauma. Figure 1 is an interior view across Row 1 of the Hyundai. The normally inflated right side impact air bag provided coverage for the aft aspect of the door and the right B-pillar area. If the air bag had deployed earlier in the crash sequence and protected the right B-pillar area, the driver's injuries may have been mitigated.

Figure 1: Interior view across Row 1.

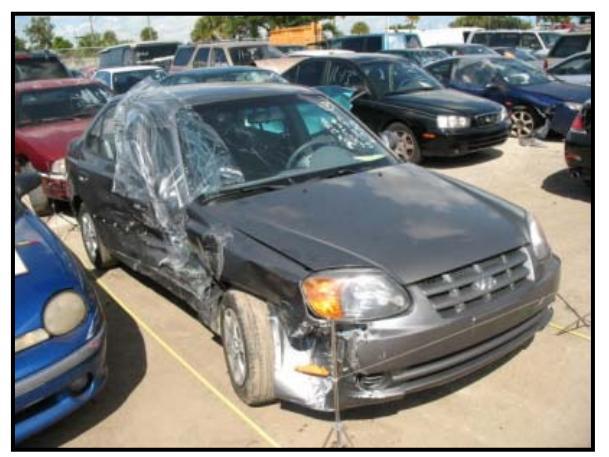
The 2005 Hyundai Accent, Figure 2, was identified by the Vehicle Identification Number (VIN): KMHCG45C85U (production sequence deleted). The vehicle was manufactured in September 2004 and had registered 49,021 km (30,461 miles) at the time of the NASS This four-door, front-wheel drive inspection. sedan was powered by a 1.6 liter/I4 engine linked to a four speed automatic transmission. The vehicle was equipped with manual three-point lap and shoulder belts in the four outboard positions and a rear center (only) lap belt. The Hyundai was equipped with driver and front right Figure 2: Front right oblique view of the passenger air bags and front seat back mounted Hyundai.

side impact air bags. The front right seat back mounted air bag deployed as a result of the crash.

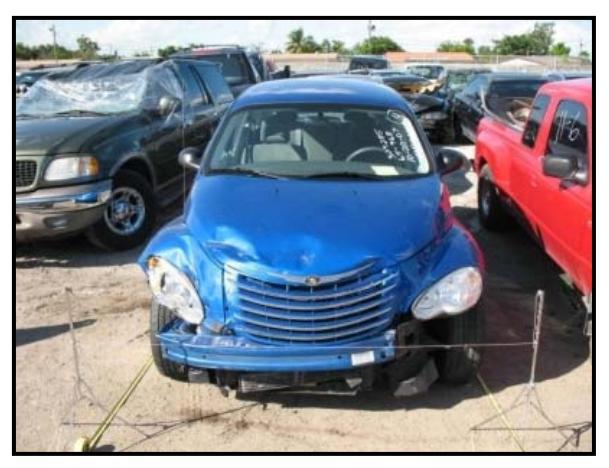
The 2006 Chrysler PT Cruiser was identified by the Vehicle Identification Number (VIN): 3A4FY48B36T (production sequence deleted) and was manufactured in November 2005. Figure 3 is a frontal view of the Chrysler. The digital odometer could not be read at the time of the NASS inspection due to damage to the electrical system. The four-door wagon was equipped with a 2.4 liter/I4 engine linked to a automatic transmission. four-speed The Chrysler's manual restraint system consisted of three-point lap and shoulder belts in the five seat positions. The vehicle was equipped a Certified Advanced Compliant (CAC) air bags for the Figure 3: Front view of the Chrysler. driver and front right passenger. The frontal air bags did not deploy as a result of the crash.

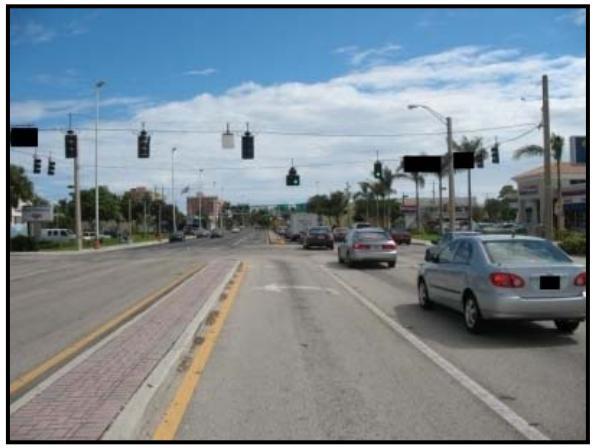
Figure 4: Eastbound trajectory view of the Hyundai.

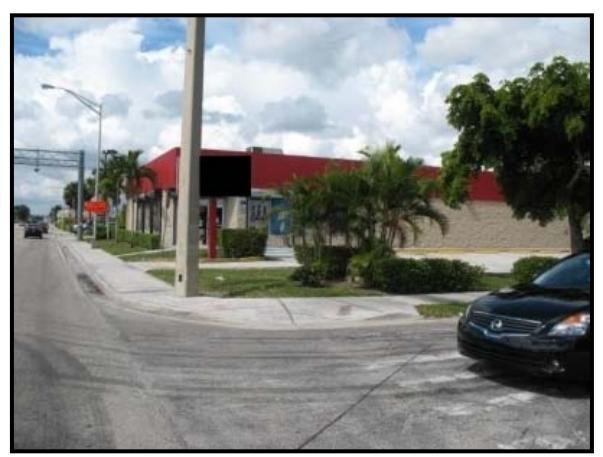
Figure 5: Northwest quadrant of the intersection.

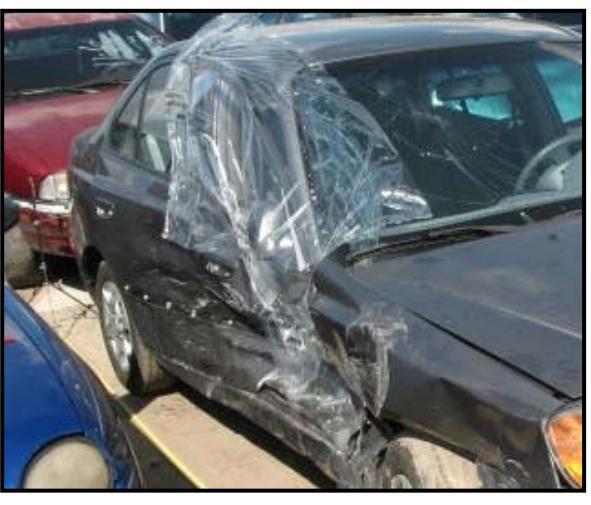
The right side plane of the Hyundai sustained moderate severity damage as a result of the intersection crash. Figure 6 is a right oblique view of the vehicle. The initial impact extended across the occupant compartment. The direct contact damage began at the right corner and

extended rearward 264 cm (104 in) to the mid aspect of the right rear door. The combined direct and induced damage length measured 312 cm (123 in). The residual crush documented at the mid-door elevation was as follows: C1 = 2 cm (0.8 in), C2 = 5 cm (2.0 in), C3 = 19 cm (7.5 in), C4 = 29 cm (11.4 in), C5 = 10 cm (3.9 in), C6 = 7 cm (2.8 in). The maximum crush measured 29 cm (11.4 in) and was located at C4, the mid aspect of the right front door. The force of the impact deformed the right side structure inboard resulting in 16 cm (6.3 in) of front right intrusion. Both doors were jammed shut. The right front window glazing disintegrated. The

right wheelbase was reduced 2 cm (0.8 in). The Figure 6: Oblique view of the impact damage. Collision Deformation Classification (CDC) of

the impact damage was 02-RYEW3. The delta V of the impact was 27 km/h (16.8 mph). The longitudinal and lateral components were -17 km/h (-10.6 mph) and -21 km/h (-13 mph), respectively.

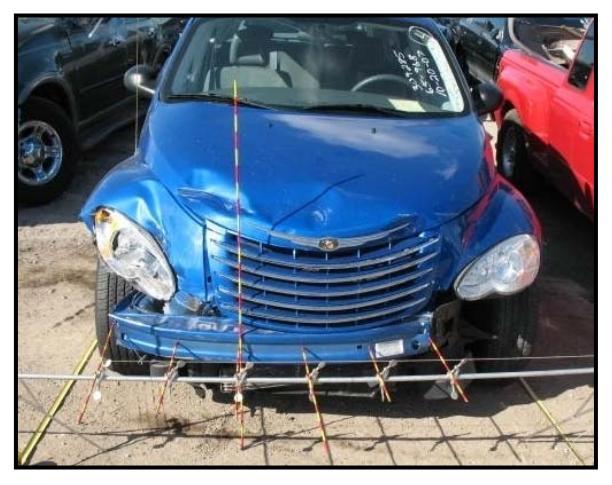
The front plane of the Chrysler sustained moderate damage as a result of the overlapping impacts, Figure 7. The extent of the damage was primarily related to the initial intersection impact. The direct contact damage extended across the full 150 cm (59 in) front end width of the vehicle. The lateral momentum of the Hyundai caused a right shift of the front bumper structure and forward sub-frame of the Chrysler. The residual documented crush along the bumper reinforcement bar was as follows: C1 = 5 cm (2.0 in), C2 = 9 cm (3.5 in), C3 = 12 cm (4.7 in),C4 = 14 cm (5.5 in), C5 = 13 cm (5.1 in), C6 =

15 cm (5.9 in). The angular impact configuration Figure 7: Chrysler frontal profile.

fender. The doors remained closed during the impact and were operational post-crash. There was no change in the wheelbase dimensions. The CDC of the impact damage was 71-FDEW1. (Note: the 11 o'clock principle direction of force was incremented by 60 to denote the right shift of the forward sub-frame.) The delta V of the impact was 19 km/h (12 mph). The longitudinal and lateral components were -15 km/h (-9.3 mph) and 12 km/h (7.5 mph), respectively.

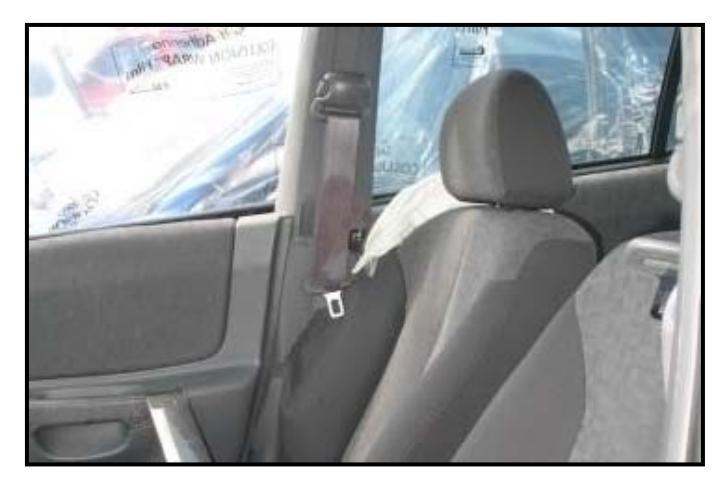
The NASS researcher documented contact evidence to the left side of the driver's knee bolster that was attributed to interaction with his left lower extremity. A large body fluid transfer was noted to the right B-pillar and the stowed front right safety belt, **Figure 8**. This region was attributed to contact from the driver's head.

Figure 8: Driver head contact to the right B-pillar.

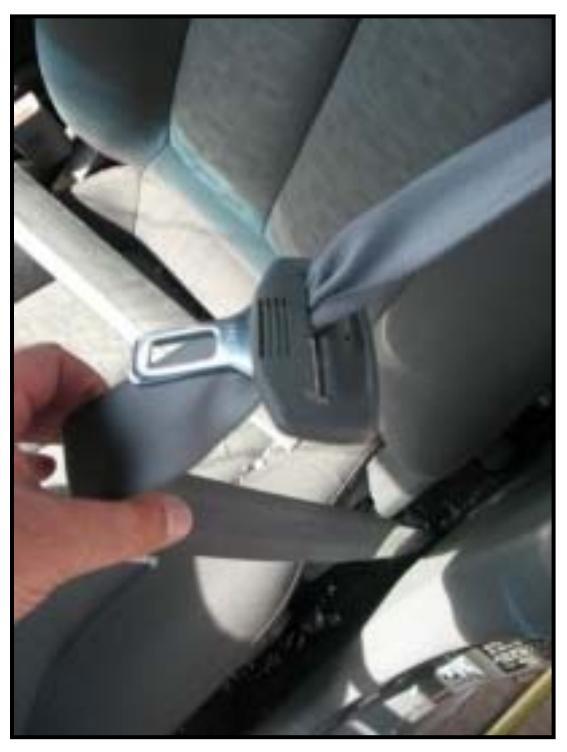
The manual restraint system in the Hyundai consisted of three-point lap and shoulder belts in the four outboard seat positions and a center rear lap The front restraints were equipped with belt. retractor pretensioners. The driver's restraint consisted of continuous loop webbing that spooled onto an Emergency Locking Retractor (ELR), an adjustable D-ring and a sliding latch plate. The webbing was stowed within the retractor upon initial observation and the retractor was operational. Inspection of the safety belt system revealed the webbing was gathered in the latch plate. With the latch plate captured at this location, there was excessive slack in the lap portion of the restraint in the buckled condition. Refer to Figure 9.

The SCI reconstruction of the crash indicated the driver was only restrained by the lap portion of the webbing. As the driver responded to the 2 o'clock direction of the impact force, he loaded the lap portion of the locked webbing with his pelvis. The driver's upper torso slipped laterally out from under Figure 9: Driver's safety belt. the shoulder webbing. The continued belt loading of

the driver caused the excess webbing to slide through the latch plate until it gathered and jammed. In this manner, webbing slack developed in the lap section and allowed the driver to be displaced across the front row of seats.

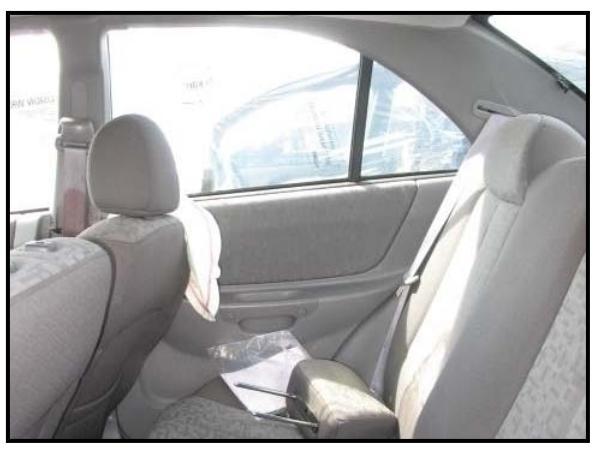
The deployment of the side air bag was impeded by the intruded right B-pillar. The air bag deployed vertically and rearward. The deflated air bag was captured behind the seat back. **Figure 10** is a left interior view across the second row.

Figure 10: Left interior view across Row 2.

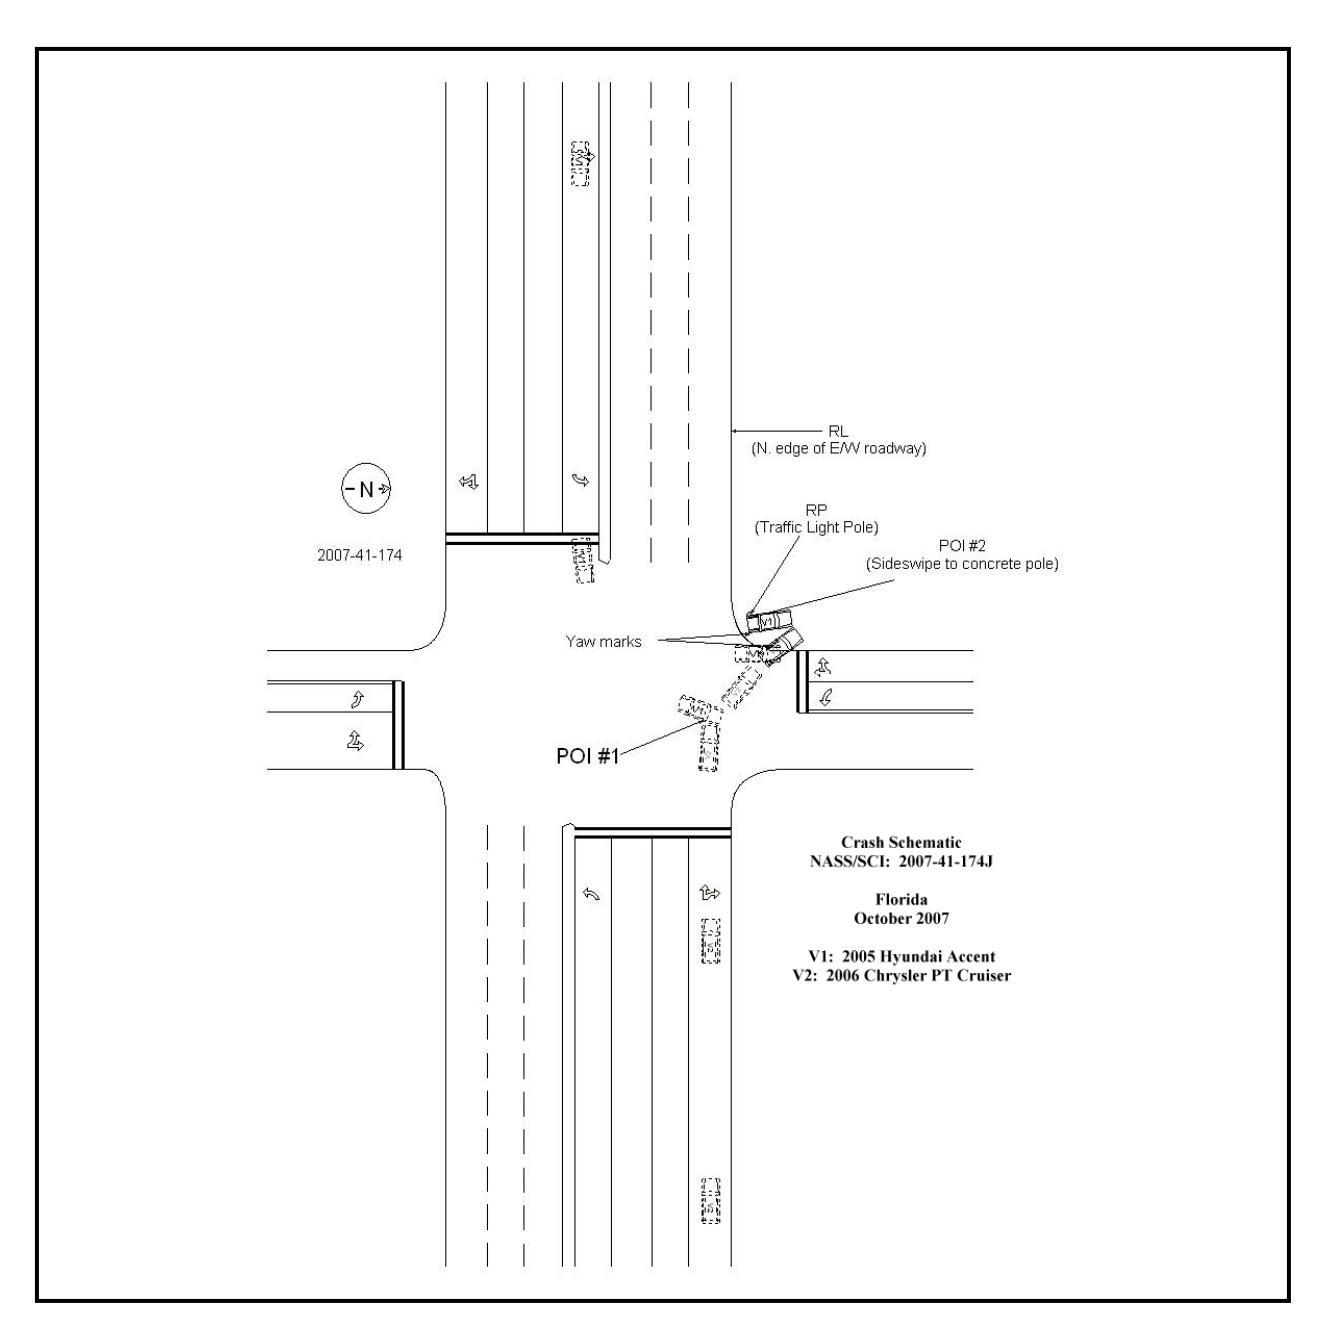
Figure 11: Crash Schematic

The westbound momentum of the Chrysler redirected the Hyundai to the northwest and caused the vehicle to initiate a counterclockwise rotation. The Chrysler was deflected to its right and continued in a northwest trajectory. The Hyundai slid laterally onto the concrete sidewalk of the northwest intersection quadrant evidenced by two scuff marks attributed to the left side tires. The left rear aspect of the Hyundai then contacted a concrete utility pole located adjacent to the sidewalk in a minor secondary contact and came to rest. The Chrysler came to rest adjacent to the Hyundai facing northwest. A schematic of the crash is included at the end of this report as **Figure 11**.
