ON-SITE SIDE IMPACT INFLATABLE OCCUPANT PROTECTION INVESTIGATION

CASE NUMBER - IN07020 LOCATION - TEXAS VEHICLE - 2006 HYUNDAI ACCENT CRASH DATE - May 2007

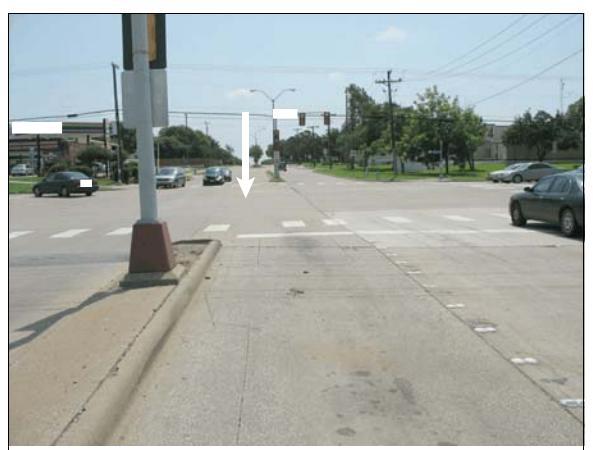
Pre-Crash: The Hyundai was stopped for the traffic signal facing east in the left turn lane (Figure 1). The driver intended to accelerate into the intersection and turn left. The Jeep was traveling south in the center through lane (Figure 2), and the driver intended to continue south through the intersection. The police report indicated that the Hyundai's driver proceeded into the intersection to execute the left turn when the traffic signal turned green. The police crash report indicated that the Jeep entered the intersection as his traffic signal turned red. The Hyundai's driver indicated that he saw the Jeep just prior to the crash and did not have time to take any avoidance actions. The Jeep's driver locked her brakes in an attempt to avoid the crash. The crash occurred in the four-leg intersection of the two trafficways (Figure 1).

Figure 1: Overview of Hyundai's approach into the intersection from the left turn lane; the Hyundai was stopped in the left turn lane; arrow shows area of impact in the intersection

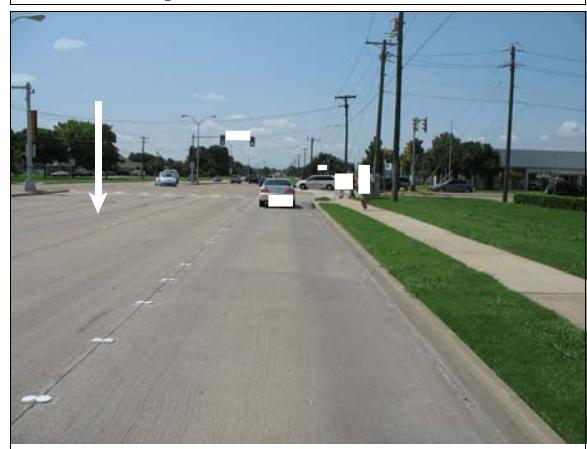
Figure 2: Overview of approach of Jeep southbound in the left through lane (arrow)

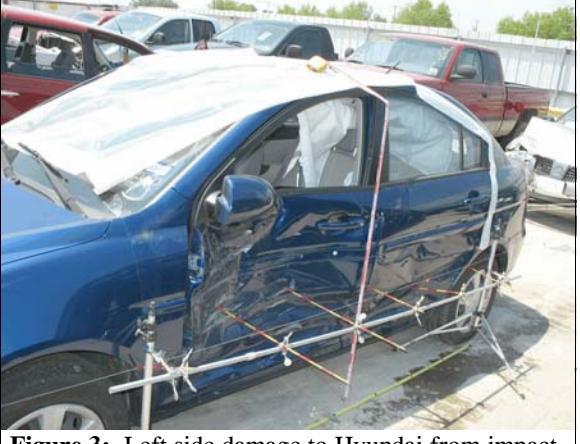
Crash: The left side of the Hyundai (**Figure 3**) was impacted by the front of the Jeep, causing the Hyundai's left side curtain air bag and driver's seat back-mounted side impact air bag to deploy. The Hyundai rotated counterclockwise, traveled

Figure 3: Left side damage to Hyundai from impact with front of the Jeep

Exterior Damage: The Hyundai's contact with the Jeep involved the left side. The left front and left rear doors sustained direct damage and were crushed inward. The direct damage began 43 centimeters (16.9 inches) rear of the left front axle and extended 156 centimeters (61.4 inches) rearward along the left side. The residual maximum crush was measured as 18 centimeters (7.1 inches) occurring at C₄ (**Figure 4**). The table below shows the Hyundai's left side crush profile.

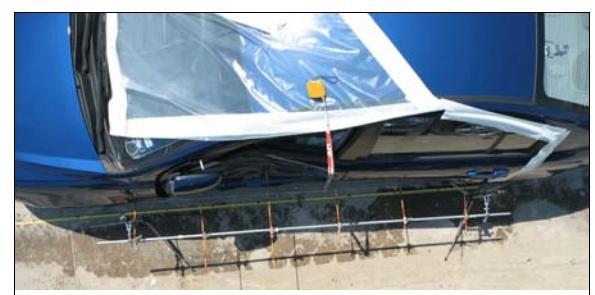
Figure 4: Top view of crush to left side of Hyundai from impact with front of the Jeep

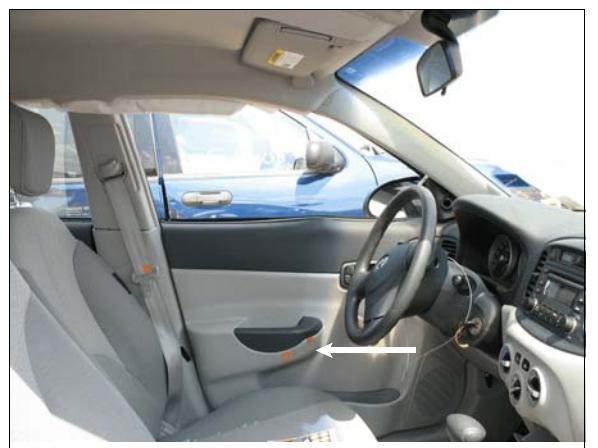
Vehicle Interior: Inspection of the Hyundai's interior revealed several small blood spots on the inboard side of the driver's seat back-mounted side impact air bag. A scuff mark was also noted on the left front door arm rest (**Figure 5**). There was no evidence of contact to the steering wheel and no indication of compression of the energy absorbing steering column. The left front door and the left B-pillar intruded 7 centimeters (2.8 inches) and 2 centimeters (0.8 inch), respectively into the driver's occupant space.

Figure 5: Overview of Hyundai driver's seat position; arrow shows location of occupant contact scuff on left front door arm rest

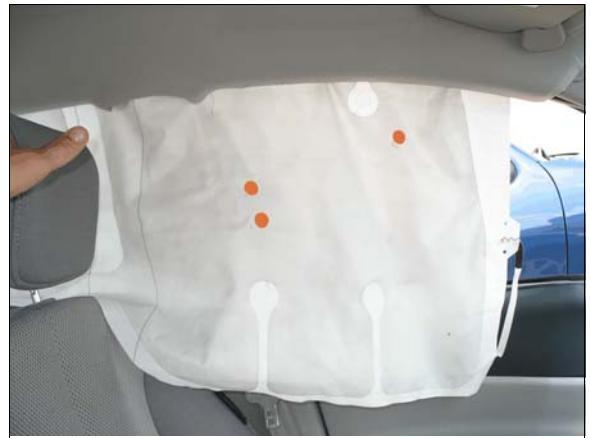
The left side curtain air bag was located along the left roof side rail, inside the head liner and extended along the roof side rail from the left A-pillar to the left C-pillar (Figures 6 and 7). The air bag inflation cylinder was located in the left C-pillar. The side curtain air bag was 130 centimeters (51.2 inches) in length and 40 centimeters (15.7 inches) in height at its maximum height adjacent to the left front seat position (Figure 6). The remainder of the side curtain air bag was 28 centimeters (11 inches) in height (Figure 7). The air bag was tethered to the A and C-pillars by a rope tether. The air bag was designed with a large inflation chamber adjacent to the left front seat position and a smaller inflation chamber adjacent to the back left seat position. Inspection of the air bag revealed three small cuts on the front portion of the air bag. These cuts were possibly caused by flying tempered glass fragments from the left front window, which disintegrated due to the left side impact. The remainder of the side curtain air bag was unremarkable and sustained no damage during the deployment.

Figure 6: Front portion of Hyundai's left side curtain air bag

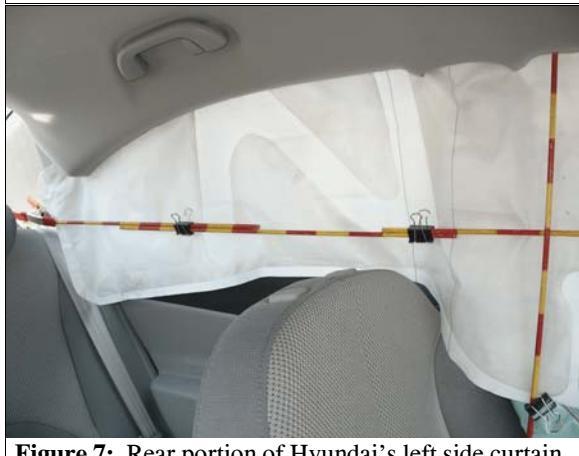
Figure 7: Rear portion of Hyundai's left side curtain air bag

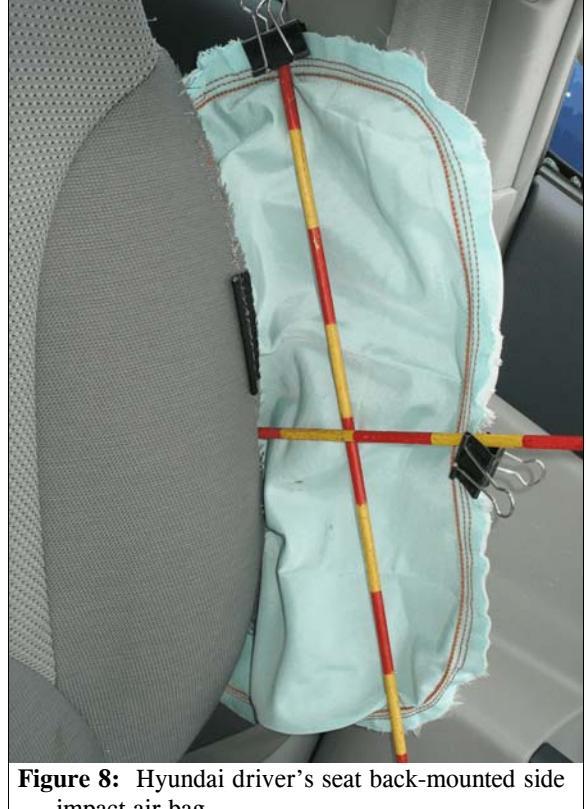
The driver's seat back-mounted side impact air bag was located in the left side of the driver's seat back. It deployed through a tear seam in the side of the seat back. The seat back-mounted side impact air bag was rectangular in shape, measuring 14 centimeters (5.5 inches) in width and 37 centimeters (14.6 inches) in height (**Figure 8**). Several small blood spots were observed on

the inboard portion of this air bag. Otherwise, the air bag was unremarkable and sustained no damage due to the deployment.

impact air bag
