# REDESIGNED AIR BAG SPECIAL STUDY (RABSS) SCI TECHNICAL SUMMARY REPORT

# NASS RABSS CASE NO. 1998-43-802G

# **RABSS VEHICLE - 1998 FORD ESCORT SE**

# **CRASH DATE - JULY, 1998**

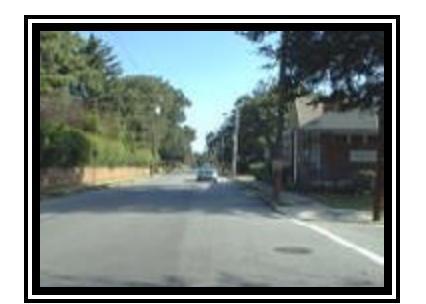
crash site and began to travel north on the urban roadway (**Figure 1**). The intermittent rain conditions caused the windshield to fog over decreasing visibility as she proceeded at a (driver reported) speed of 32 km/h (20 mph). The driver adjusted the climate controls in an attempt to defog the windshield and failed to notice the vehicle as it traveled towards the right (east) curbline.

Figure 1. Northbound approach for the 1998 Ford Escort SE (struck pole in background).

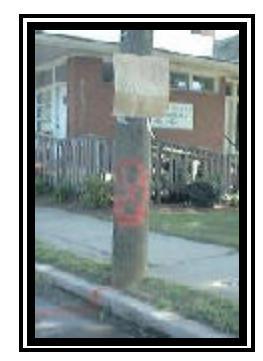
Figure 2. Struck pole.

As the Ford Escort exited the east pavement edge of the urban two lane roadway, the front right area struck a 30.5 cm (12.0 in) wooden utility pole (**Figure 2**) resulting in moderate damage. Initial contact involved the extreme front right corner area which displaced the bumper and leading edge of the right fender. The continued forward motion of the vehicle resulted in engagement of the right front wheel/tire against the pole. This was the first significant structural contact. Therefore, the air bag system probably deployed at this time, late in the crash sequence. The impact induced deceleration was sufficient to deploy the Ford's redesigned frontal air bag system. The damage algorithm of the WinSMASH program computed a (barrier equivalent) velocity change of 12.5 km/h (7.8 mph). The specific longitudinal component was -12.5 km/h (-7.8 mph). The Collision Deformation Classification (CDC) for this impact to the Ford Escort was 12-FREE-4. At this point, the Ford rotated clockwise approximately 15 degrees and came to rest in close proximity to the utility pole facing northeast.

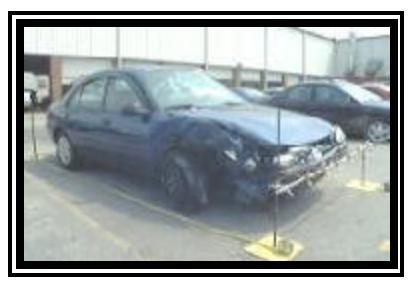
The 1998 Ford Escort SE sustained moderate frontal damage as a result of the impact with the utility pole (**Figure 3**). The direct contact damage began at the front right bumper corner and extended 22.0 cm (8.7 in) inboard. The impact deformed the full frontal width resulting in a combined direct and induced damage length (Field L) of 133.0 cm (52.4 in). Six crush measurements were documented at the level of the reinforcement bar (bumper cover separation): C1= 0 cm, C2= 0 cm, C3= 1.0 cm (0.4 in), C4= 0 cm, C5= 1.0 cm (0.4 in), C6= 3.0

Figure 3. Frontal damage to the 1998 Ford Escort SE.

cm (1.2 in). The contact damage extended rearward down the right side surface which deformed the fender and deflated/restricted the right front wheel/tire. Minor displacement of the hood was noted from engagement against the pole. Reduction in the right side wheelbase measured 19.0 cm (7.5 in). The windshield fractured at the right lower A-pillar area from exterior impact forces and the right mid-windshield area from the (interior) passenger air bag module cover flap. Unexplained damage which cannot be tied to another event was identified at the front left area and included in the NASS case file as overlapping damage (CDC = 12-FZEW-1), however, this minor damage had no effect on the WinSMASH output.

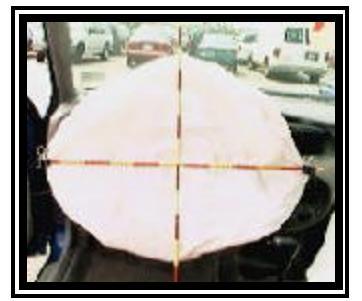
The 1998 Ford Escort SE was equipped with redesigned frontal air bags for the driver and front right passenger positions. The air bags had deployed as a result of the crash. The driver air bag was housed in the center of the steering wheel with a horizontally oriented flap tear seam (H-configuration). No contact evidence was identified on the air bag or exterior surface of the module cover flaps. The flaps were asymmetrical in shape as the upper flap measured 22.0 cm (8.7 in) in width and 8.0 cm (3.1 in) in height while the lower flap measured 22.0 cm (8.7 in) in width and 11.0 cm (4.3 in) in height. The NASS researcher measured the diameter of the driver air bag at 57.0 cm (22.4 in) in its deflated state (**Figure 4**). The bag was tethered by two internal straps and vented by two ports located at the 11 o'clock and 1 o'clock sectors on the rear aspect of the air bag.

Figure 4. 1998 Ford Escort SE redesigned driver air bag.

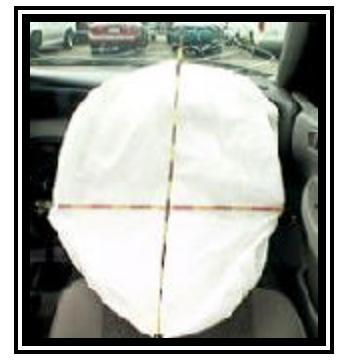
The front right passenger air bag deployed from the right mid-instrument panel area with a single cover flap design hinged at the top aspect. There was no contact evidence identified on the air bag or exterior surface of the module cover flap. The cover flap was rectangular in shape and measured 31.5 cm (12.4 in) in width and 22.0 cm (8.7 in) in height. The NASS researcher measured the passenger air bag at 44.0 cm (17.3 in) in width and 63.0 cm (24.8 in) in height in its deflated state (**Figure 5**). No internal tether straps were present. The bag was vented by two ports located at the 10 o'clock and 2 o'clock sectors on the side aspect of the air bag. No cutoff switch was reported for the front right redesigned passenger air bag.

Figure 5. 1998 Ford Escort SE redesigned passenger air bag.

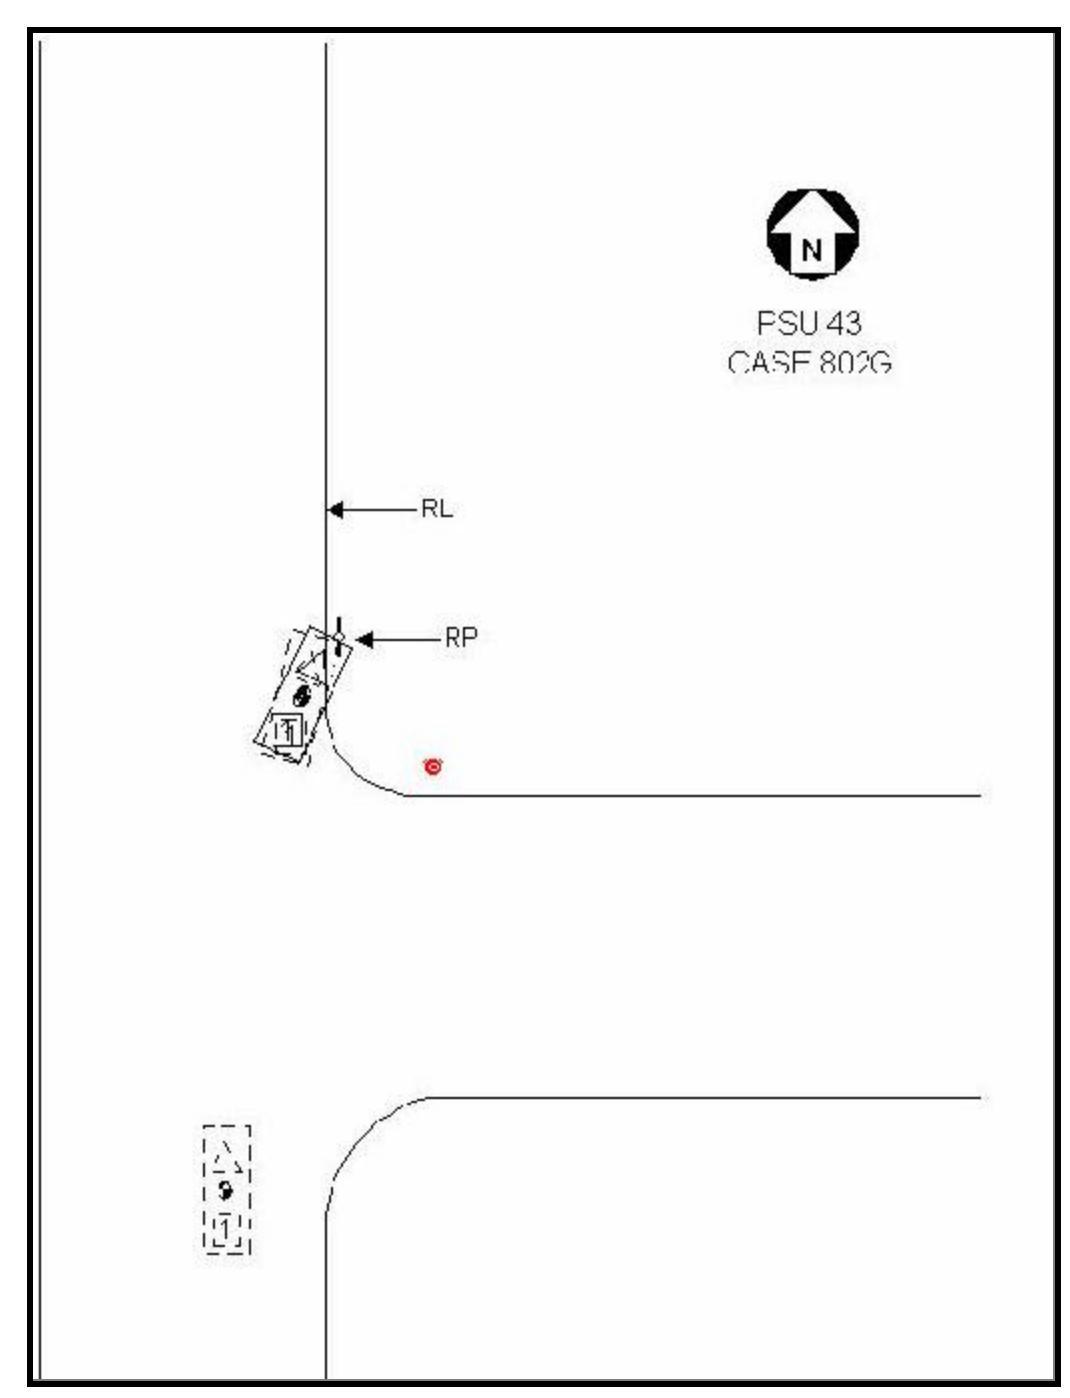
Figure 6. NASS Scene Diagram.

This single vehicle crash occurred during the late evening hours of July, 1998. At the time of the crash, it was dark (street lighted) with rainy conditions as the roads were wet. The crash occurred off the east pavement edge of a straight and level two lane north/south asphalt roadway (see Figure 6 - page 6). No traffic control was present at the scene which had a posted speed limit of 56 km/h (35 mph). The roadside environment featured barrier curbs and pedestrian sidewalks.
