NOT-IN-TRAFFIC SURVEILLANCE

CALSPAN REMOTE HYPERTHERMIA DEATH INVESTIGATION

SCI CASE NO: CA08022

VEHICLE: 1998 CHEVROLET LUMINA

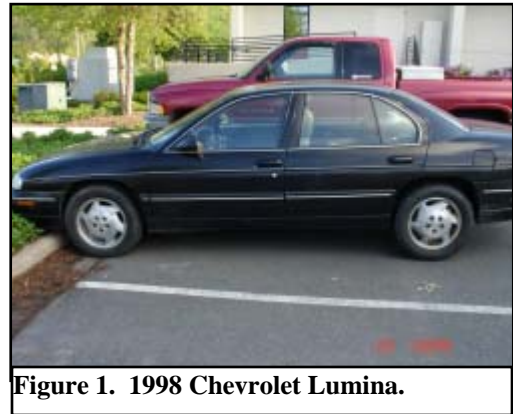
Figure 1. 1998 Chevrolet Lumina.

This remote investigation focused on the circumstances surrounding the death of a 9-month-old female that was left unattended in a 1998 Chevrolet Lumina, **Figure 1**. The child was restrained within a Forward Facing Child Safety Seat (FFCSS) in the rear right position of the Chevrolet. The incident occurred over 3.5 hours in the driveway of the father's residence. At the time of the incident, the weather was reported as mostly cloudy and temperature ranged from 23.0 degrees C (73.4 degrees F) near the start of the incident to 22.0 degrees C (71.6 degrees F) at the end of the incident.

The 1998 Chevrolet Lumina LS was a four-door, front-wheel drive sedan powered by a 3.1 liter, V6 engine linked to a four-speed automatic transmission. The vehicle's exterior was black in color and the interior was gray with cloth upholstered seats. The vehicle was designed to carry six occupants. The side windows and backlight were AS2 glazing and did not contain after-market tint. The Lumina was not equipped with a sunroof. The Chevrolet's Vehicle Identification Number (VIN) and mileage were not documented by the investigating police agency.

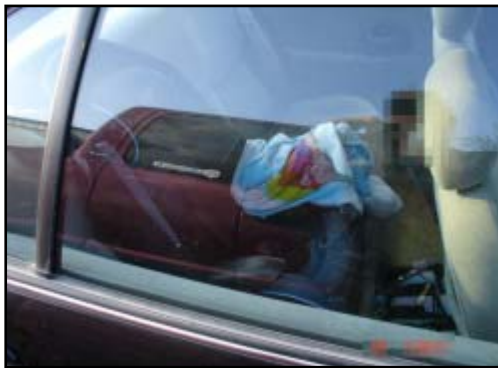
Figure 2. Rear right seating position and FFCSS.

On the day of the incident, the 19-year-old driver of the Lumina (mother) drove to the daycare center where the 9-month-old child had been for part of the day. The mother picked up the child and placed her in a FFCSS in the rear right position of the Chevrolet (**Figure 2**). It's unknown if the child was restrained by the internal harness system or the vehicle's safety belt. The driver then drove the Chevrolet an unspecified distance to the residence of the child's father. During the commute, the child reportedly fell asleep in the vehicle.
