On-Site Rollover Investigation
Dynamic Science, Inc. (DSI), Case Number DS10004
2007 Ford Explorer XLT
California
December 2009

1. Report No. DS10004		2. Government Accession No.		3. Recipient Catalog No.	
4. Title and Subtitle On-Site Rollover Investigation				5. Report Date September 16, 2010

14. Sponsoring Agency Code	
15. Supplemental Notes					
16. Abstract The focus of this investigation was the rollover dynamics of a 2007 Ford Explorer XLT involved in a single-vehicle crash and subsequent rollover. The vehicle was equipped with Electronic Stability Control (ESC), traction control, and roll stability control technology. The crash occurred on a four-lane divided eastbound interstate highway during December 2009 in the state of California. The Ford was being driven by a restrained 50-year-old male and was traveling eastbound in the third lane from the right when the driver lost control of the vehicle. The Ford departed the roadway on the left edge and its front end impacted a concrete traffic barrier. Following the impact the vehicle initiated a three quarter-turn right side leading turn-over type rollover, returned to the roadway, and came to rest on its left side and facing

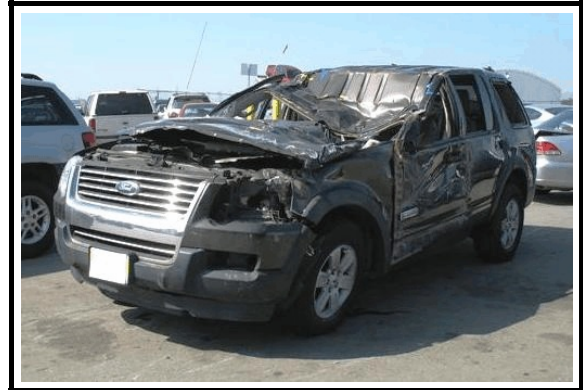
Figure 1. Subject vehicle, 2007 Ford Explorer XLT

The focus of this on-site investigation was the rollover dynamics of a 2007 Ford Explorer XLT (**Figure 1**) involved in a single-vehicle crash and subsequent rollover. The vehicle was equipped with Electronic Stability Control (ESC), traction control, and roll stability control technology intended to reduce the risk of a rollover. The crash occurred on a four-lane divided eastbound interstate highway during December 2009 in the state of California. The Ford was being driven by a restrained 50-year-old male.

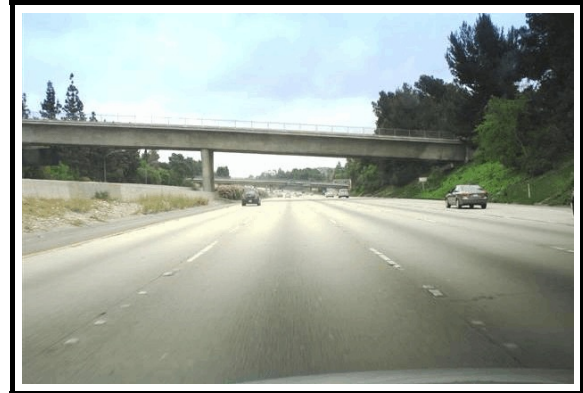
Figure 2. Pre-crash approach to impact, subject vehicle

The Ford was traveling eastbound in the third lane from the right (**Figure 2**) and decelerated prior to impact. The Ford's EDR-reported speed was 106.6 km/h (66.2 mph) at 5 seconds prior to Algorithm Enable (AE) and 56.4 km/h (35.1 mph) at 1 second prior to AE. The driver stated during the interview that he was driving through standing water and the vehicle's tires lost traction due to hydroplaning. The likelihood of hydroplaning was probably increased due to the low tire pressure of the vehicle's right rear tire. The driver lost control of the vehicle, it initiated a counterclockwise rotation, and then departed the roadway on the left edge. He braked without lockup and steered right to counteract the rotational forces. The vehicle traveled across the asphalt shoulder and dirt embankment.

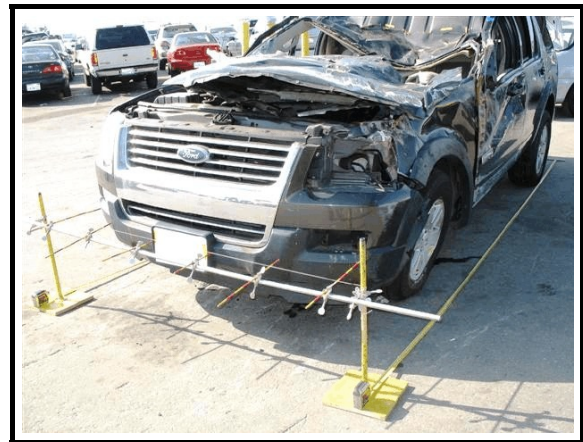
Figure 3. Front end crush profile measurement

Direct damage to the front end began at the left front bumper corner and extended 54.0 cm (21.3 in) to the right. The Field L was distributed from bumper corner to bumper corner and measured 170.0 cm (66.9 in) (**Figure 3**). Six crush measurements were taken at the bumper level as follows: $C_1 = 3.0$ cm (1.2 in), $C_2 = 3.0$ cm (1.2 in), $C_3 = 2.0$ cm (0.8 in), $C_4 = 1.0$ cm (0.4 in), $C_5 = 1.0$ cm (0.4 in), $C_6 = 0$ cm. Maximum crush was located at C_1 . The Collision Deformation Classification (CDC) for the frontal impact was 02FDLW1.

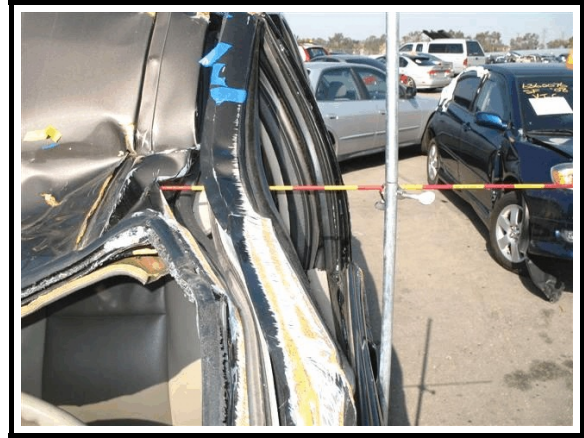
Figure 4. Maximum lateral crush measurement, left roof side rail

and measured 134.0 cm (52.8 in). Direct damage to the top plane began on the roof at 58.0 cm (22.8 in) aft of the rear axle, extended forward 291.0 cm (114.5 in), and ended at the leading edge of the hood. The damage was distributed laterally from roof side rail to roof side rail and measured 131.0 cm (51.8 in). The maximum lateral crush to the greenhouse was located on the left roof side rail at 120.0 cm (47.2 in) aft of the front axle and measured 8.0 cm (3.1 in) (**Figure 4**). The maximum vertical crush from the rollover was masked by the vehicle-to-vehicle impact and was not determined. The CDC for the Event 2 rollover was 00TDDO99.

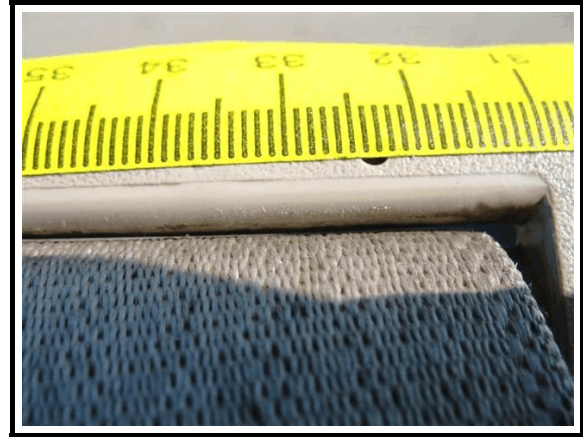
Figure 5. Driver's safety belt latch plate showing evidence of occupant loading

The driver's safety belt latch plate was scuffed as a result of occupant loading (**Figure 5**). The safety belt webbing was scuffed at 2.0 cm (0.8 in), 7.0 cm (2.8 in), 13.0 cm (5.1 in), and 14.0 cm (5.5 in) below the stop button. Beginning 29.0 cm (11.4 in) above the stop button a stretched area of webbing measured 11.0 (4.3 in) in length. Based on evidence of occupant loading, it was determined that the safety belt was used to restrain the driver during the crash.

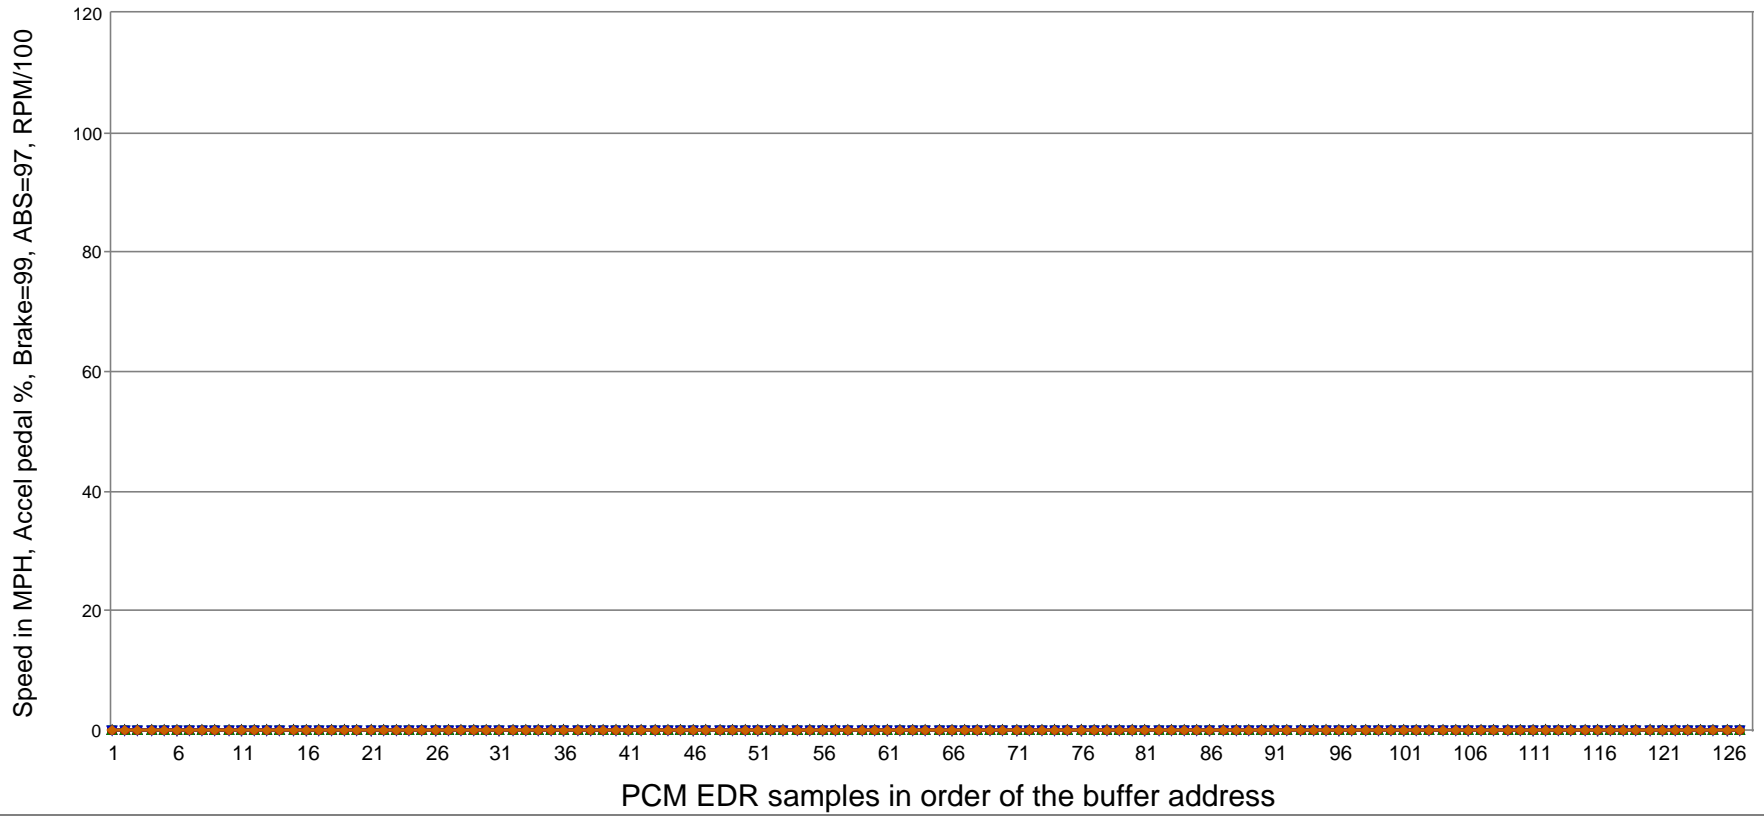
PCM EDR Data (1)

1FMEU63E67U*** PCM EDR Crash Data - RDS Not Received**

▲ Vehicle Speed (MPH) ■ Accelerator Pedal (%) ● Brake Switch (0=Off/99=On) ▼ ABS (0=Inactive/97=Active) ◆ RPM/100
