**CALSPAN REMOTE AIR BAG DEPLOYMENT INVESTIGATION
CALSPAN CASE NO. 94-43
VEHICLE - 1994 FORD MUSTANG
LOCATION - [REDACTED], VA
ACCIDENT DATE - [REDACTED] 1994**

14. Sponsoring Agency Code	
15. Supplementary Notes Remote investigation of a child fatality that resulted from the deployment of a passenger side air bag in a 1994 Ford Mustang.

**SELECTED PRINTS
CALSPAN CASE NO. 94-43
VA**

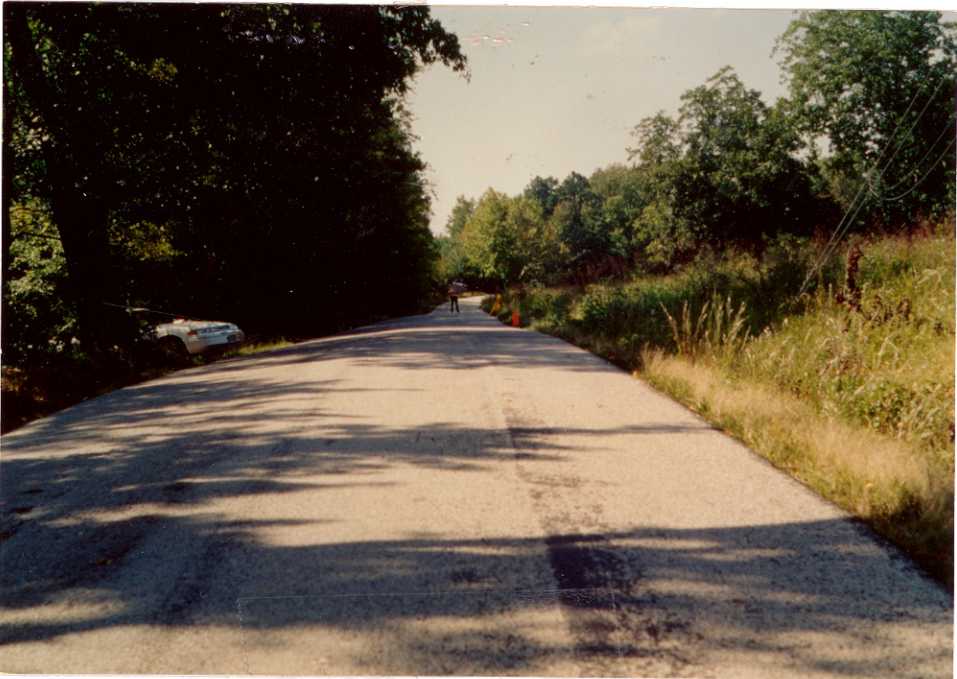
1. Pre-crash trajectory of the northbound Ford Mustang.

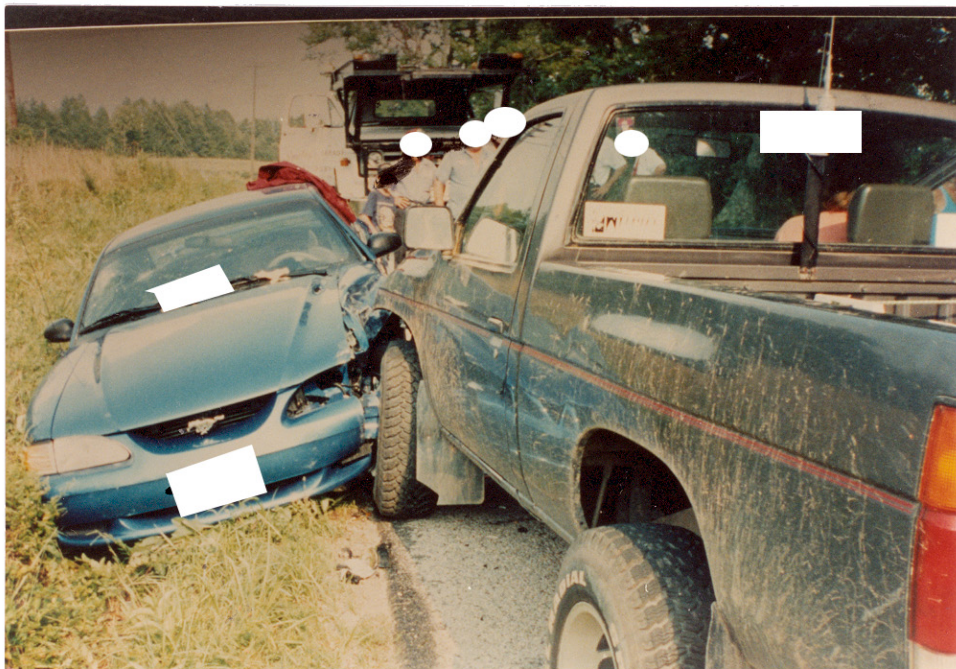
4. Engagement of the vehicles at final rest.

The vehicles came to rest fully engaged at or near the point of impact. At rest, the Ford Mustang was straddling the right roadedge with the left side tires on the edge of the asphalt road surface and the right side tires resting in a shallow drainage ditch which paralleled the roadway. The Nissan pickup truck came to rest obstructing the northbound travel lane with its left side tires adjacent to the east roadedge. Both vehicles sustained disabling damage and were towed from the crash scene.

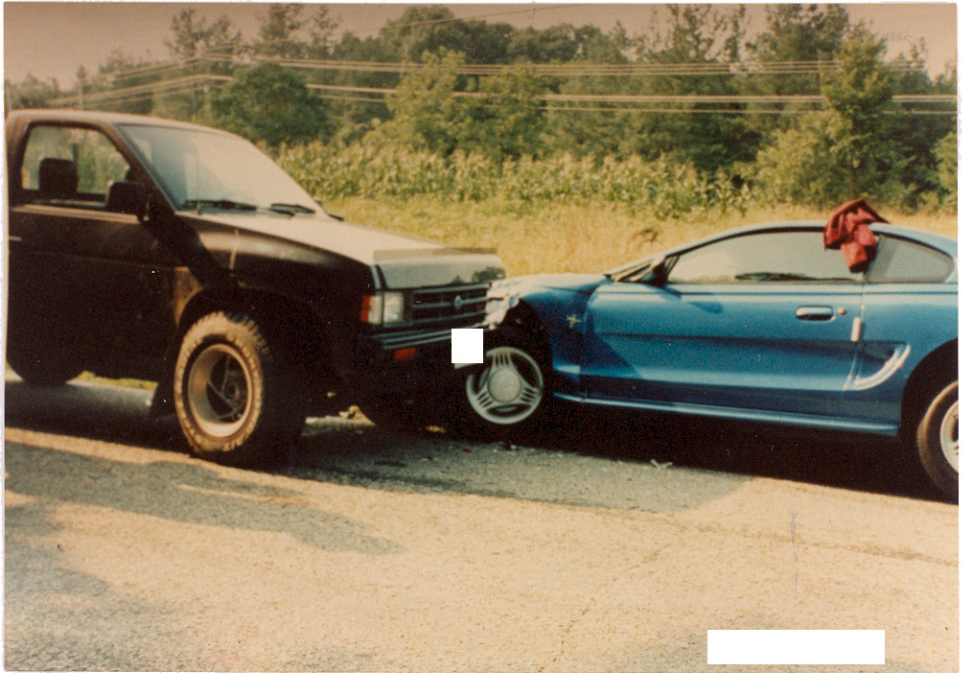
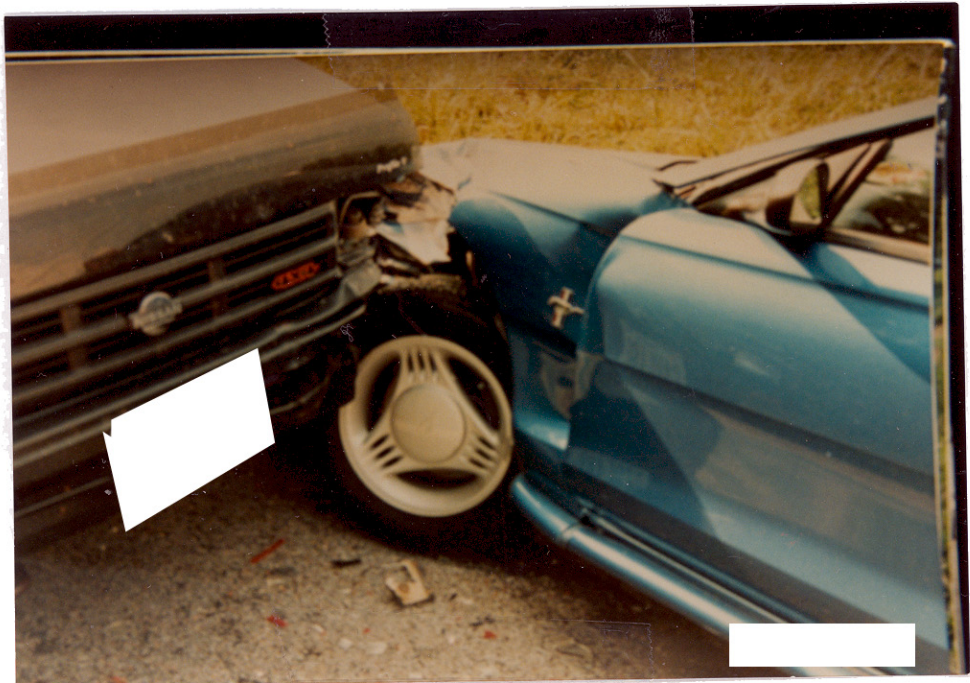
5. & 6. Additional views of the final rest positions of the vehicles.

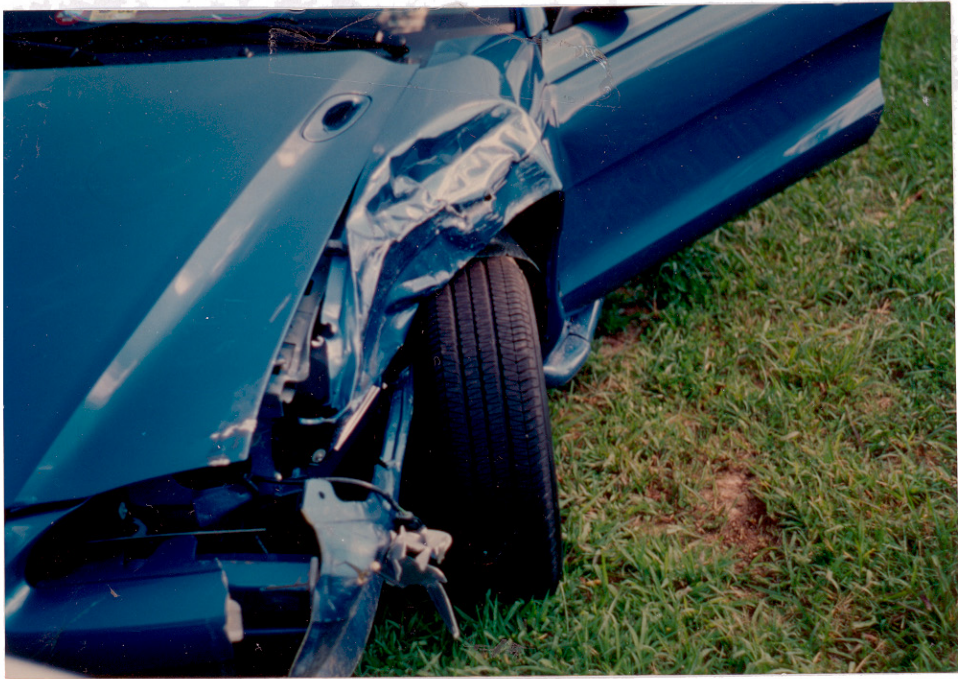
7. Close-up view of the damage to the Ford Mustang.

The vehicles impacted in a head-on, off-set configuration involving the left front corner areas. Resultant directions of force were 12 o'clock for both vehicles. Initial contact damage on the Mustang began on the front bumper outboard of the left headlamp and continued longitudinally onto the left front fender for a length of approximately 114.3 cm (45.0"). Residual bumper crush was estimated at 12.7-15.2 cm (5-6"). The Nissan pickup truck sustained approximately 20.3-25.4 cm (8-10") of front bumper crush from engagement with the front bumper and left front tire of the Mustang. In addition, the Nissan pickup truck sustained approximately 15.2-20.3 cm (6-8") of sheetmetal deformation at the corner of the left front fender. The Collision Damage Classification (CDC) for the Mustang and the pickup truck were 12-FLEE-4 and 12-FLEE-2 respectively. Due to the impact configuration which resulted in side engagement with the Mustang, the CRASH Program could not be utilized to compute velocity changes, therefore a velocity change was estimated at 16-20 km/h (10-12 mph). The impact induced deceleration was of sufficient magnitude to deploy the supplemental driver and passenger side air bag system.

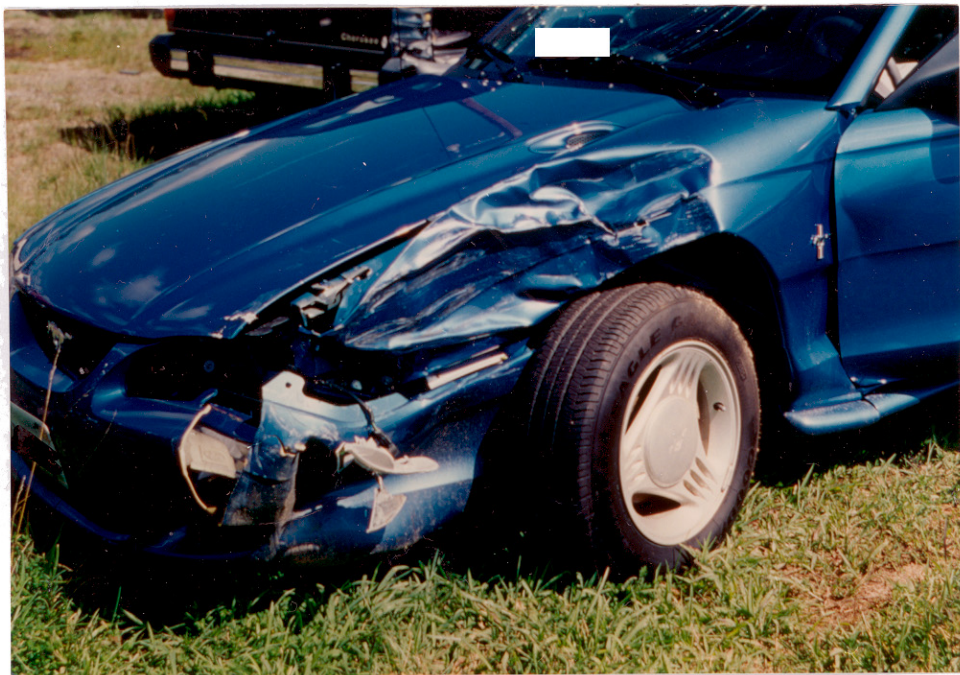
8. Left frontal view of the impact damage.

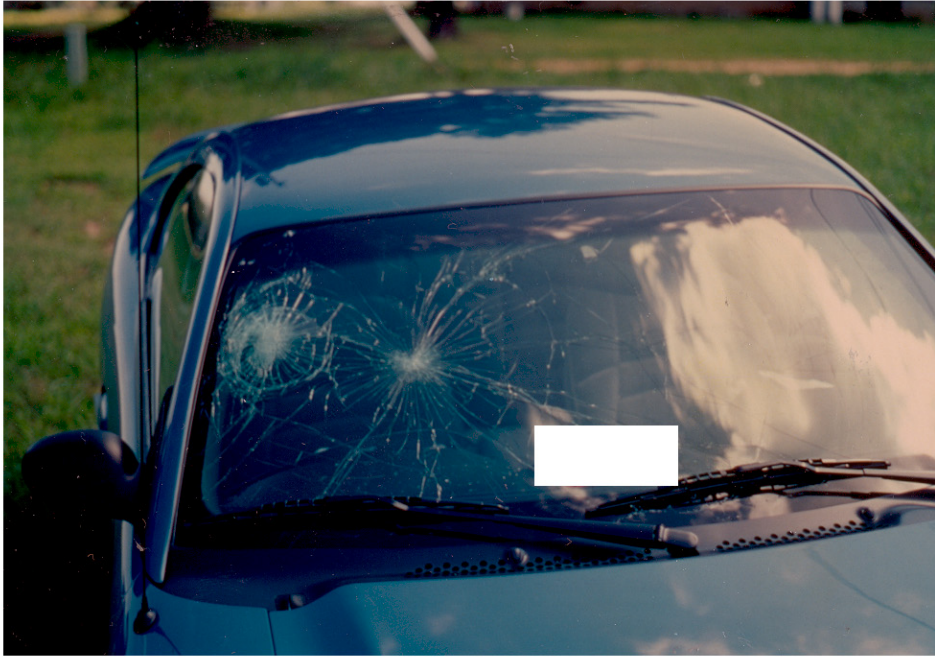
9. Exterior view of the windshield contacts by the 4 year old child occupant of the Mustang.

The child was subsequently displaced in a upward direction as his head was hyperextended by the deploying air bag. His mid forehead area impacted the vehicle's windshield with sufficient force to crack the laminated glazing and bow the windshield in an outward direction. The head contact was located at the upper right quadrant of the windshield adjacent to the right A-pillar. The autopsy report identified an abrasion to the mid forehead which resulted from the windshield contact. This contact sequence could have contributed to the severity of the C-spine and cerebral injuries noted above. In addition to the head contact with the windshield, the child occupants right hand contacted the windshield left of the head contact location, thus indicating that the child probably attempted to brace with his right arm as he initiated his trajectory in response to the pre-crash braking force. He sustained abrasions to the dorsal aspect of the right mid forearm and multiple small lacerations with abrasions of the dorsal aspect of the right hand from the windshield contact. The occupant sustained an abrasion with contusion over the lateral posterior aspect of the upper right thigh from possible rebound contact into the right door panel. He reportedly came to rest in a slumped position on the right front seat.

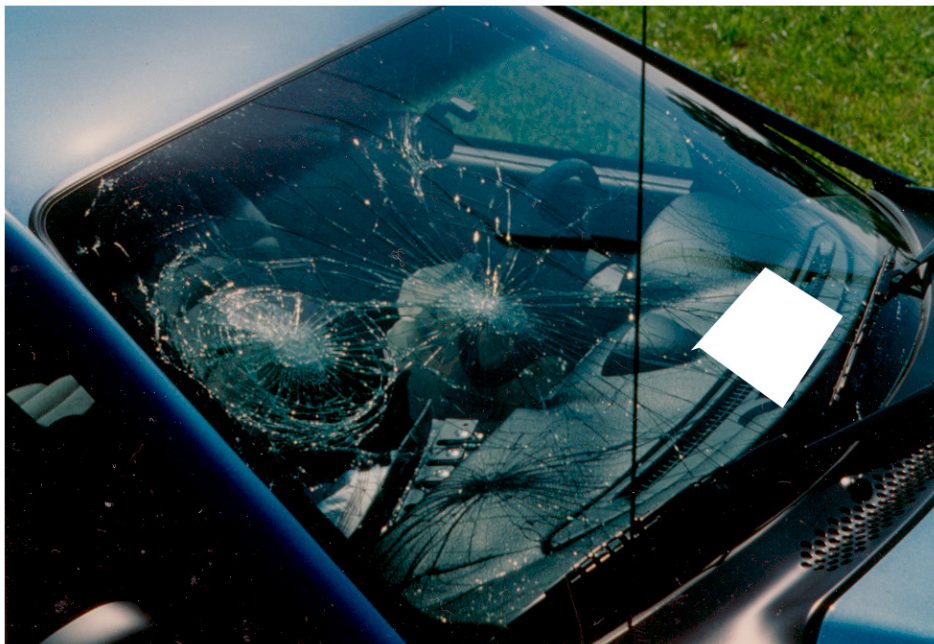
10. Additional view of the windshield contacts.

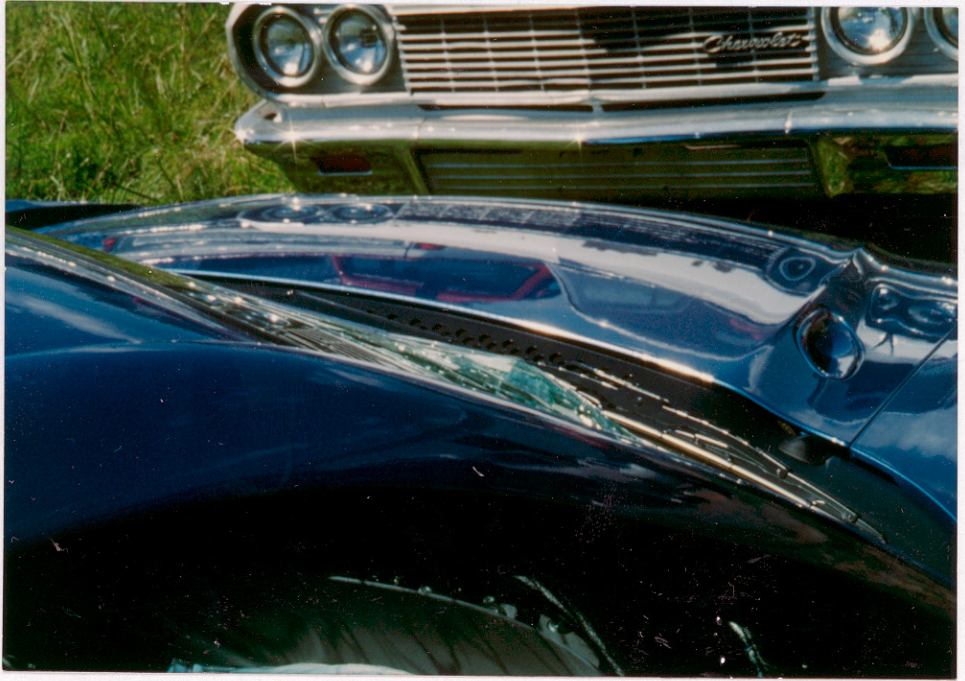
11. Outward bowing of the windshield from the head contact.

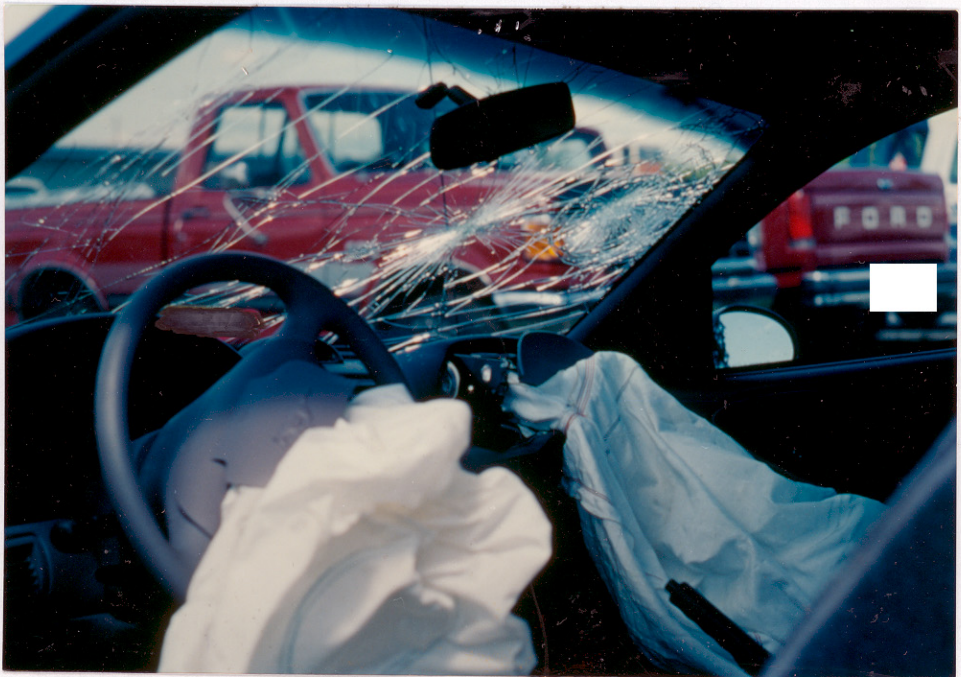
12. Overall interior view of the deployed air bags and windshield contacts.

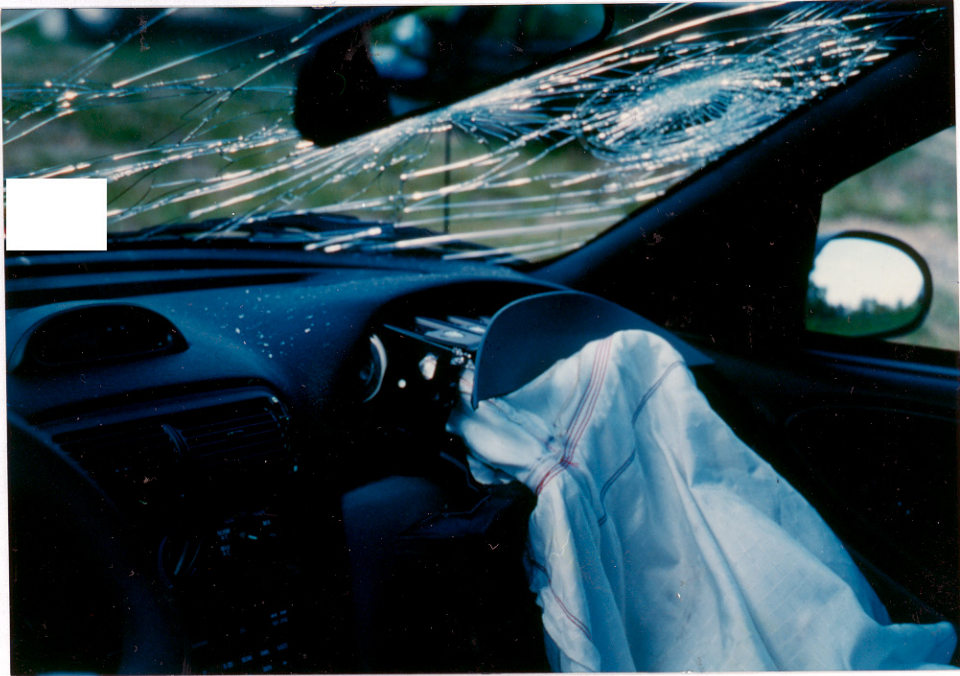
The passenger side air bag module partially separated from the instrument panel mount (refer to Photograph No. 13). The rearward displacement probably resulted from deployment of the system, however, the mechanism which allowed the separation was not known.

13. Rearward displacement/separation of the passenger side air bag module.

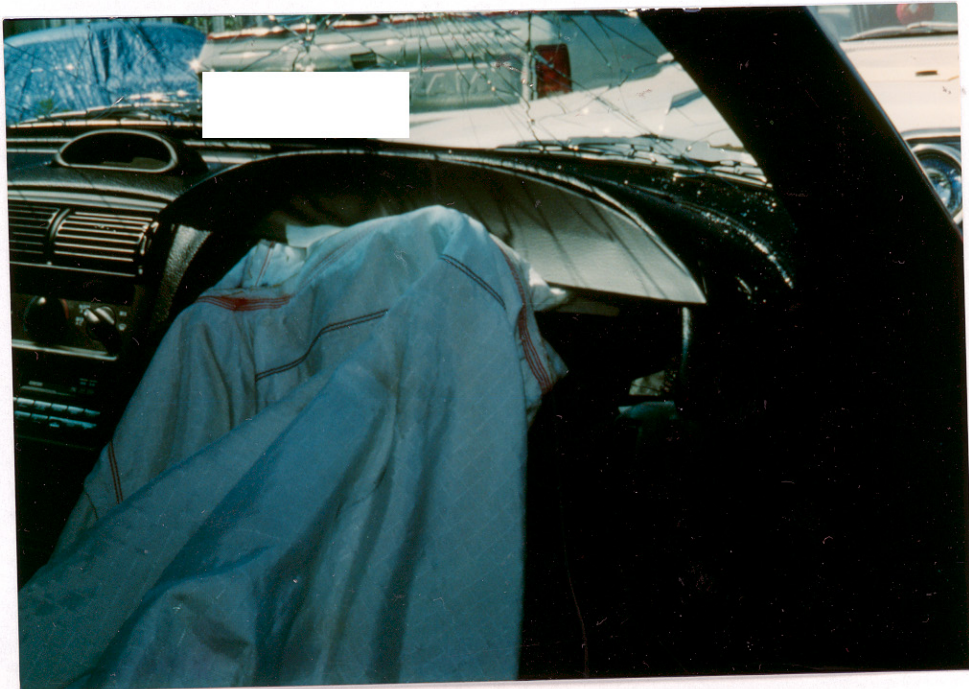
14. Close-up view of the passenger side air bag module.

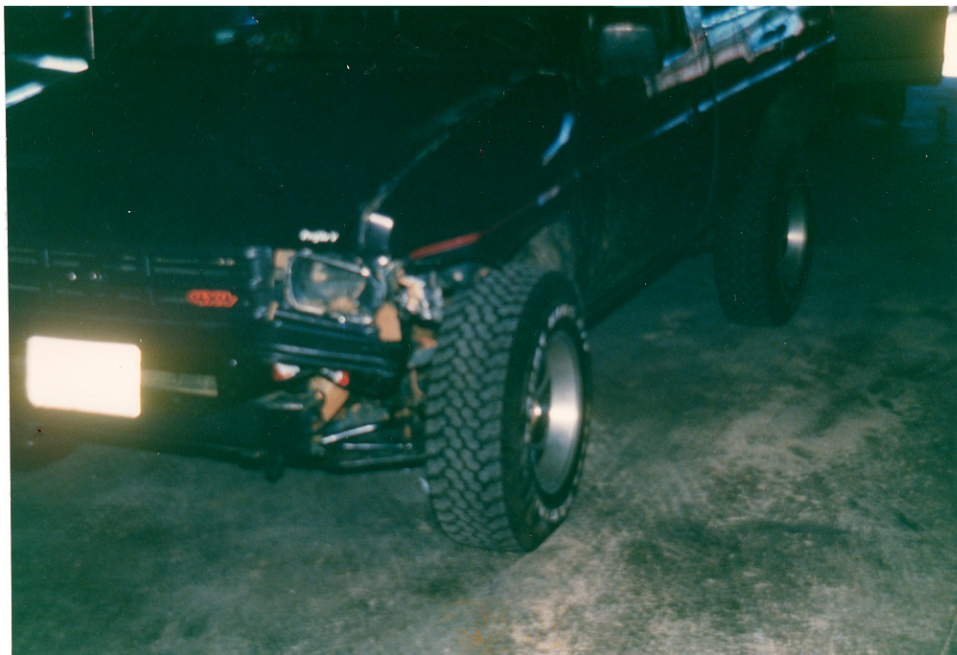
15. Frontal damage to the Nissan pickup truck.
