REPORT NUMBER 104-GTL-04-002

**SAFETY COMPLIANCE TESTING FOR
FMVSS NO. 104
WINDSHIELD WIPING AND WASHING SYSTEMS**

**NISSAN MOTOR CO., LTD.
2004 NISSAN MAXIMA, PASSENGER CAR
NHTSA NO. C45207**

**GENERAL TESTING LABORATORIES, INC.
1623 LEEDSTOWN ROAD
COLONIAL BEACH, VIRGINIA 22443**

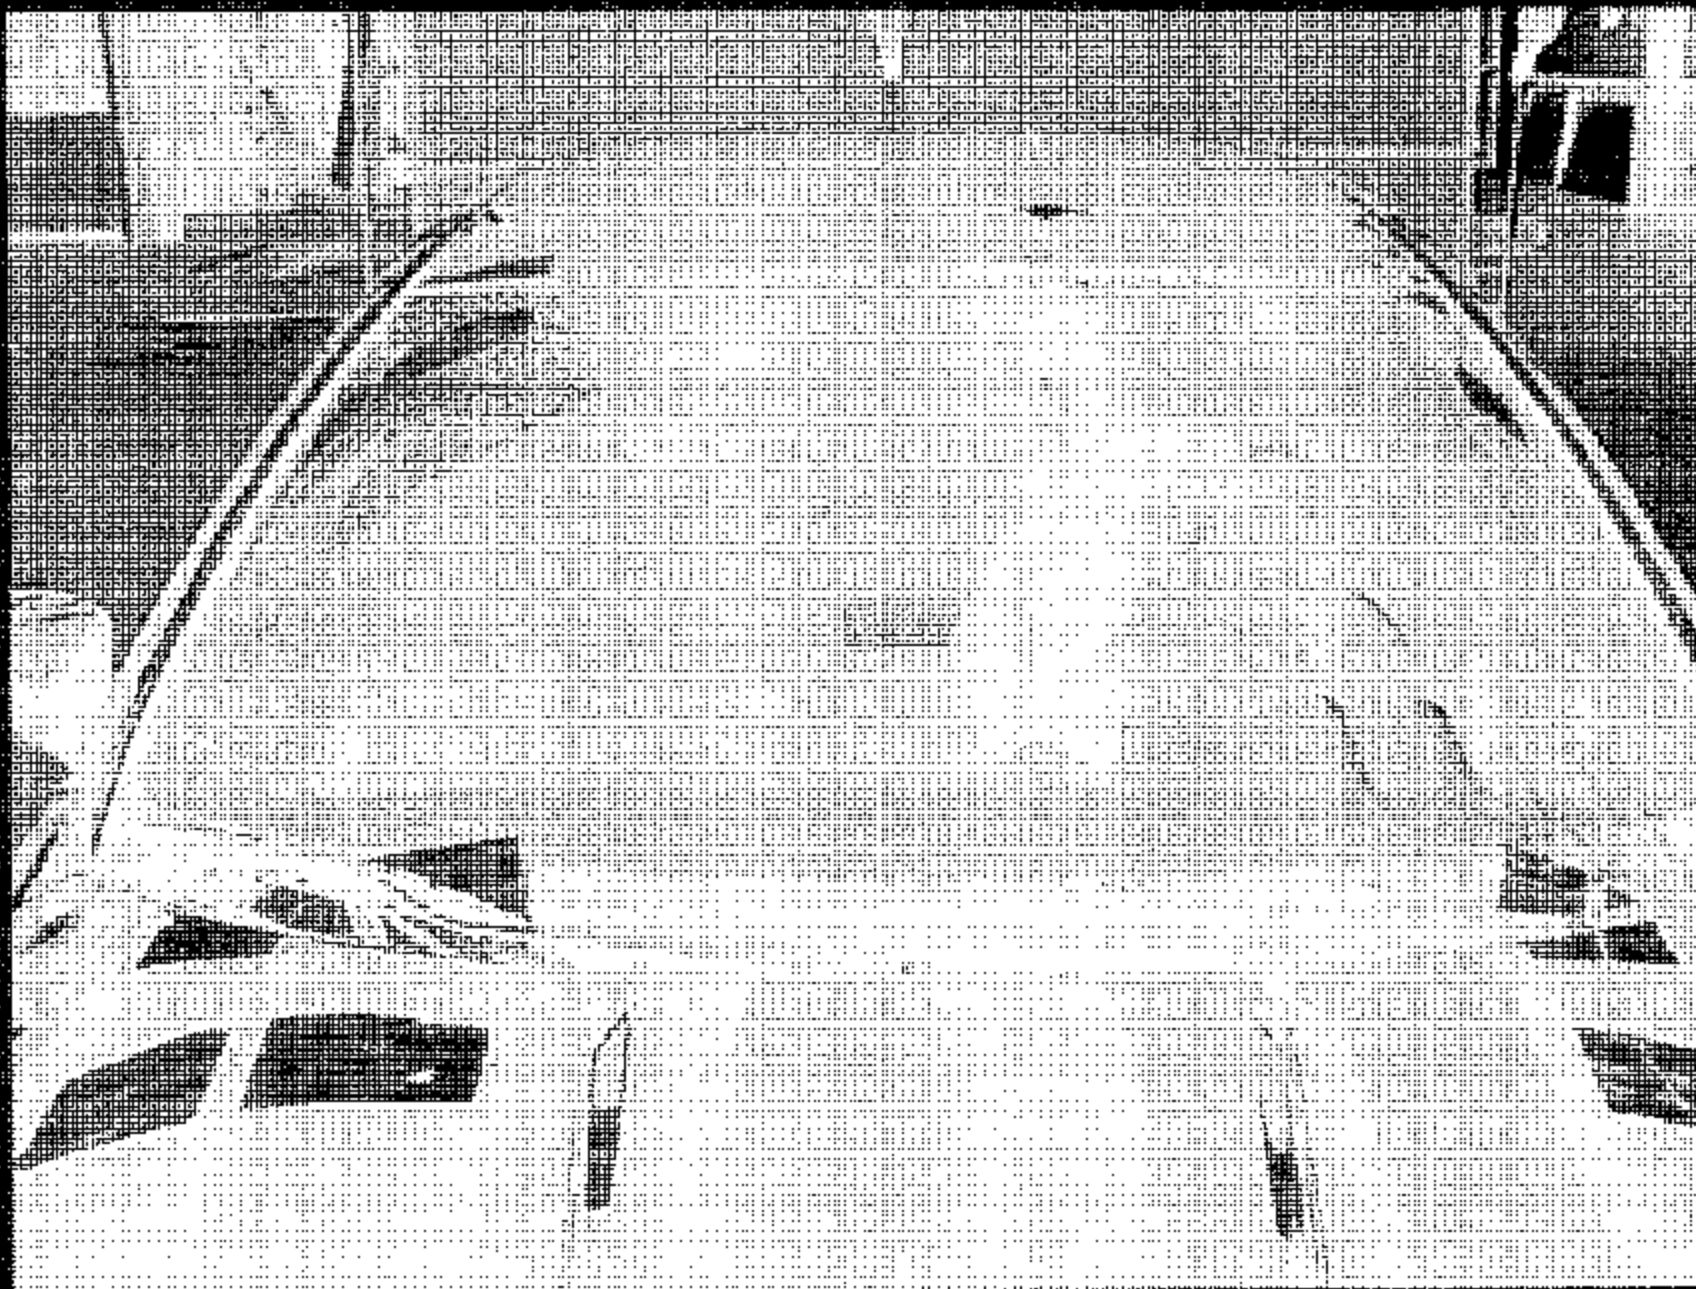
The test was conducted with the windshield wiper system operating at the high speed setting, engine at idle RPM and the spray nozzles spraying water at a minimum of 50 cubic inches per minute. The wiper blade wipe pattern was outlined on the glazing surface and then transferred to a windshield pattern. The wiped area was determined for areas A, B and C from the windshield pattern.

FIGURE 5.9
WIPED AREA TEST

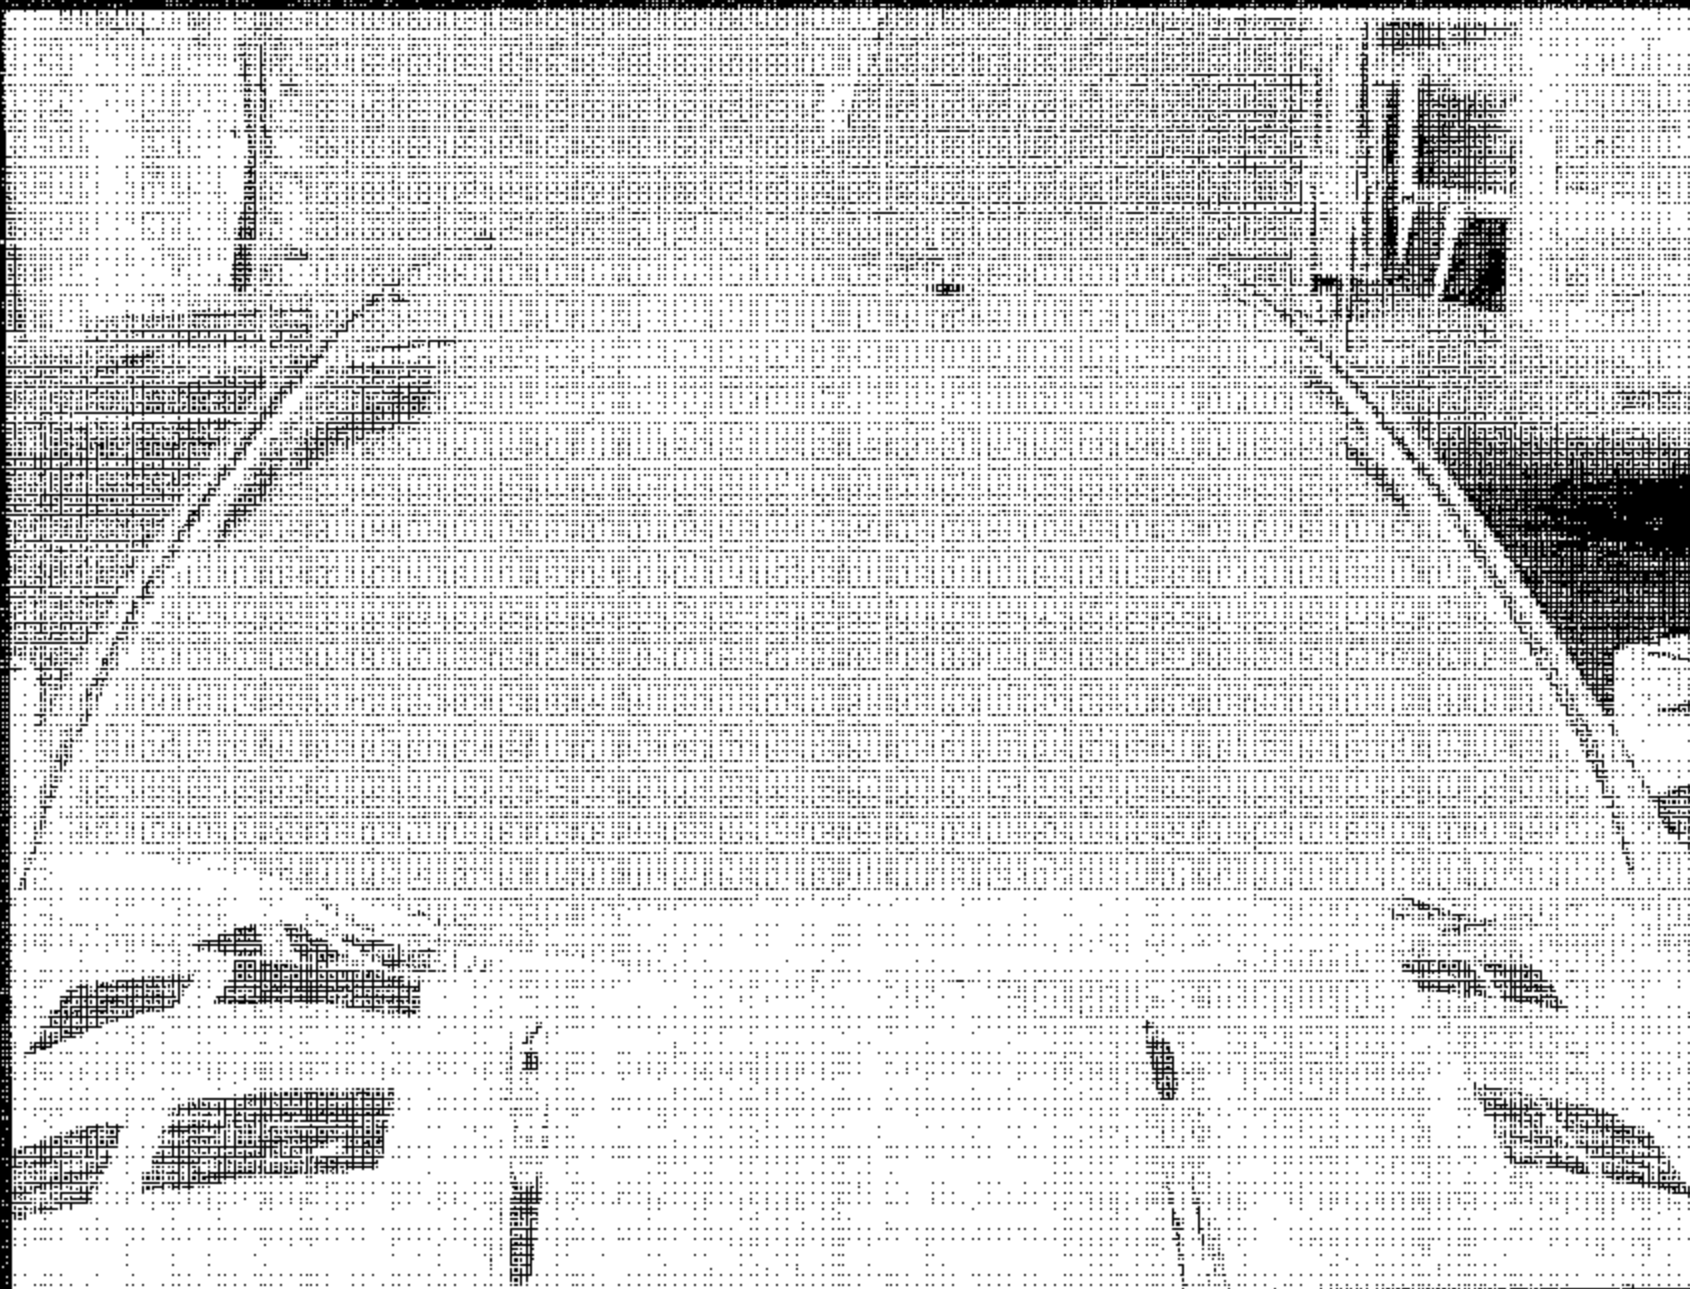
The windshield glazing surface was coated with a mixture of water and fine grade test dust. Within 15 seconds following application of the water-dust mixture, the windshield wiper and washing system was activated in the high speed mode for ten complete cycles. The vehicle's engine was operating at idle RPM. The cleared areas of the windshield were marked on the inside windshield surface. After ten complete cycles the system was deactivated and the wiped area transferred to a windshield pattern.

FIGURE 5.11
CAPABILITY TEST #1 - PRE-COATED WINDSHIELD

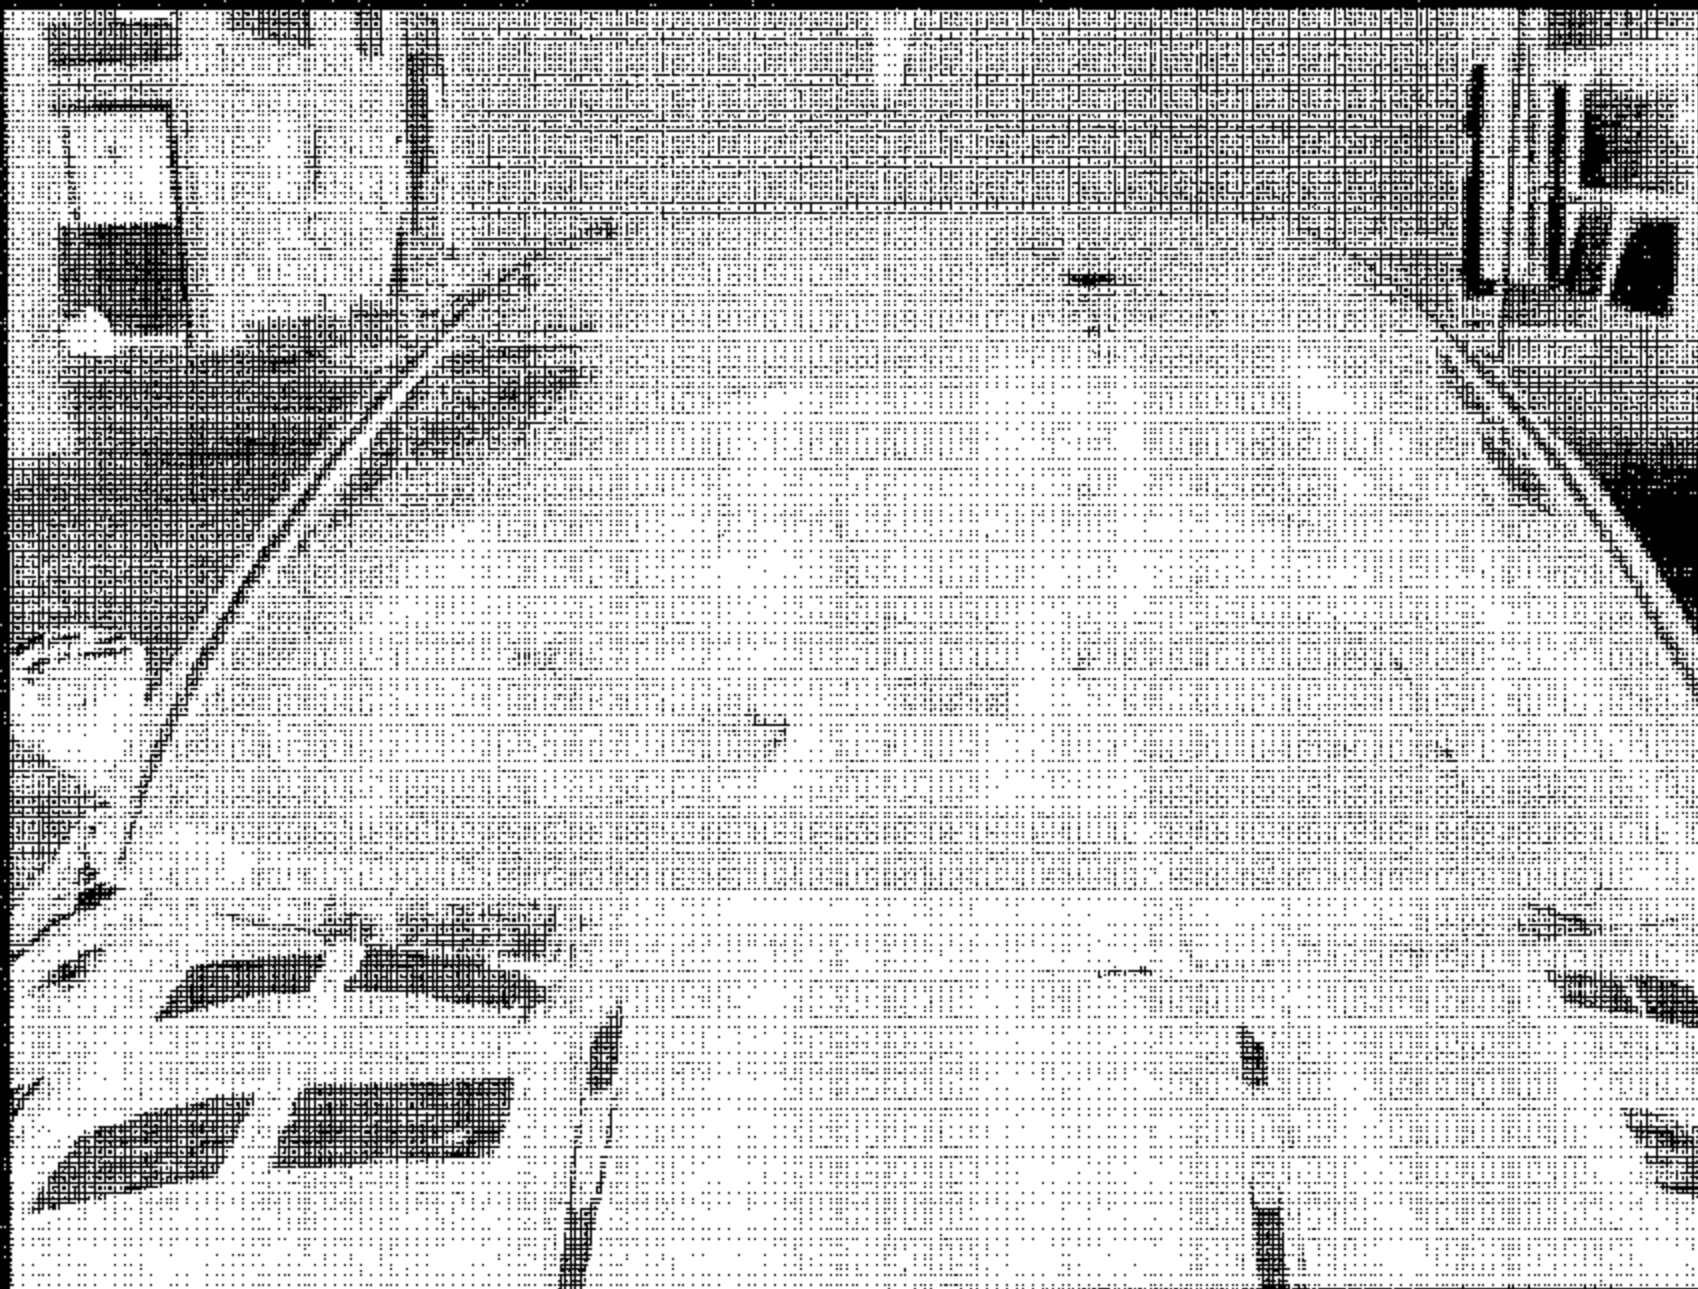
FIGURE 5.12
CAPABILITY TEST #1 - IN PROGRESS

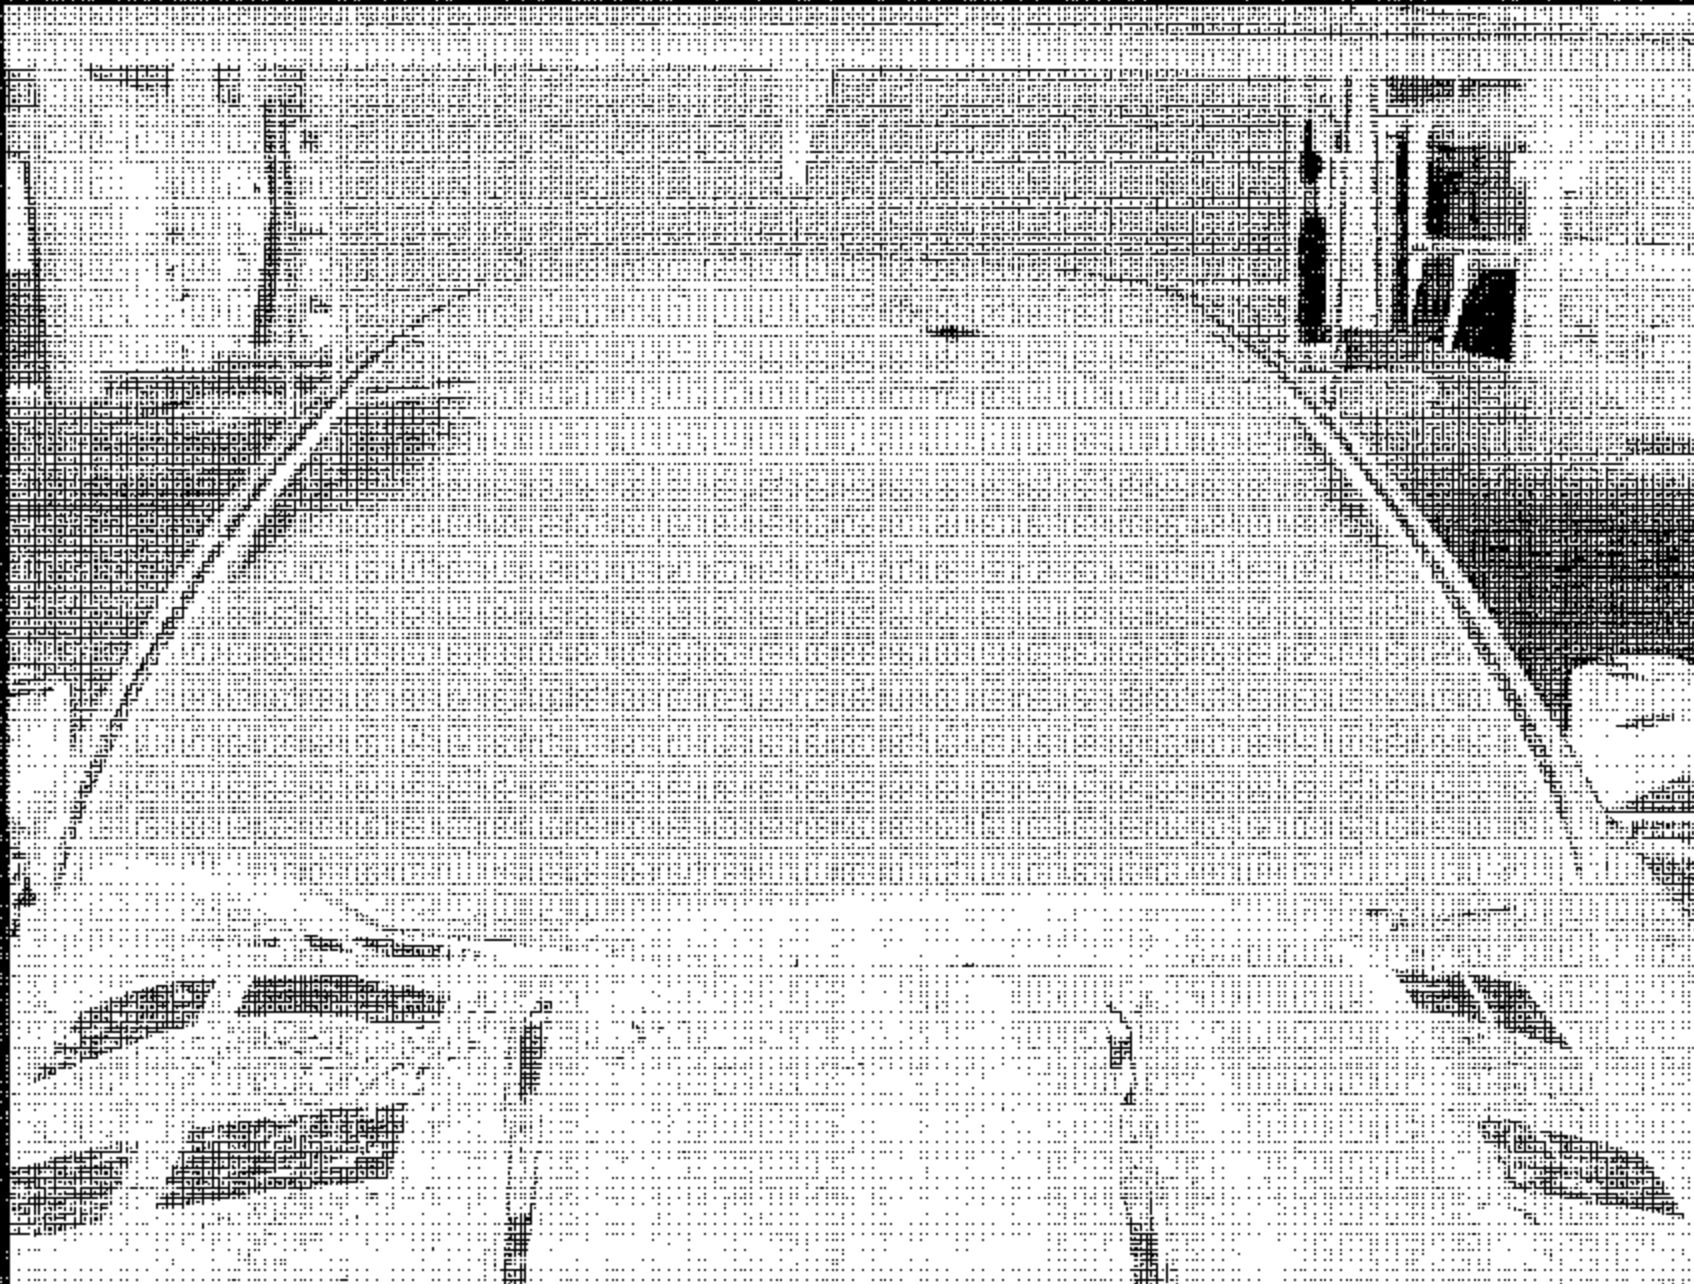
The glazing surface was cleaned and dried. The water dust mixture was re-applied and the test repeated.

FIGURE 5.14
CAPABILITY TEST #2 – PRE-COATED WINDSHIELD

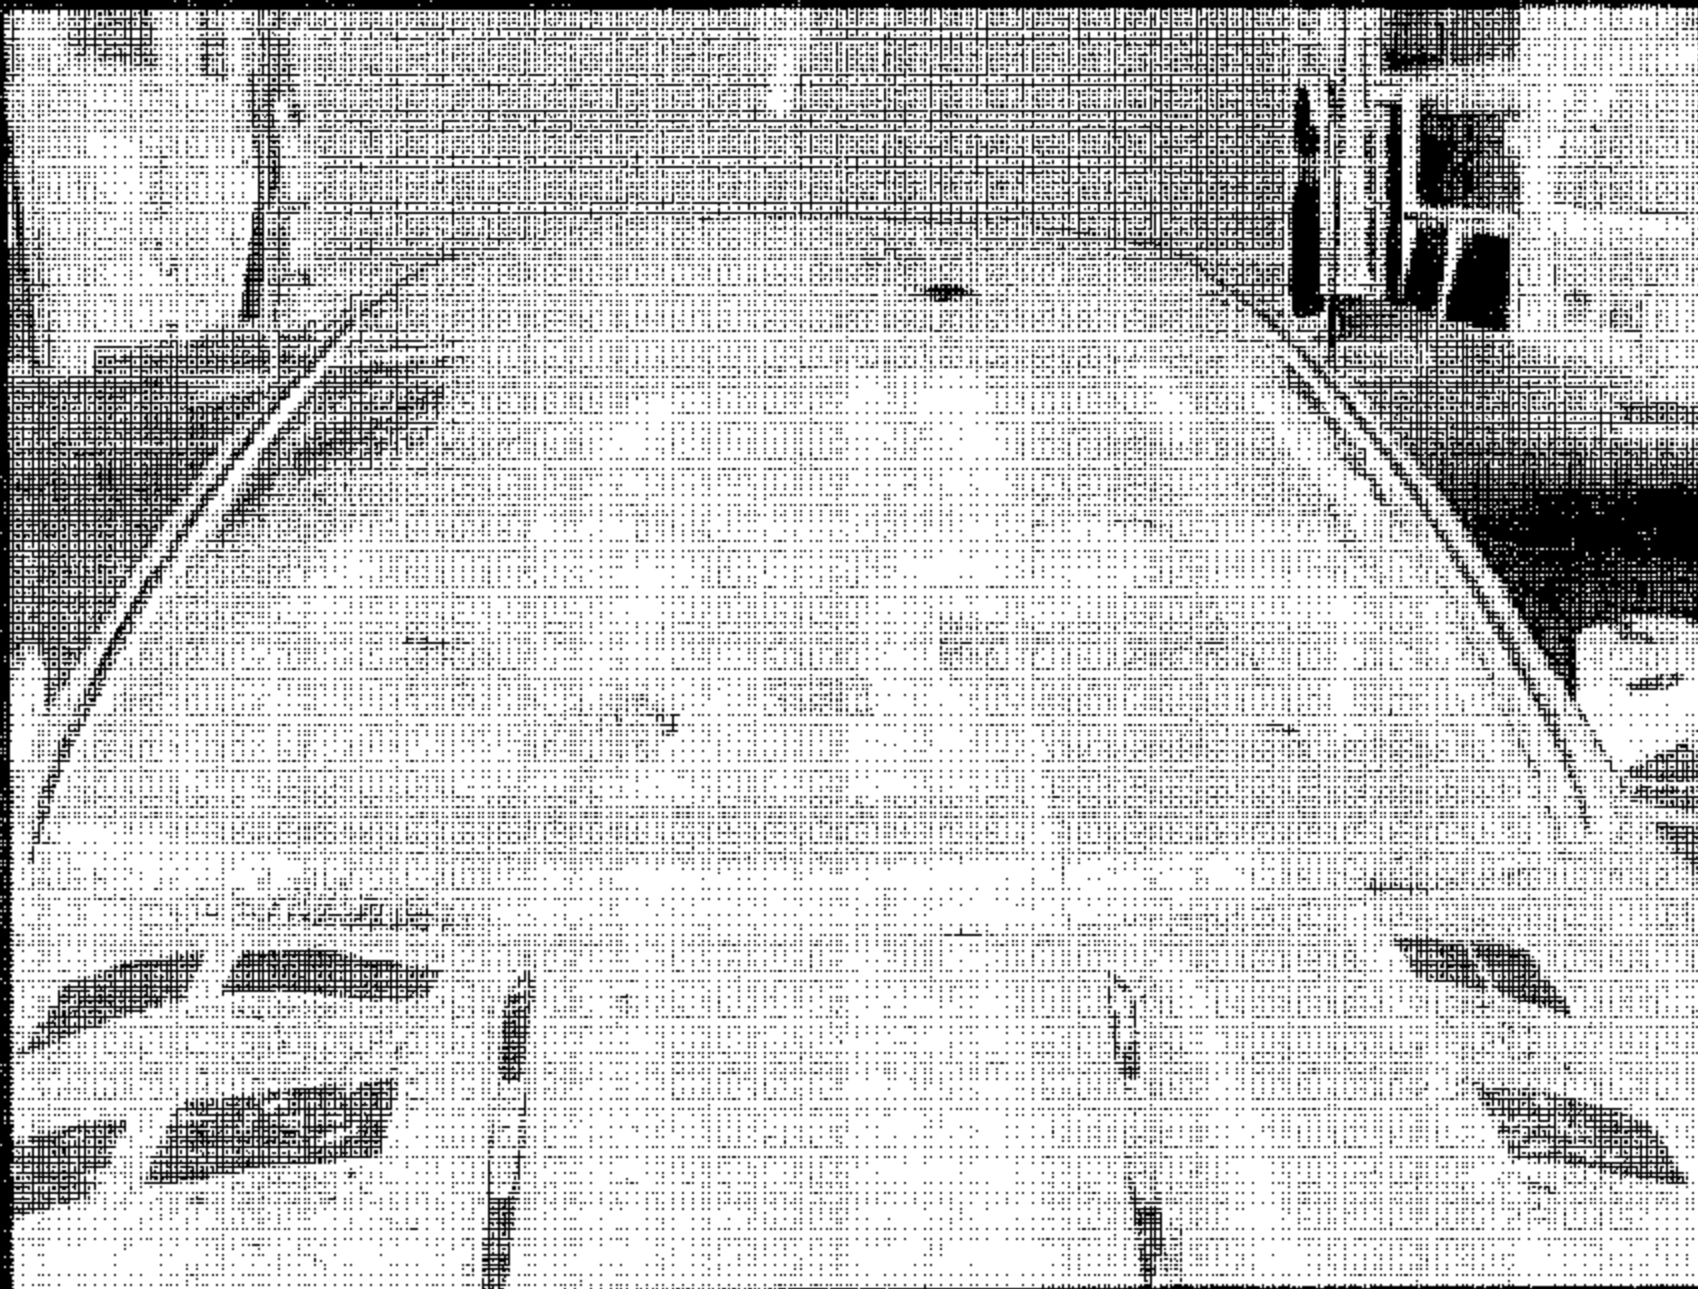
FIGURE 5.15
CAPABILITY TEST #2 – IN PROGRESS

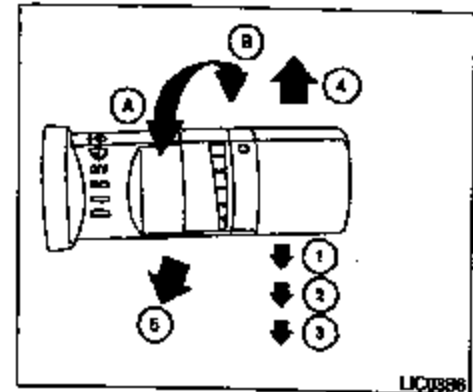
WINDSHIELD WIPER AND WASHER SWITCH

Push the lever down to operate the wiper at the following speed:

- ① Intermittent — Intermittent operation can be adjusted by turning the knob toward Ⓐ (Slower) or Ⓑ (Faster). Also, the intermittent operation speed varies in accordance with the vehicle speed. (For example, when the vehicle speed is high, the intermittent operation speed will be faster.)

- ② Low — continuous low speed operation
- ③ High — continuous high speed operation

Push the lever up ④ to have one sweep operation of the wiper.

Push the lever toward you ⑤ to operate the washer. The wiper will also operate several times.
