REPORT NUMBER: 201UI-CAL-09-02

**SAFETY COMPLIANCE TESTING FOR FMVSS 201  
OCCUPANT PROTECTION IN INTERIOR IMPACT  
UPPER INTERIOR HEAD IMPACT PROTECTION**

**CHRYSLER LLC.  
2009 DODGE JOURNEY**

FINAL REPORT

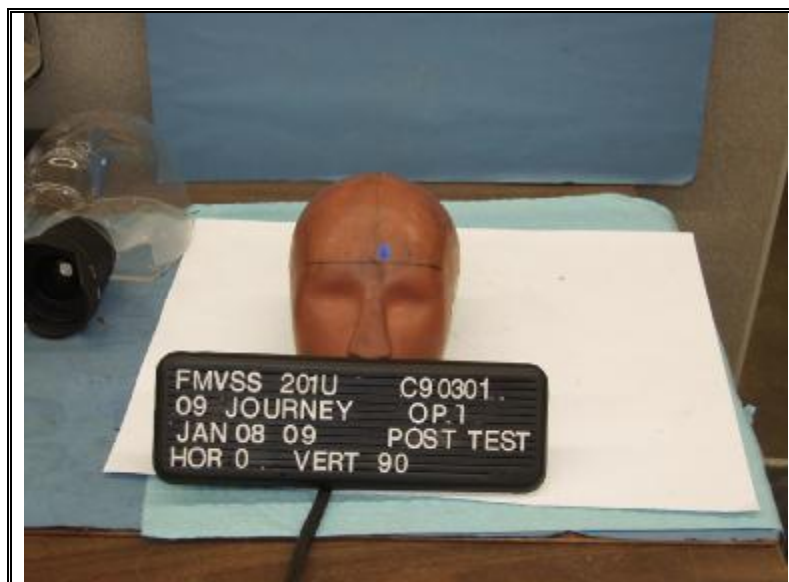
POST-IMPACT OP1 HEADFORM

Impact Point Description (from lower midpoint on midsagittal line)			
On Centerline	7	<input type="checkbox"/>	mm right <input checked="" type="checkbox"/> mm left
On Centerline	9		mm up

Free Motion HIC	816.7
HIC(d)	782.6
Impact Velocity (kph)	23.8
HIC T1 (msec)	5.1
HIC T2 (msec)	11.3

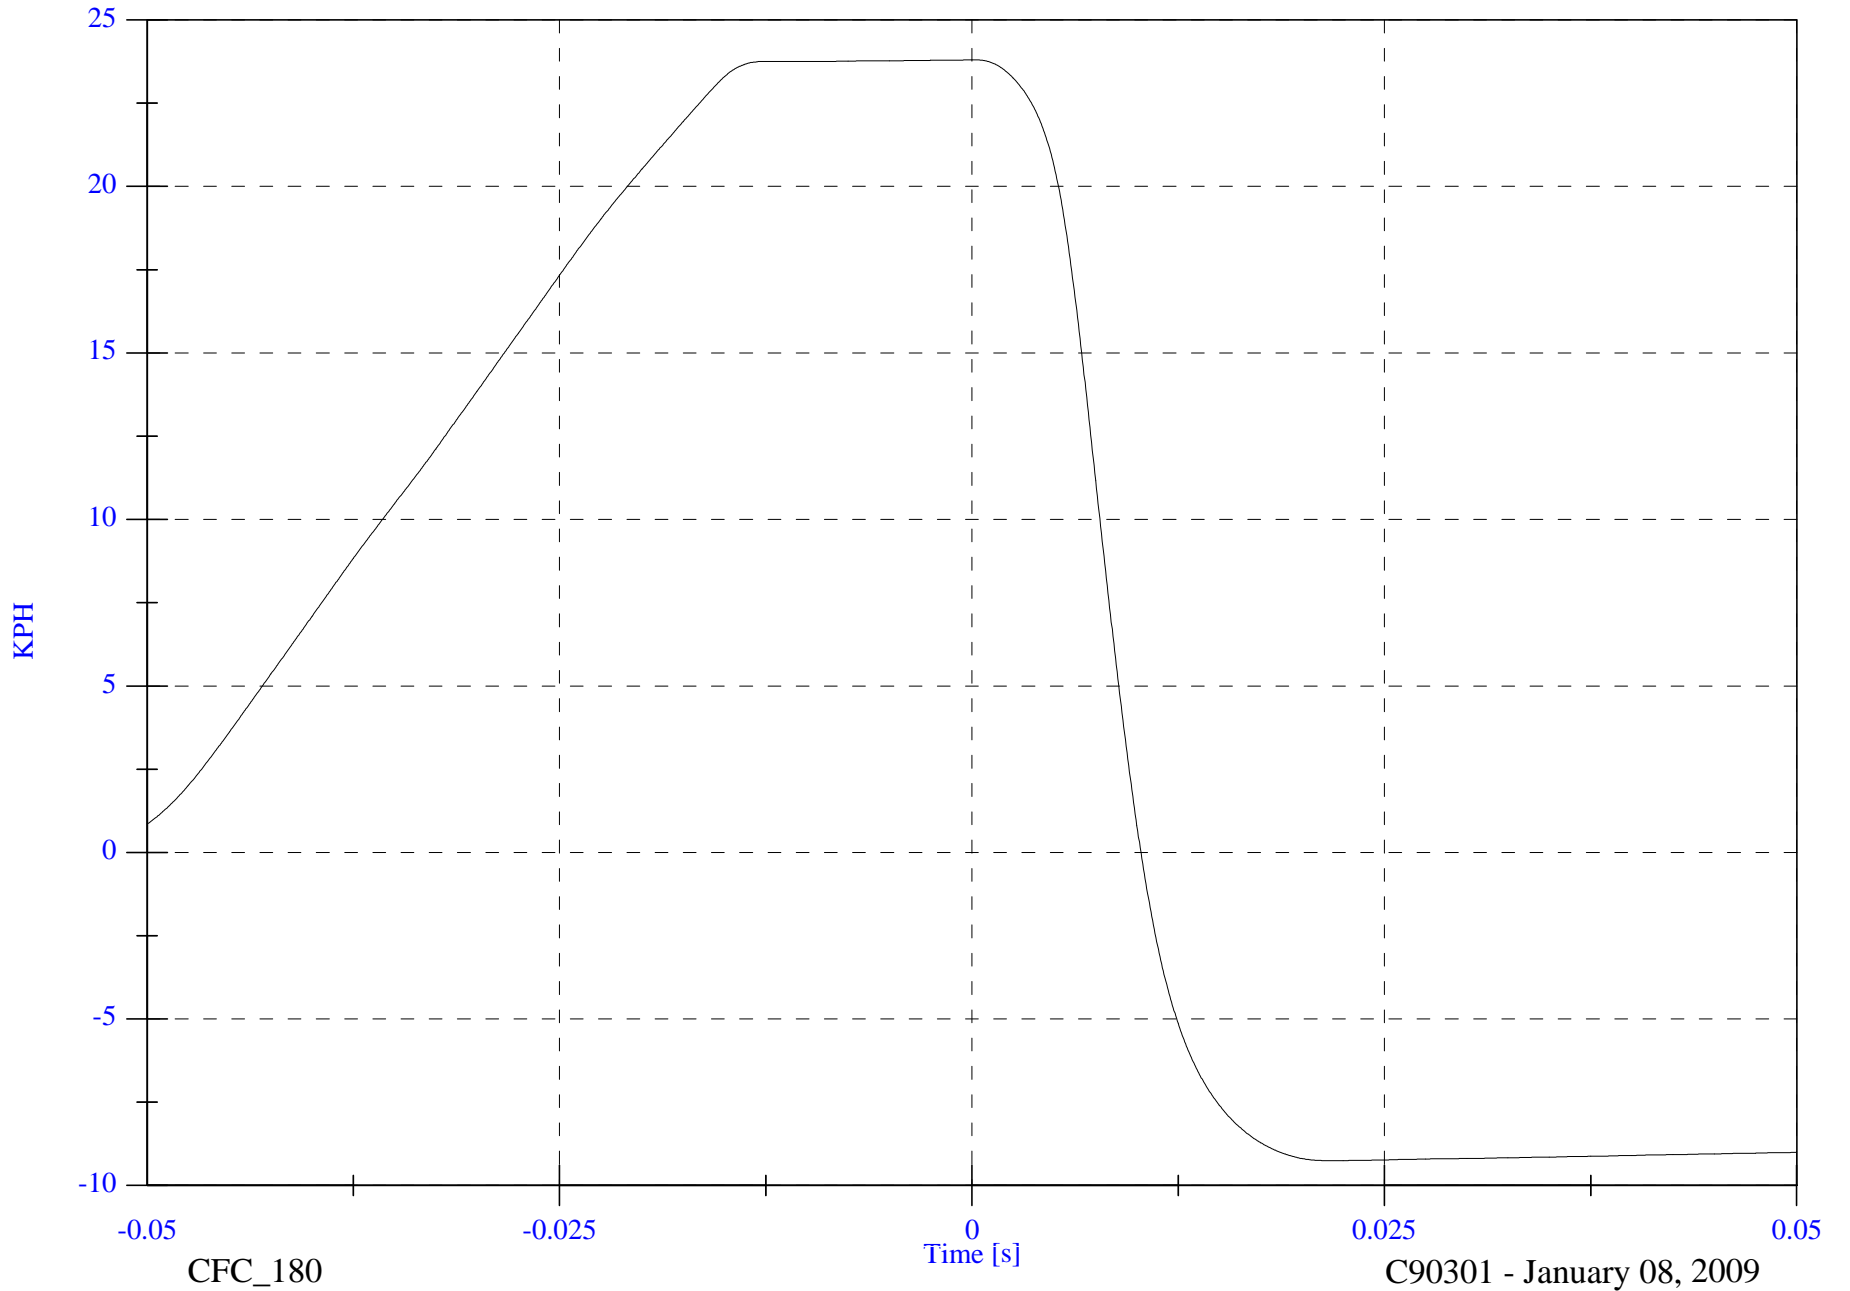
C90301 PASSENGER SIDE OP1 IMPACT PLOT #5

Max: 23.8 [KPH] at 0.000 [s]

Min: -9.3 [KPH] at 0.022 [s]

### Headform Velocity

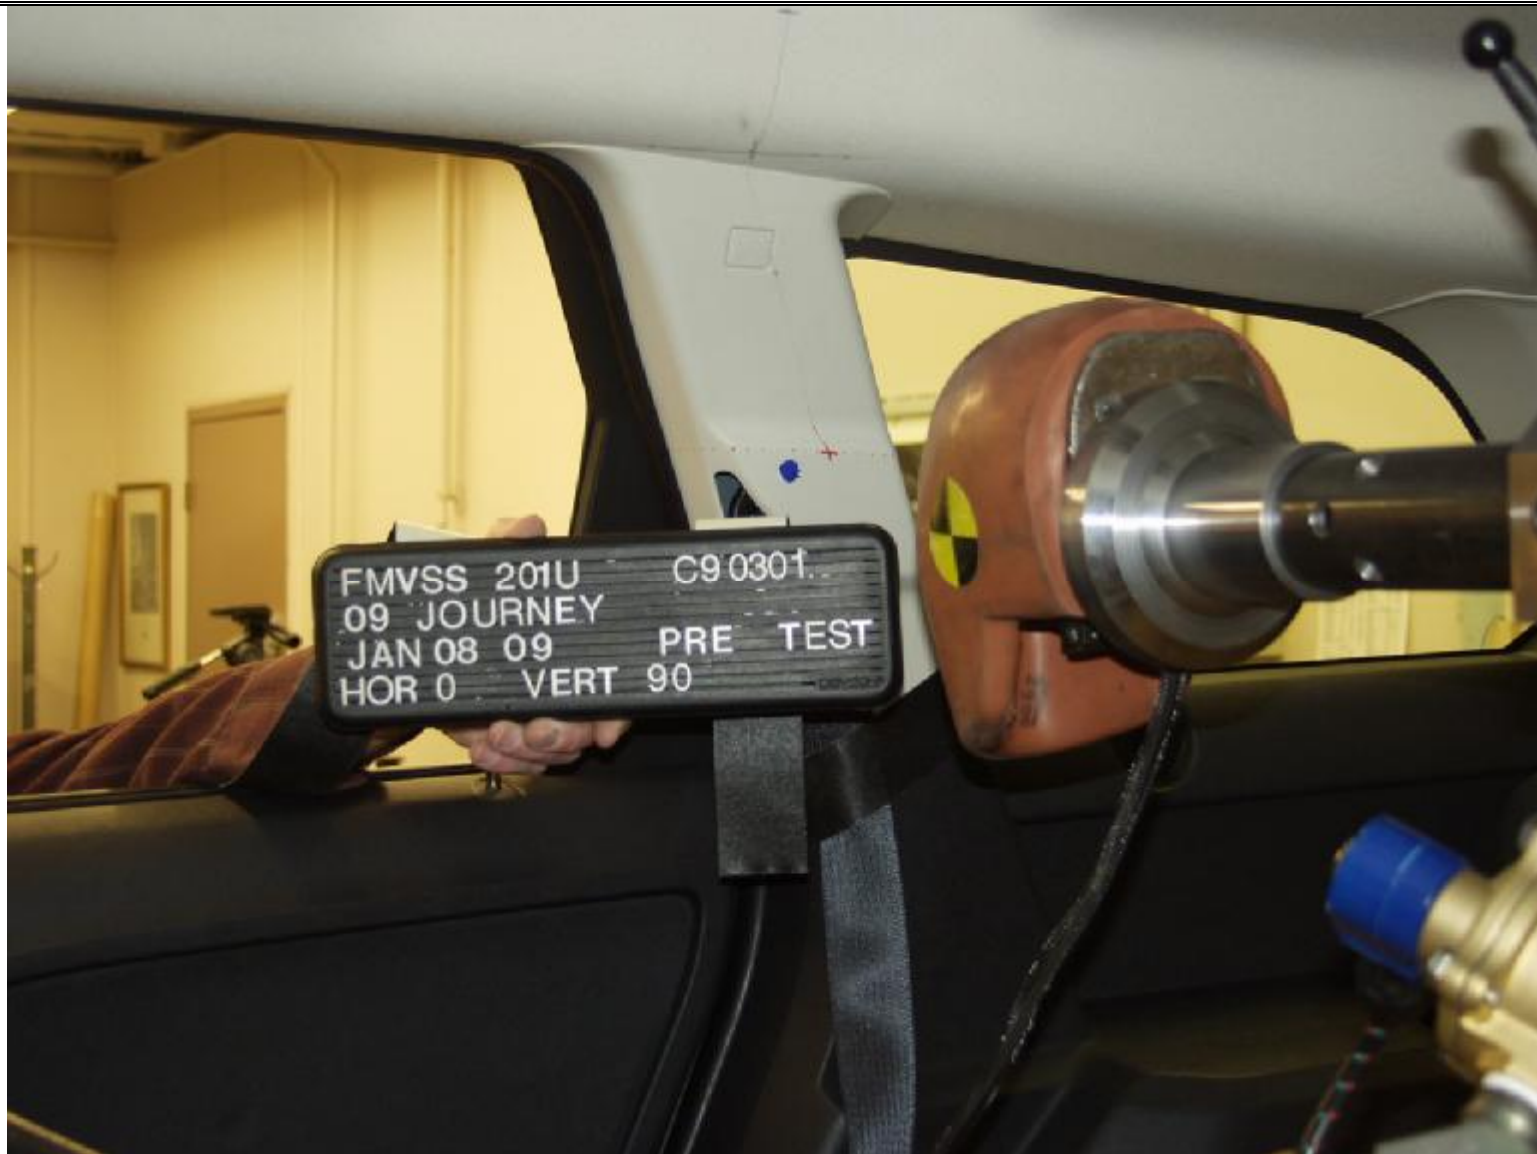
PRE-IMPACT OP1

Test Number:	1
Test Date:	Jan 08,2009
Target Location:	Other Pillar
Target Code:	OP1
Horizontal Impact Angle:	90°
Vertical Impact Angle:	0°
Ambient Temperature:	20°C
Relative Humidity:	23
Time of Impact:	9:00
Headform Number:	0062

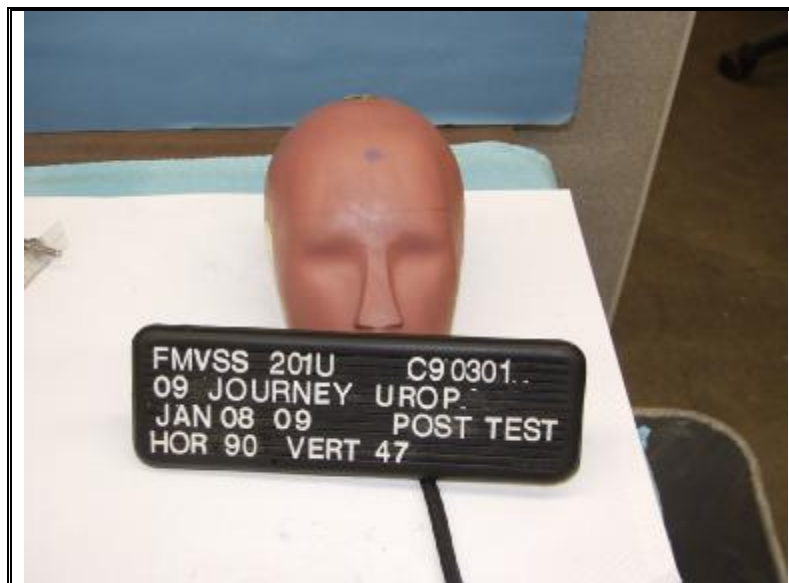
POST-IMPACT UROP HEADFORM

Impact Point Description (from lower midpoint on midsagittal line)					
On Centerline	0	<input type="checkbox"/>	mm right	<input type="checkbox"/>	mm left
On Centerline	38				mm up

Free Motion HIC	442.3
HIC(d)	500.1
Impact Velocity (kph)	23.46
HIC T1 (msec)	3.7
HIC T2 (msec)	15.3

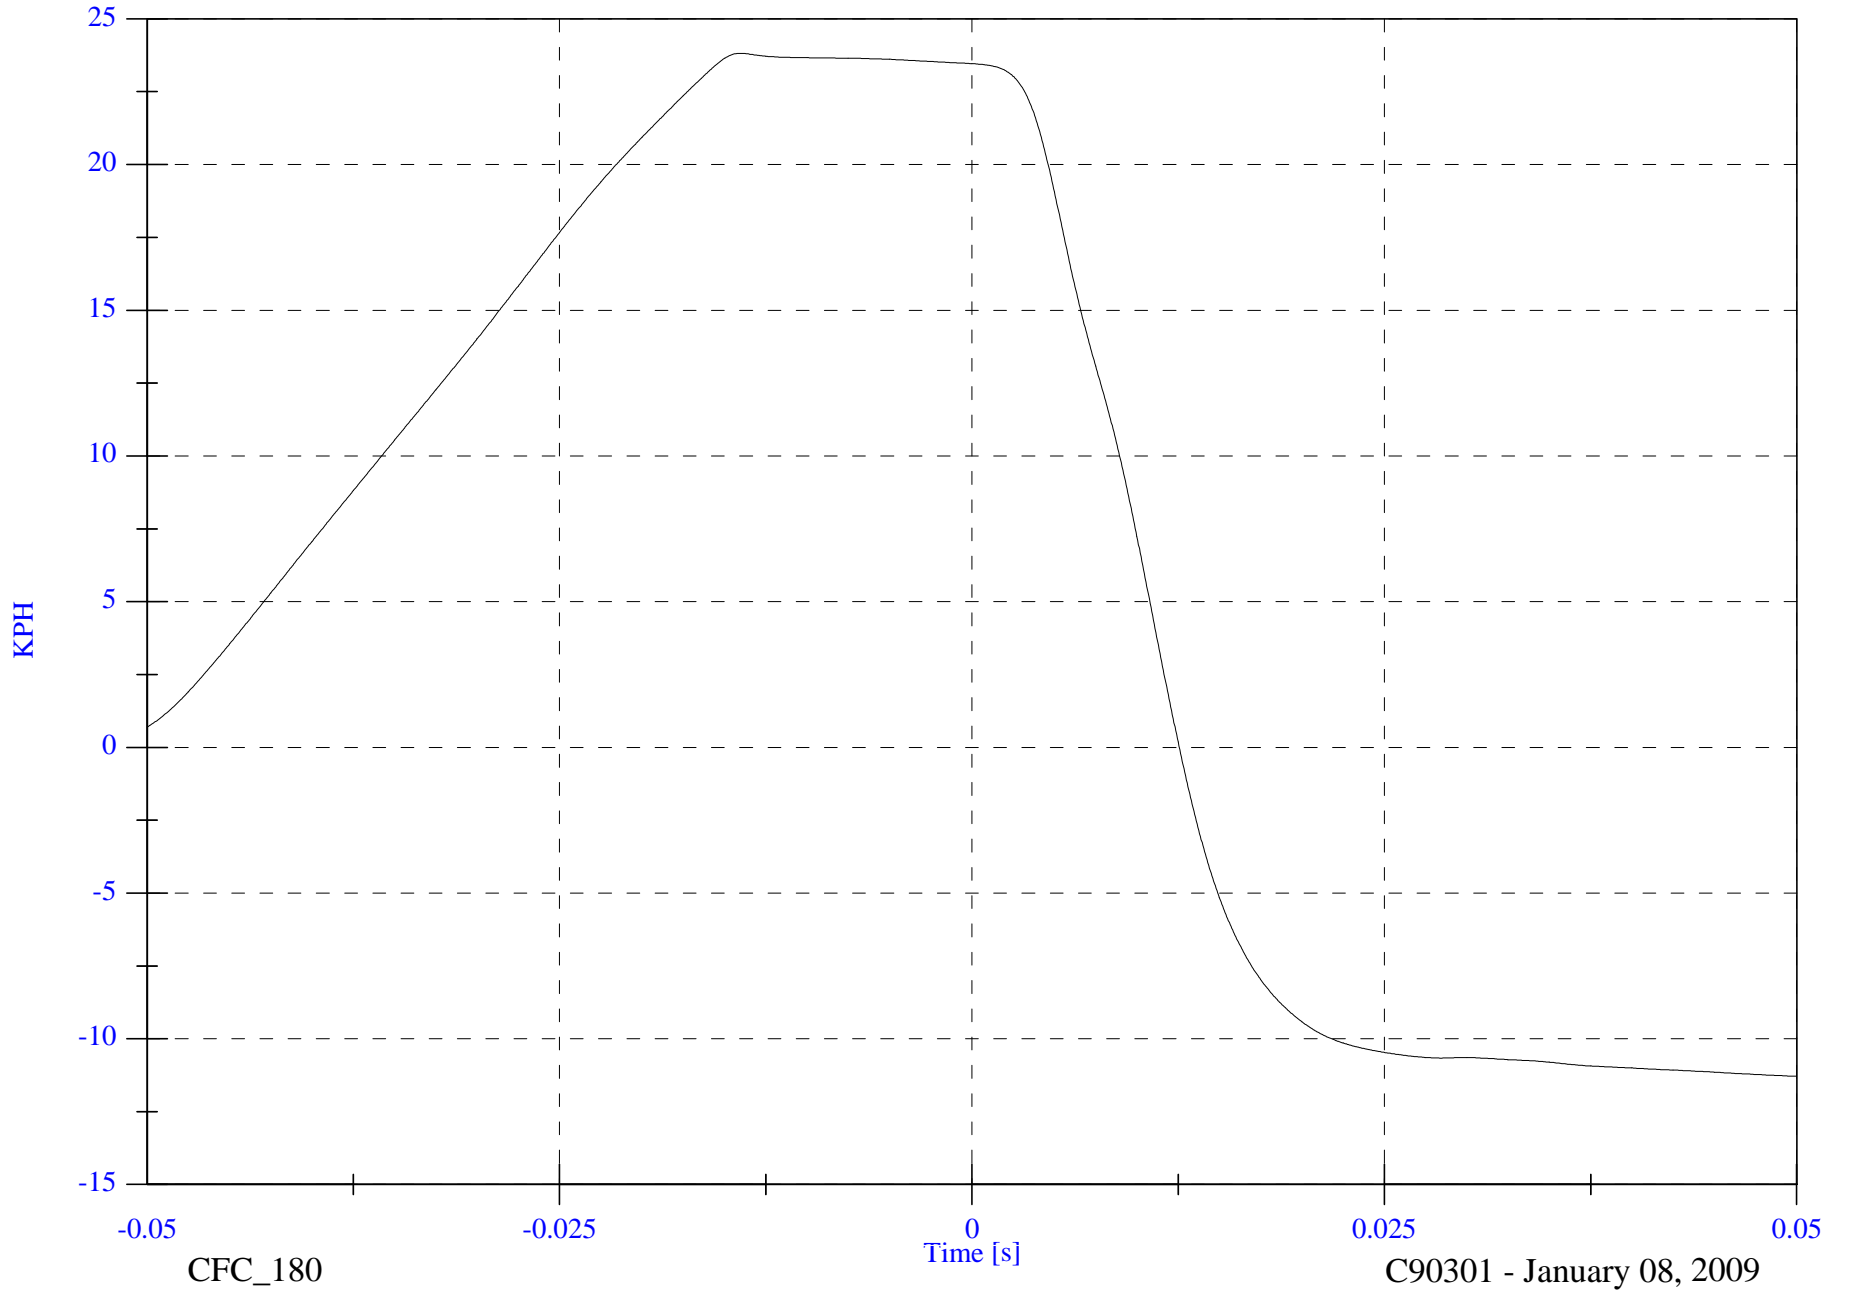
C90301 PASSENGER SIDE UROP IMPACT PLOT #5

### Headform Velocity

Min: -11.3 [KPH] at 0.050 [s]

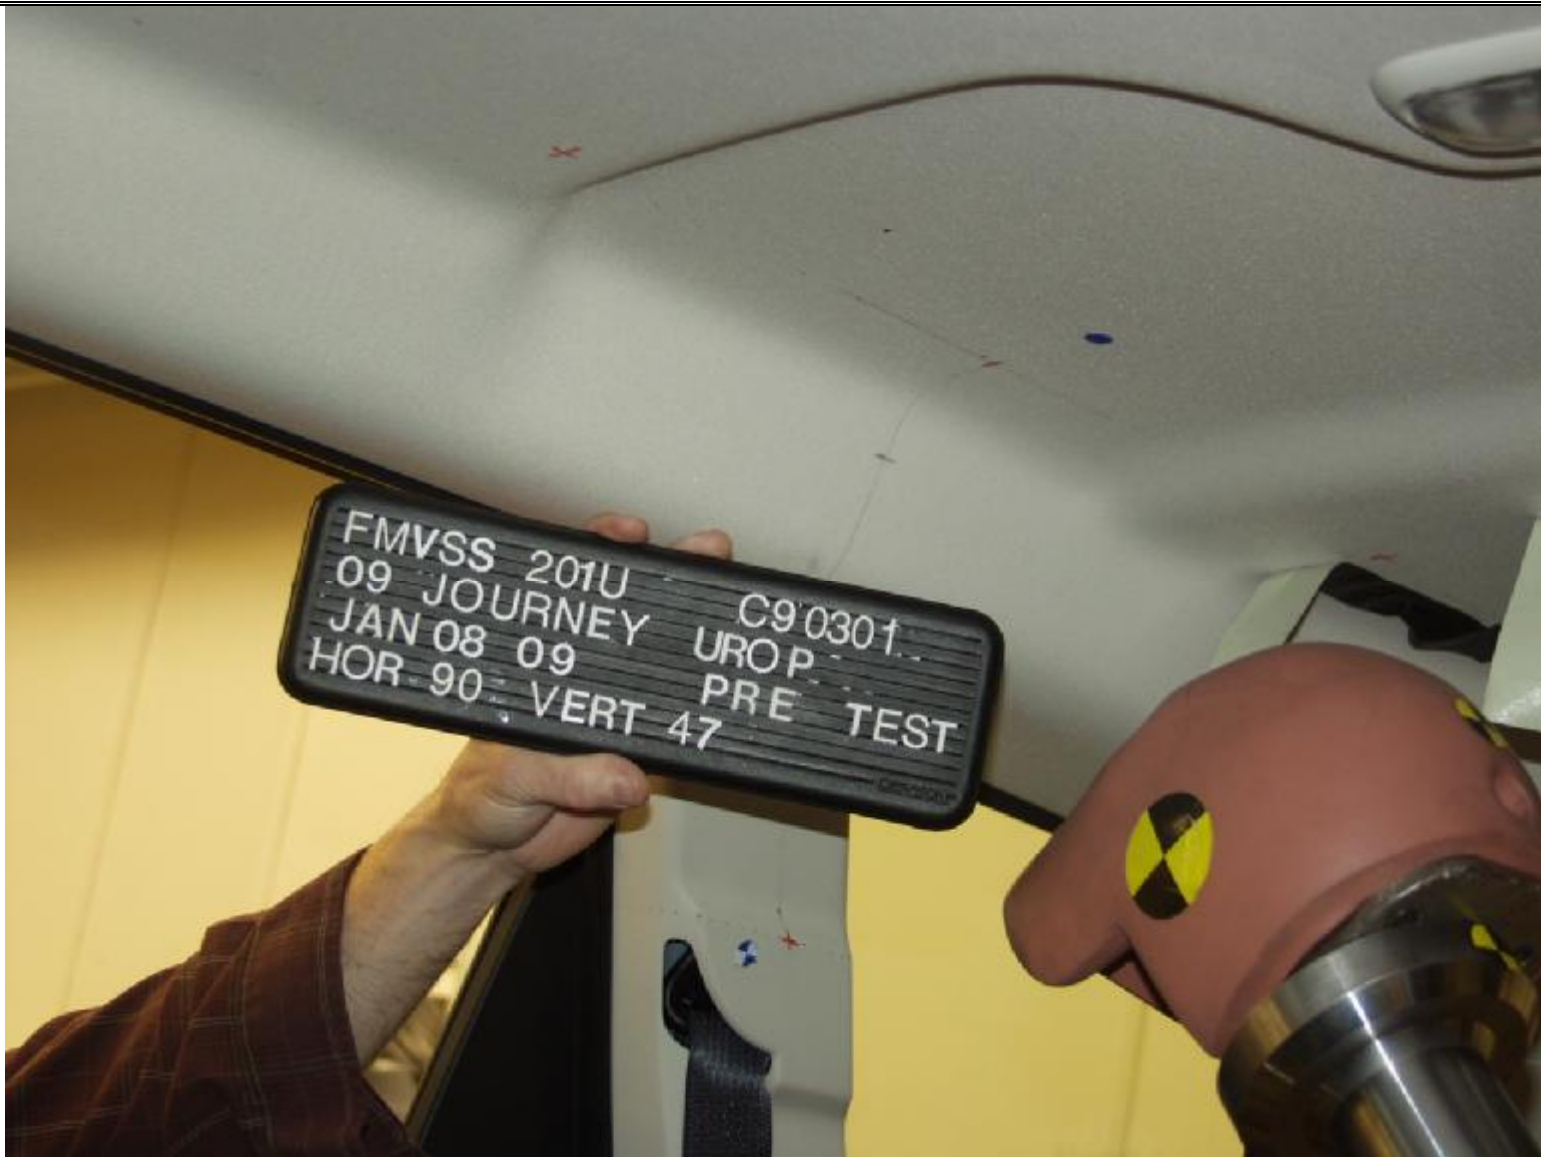
PRE-IMPACT UROP

Test Number:	2
Test Date:	Jan 08, 2009
Target Location:	Upper Roof
Target Code:	UROP
Horizontal Impact Angle:	90°
Vertical Impact Angle:	47°
Ambient Temperature:	20°C
Relative Humidity:	23
Time of Impact:	9:30
Headform Number:	1140

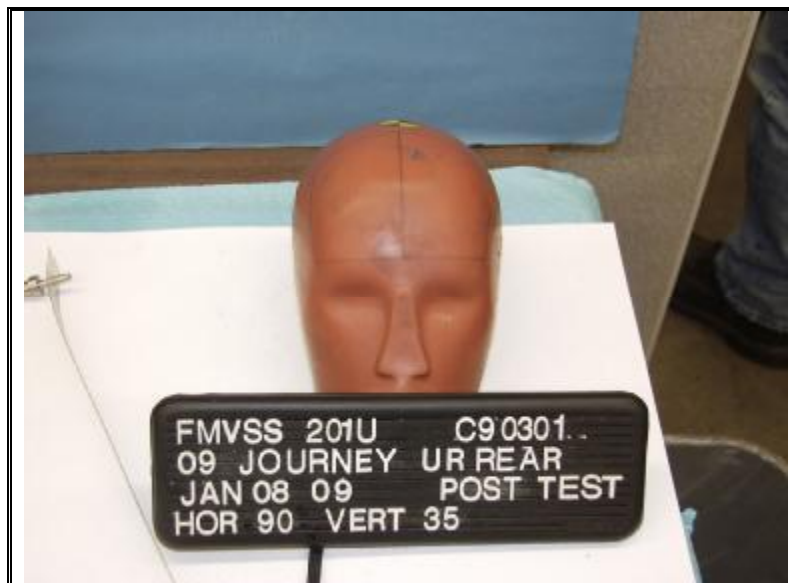
POST-IMPACT URREAR HEADFORM

Impact Point Description (from lower midpoint on midsagittal line)			
On Centerline	11	mm right	x mm left
On Centerline	70	mm up

Free Motion HIC	435.0
HIC(d)	494.6
Impact Velocity (kph)	23.51
HIC T1 (msec)	4.4
HIC T2 (msec)	15.2

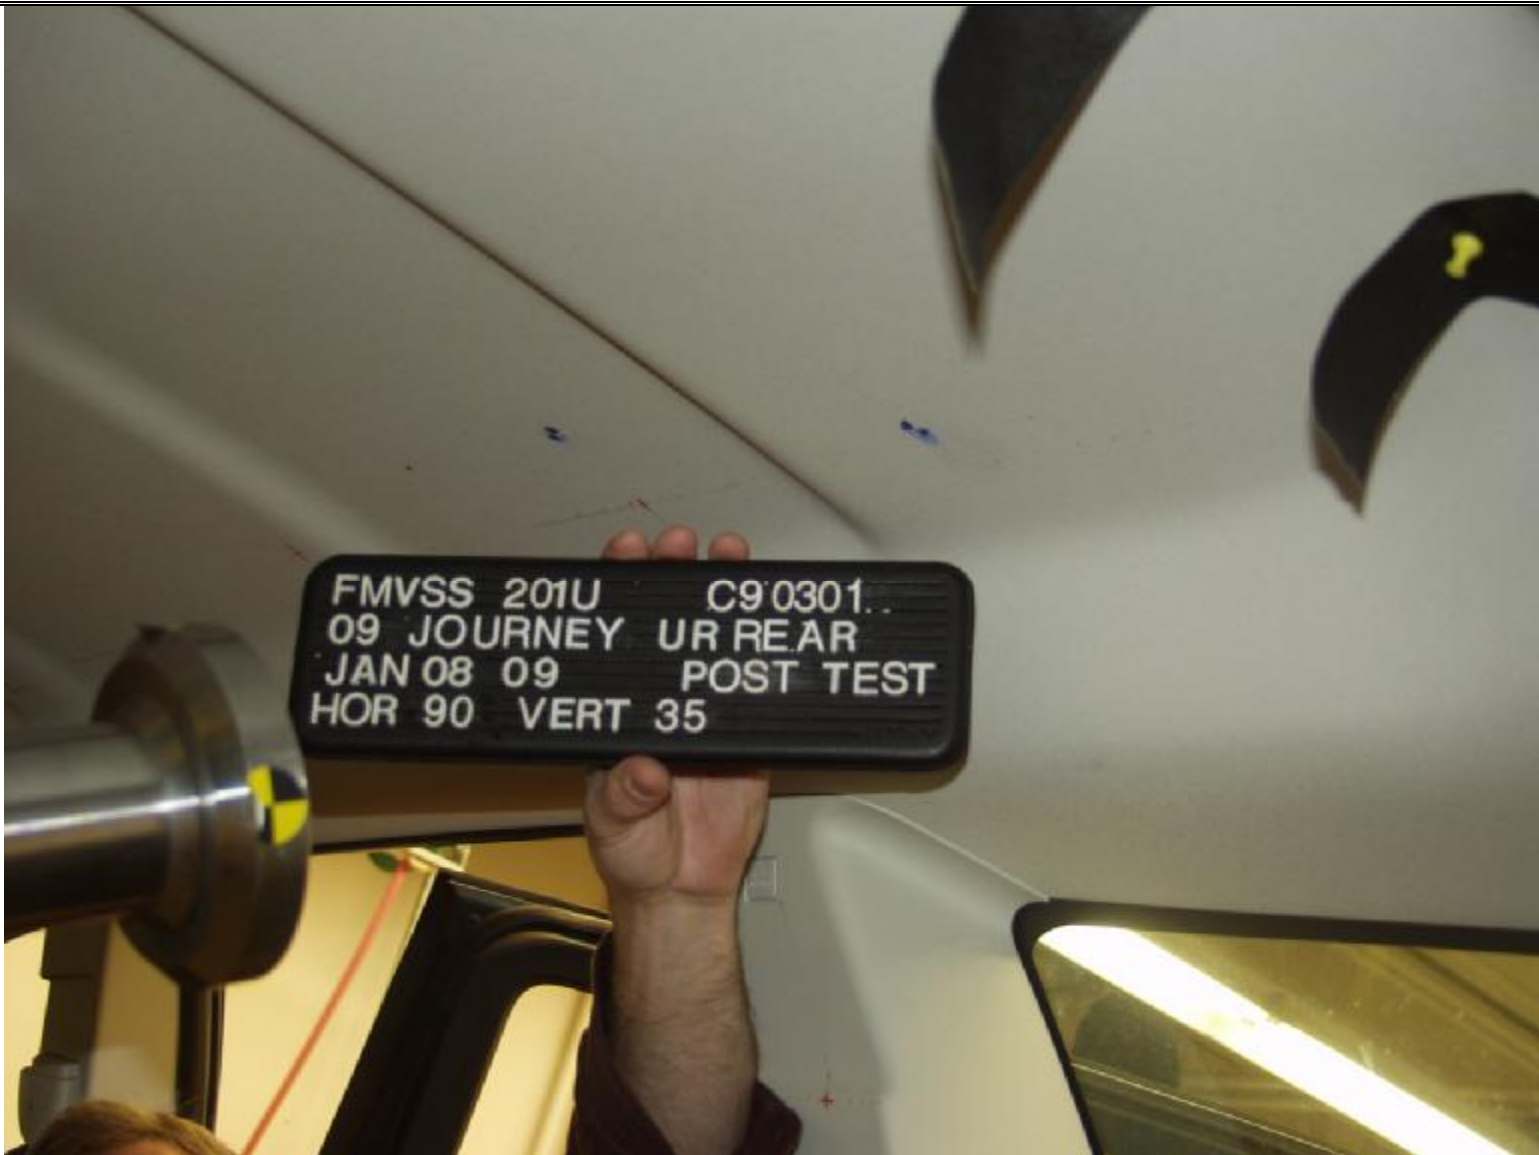
POST-IMPACT URREAR

Test Number:	3
Test Date:	Jan 08,2009
Target Location:	Upper Roof
Target Code:	URREAR
Horizontal Impact Angle:	90°
Vertical Impact Angle:	35°
Ambient Temperature:	20°C
Relative Humidity:	23
Time of Impact:	10:00
Headform Number:	0355

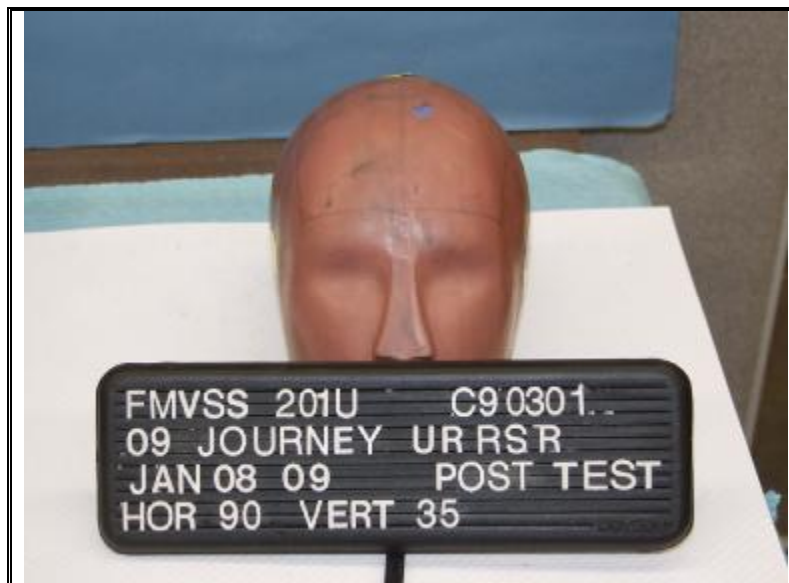
POST-IMPACT URRSR HEADFORM

Impact Point Description (from lower midpoint on midsagittal line)			
On Centerline	11	<input type="checkbox"/>	mm right <input checked="" type="checkbox"/> mm left
On Centerline	64		mm up

Free Motion HIC	572.3
HIC(d)	598.2
Impact Velocity (kph)	23.47
HIC T1 (msec)	5.5
HIC T2 (msec)	13.8

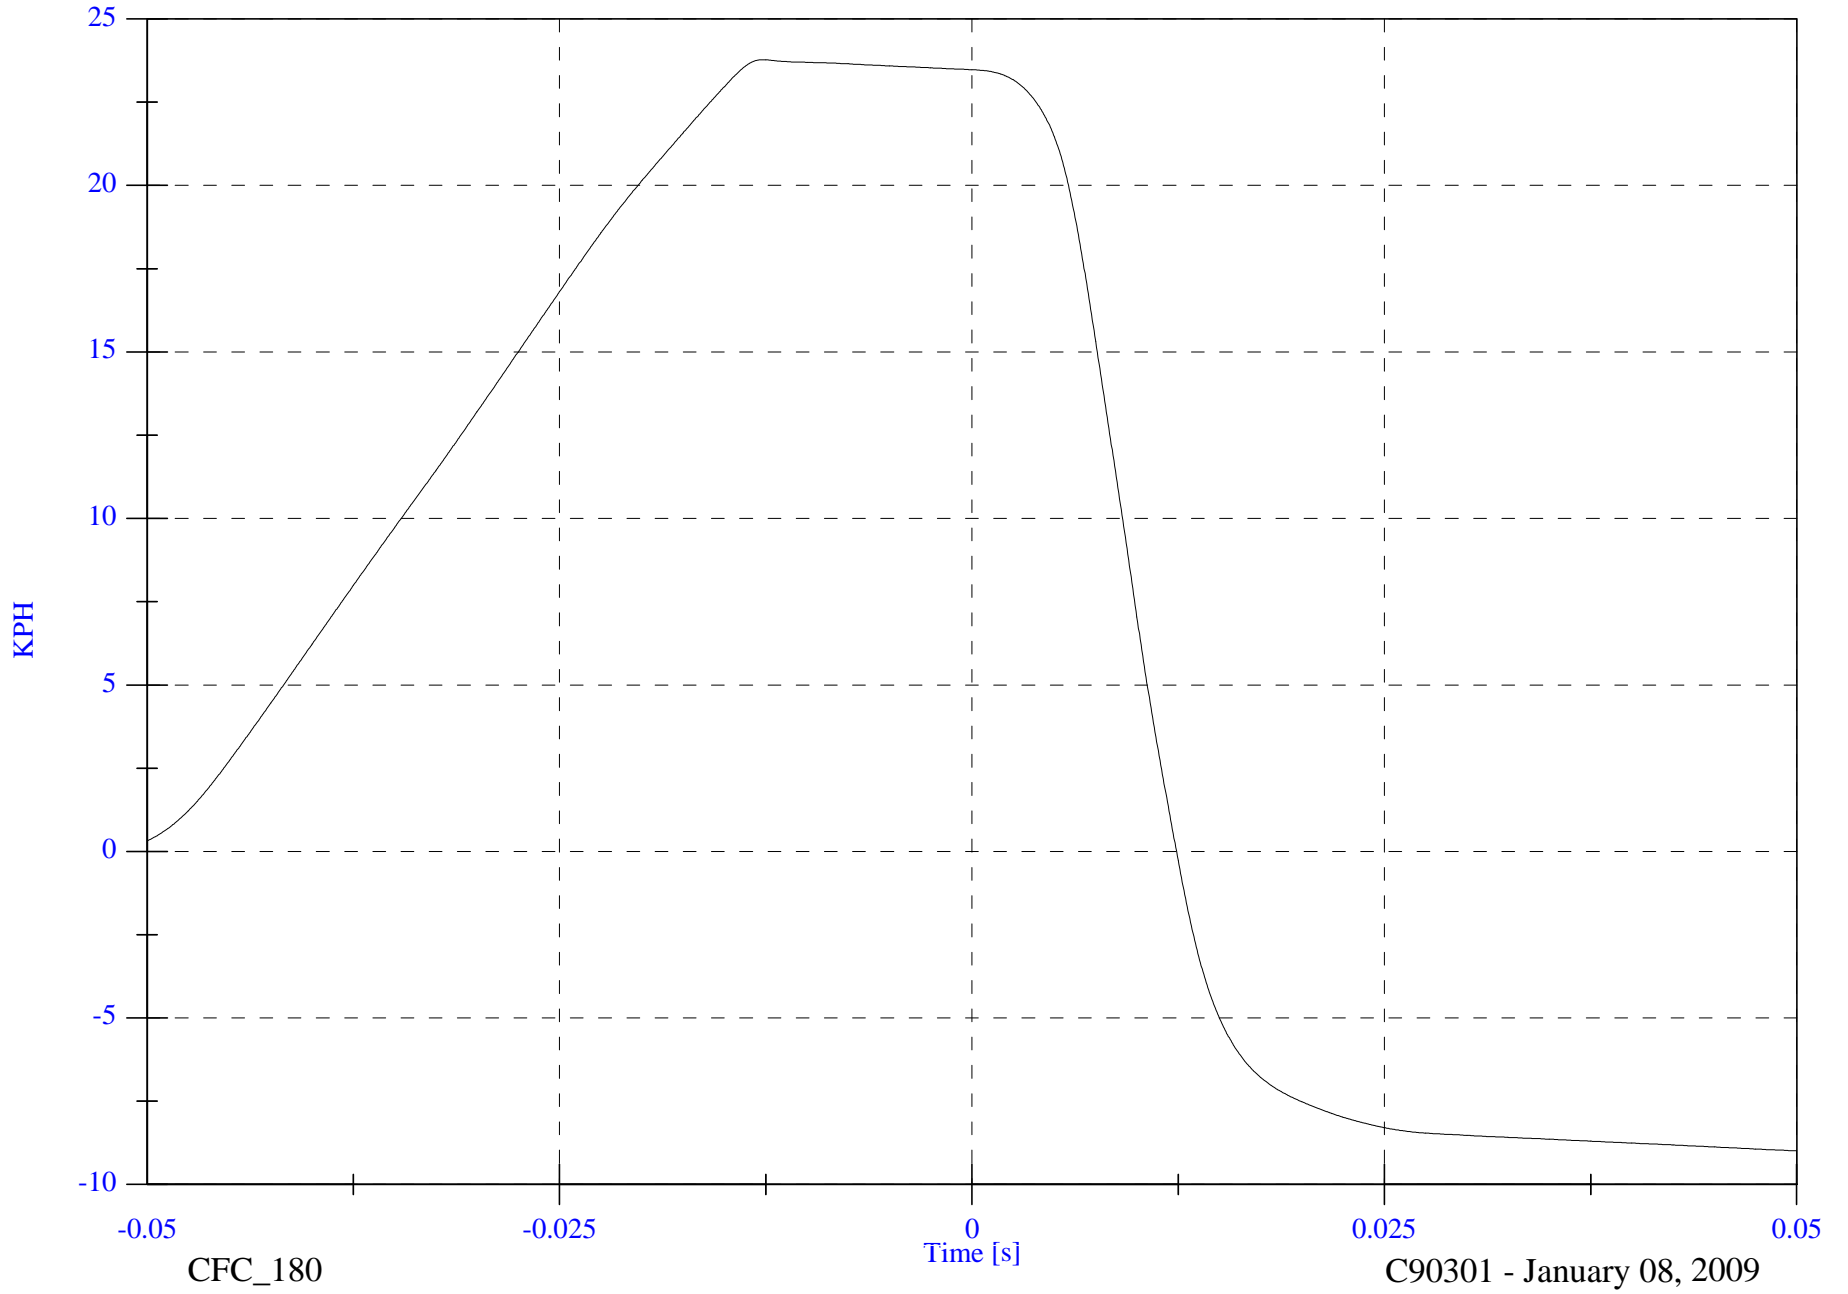
C90301 PASSENGER SIDE URRSR IMPACT PLOT #5

### Headform Velocity

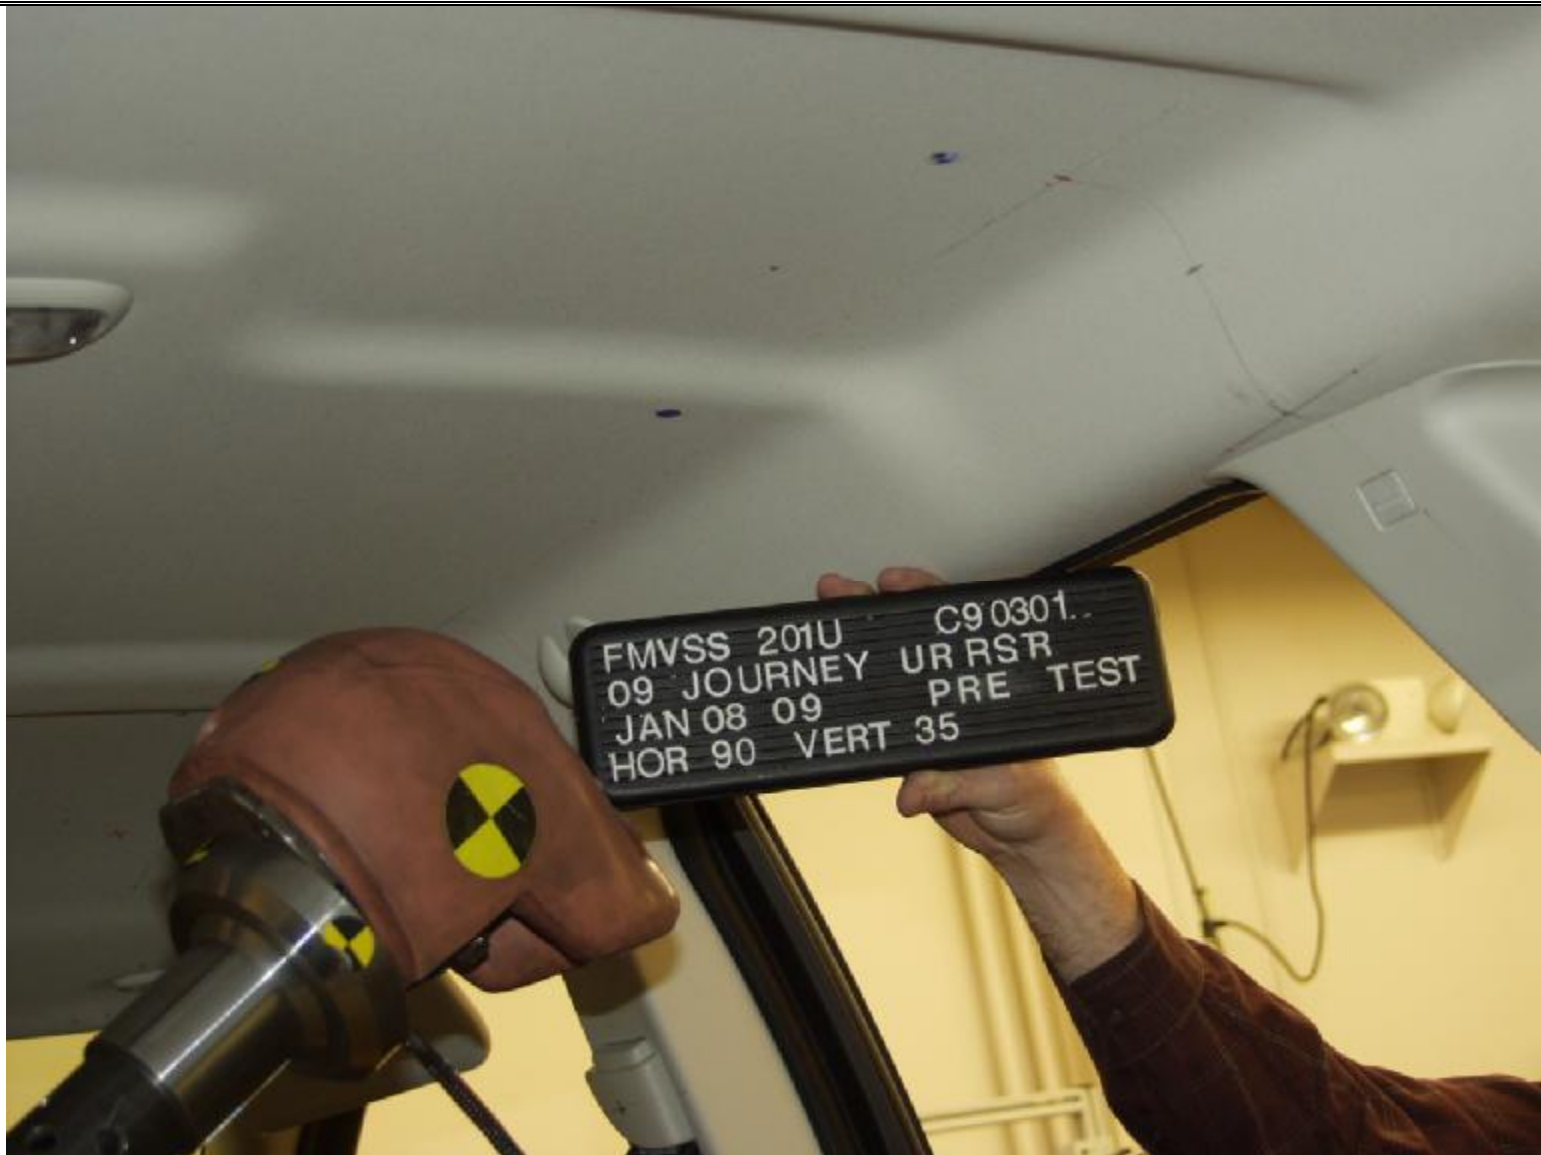
PRE-IMPACT URRSR

Test Number:	4
Test Date:	Jan 08,2009
Target Location:	Upper Roof
Target Code:	URRSR
Horizontal Impact Angle:	90°
Vertical Impact Angle:	35°
Ambient Temperature:	20°C
Relative Humidity:	23
Time of Impact:	10:30
Headform Number:	0805

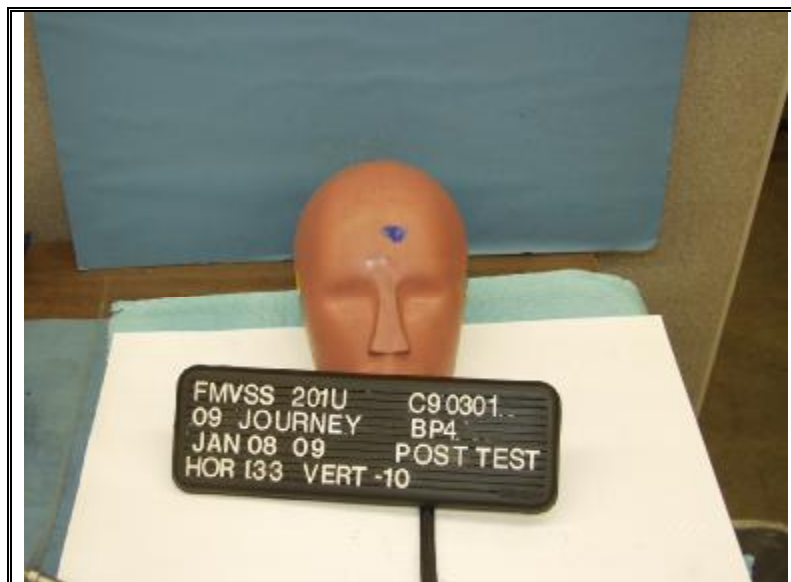
POST-IMPACT BP4 HEADFORM

Impact Point Description (from lower midpoint on midsagittal line)			
On Centerline	8	<input type="checkbox"/>	mm right <input checked="" type="checkbox"/> mm left
On Centerline	15		mm up

Free Motion HIC	273.6
HIC(d)	372.8
Impact Velocity (kph)	23.56
HIC T1 (msec)	1.3
HIC T2 (msec)	18.3

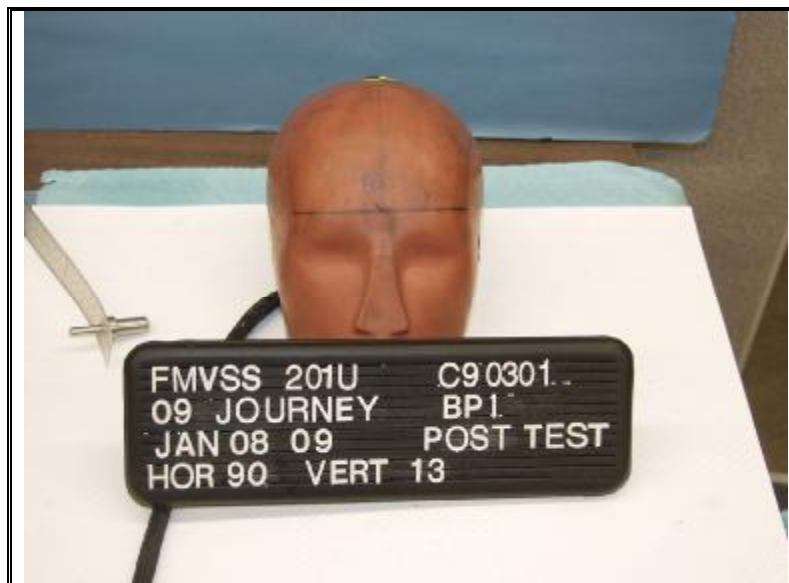
POST-IMPACT BP1 HEADFORM

Impact Point Description (from lower midpoint on midsagittal line)					
On Centerline	<b>5</b>	<input checked="" type="checkbox"/>	mm right	<input type="checkbox"/>	mm left
On Centerline	<b>16</b>				mm up

Free Motion HIC	<b>287.9</b>
HIC(d)	<b>383.6</b>
Impact Velocity (kph)	<b>18.54</b>
HIC T1 (msec)	<b>1.9</b>
HIC T2 (msec)	<b>13.3</b>

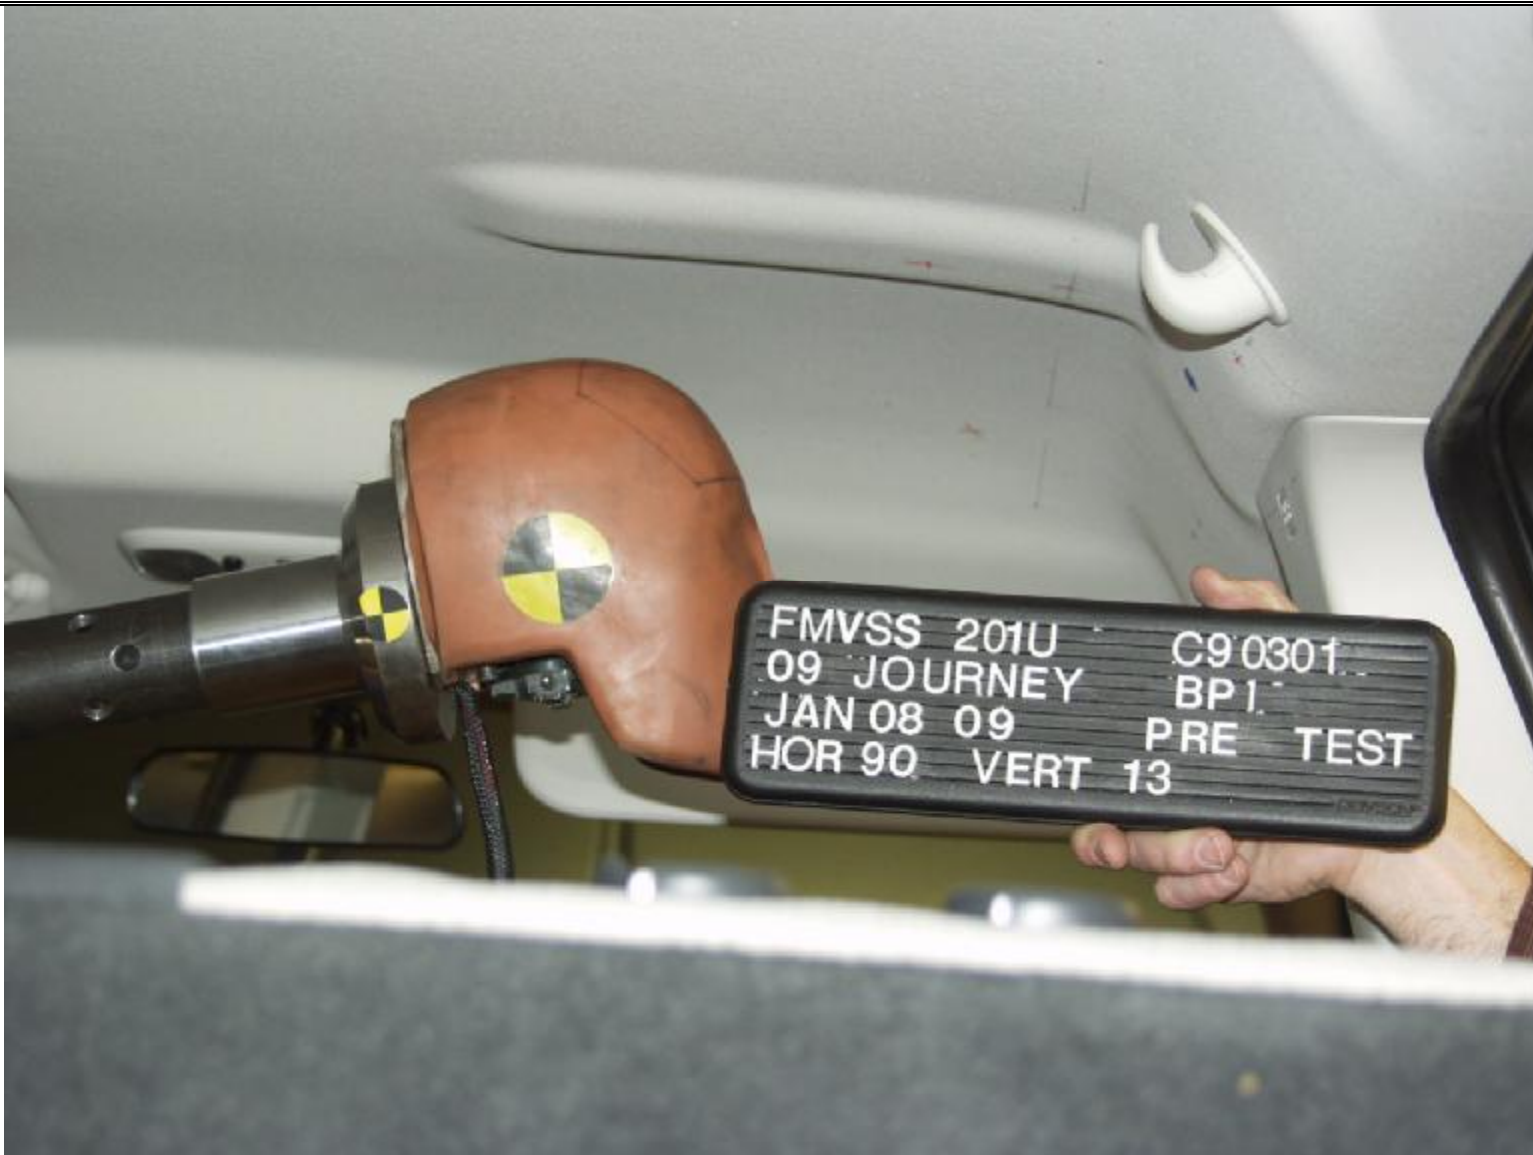
PRE-IMPACT BP1

Test Number:	<b>6</b>
Test Date:	<b>Jan 08,2009</b>
Target Location:	<b>B-Pillar</b>
Target Code:	<b>BP1</b>
Horizontal Impact Angle:	<b>90°</b>
Vertical Impact Angle:	<b>13°</b>
Ambient Temperature:	<b>20°C</b>
Relative Humidity:	<b>23</b>
Time of Impact:	<b>12:00</b>
Headform Number:	<b>0062</b>

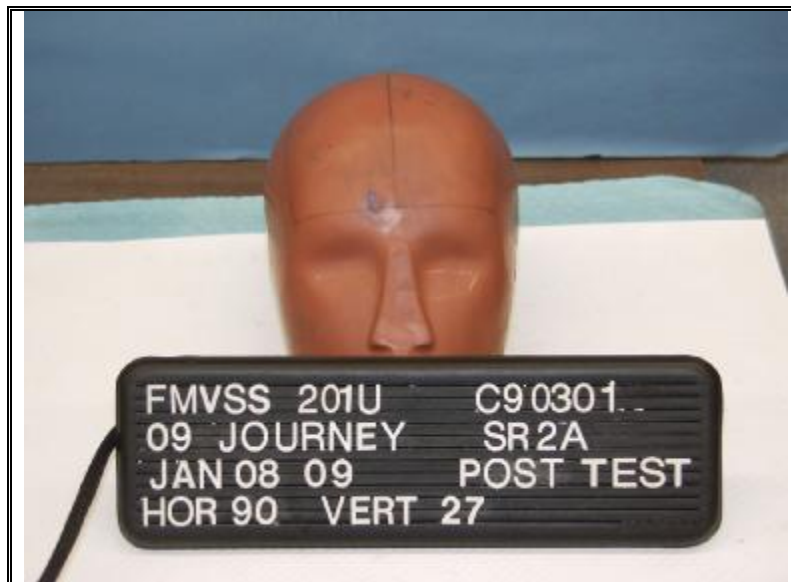
POST-IMPACT SR2A HEADFORM

Impact Point Description (from lower midpoint on midsagittal line)					
On Centerline	10	<input checked="" type="checkbox"/>	mm right	<input type="checkbox"/>	mm left
On Centerline	3				mm up

Free Motion HIC	194.4
HIC(d)	313.8
Impact Velocity (kph)	18.48
HIC T1 (msec)	3.6
HIC T2 (msec)	14.7

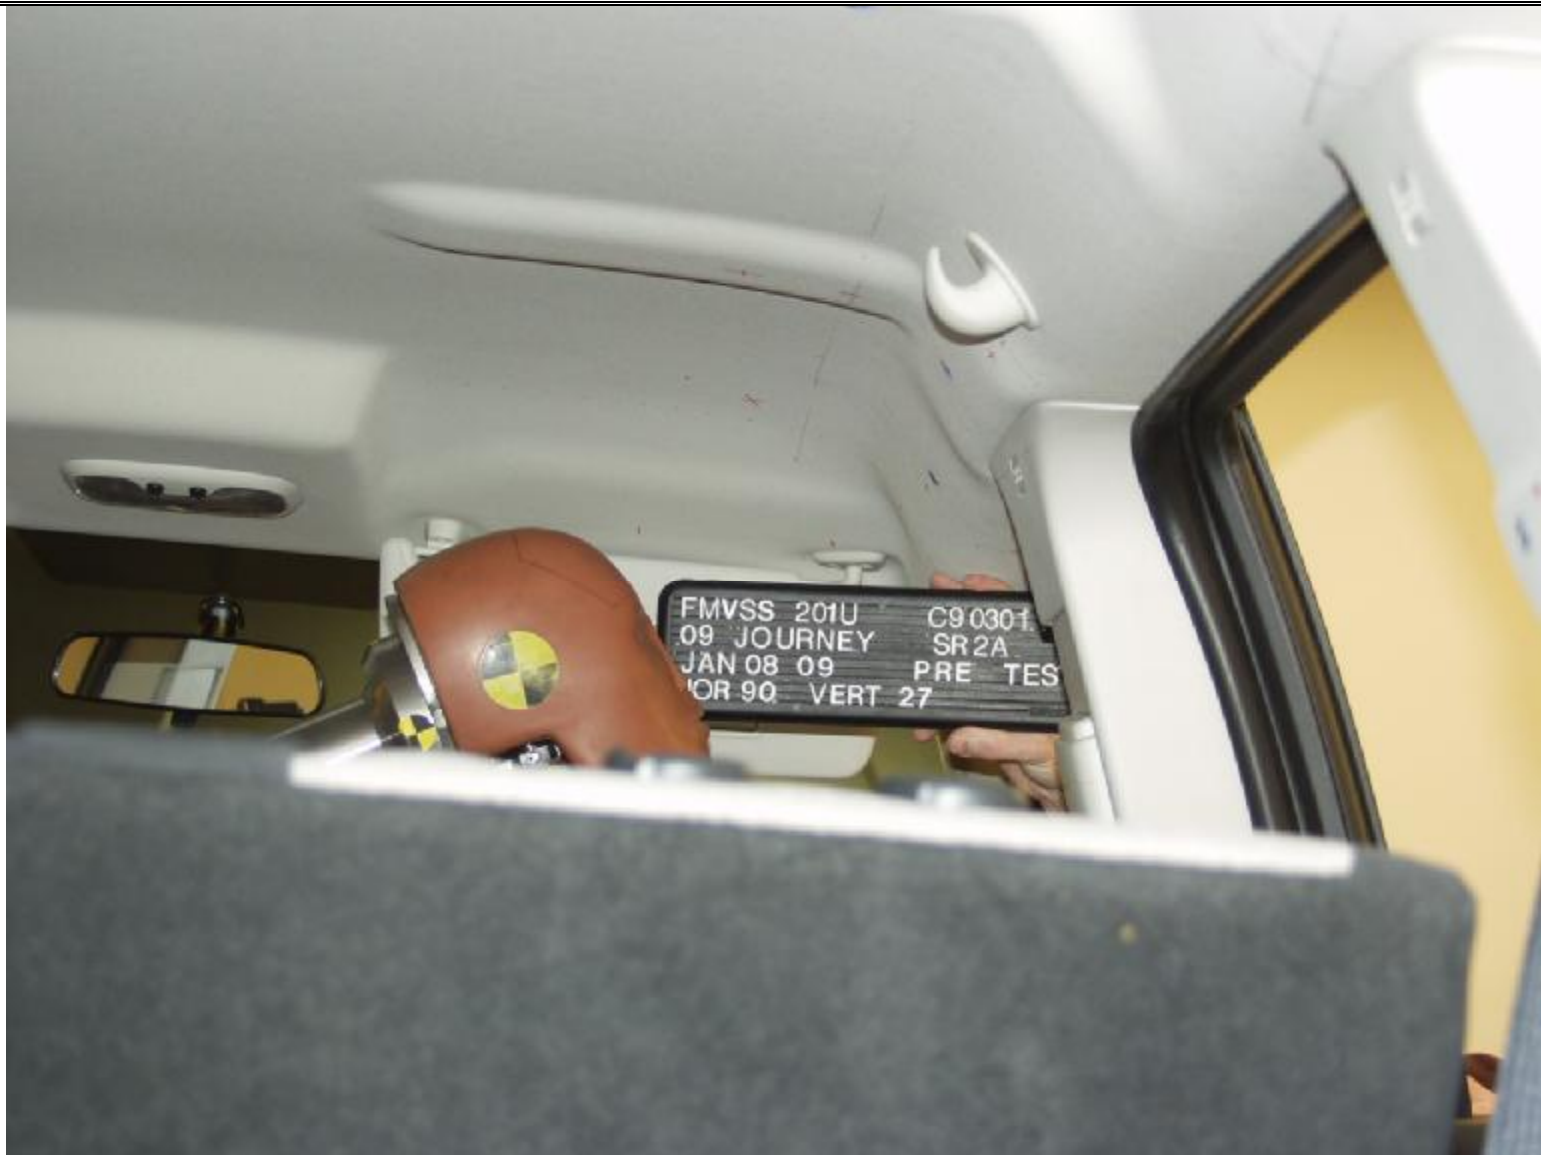
PRE-IMPACT SR2A

Test Number:	7
Test Date:	Jan 08,2009
Target Location:	Side Rail
Target Code:	SR2A
Horizontal Impact Angle:	90°
Vertical Impact Angle:	27°
Ambient Temperature:	20°C
Relative Humidity:	23
Time of Impact:	13:15
Headform Number:	1140
