REPORT NUMBER: 201UI-CAL-09-02

**SAFETY COMPLIANCE TESTING FOR FMVSS 201  
OCCUPANT PROTECTION IN INTERIOR IMPACT  
UPPER INTERIOR HEAD IMPACT PROTECTION**

**CHRYSLER LLC.  
2009 DODGE JOURNEY**

FINAL REPORT

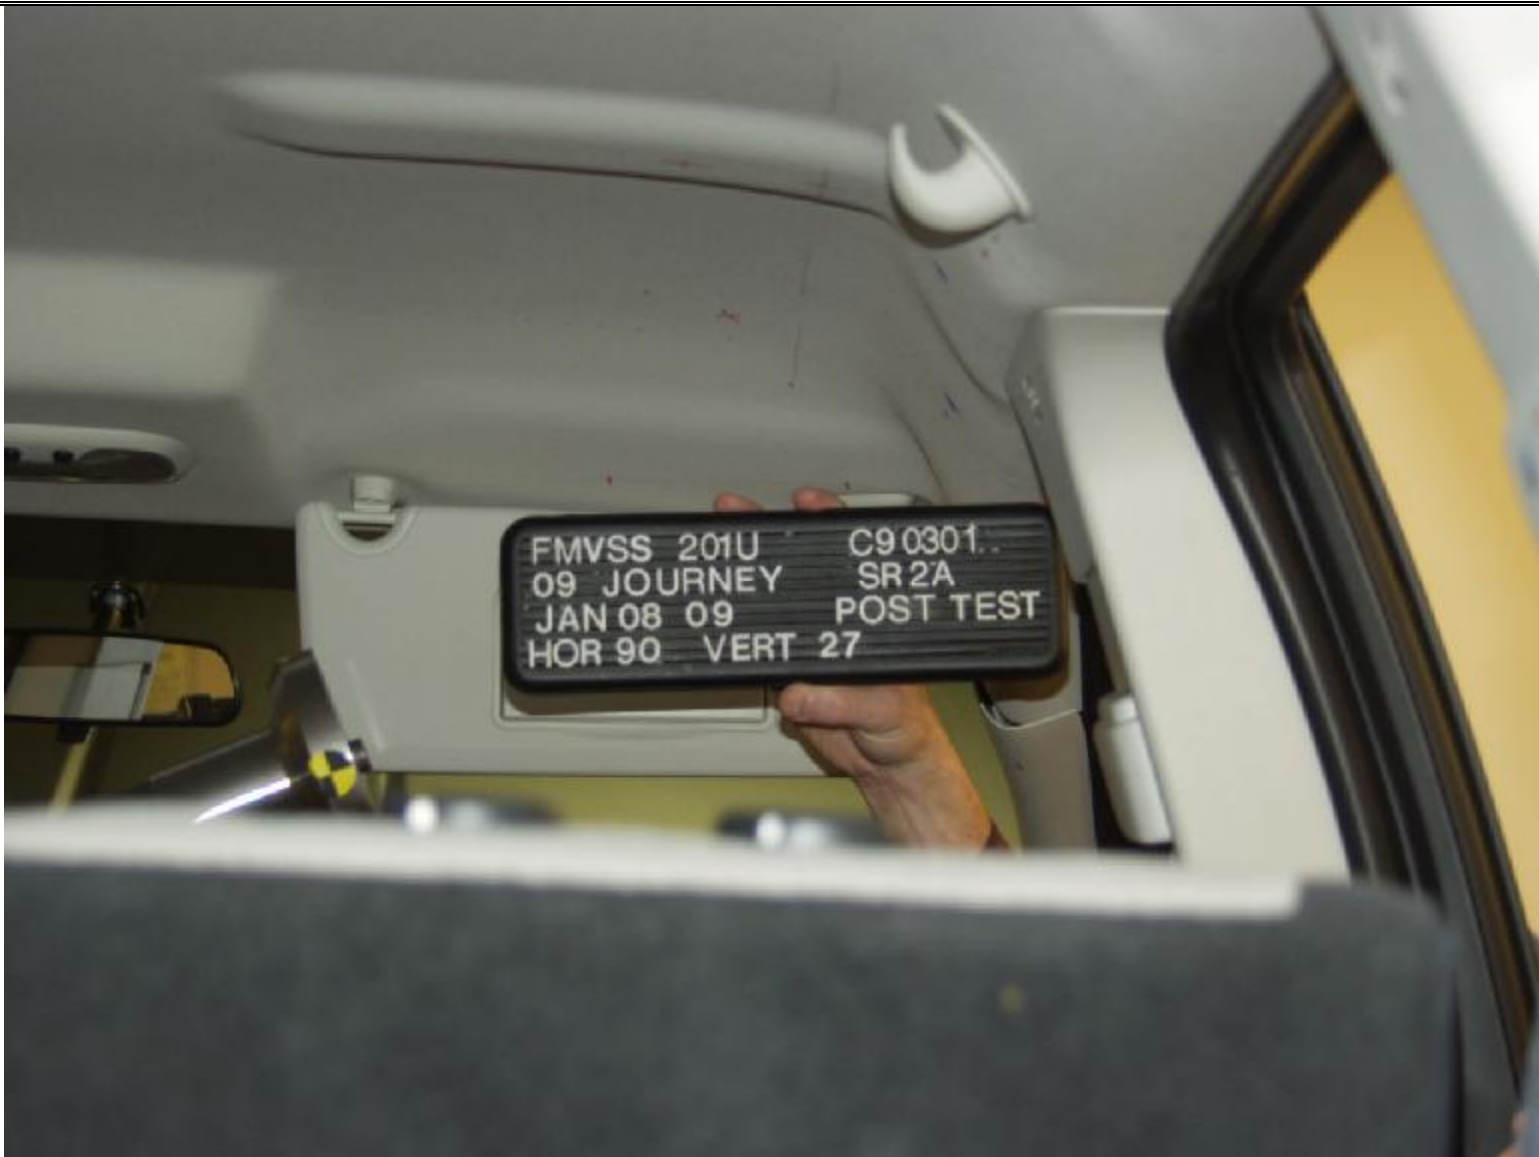
POST-IMPACT SR2A

Test Number:	7
Test Date:	Jan 08,2009
Target Location:	Side Rail
Target Code:	SR2A
Horizontal Impact Angle:	90°
Vertical Impact Angle:	27°
Ambient Temperature:	20°C
Relative Humidity:	23
Time of Impact:	13:15
Headform Number:	1140

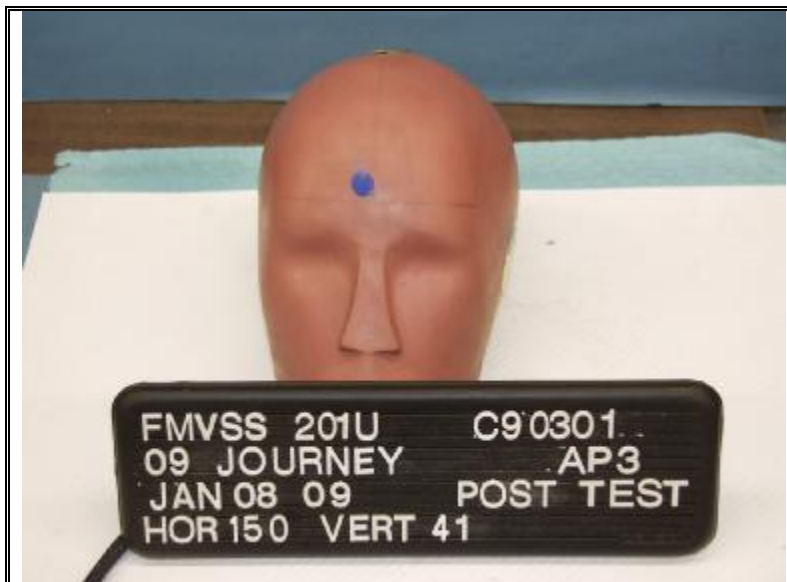
POST-IMPACT AP3 HEADFORM

Impact Point Description (from lower midpoint on midsagittal line)				
On Centerline	5	x	mm right	mm left
On Centerline	8		mm up

Free Motion HIC	247.3
HIC(d)	353.0
Impact Velocity (kph)	18.45
HIC T1 (msec)	2.6
HIC T2 (msec)	14.6

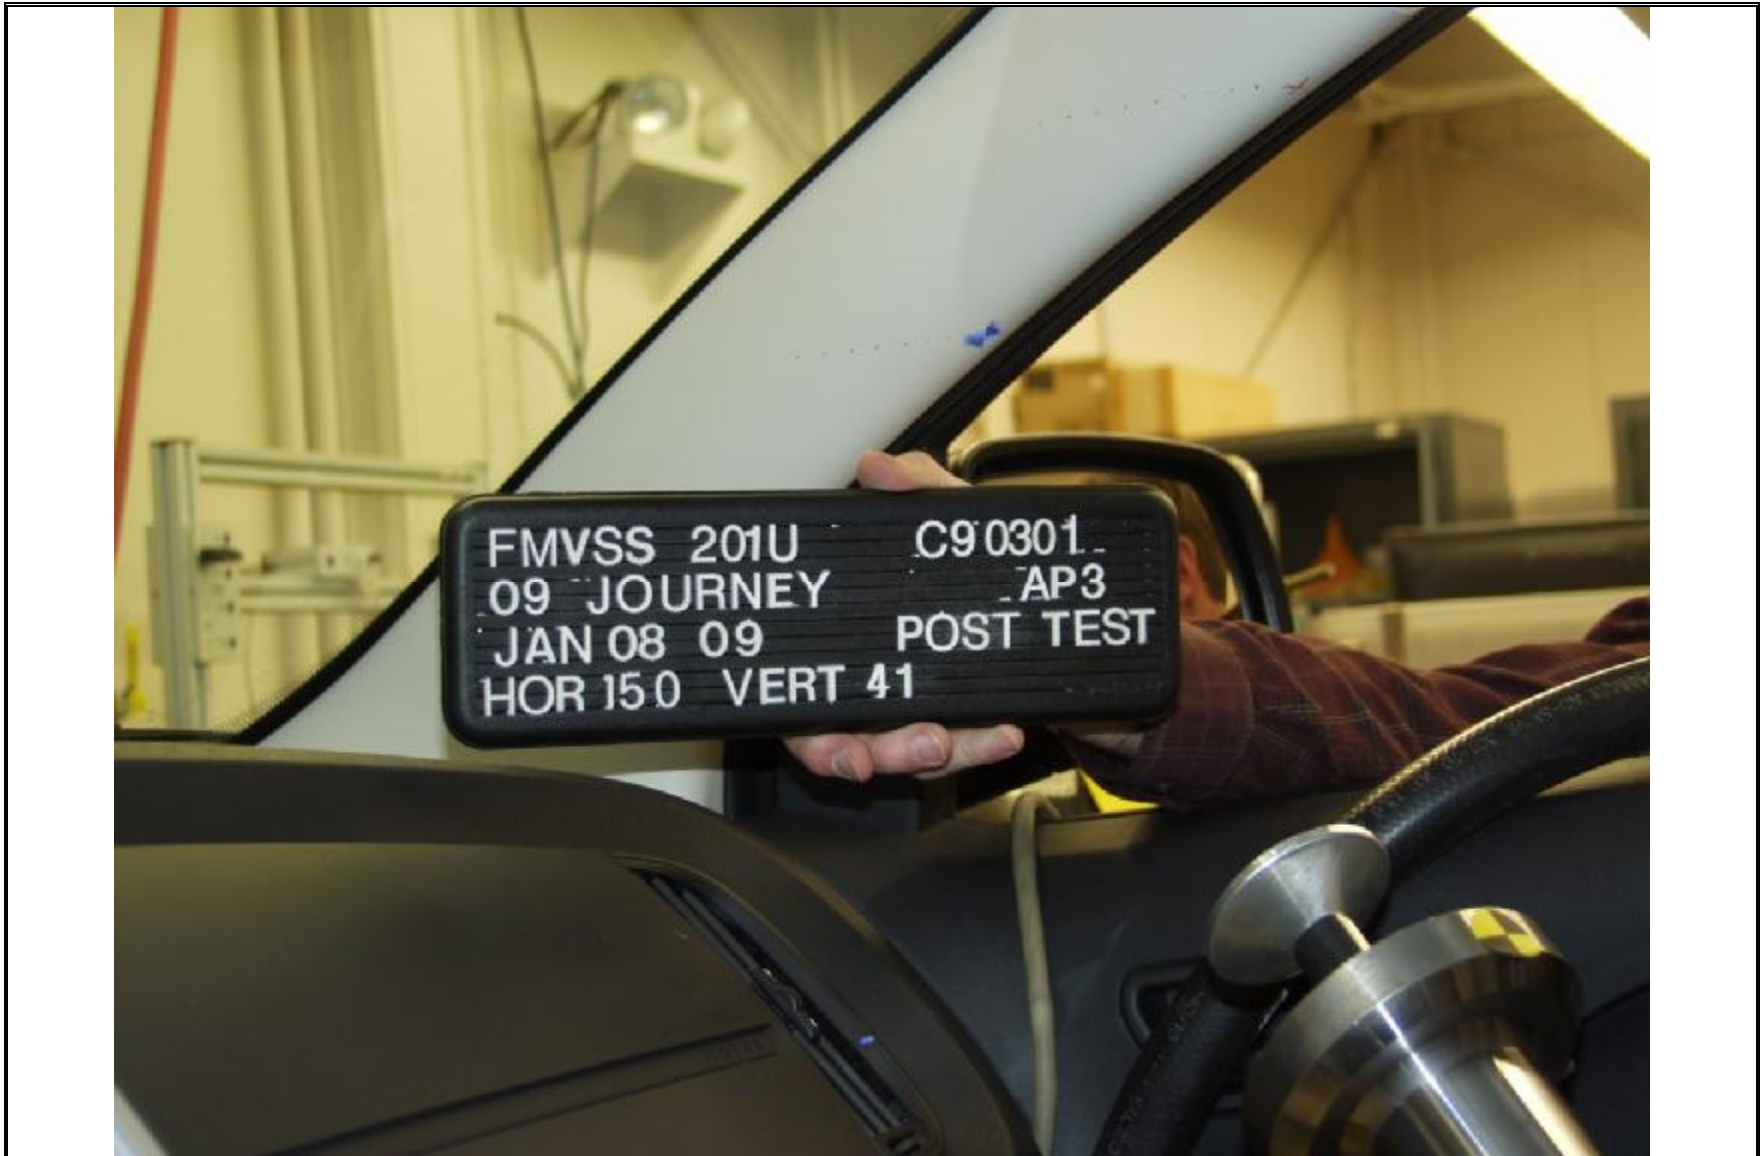
POST-IMPACT AP3

Test Number:	8
Test Date:	Jan 08,2009
Target Location:	A-Pillar
Target Code:	AP3
Horizontal Impact Angle:	150°
Vertical Impact Angle:	41°
Ambient Temperature:	20°C
Relative Humidity:	23
Time of Impact:	13:45
Headform Number:	1140

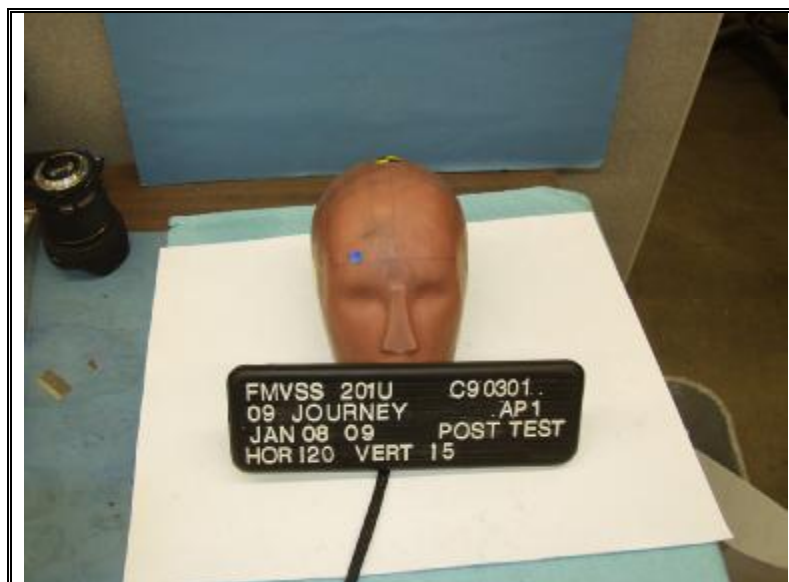
POST-IMPACT AP1 HEADFORM

Impact Point Description (from lower midpoint on midsagittal line)				
On Centerline	35	x	mm right	mm left
On Centerline	5		mm up

Free Motion HIC	105.6
HIC(d)	246.1
Impact Velocity (kph)	18.57
HIC T1 (msec)	3.7
HIC T2 (msec)	18.0

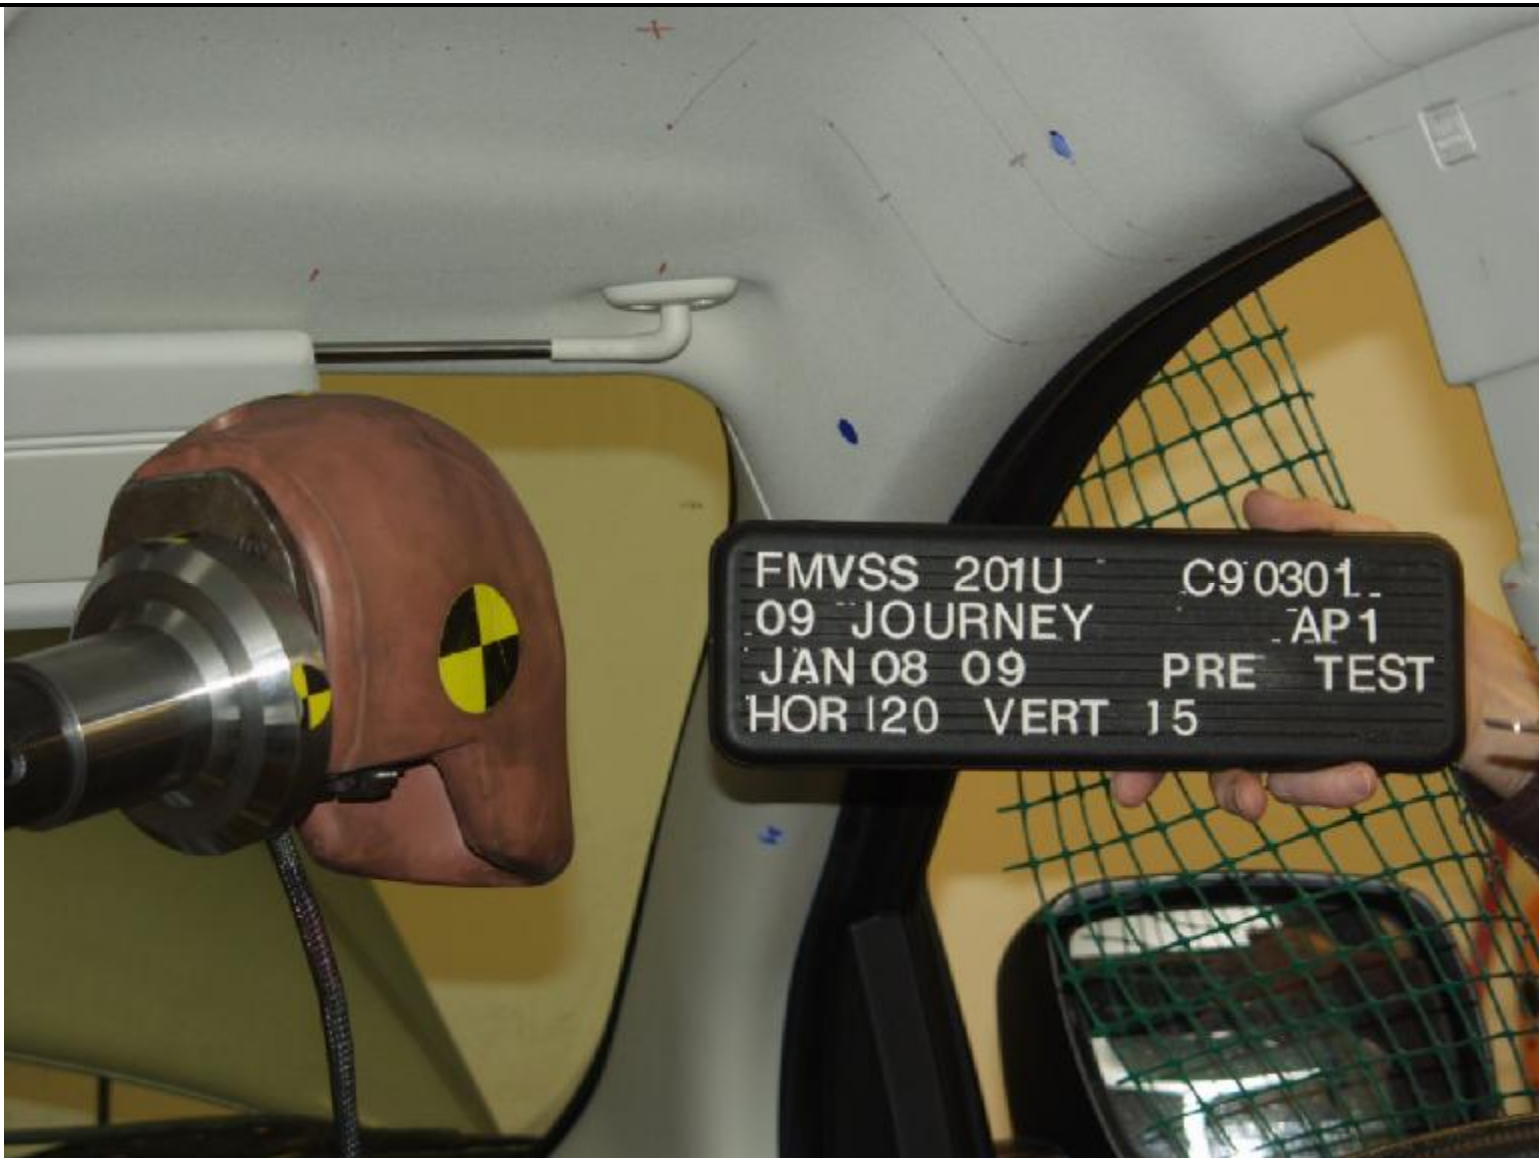
PRE-IMPACT AP1

Test Number:	9
Test Date:	Jan 08,2009
Target Location:	A-Pillar
Target Code:	AP1
Horizontal Impact Angle:	120°
Vertical Impact Angle:	15°
Ambient Temperature:	20°C
Relative Humidity:	23
Time of Impact:	14:30
Headform Number:	0805

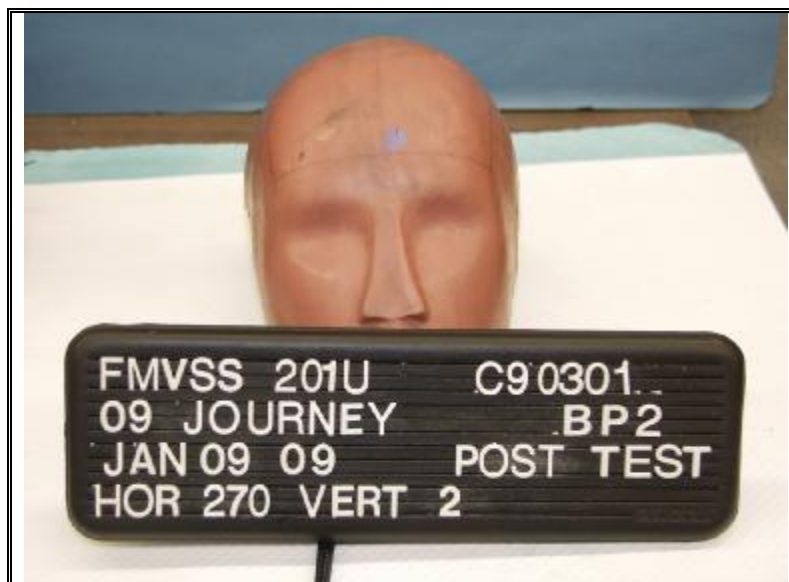
POST-IMPACT BP2 HEADFORM

Impact Point Description (from lower midpoint on midsagittal line)			
On Centerline	<b>4</b>	<input type="checkbox"/>	mm right <input checked="" type="checkbox"/> mm left
On Centerline	<b>10</b>		mm up

Free Motion HIC	<b>623.8</b>
HIC(d)	<b>637.0</b>
Impact Velocity (kph)	<b>23.47</b>
HIC T1 (msec)	<b>2.1</b>
HIC T2 (msec)	<b>8.1</b>

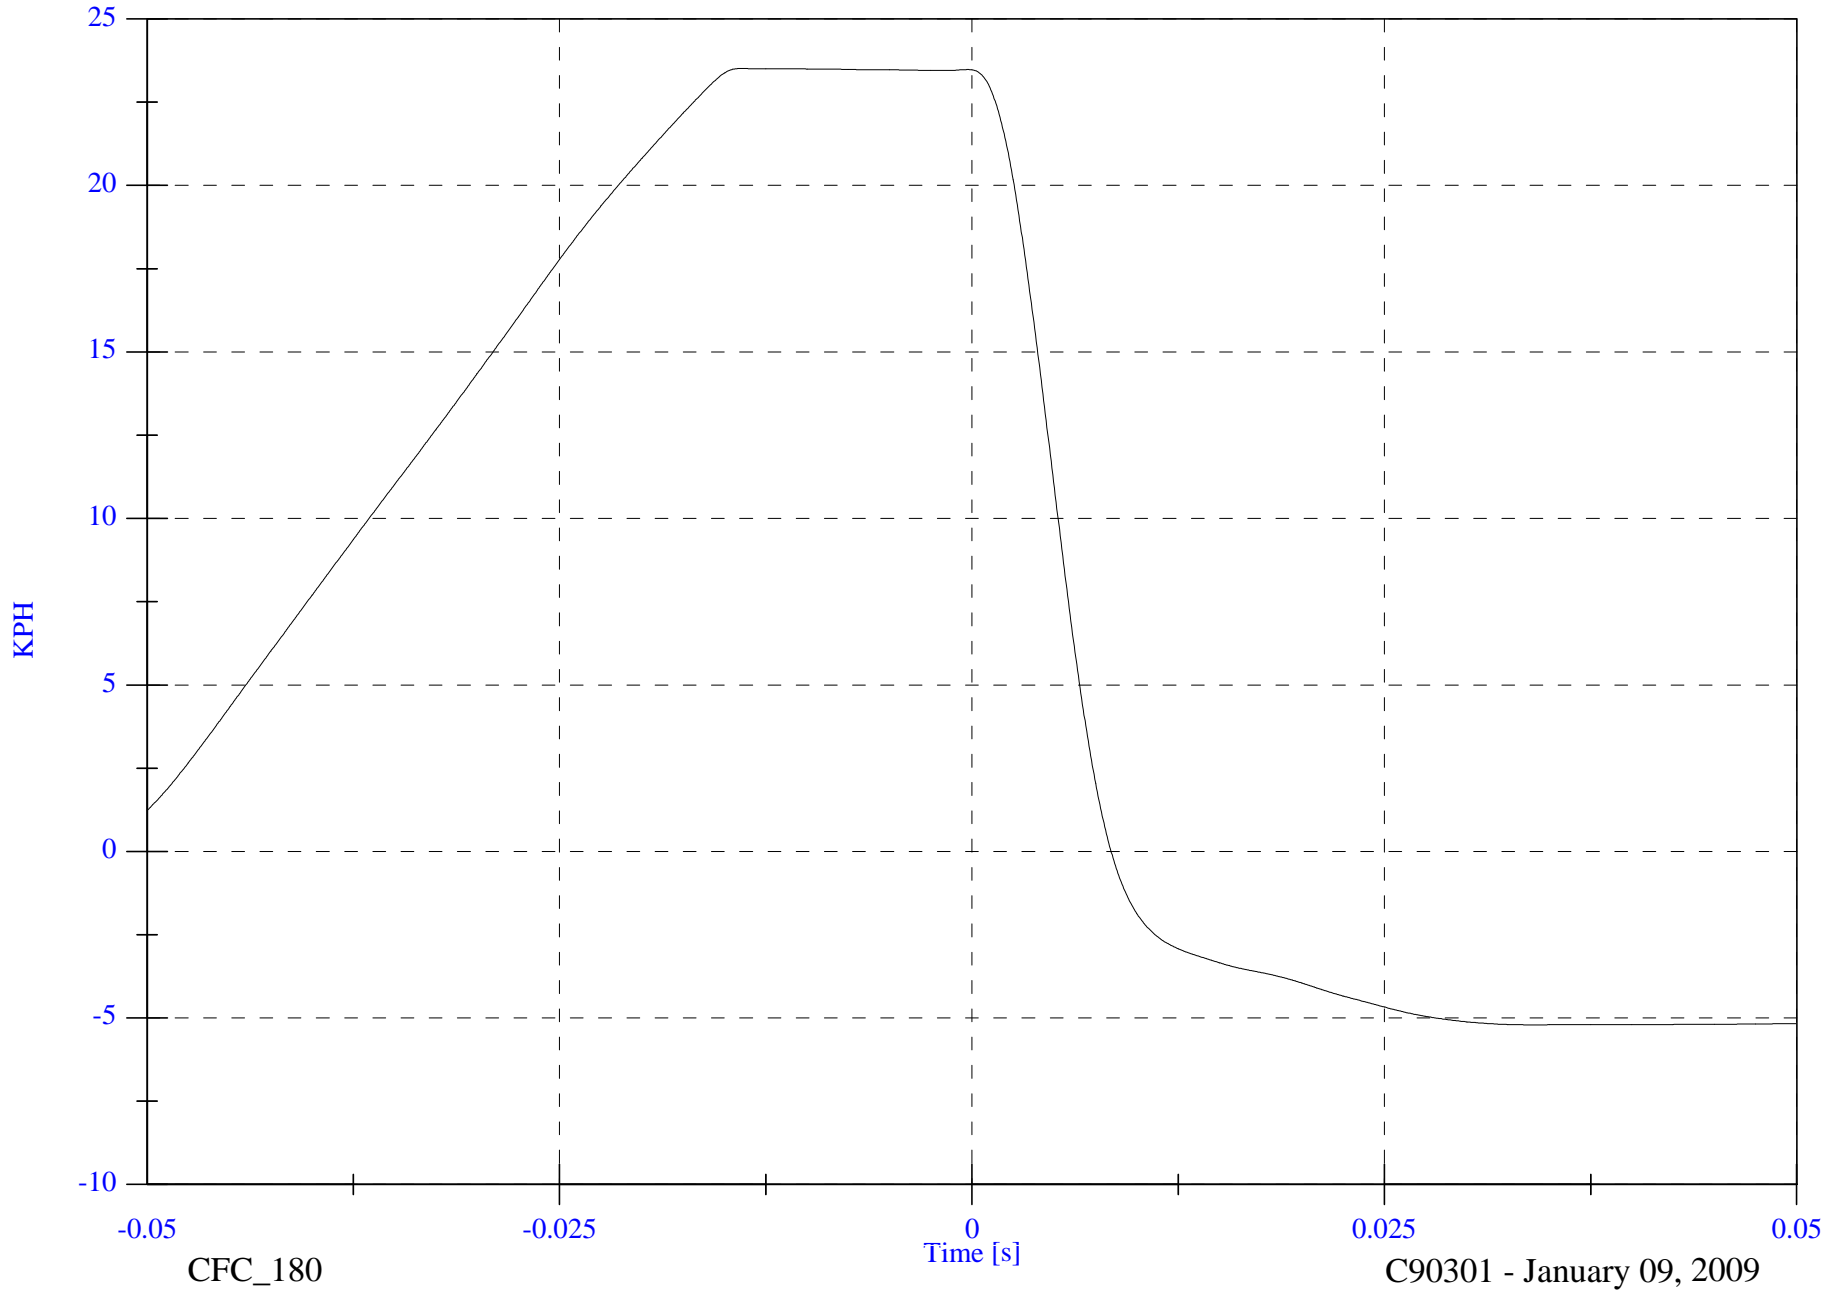
C90301 DRIVER SIDE BP2 IMPACT PLOT #5

Max: 23.5 [KPH] at -0.014 [s]

### Headform Velocity

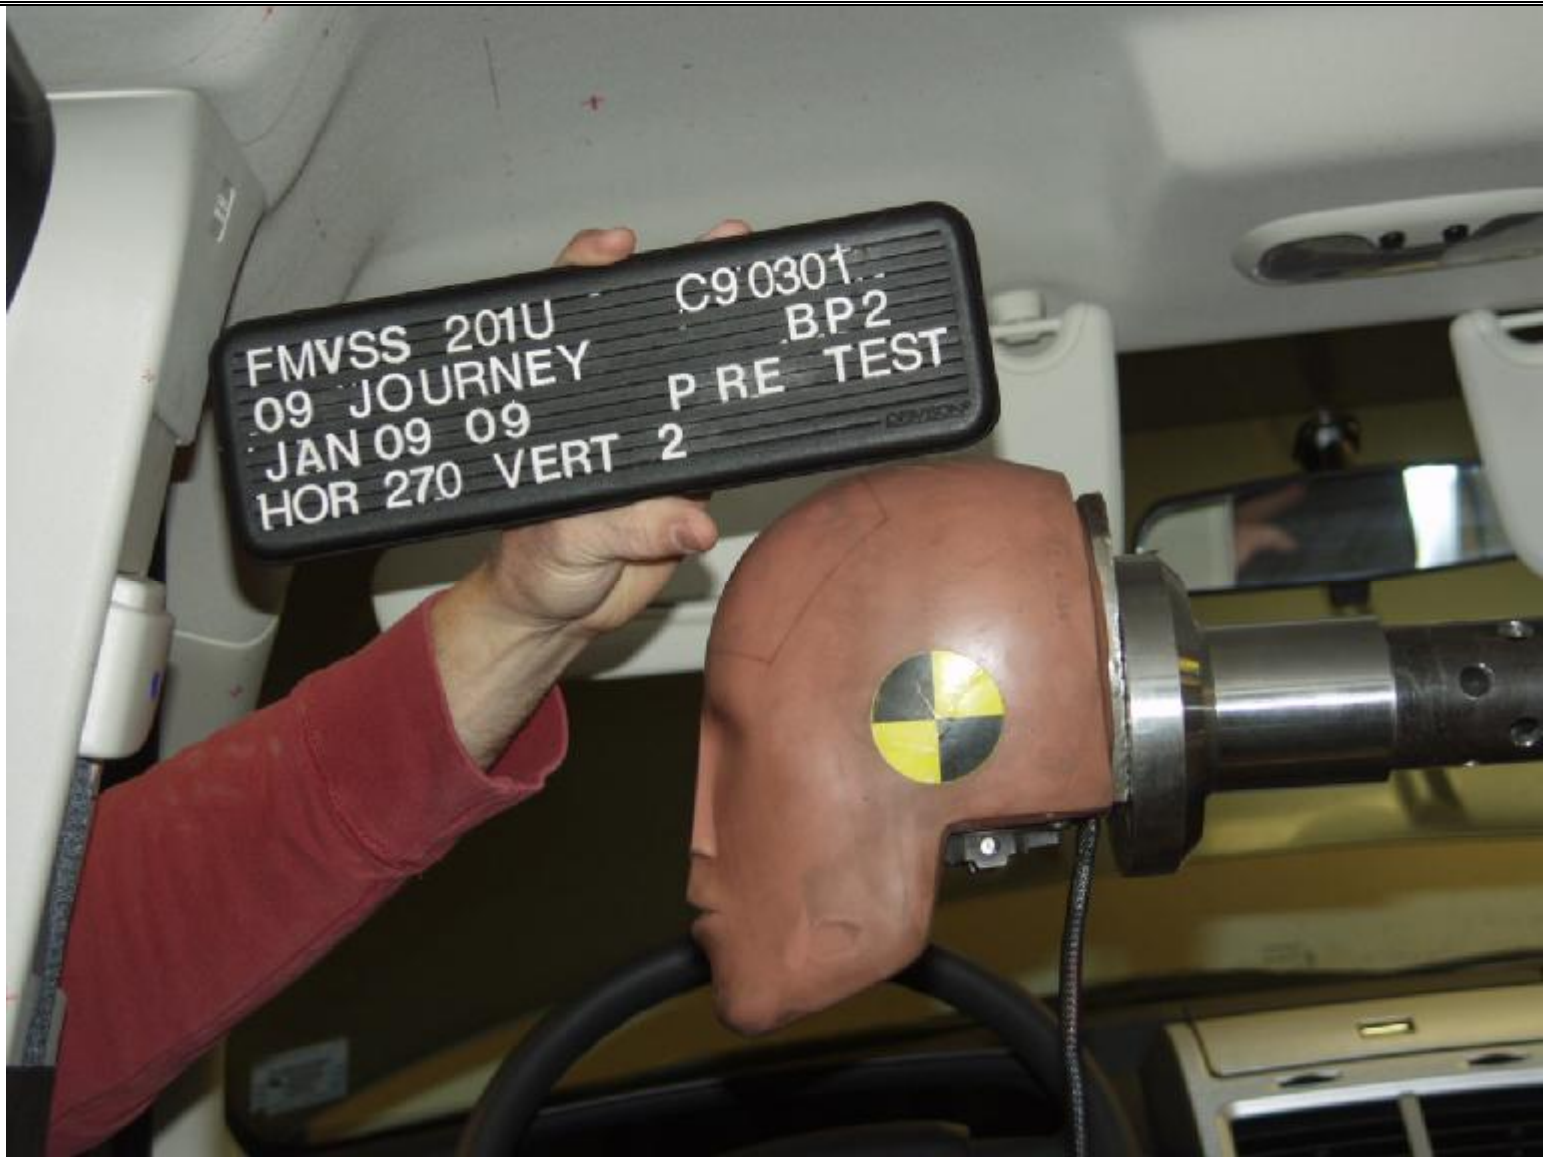
PRE-IMPACT BP2

Test Number:	<b>10</b>
Test Date:	<b>Jan 09,2009</b>
Target Location:	<b>B-Pillar</b>
Target Code:	<b>BP2</b>
Horizontal Impact Angle:	<b>270°</b>
Vertical Impact Angle:	<b>2°</b>
Ambient Temperature:	<b>20°C</b>
Relative Humidity:	<b>18</b>
Time of Impact:	<b>8:45</b>
Headform Number:	<b>0805</b>

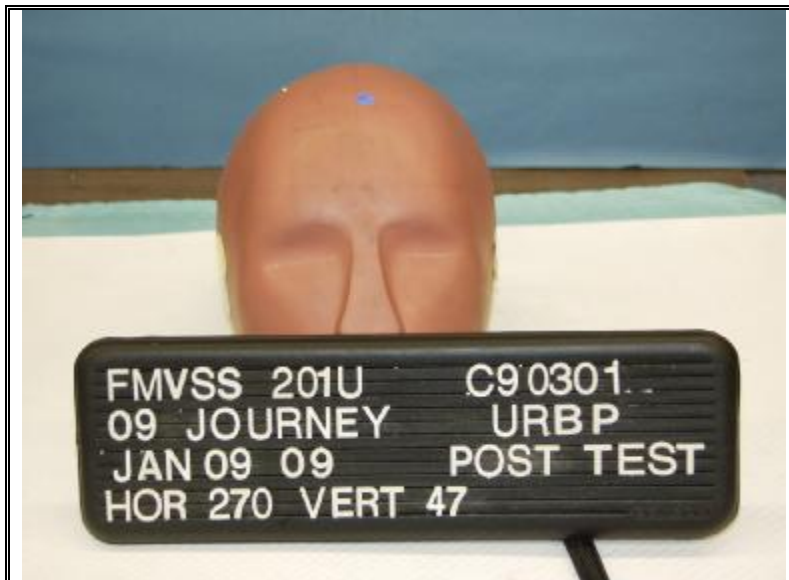
POST-IMPACT URBP HEADFORM

Impact Point Description (from lower midpoint on midsagittal line)			
On Centerline	0	<input type="checkbox"/>	mm right <input type="checkbox"/> mm left
On Centerline	50		mm up

Free Motion HIC	683.5
HIC(d)	682.1
Impact Velocity (kph)	23.7
HIC T1 (msec)	3.2
HIC T2 (msec)	10.6

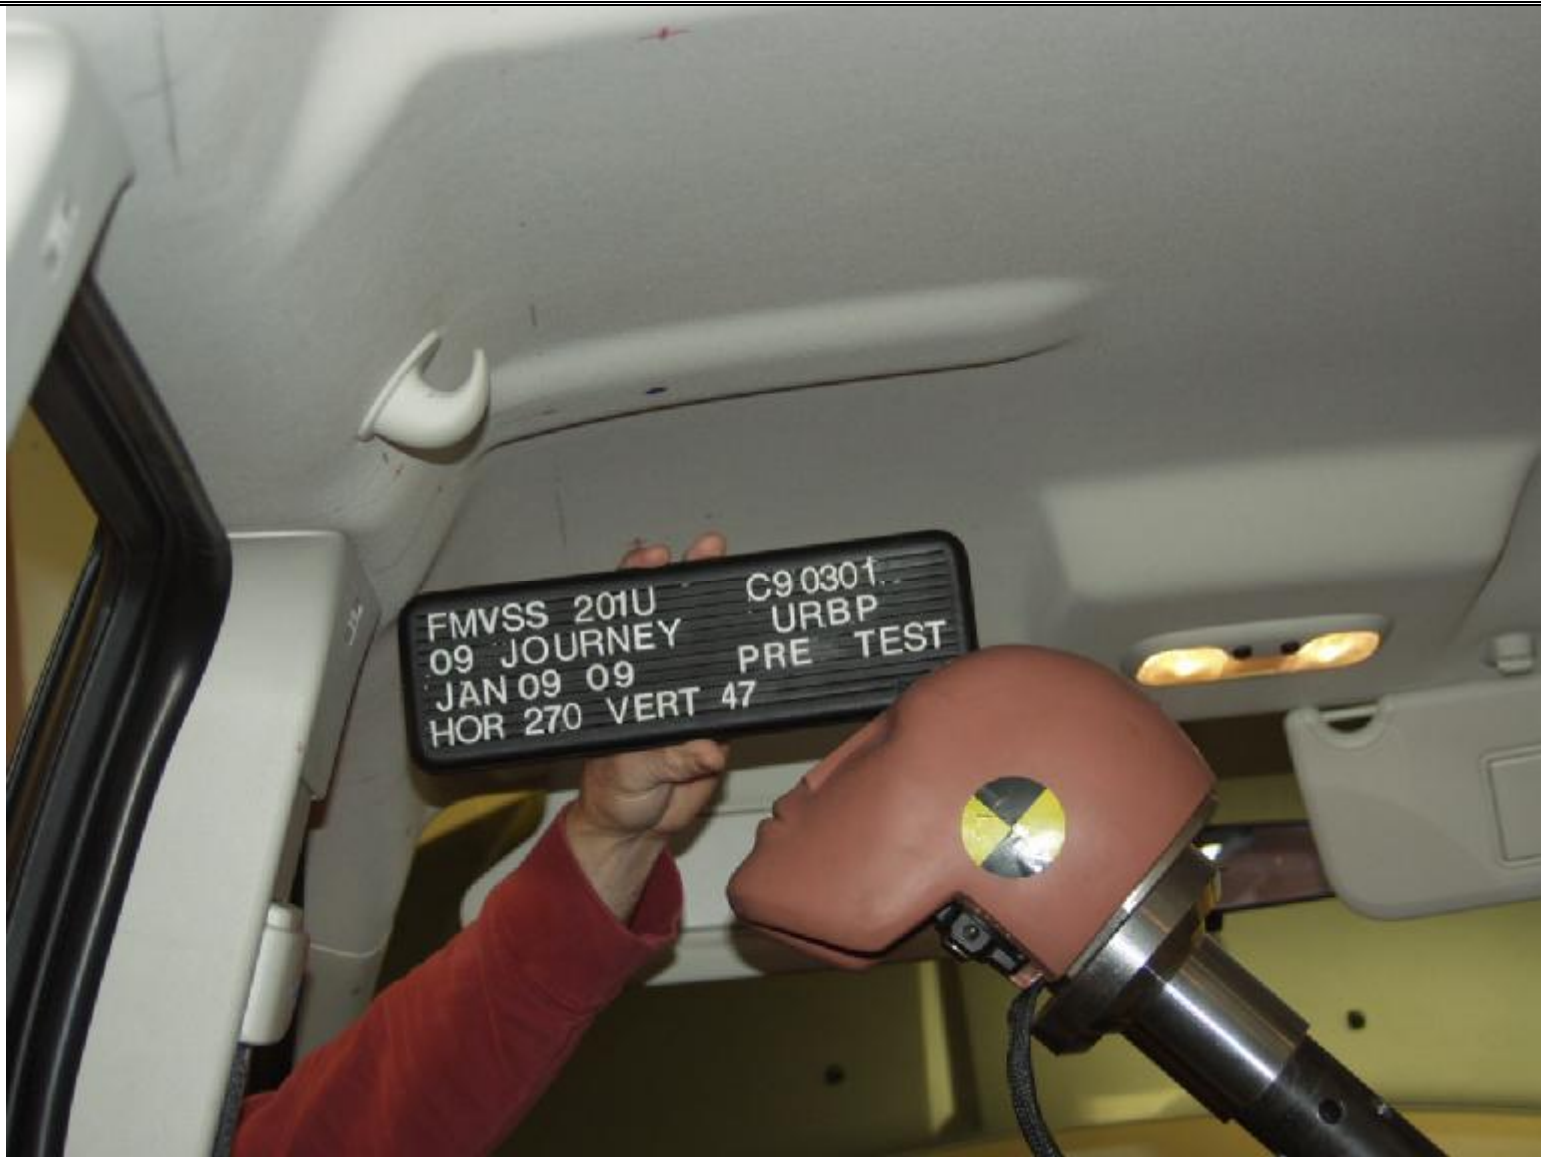
PRE-IMPACT URBP

Test Number:	11
Test Date:	Jan 09,2009
Target Location:	Upper Roof
Target Code:	URBP
Horizontal Impact Angle:	270°
Vertical Impact Angle:	47°
Ambient Temperature:	20°C
Relative Humidity:	18
Time of Impact:	9:15
Headform Number:	1142

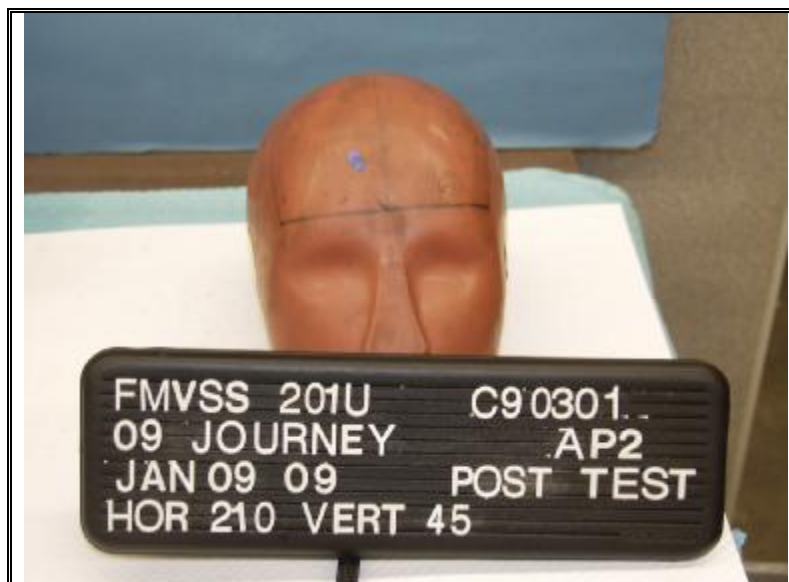
POST-IMPACT AP2 HEADFORM

Impact Point Description (from lower midpoint on midsagittal line)					
On Centerline	10	<input checked="" type="checkbox"/>	mm right	<input type="checkbox"/>	mm left
On Centerline	24				mm up

Free Motion HIC	222.2
HIC(d)	334.0
Impact Velocity (kph)	23.7
HIC T1 (msec)	2.6
HIC T2 (msec)	13.2

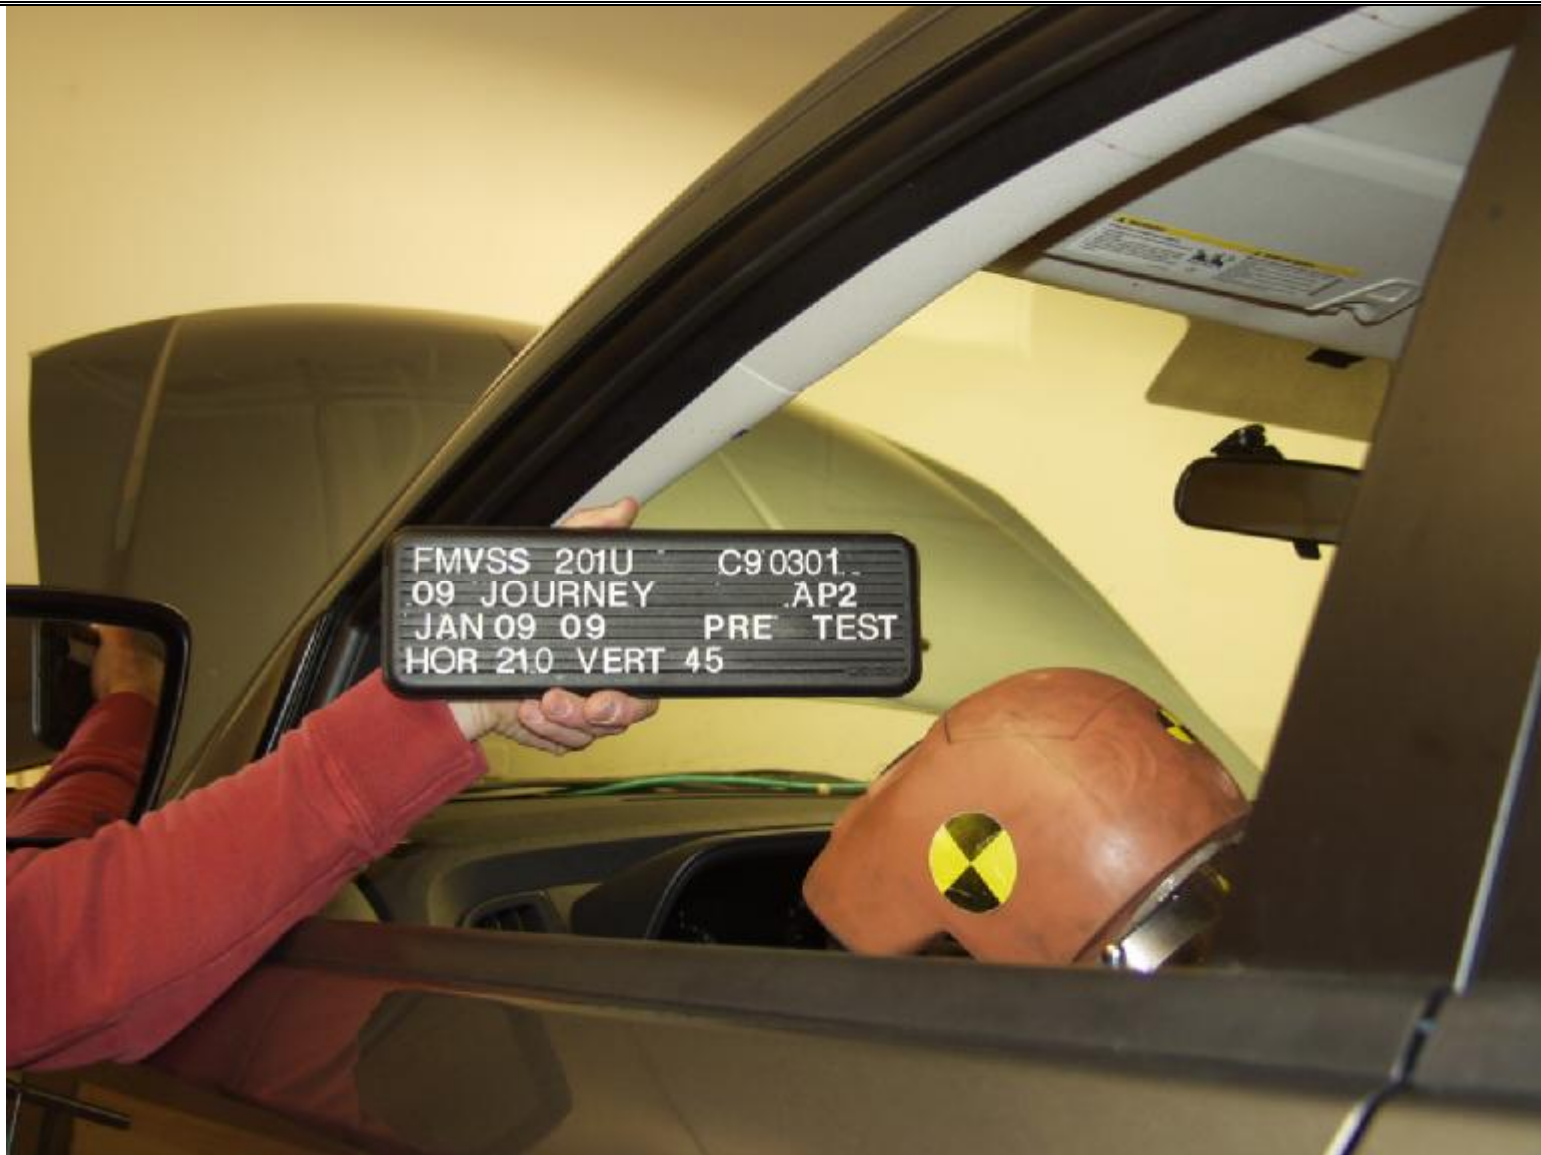
PRE-IMPACT AP2

Test Number:	12
Test Date:	Jan 09,2009
Target Location:	A-Pillar
Target Code:	AP2
Horizontal Impact Angle:	210°
Vertical Impact Angle:	45°
Ambient Temperature:	20°C
Relative Humidity:	18
Time of Impact:	10:00
Headform Number:	0062

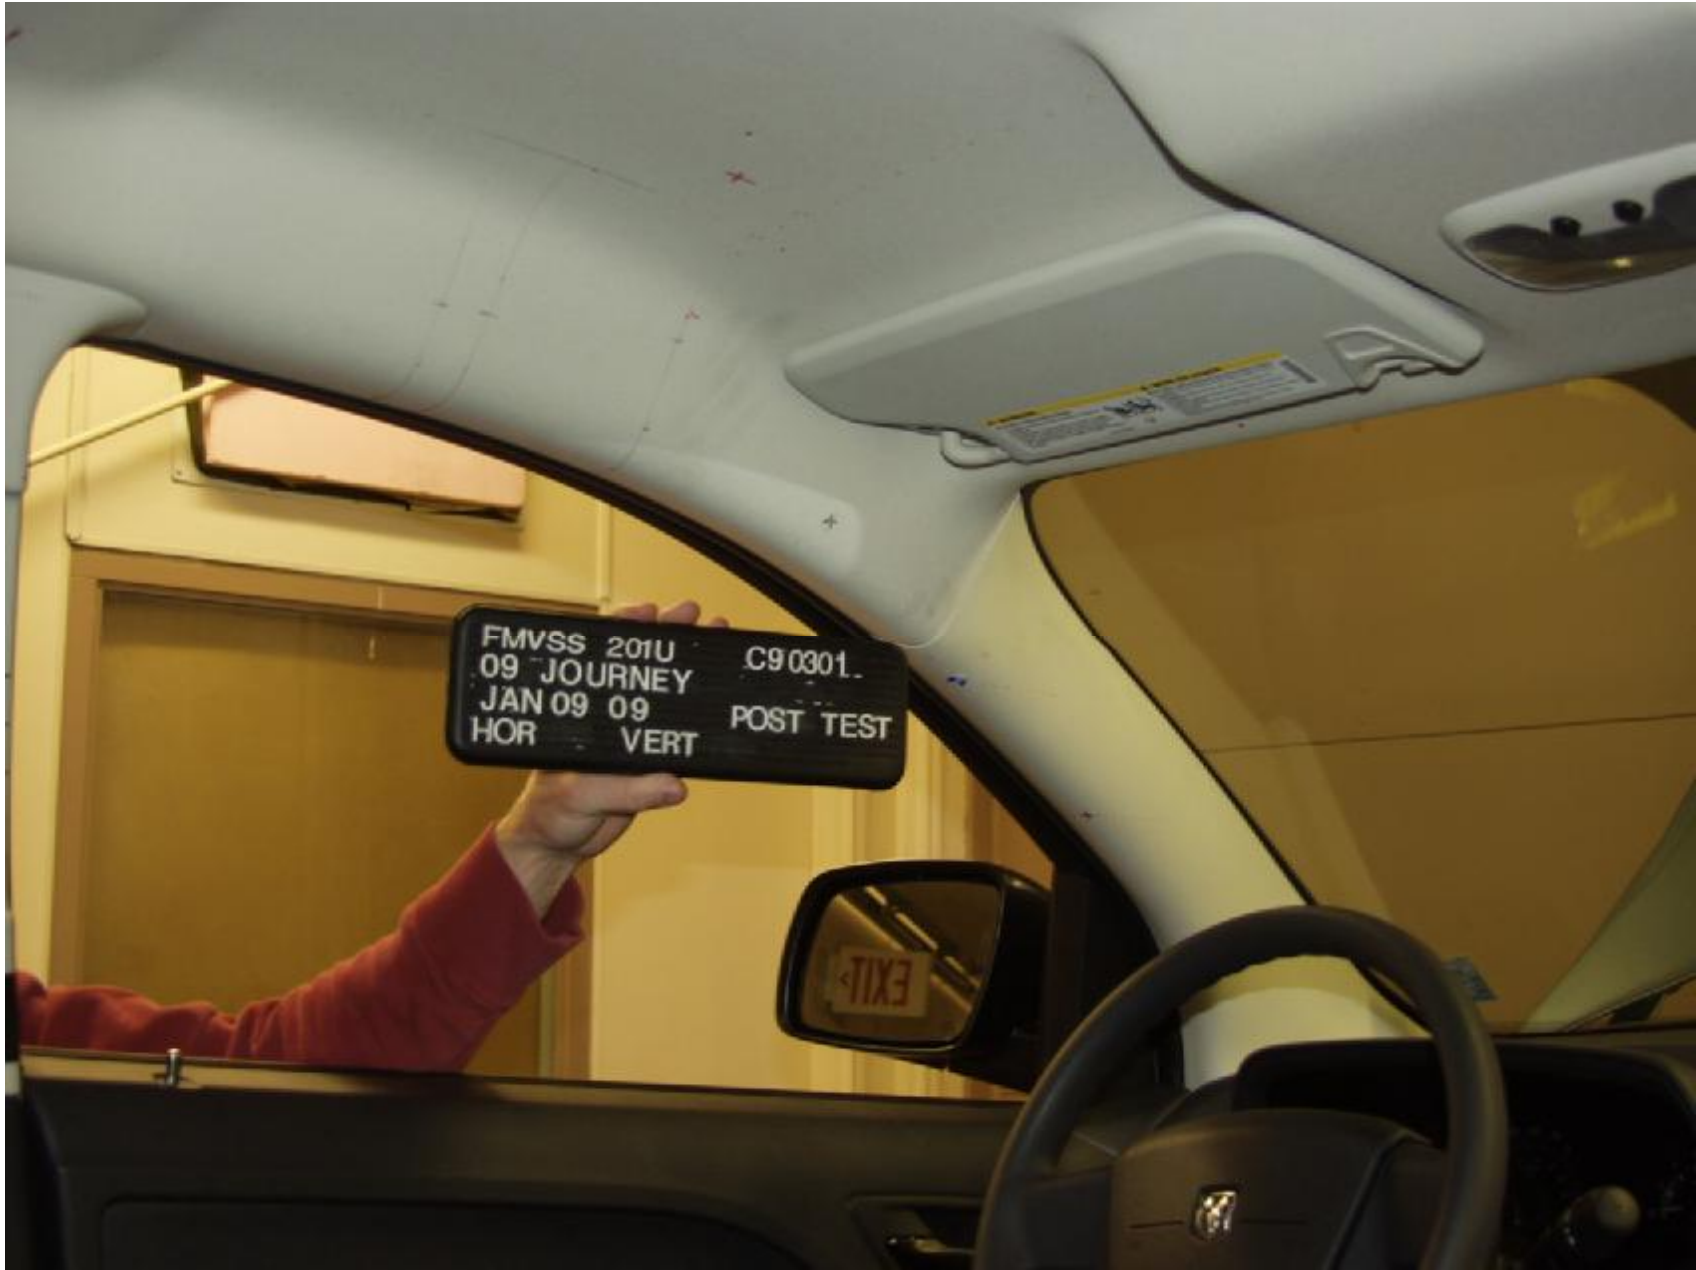
Figure A-17 : POST-TEST DRIVER SIDE A-PILLAR

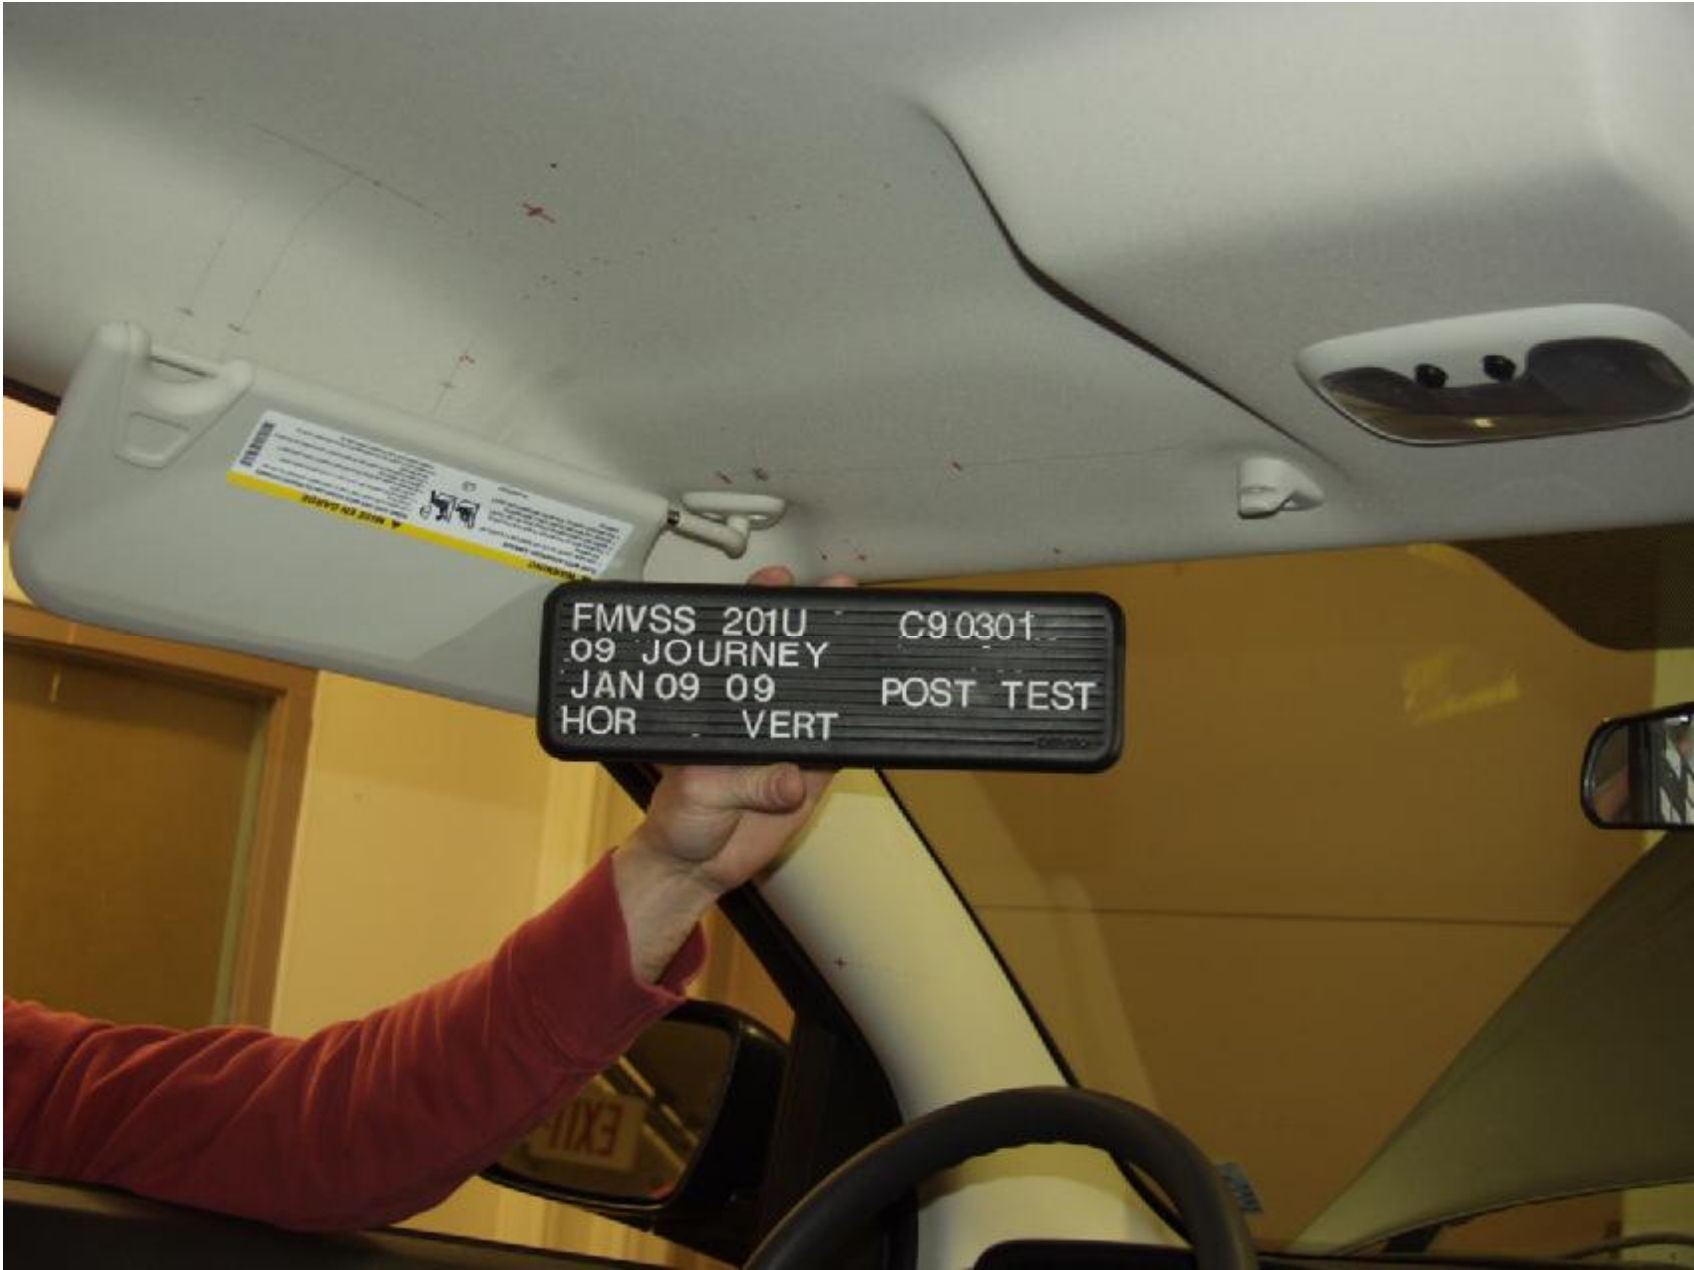
Figure A-18 : POST-TEST DRIVER SIDE FRONT HEADER

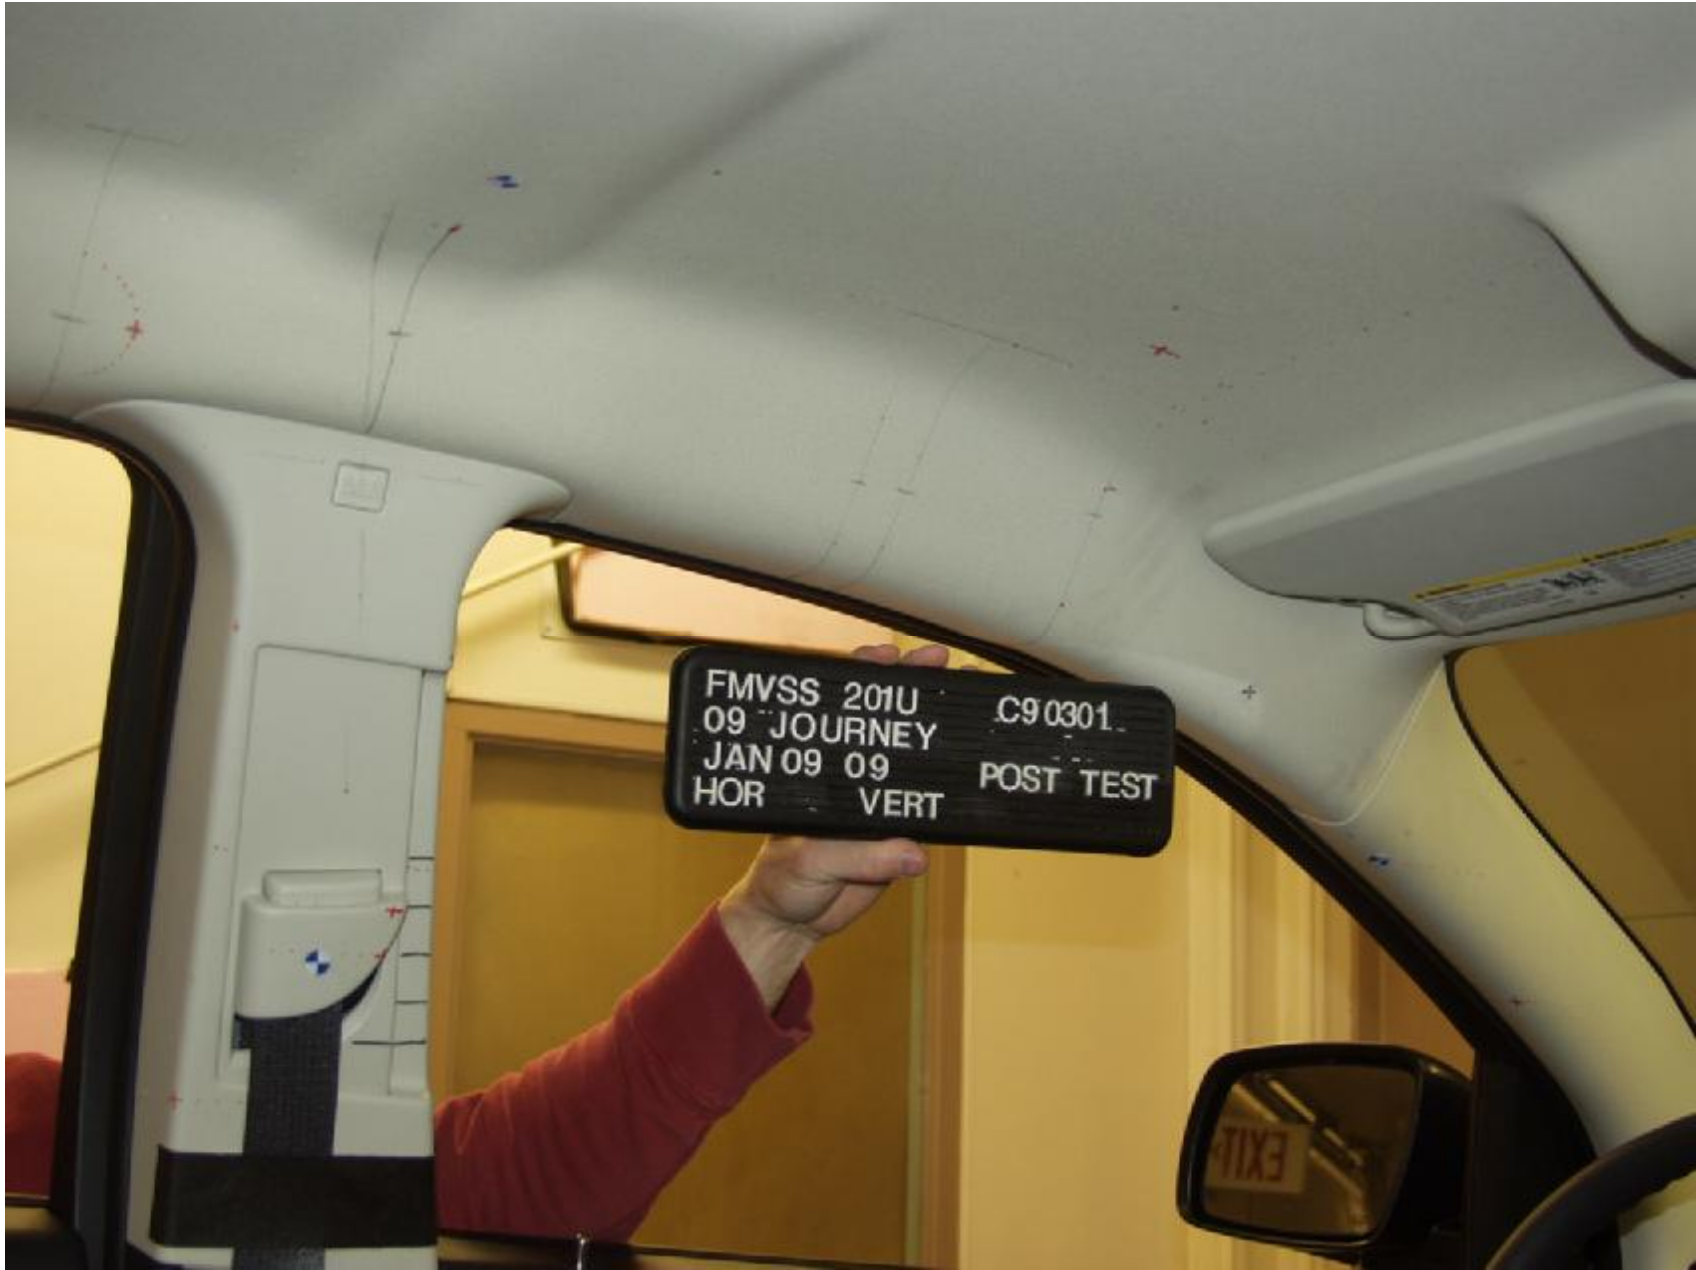
Figure A-19 : POST-TEST DRIVER SIDE SIDE RAIL
