REPORT NUMBER: 201UI-CAL-09-02

**SAFETY COMPLIANCE TESTING FOR FMVSS 201  
OCCUPANT PROTECTION IN INTERIOR IMPACT  
UPPER INTERIOR HEAD IMPACT PROTECTION**

**CHRYSLER LLC.  
2009 DODGE JOURNEY**

FINAL REPORT

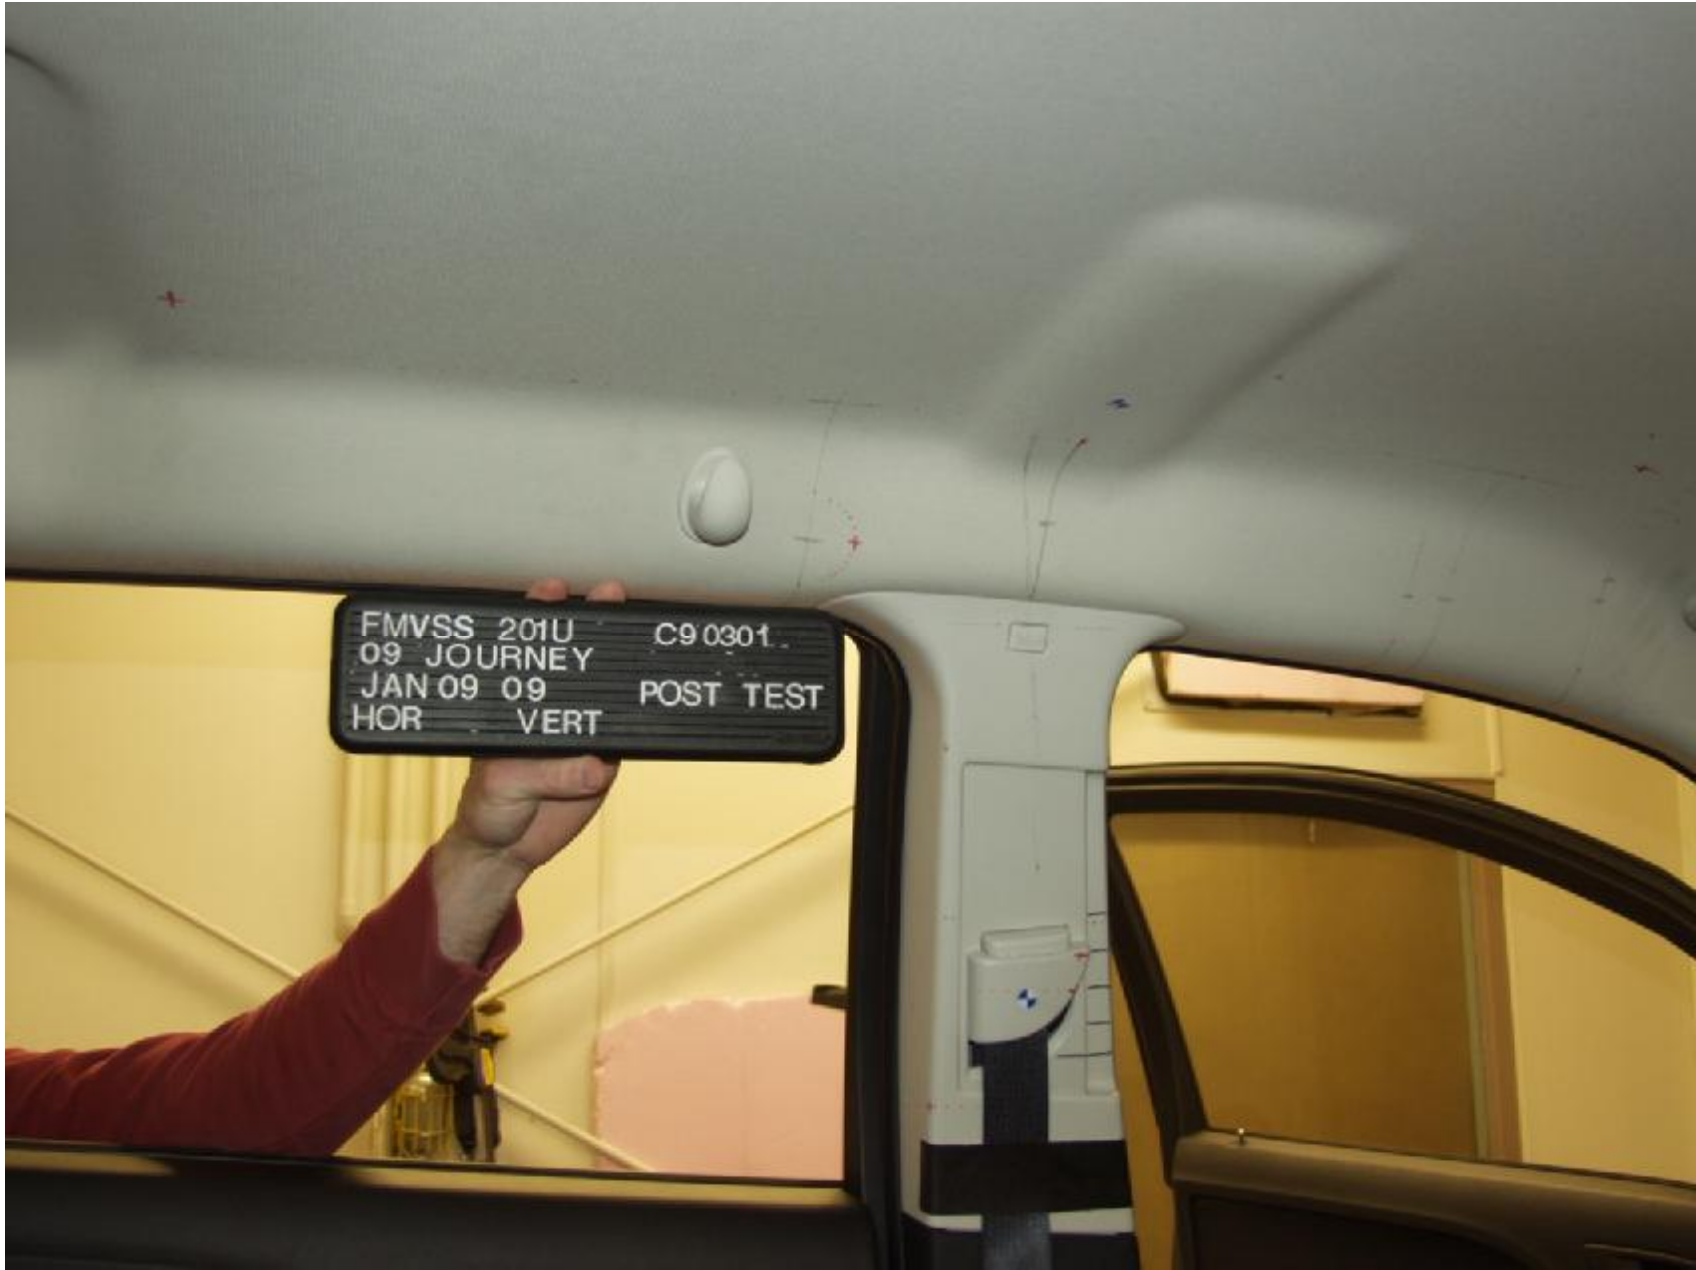
Figure A-20 : POST-TEST DRIVER SIDE B-PILLAR
