Hydrologic & Hydraulic News

April 2014
Vol. 2, Issue 1

Scour and the Test of Time: Herbert C. Bonner Bridge Crossing Oregon Inlet, North Carolina

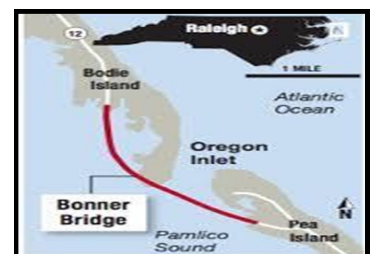
Figure 1—Map of Bonner Bridge over Oregon Inlet

NC 12 begins near the Virginia line at Corolla Lighthouse, passes the site of the Wright Brother's first flight at Kitty Hawk, Roanoke Island home of the first English child born in the America's and the Lost Colony. Via Bonner Bridge, NC 12 crosses Oregon Inlet (Figures 1 and 2), created by a tropical storm in 1846, near Manteo and Nags Head. NC 12 then threads through 70 miles of Cape Hatteras National Seashore passing Hatteras Lighthouse and the Graveyard of the Atlantic.

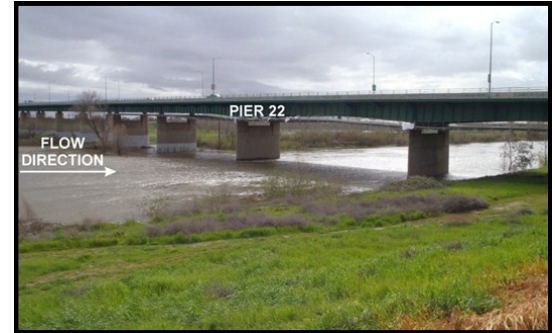
Figure 3— Feather River Bridge: Br. No. 18-0009 in Sutter County, CA

Due to high flows occurring in March 2011, the Feather River Bridge — Br. No. 18-0009 (Figure 3) - experienced massive scour in the main channel at Pier 22. The severity of the scour prompted an emergency structural retrofit of Pier 22, that was completed in December 2011. CalTrans engaged the J. Sterling Jones Hydraulic Research Lab (HRL) through the Transportation Pooled Fund 5(211) "Bridge Pier Scour Research" to study the scour at the bridge.

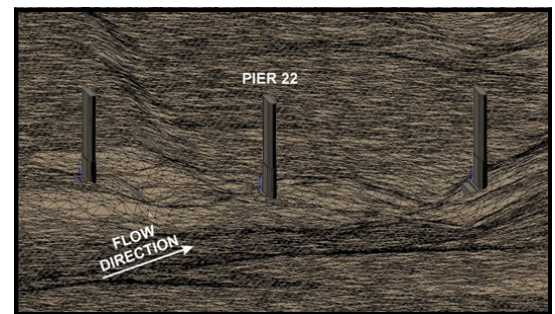
Figure 4—Full scale model using the 2007 sonar bathymetric field data

The research study utilizes sonar bathymetric data taken in 2007 and after the 2011 flood to construct full scale Computational Fluid Dynamics (CFD) models. Bathymetric data from the 2007 survey are used as a baseline stream bed condition (Figure 4) while the data obtained after March 2011 flood is used as a post-event scour condition. The CFD analysis, run on the Argonne National Lab high performance computing clusters, will identify the hydraulic erosion/scouring force distribution and reveal the change of hydraulic forces during the development of the scour hole (Figure 5).

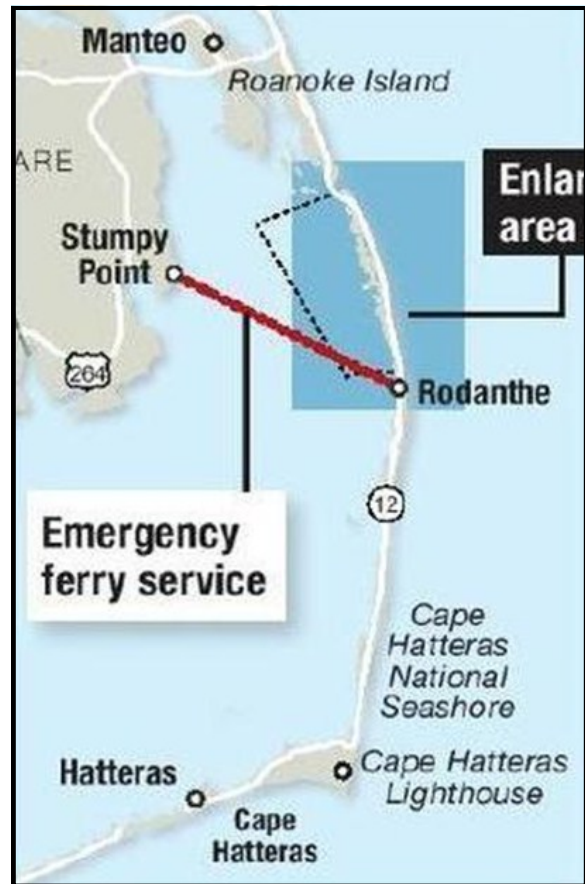
Figure 9— Graphic showing ferry operations between mainland and Hatteras Island

On December 3rd, NCDOT Ferry Division moved four vessels into Pamlico Sound to begin operations between the emergency docks at Stumpy Point on the mainland and the village of Rodanthe on Hatteras Island (Figure 9). The 180' River Class boats carry a maximum of 38 vehicles and operates during daylight hours only. Priority boarding was implemented for the 18 mile and 90 minute trip one way. Overland travel to Stumpy Point added an additional 45 minutes to the detour operation.

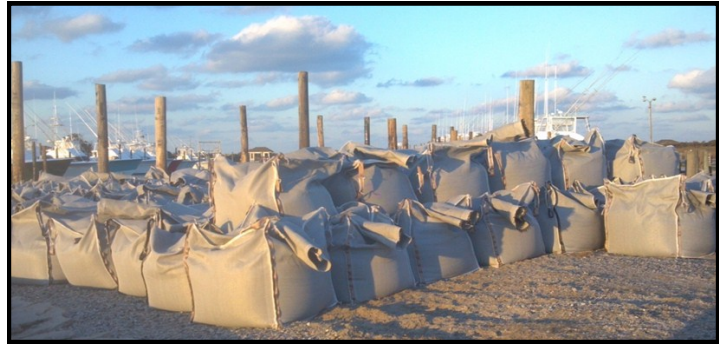
Figure 11—Geotextile Sand Bag Stockpile (4'x4'x4' cubes)

Geotextile bags (Figure 11) begin arriving and filled. Contractor's crane and pile hammer are moved to work off the bridge deck at Bent 164.

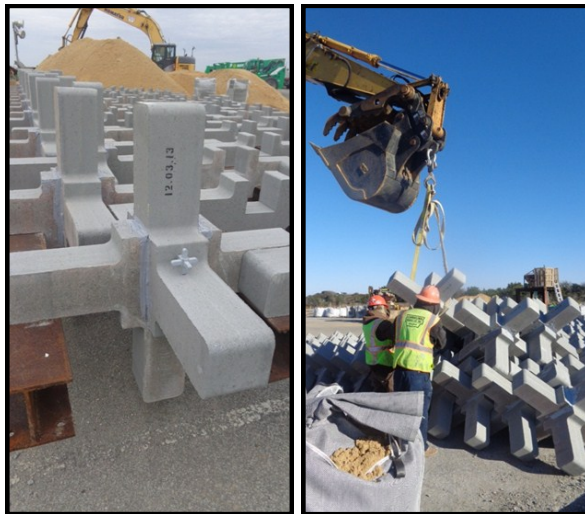
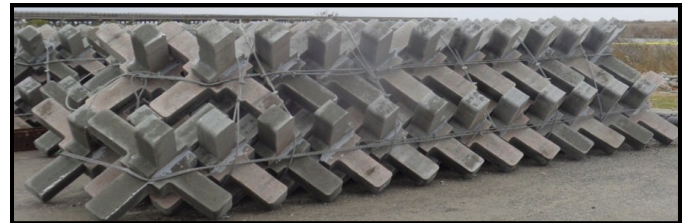
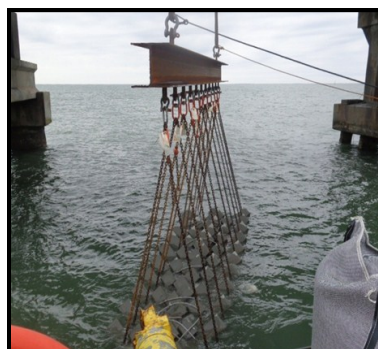
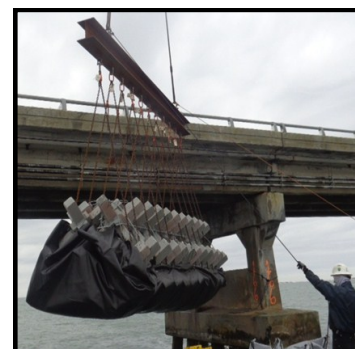
The contractor, Carolina Bridge, continues A-jacks® and sandbag installation (Figure 14). Weather conditions were favorable immediately after passage of the nor'easter. However, diver safety protocol limited placement of A-jack® logs (Figures 15, 16, 17, and 18) and sandbags to periods of slack tide twice a day. Water temperature, visibility, and tidal flow velocity allow for a dive window of only 75 to 90 minutes at slack tide. Carolina Bridge dive support was provided by Crofton Diving of Portsmouth, Va.

Figure 15—A-jacks® Assembly Area and Stockpile

Figure 16 - Stainless Steel Cable & Hardware Binding

Figure 17—Contractor Jig For A-jack® Log Placement

Figure 18—Geotextile Filter Applied to A-jack® Logs

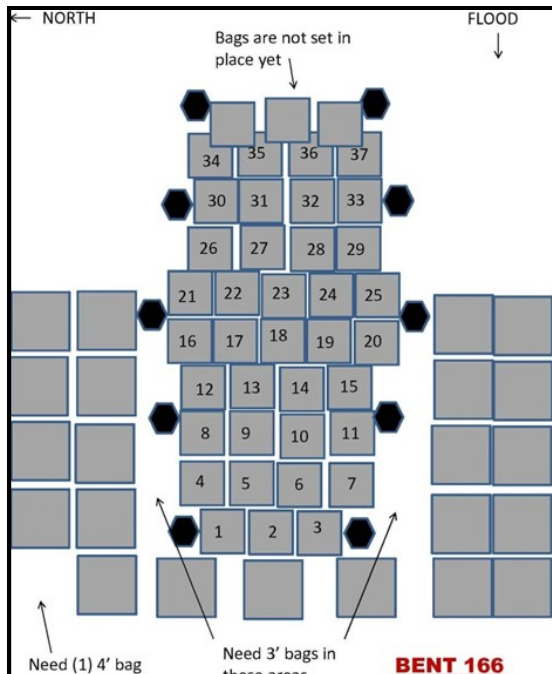
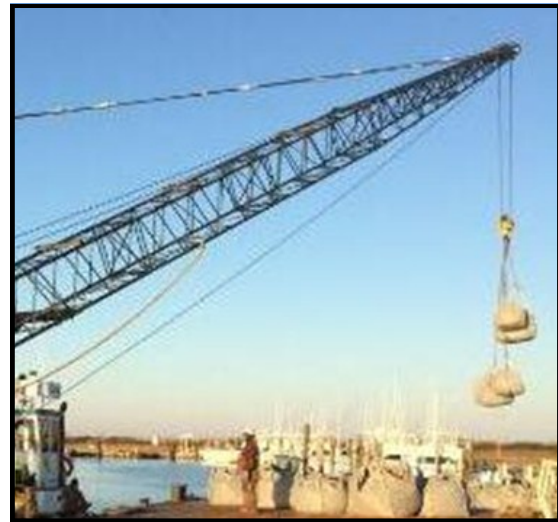
Upon establishing A-jacks® perimeter, the area around and between the battered 10 pile group of Bent 166 was protected with geotextile sandbags (Figures 19 and 20).

Figure 19—Placement of Geotextile Sand Bags around Bent 166

Figure 20—Contractor lifting the Sand Bags to place at Bent
