FMVSS 212/219/301
ELECTRIC VEHICLE TESTING - GROUP V

Jet Industries Inc.
1981 Electrica 007

TEST REPORT

1. Report No.	2. Government Accession No.	3. Recipient's Catalog No.	
4. Title and Subtitle FMVSS 212, 219, 301 ELECTRIC VEHICLE TESTING - GROUP V - 1981 ELECTRICA 007		5. Report Date November 1981

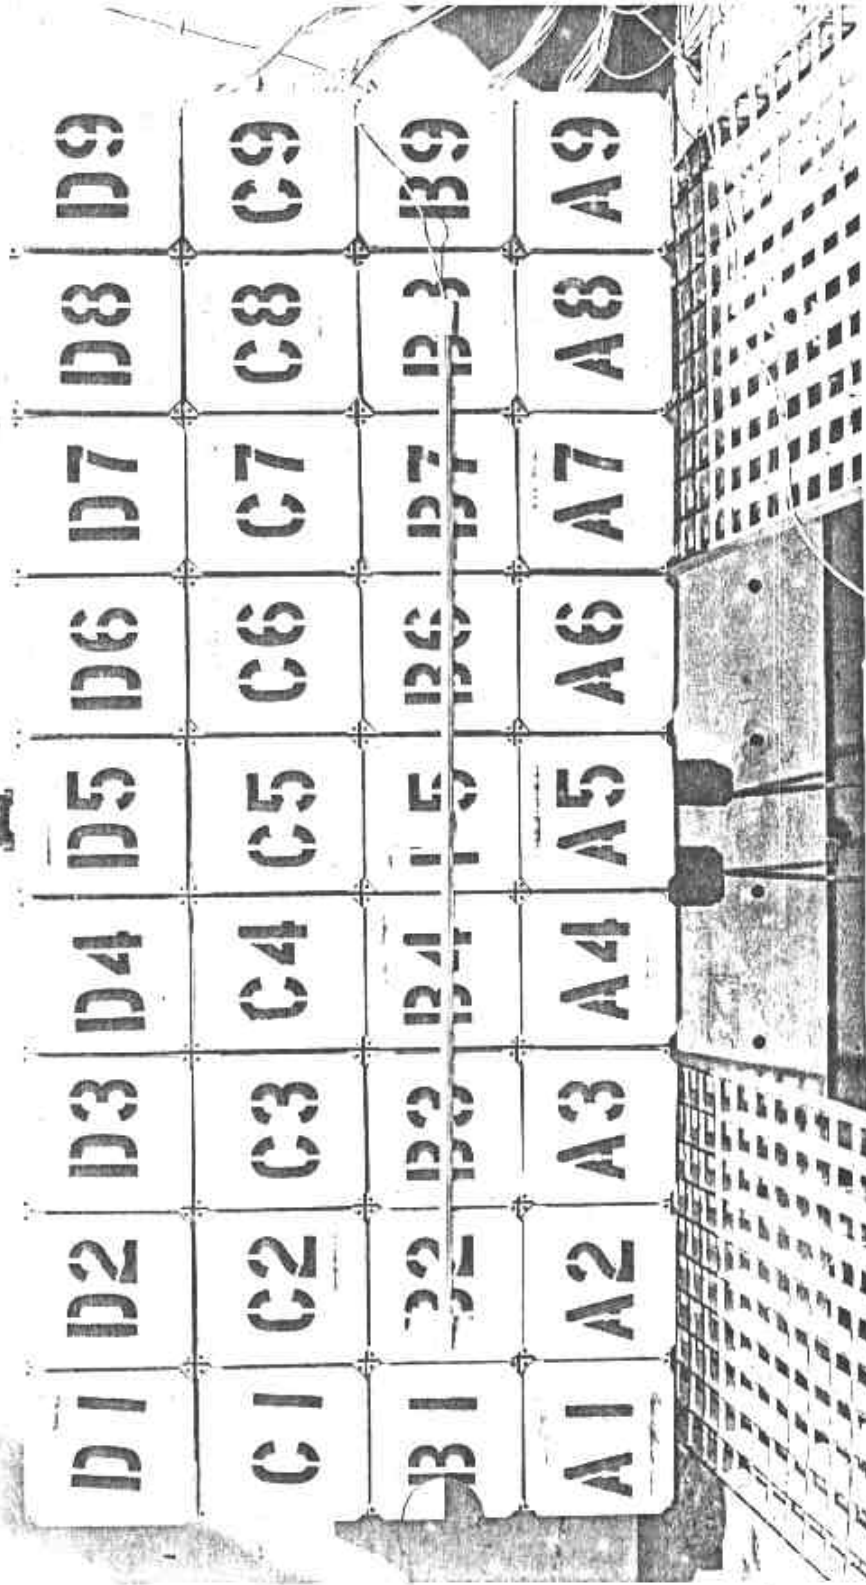
FIGURE 1-1. LOAD CELL BARRIER FACE.

The load cell barrier face is pictured in Figure 1-1. The barrier consists of a 9 X 4 array of 50 klb load cells each faced with a section of 1-3/4-inch thick plywood. Plywood sections for Rows C and D (upper two rows) each measure ten inches high and nine inches wide. Plywood sections for Rows A and B (lower two rows) each measure nine inches high and nine inches wide. Overall width of the barrier is 83 inches and overall height is 38-3/4 inches. The lower edge of the barrier is 2-5/8 inches above the surface of the ground.

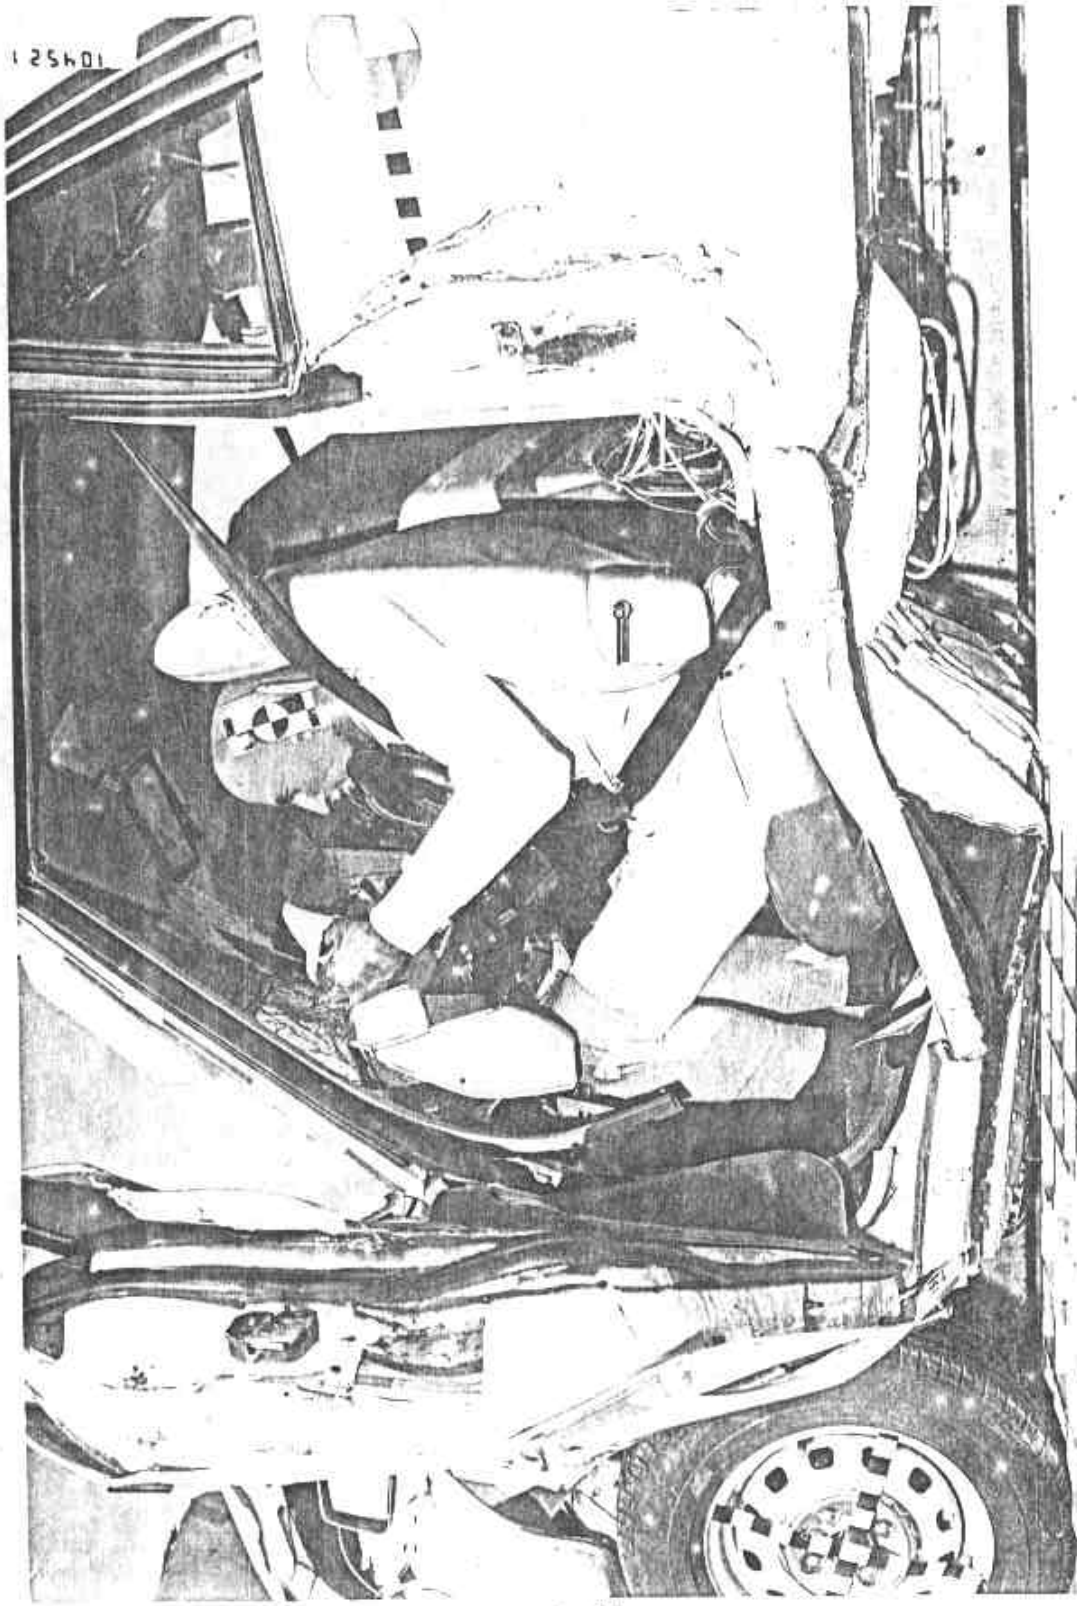
FIGURE 4-11. POST-TEST VIEW OF DRIVER DUMMY - 1981 ELECTRICA 007.

<u>Driver</u>	<u>Passenger</u>
Head	<u>Steering wheel rim</u> <u>Upper edge of dash</u>	<u>Top of dash</u>
Chest	<u>Steering wheel hub</u> <u>and rim</u>	<u>None</u>
Abdomen	<u>Steering wheel rim</u>	<u>None</u>
Left Knee	<u>Lower dash</u>	<u>Lower dash</u>
Right Knee	<u>Lower dash</u>	<u>Lower dash</u>
DOOR OPENING	<u>Front</u>	<u>Rear</u>
	<u>Left</u> <u>Right</u>	<u>Left</u> <u>Right</u>
	<u>Tools</u> <u>Tools</u>	<u>N/A</u> <u>N/A</u>
	<u>Required</u> <u>Required</u>	
SEAT MOVEMENT		
Seatback Failure	<u>None</u> <u>None</u>	<u>Seat removed before</u>
Seat Shift (in.)	<u>None</u> <u>1" forward</u>	<u>test</u>
