PUBLIC ROADS

VOL. 10, NO. 7

SEPTEMBER, 1929

Page
A Study of Gravel, Topsoil, and Sand-Clay Roads in Georgia - - - - -	117

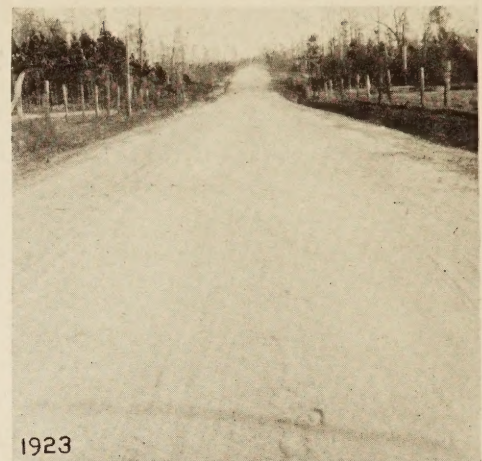
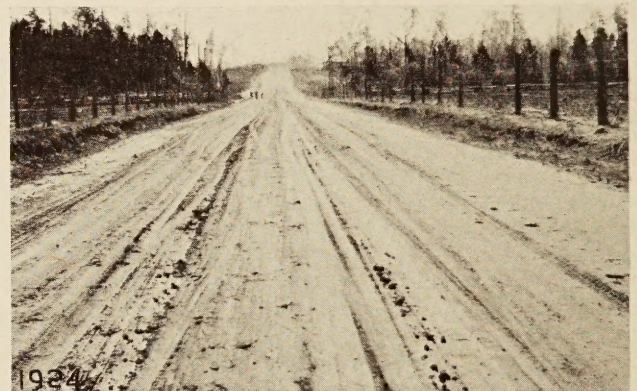
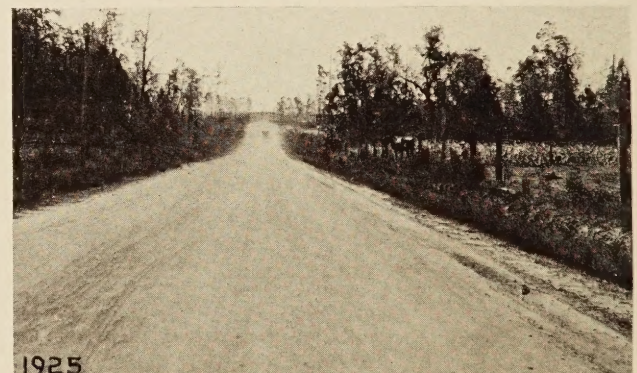
PROJECT NO. 5, IN BACON COUNTY. SAMPLE POINT NO. 2

1923

1924

1925

index is 57 cents. It appears from this project that when the vehicle index gets much below \$1 it is probable that conditions are unsatisfactory and rebuilding with a higher type of material is necessary. The same indication is seen on project No. 5, in Bacon County, and No. 41, in Douglas County.

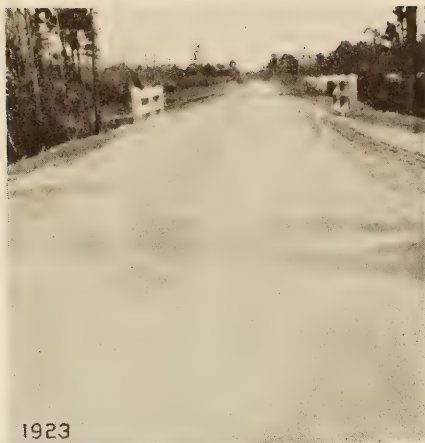
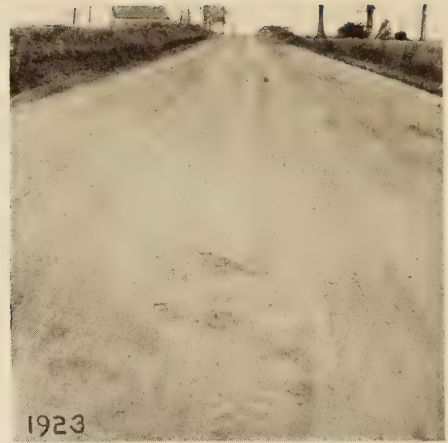
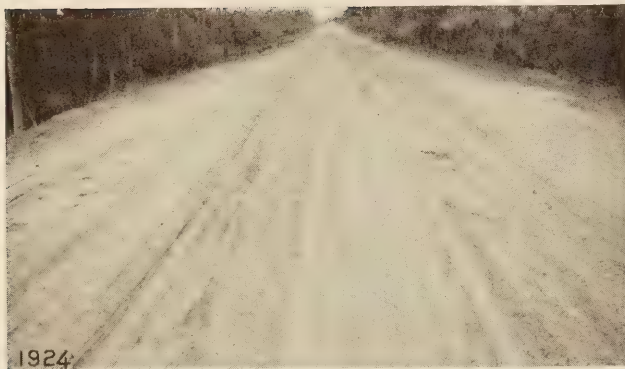
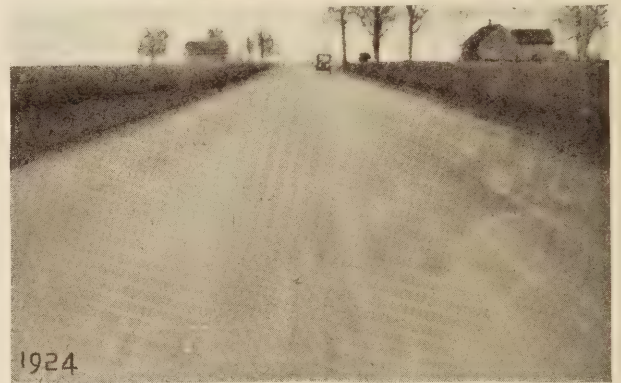
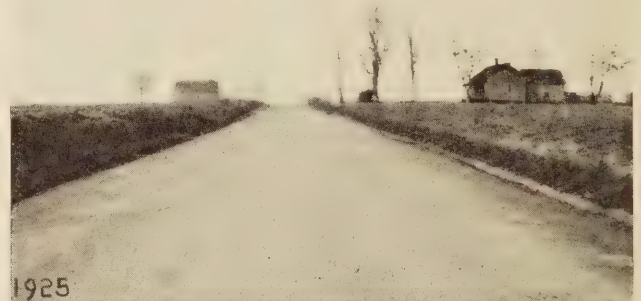
PROJECT No. 76, IN WHEELER COUNTY. SAMPLE POINT
No. 3

1923

1924

1925

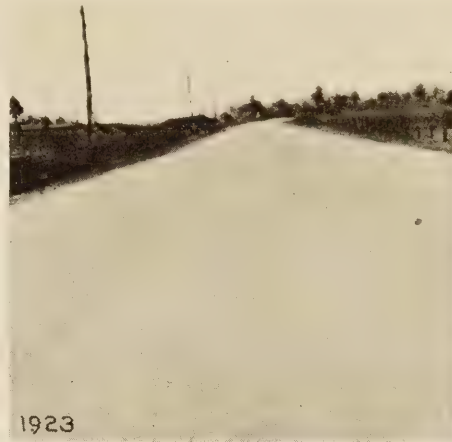
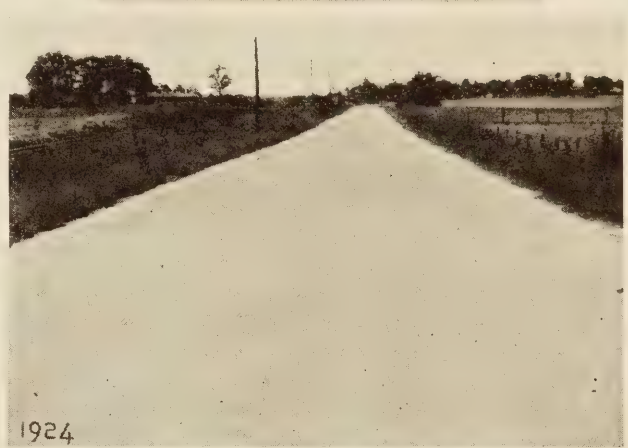
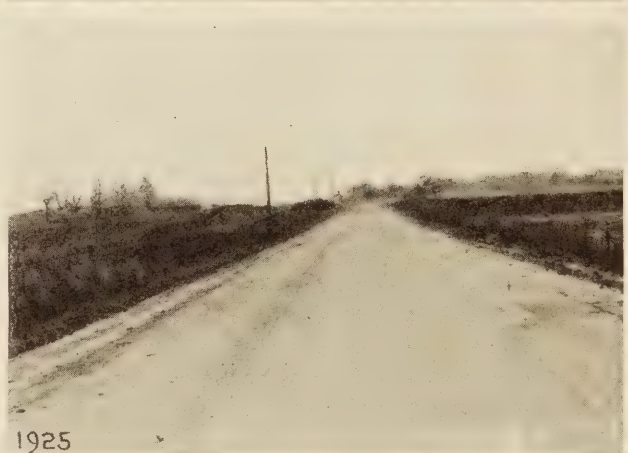
PROJECT NO. 134, IN COWETA COUNTY. SAMPLE POINT NO. 2

1923

1924

1925
