# PUBLIC ROADS

A JOURNAL OF HIGHWAY RESEARCH

VOL. 10, NO. 8

OCTOBER, 1929

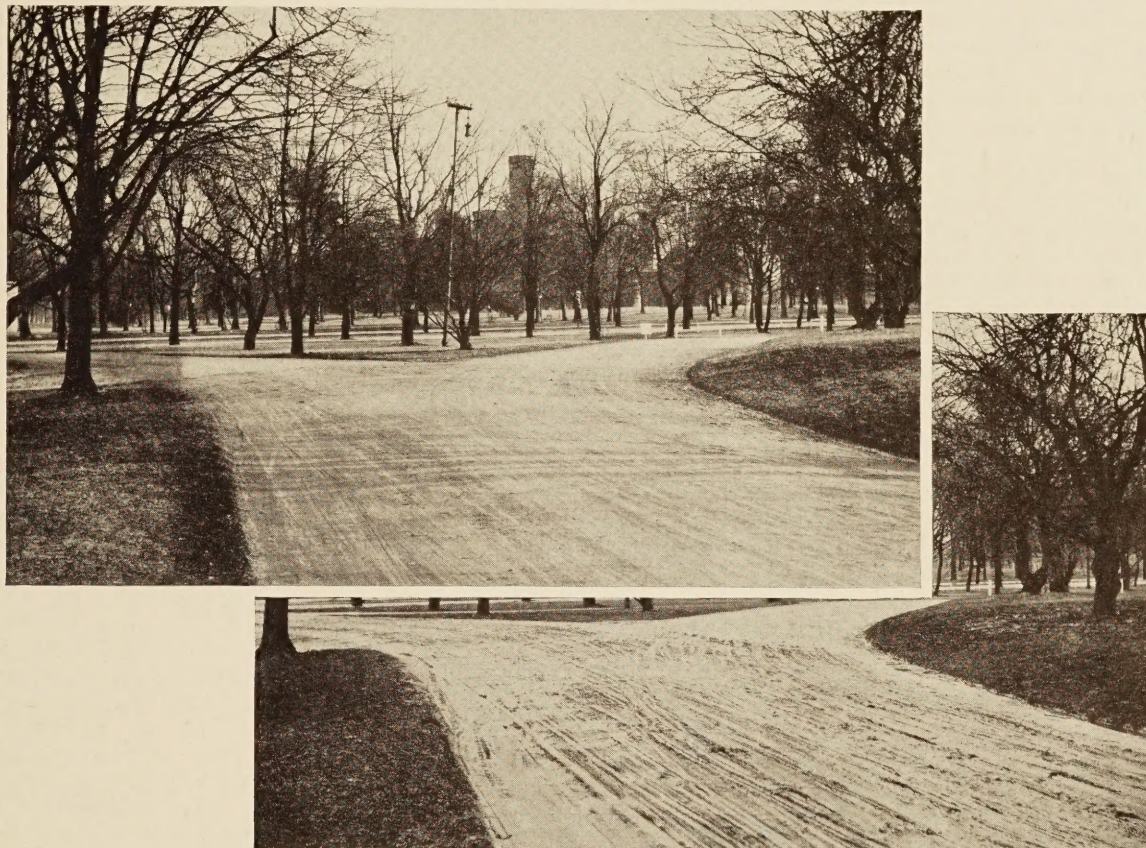
FIGURE 2.—APPEARANCE OF SECTION 3 (1912-1915) IN DRY AND WET WEATHER. NOTE STABLE CONDITION OF SECTION 4 ON THE RIGHT DURING WET WEATHER

Shortly after the original treatment, section 3 showed a tendency to become muddy in wet weather and after periods of continued rain the surface was covered with a deep oily mud which gradually worked into ridges along the edges of the road. Figure 2 illustrates the condition of the surface during dry and rainy periods.

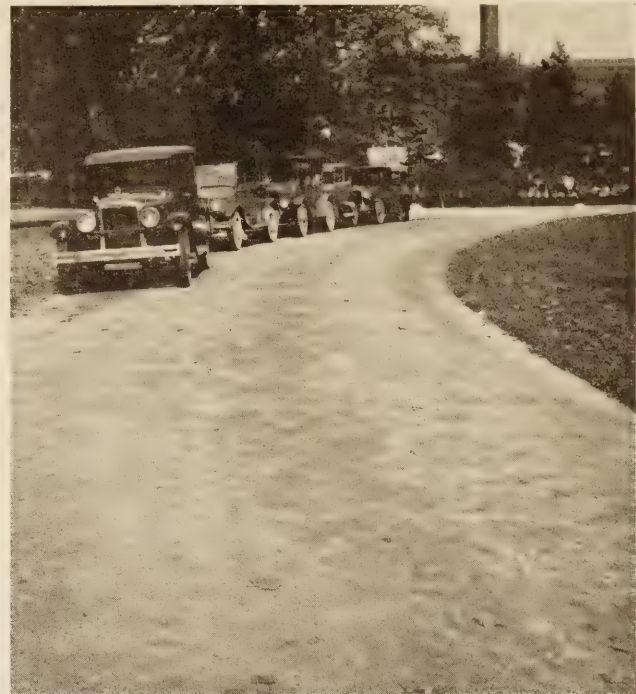
FIGURE 4.—PRESENT APPEARANCE OF SECTION 1. PARKING OF CARS ON ONE SIDE LEAVES ONLY A SINGLE TRAFFIC LANE FOR THE ONE-WAY TRAFFIC

ever, it is smooth riding and intact and the edges are in good condition, free from breaking or raveling. Both ends of the section, where they intersect sections 2 and 8, are sharp curves and in making the turns traffic has continually encroached upon the lawn. In maintaining the section the surface has been gradually widened to correct this condition. The two cross drains shown in Figure 1, together with the natural slope, afford the section ample drainage.

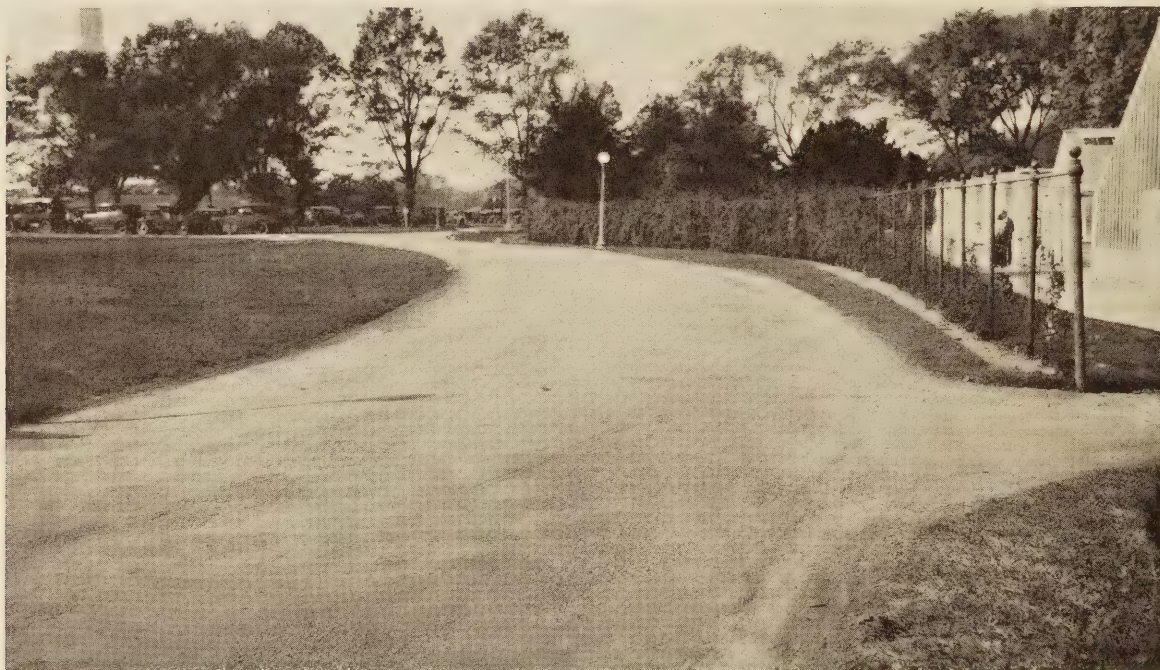
FIGURE 5.—PRESENT CONDITION OF THE CENTRAL PORTION OF SECTION 2. NOTE HEAVY PATCHING AND SHOWING OF THE SURFACE MAT ALONG RIGHT SIDE

for the entire section. The central portion of the section has always required considerably more maintenance than the remainder and its condition at present, as illustrated in Figure 5, is probably worse than any other area included in the experiments. Its tendency to shove under traffic during very hot weather has recently required the extensive use of crushed stone in an attempt to stabilize the bituminous mat which is about 2 inches thick.

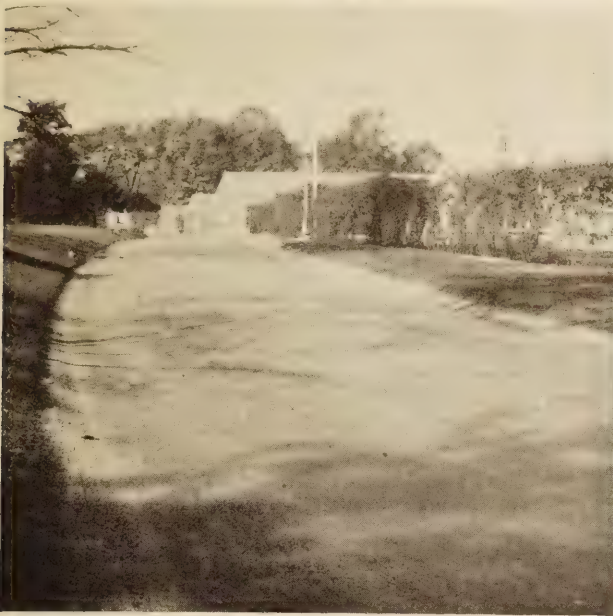
FIGURE 6.—PRESENT APPEARANCE OF THE EAST END OF SECTION 2. ALTHOUGH LYING IN A CUT THE BITUMINOUS GUTTERS AND NATURAL SLOPE AFFORD AMPLE DRAINAGE

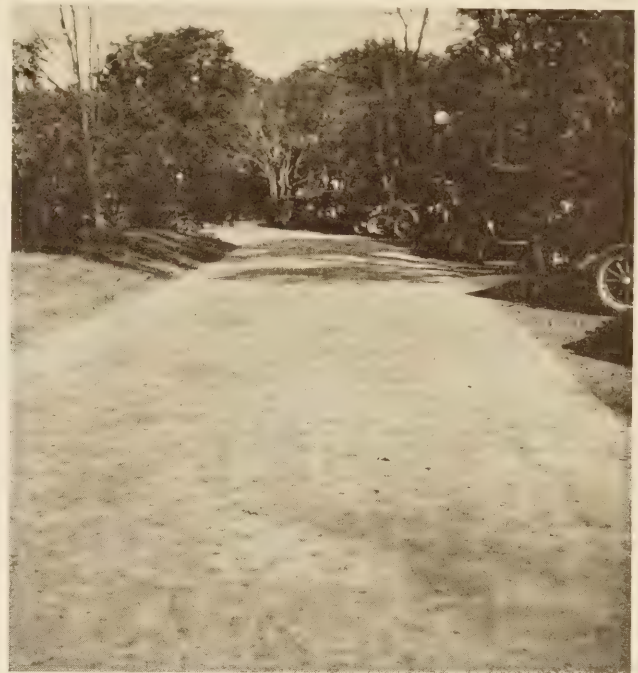
FIGURE 8.—LOCATION AND PRESENT CONDITION OF SECTION 4. THE SURFACE MAT, ALTHOUGH INTACT, IS VERY LIFELESS IN APPEARANCE, DUE TO INSUFFICIENT TRAFFIC

Section 4, which carries traffic in both directions, is in very good condition. Its surface, although very dull in appearance, is smooth and intact. Some breaking along the edges has been caused by vehicles leaving or coming onto the surface from the adjacent parking areas. The average daily traffic carried by the section, as shown by the 1928 count, was 305

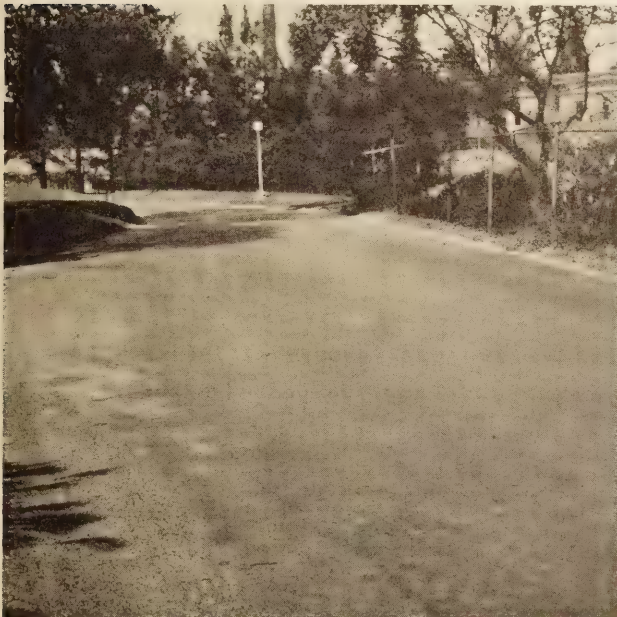
FIGURE 7.—EAST END OF SECTION 3. PRESENT CONDITION

Section 3 is in excellent condition. Its surface is firm and smooth and shows no tendency to ravel although the coarse stone is exposed. Like section 2, it carries very heavy traffic traveling in both directions. The recent count showed a daily average of 5,213 vehicles. On several occasions the number of vehicles passing over the section exceeded 500 per hour. The gradual widening of the travel area along the edges has increased the width of the section to approximately 20 feet. Figures 7 and the cover page show the present condition of the section as well as its location which is mainly in a cut. The natural slope and the bituminous gutters provide satisfactory drainage.

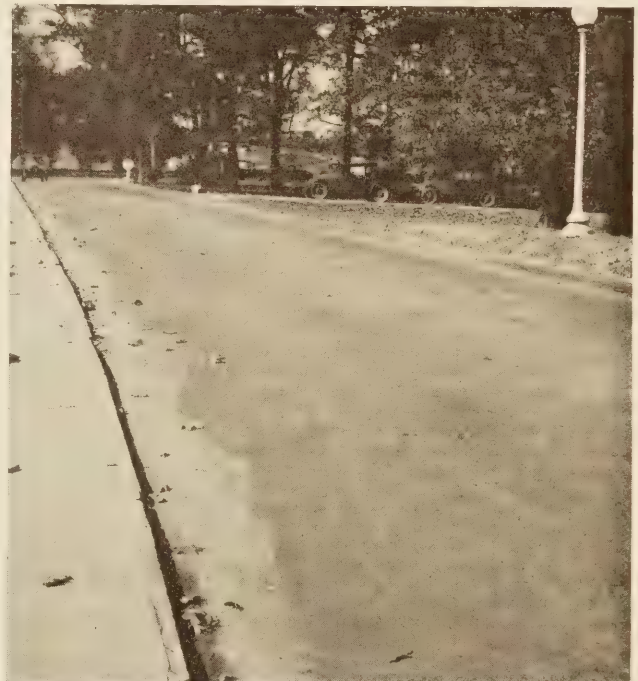
FIGURE 9.—GENERAL VIEW OF LOCATION AND PRESENT CONDITION OF SECTION 8

Section 8, although in service for a considerably shorter period of time than the other sections, is giving excellent service at a remarkably low cost and to all appearances is suffering no deterioration from traffic. The 1928 count showed it to be carrying an average of 3,542 vehicles daily. The surface is smooth and intact save for a few small hair cracks which have been filled with bituminous material. Some large stones of the macadam course are showing but there is no tendency to crush or ravel. The section lies in a cut throughout its length but has a natural slope sufficient to carry off surface water satisfactorily. A concrete sidewalk on the south side and a slight embankment on the north side afford ample protection to the edges. Figure 9 shows the location and present condition of the section.

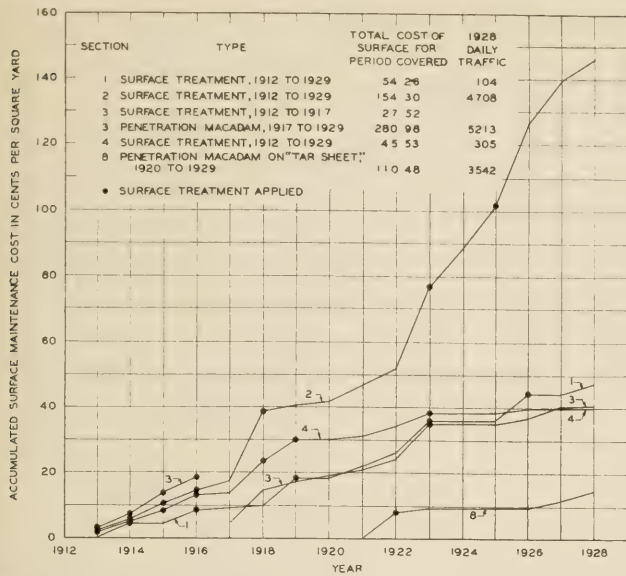
FIGURE 10.—COMPARISON OF COST OF MAINTAINING EXPERIMENTAL SECTIONS EXCLUSIVE OF CONSTRUCTION COSTS

Although the maintenance costs of sections 1 and 4 are not comparable with the others, they are of interest in showing that a certain amount of maintenance is necessary regardless of traffic, if the surface is to be protected from deterioration from natural causes. The maintenance cost per vehicle carried, for these two sections, is many times higher than that of the more heavily traveled sections. Similarly, section 4, has carried three times as much traffic as section 1, but its actual maintenance cost has been materially less. Indications are that section 1 has suffered consistently from lack of traffic and it is believed that this accounts for its higher maintenance cost.

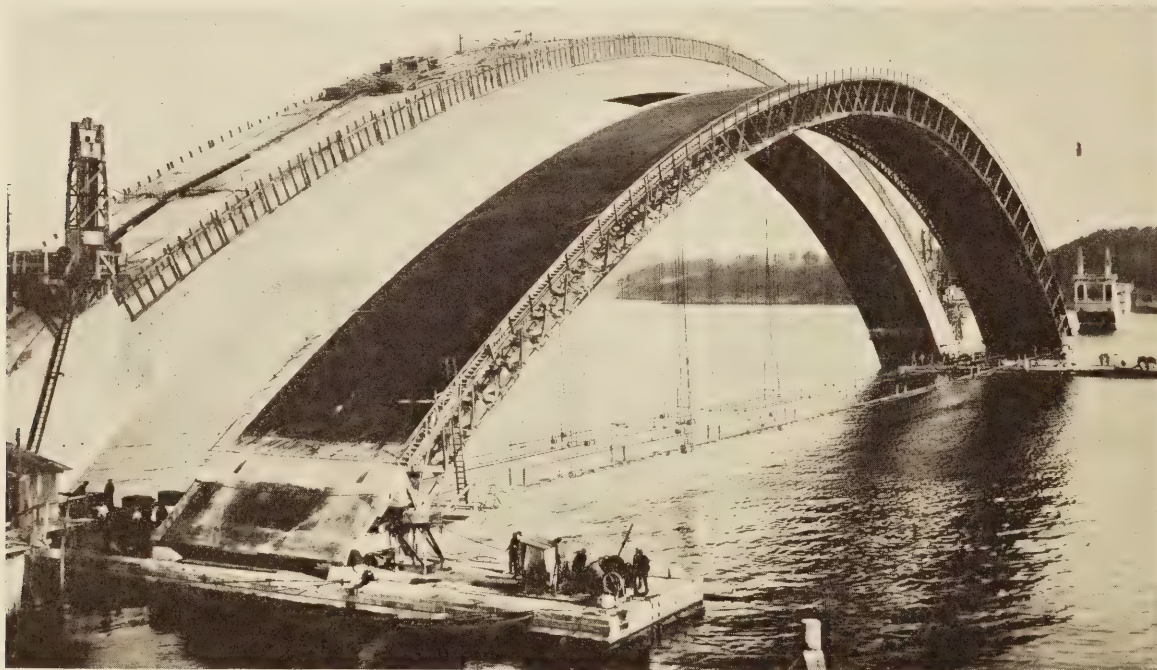
AN ARCH CONSTRUCTED BY THE FREYSSINET METHOD

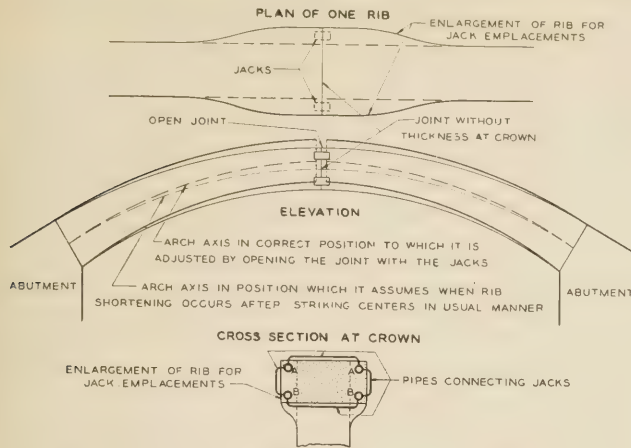
FIGURE 1.—SKETCH SHOWING POSITION OF HYDRAULIC JACKS FOR ADJUSTMENT OF ARCH AXIS

The ribs are separated into two halves at the crown by a transverse joint without thickness. (See figs. 1 and 2.) A group of jacks is placed at this joint in each rib and in emplacements provided for the purpose. By exerting a horizontal jack pressure equal to or a little greater than the thrust of the arch the joint is opened and the arch is lifted off the centers. The

axis may thus be put in the position anticipated in the design. The amount by which the joint must be opened to accomplish this purpose is a measure of the combined rib shortening which has occurred, due to all causes.

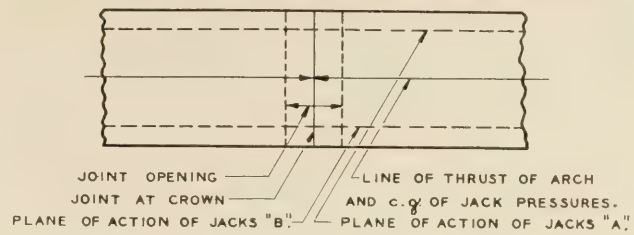
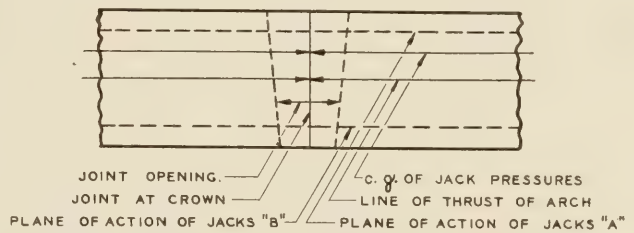
UNIFORM JOINT OPENING WHEN LINE OF THRUST AND C. G. OF JACK PRESSURES COINCIDE.

JOINT OPENING WHEN THE C. G. OF JACK PRESSURES IS SHIFTED TO A POSITION ABOVE THE LINE OF THRUST, PRODUCING A ROTATION OF THE FACES OF THE JOINT. THE C. G. OF THE JACK PRESSURES IS LIFTED BY MAKING THE PRESSURE IN JACKS "A" GREATER THAN IN "B".

FIGURE 2.—SKETCH SHOWING OPENING OF JOINT AT CROWN OF ARCH

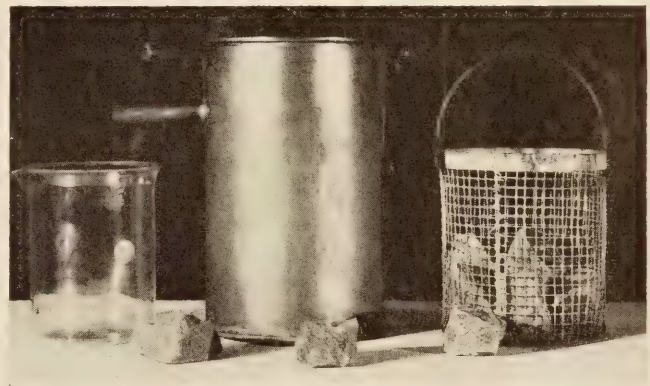
FIGURE 1.—APPARATUS USED IN DETERMINING APPARENT SPECIFIC GRAVITY
