# PUBLIC ROADS

A JOURNAL OF HIGHWAY RESEARCH

VOL. 13, NO. 4

JUNE, 1932

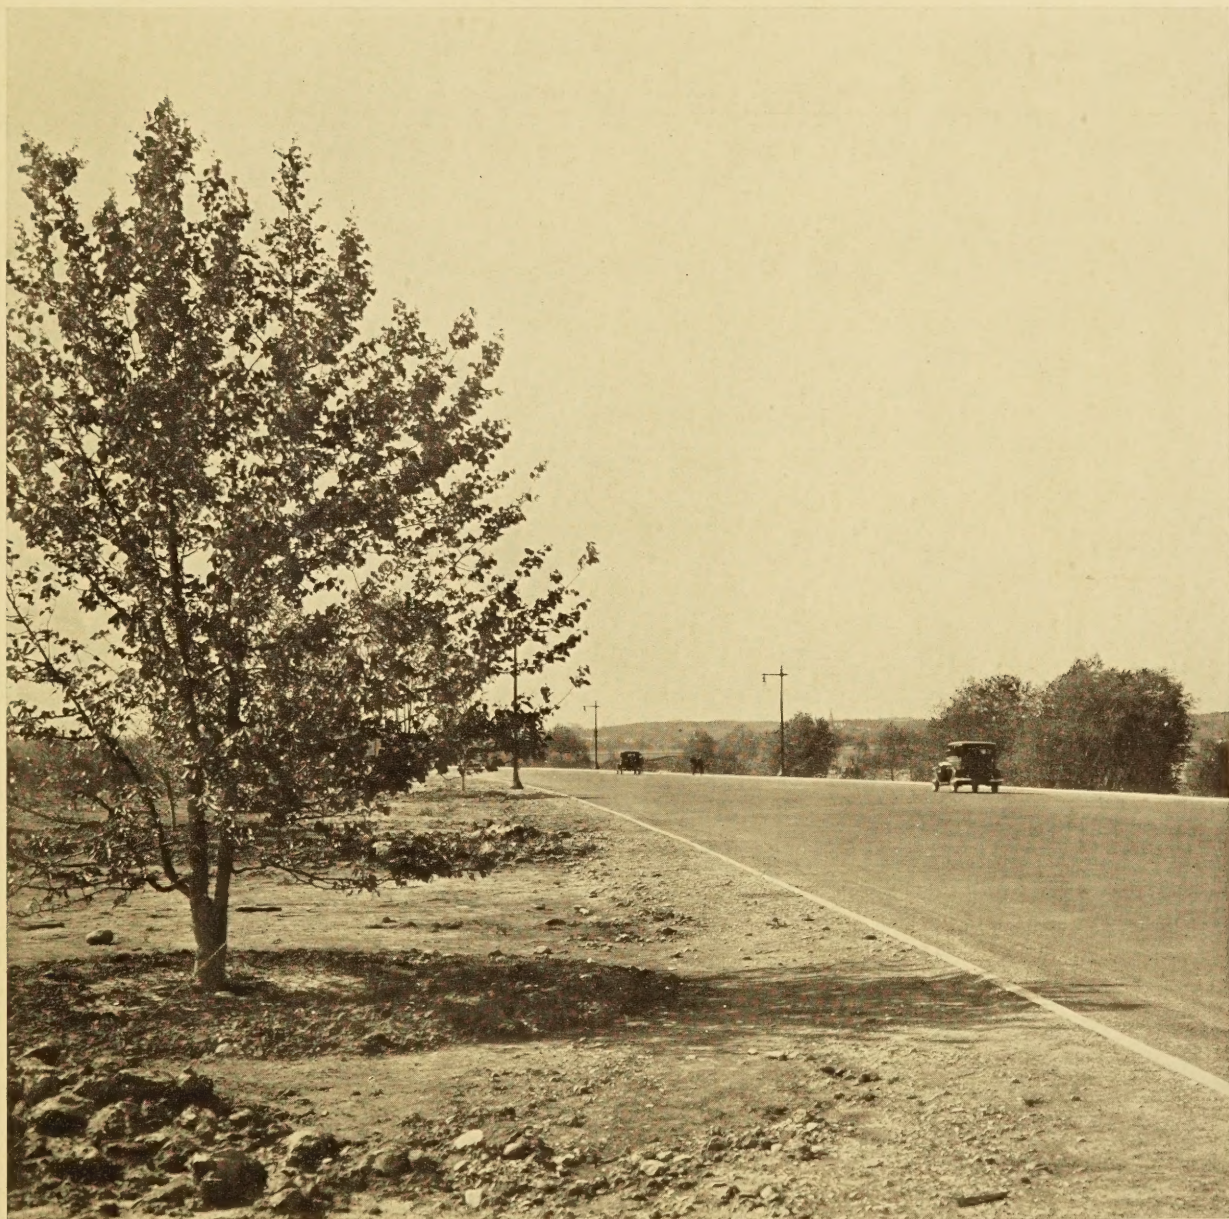
SECTION OF MOUNT VERNON MEMORIAL HIGHWAY ON COLUMBIA ISLAND, D. C.

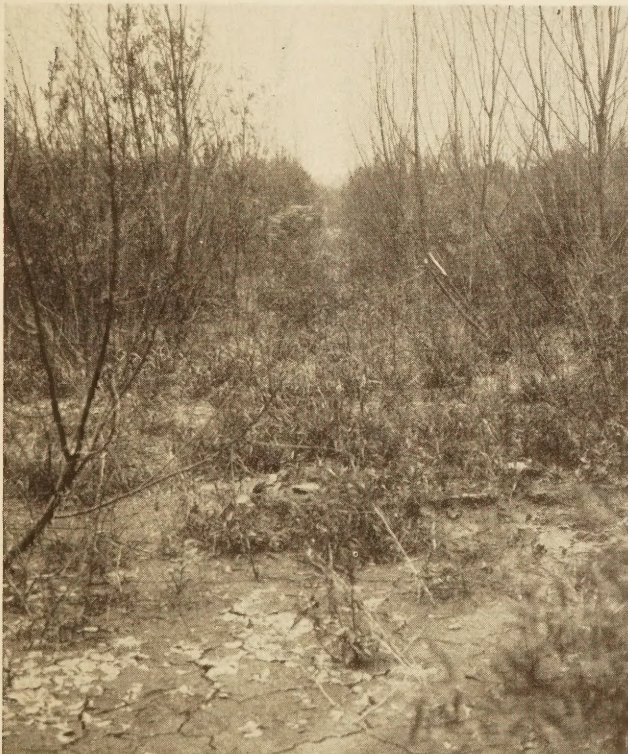
FIGURE 1.—LOOKING NORTH FROM STATION 13+00, ALONG THE CENTER LINE, BEFORE DRAINAGE

At the time it was desired to start grading operations on Columbia Island a section about 300 feet in length between stations 10+00 and 13+00 (see fig. 1) was covered with water and was so unstable that a person attempting to walk along the center line would sink in to his knees.

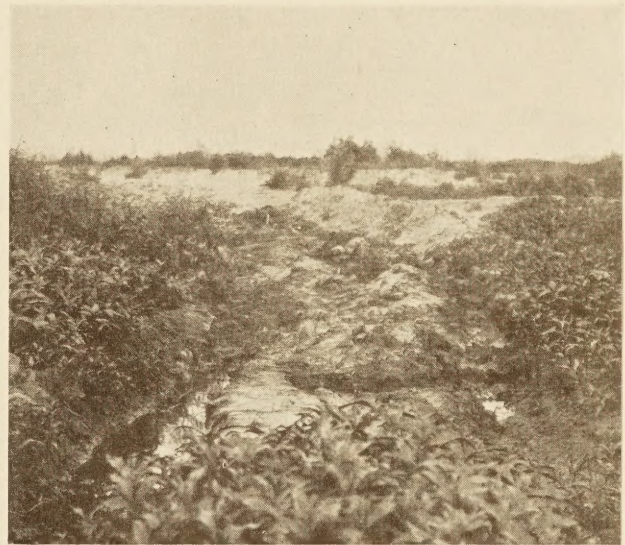
FIGURE 2.—WET AREA AT STATION 20+00. POWER SHOVEL WAS STUCK AT THIS POINT

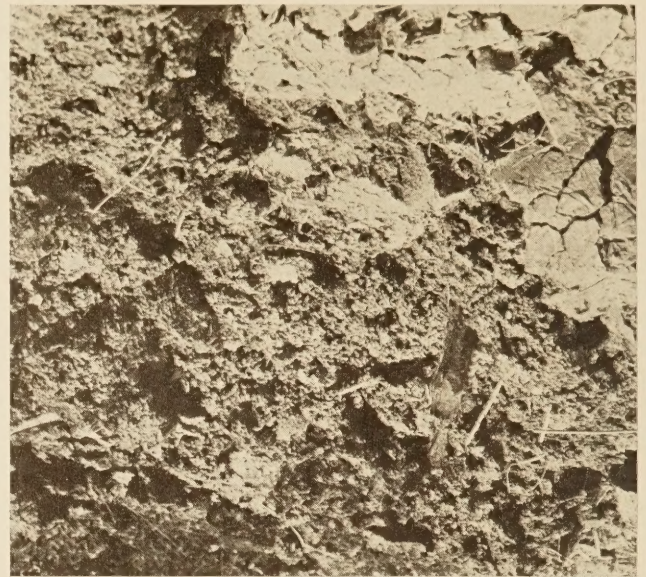
FIGURE 3.—CHARACTER OF MUCK ENCOUNTERED. MATERIAL AT THIS SPOT DISTURBED WITH DYNAMITE IN EFFORT TO HASTEN DOWNWARD PERCOLATION INTO UNDERLYING SAND LAYER

water carriers. The character of this muck is shown in Figure 3. Mixtures of the two soils were, of course, encountered.

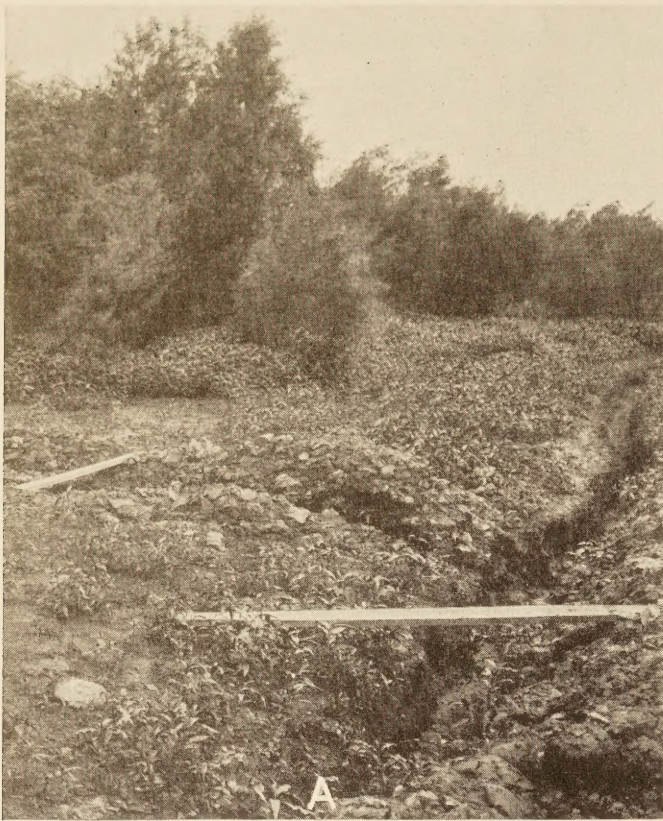
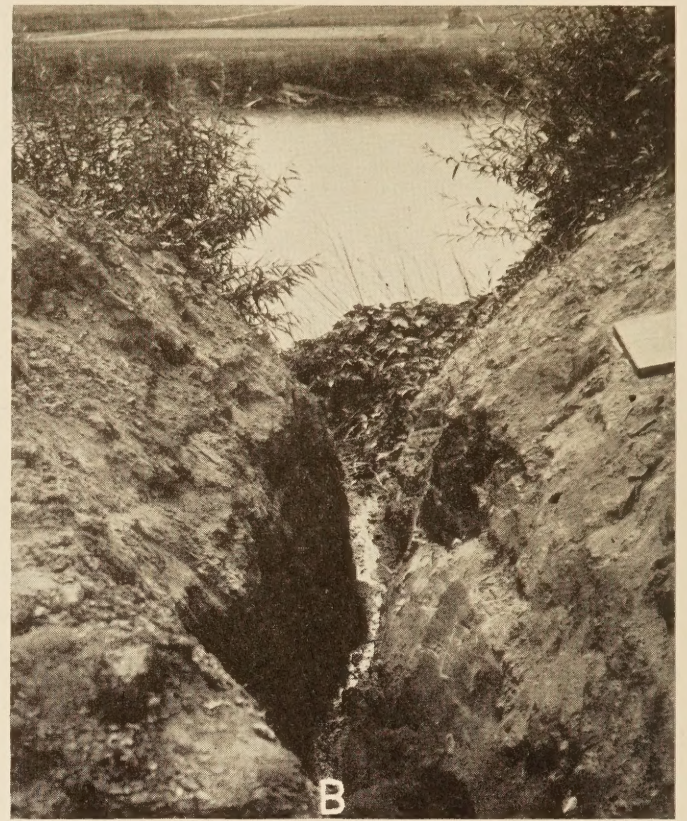
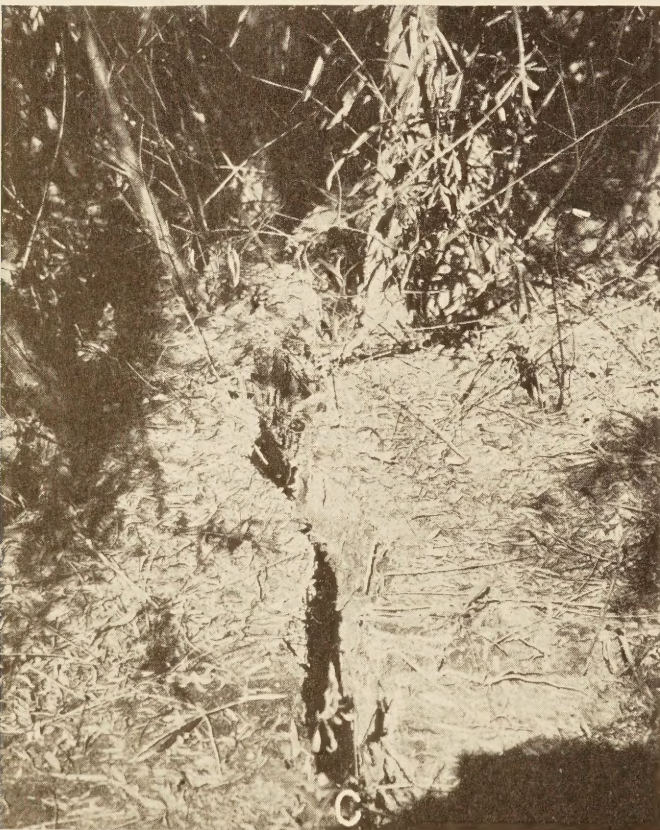
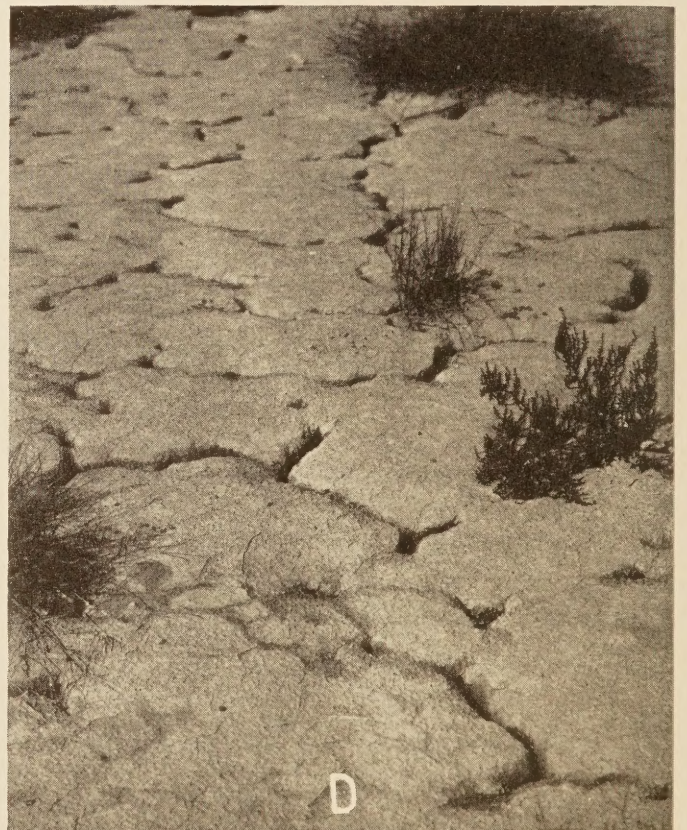
FIGURE 7.—STEPS IN THE DRAINAGE OF COLUMBIA ISLAND

A.—Ditches for removing surface water.

C.—Typical shrinkage crack in wet area after drainage.

D.—Shrinkage cracks in soil after drainage.

through the muck to the sand. The material close to the trench would begin to drain and as it dried out cracks were formed. These cracks, illustrated in Figure 7, C and D, extended back from the ditch and served as water carriers and so the whole area was gradually drained.
