# PUBLIC ROADS

A JOURNAL OF HIGHWAY RESEARCH

VOL. 13, NO. 7

SEPTEMBER, 1932

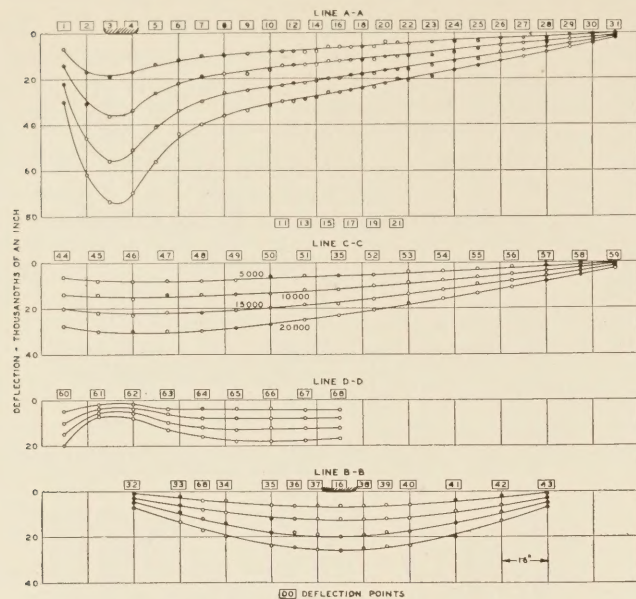
FIGURE 14.—DEFLECTIONS OF FIRST SLAB UNDER EDGE LOADING BEFORE IMPACT

The deflection curves for the slab and for the stringers nearest the load are shown in Figure 14. Two sets of measurements of deflection were made for two applications of each of the four loads on the same day. The two sets of values agreed with each other within close limits and the values shown are for the means of the two measurements.

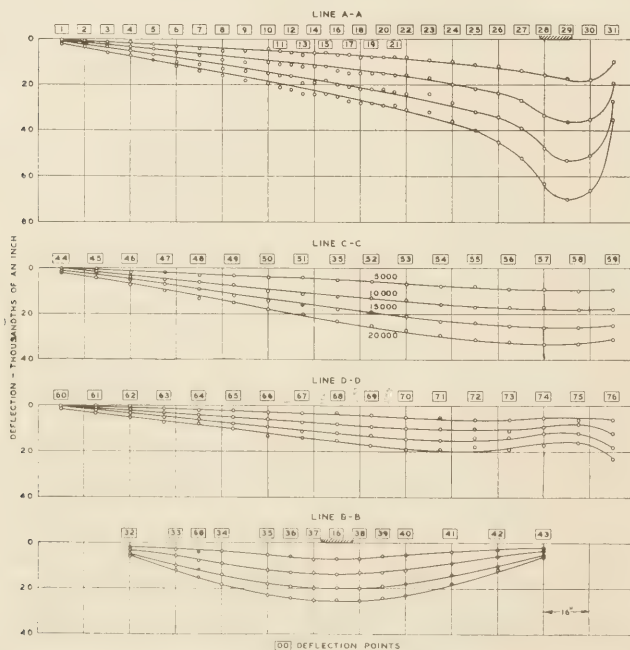
FIGURE 24.—DEFLECTIONS OF SECOND SLAB UNDER EDGE LOADING BEFORE IMPACT

The deflection curves in Figure 24 are the mean values obtained in these loadings. The only significant strain measurements obtained were at the centers of

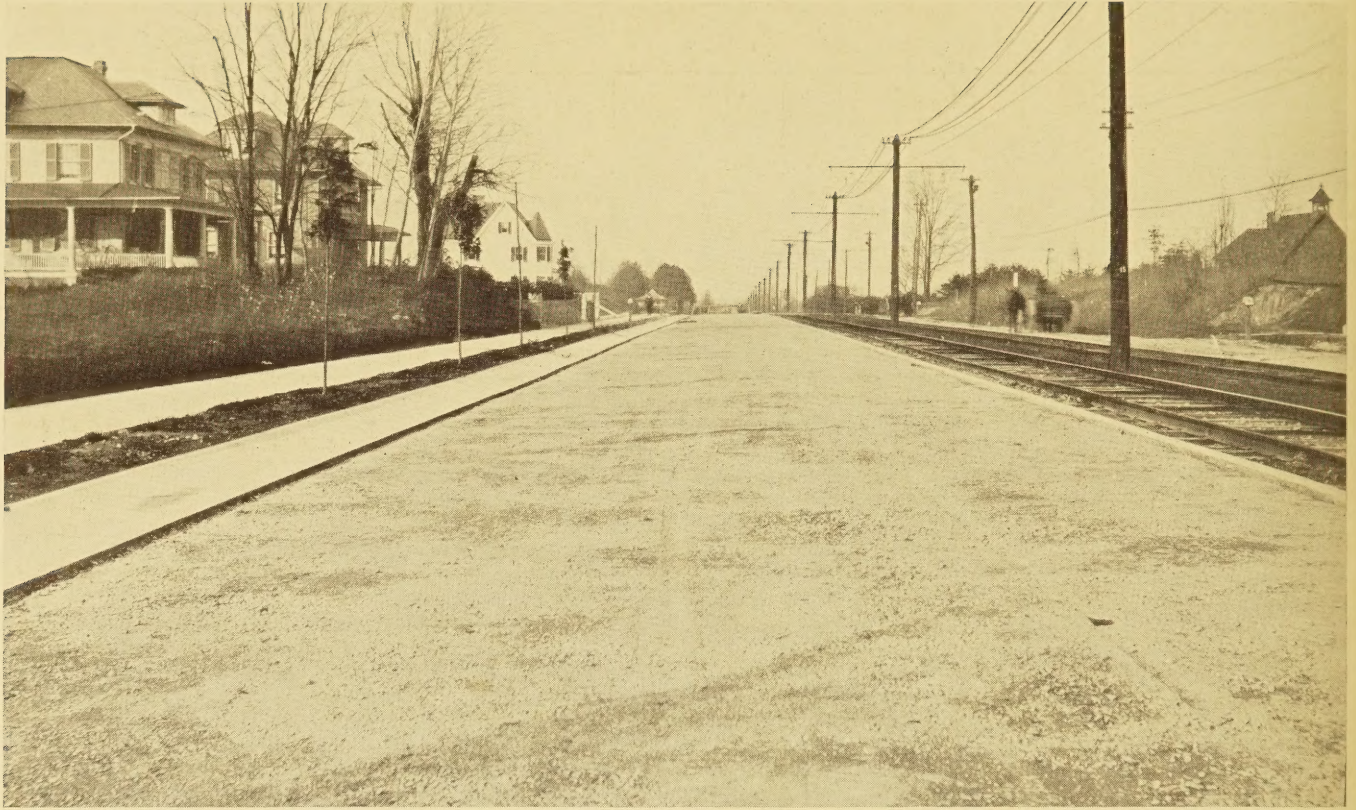
CONNECTICUT AVENUE EXPERIMENTAL ROAD, CHEVY CHASE, MD., NOVEMBER 11, 1912  
PORTLAND CEMENT CONCRETE BASE READY FOR CONSTRUCTION OF BITUMINOUS CONCRETE SURFACE

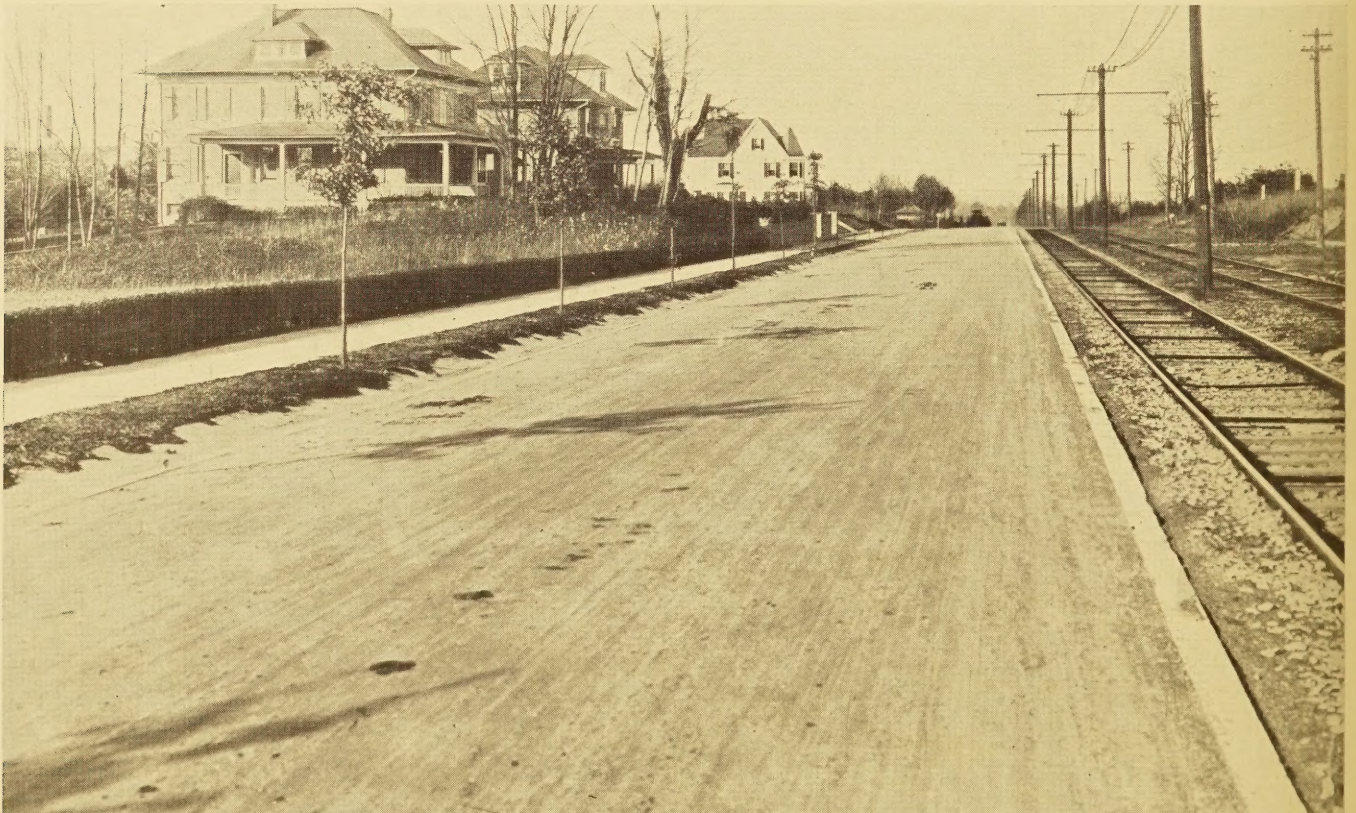
CONDITION OF BITUMINOUS CONCRETE SURFACE AFTER ONE YEAR OF SERVICE, DECEMBER, 1913
