PUBLIC ROADS

A JOURNAL OF HIGHWAY RESEARCH

VOL. 13, NO. 11

Page
Surface Treatment of Topsoil Roads	169
Effect of Size of Specimen, Size of Aggregate, and Method of Loading Upon the Uniformity of Flexural Strength Tests	177

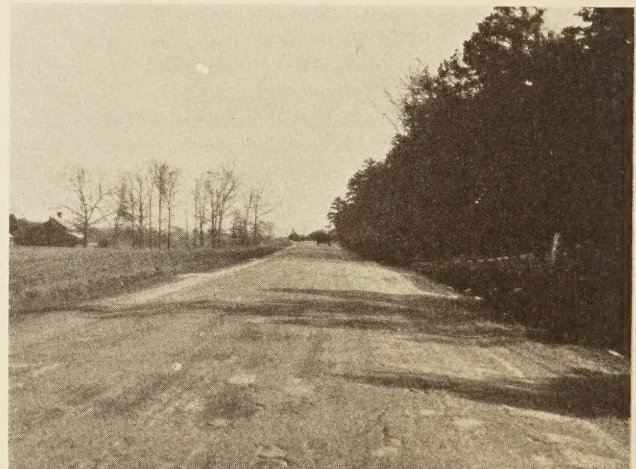
FIGURE 3.—FAILURE OF THE HEAVY NONSKID TREATMENT ON SECTION 8

This section was allowed to go through the winter following construction without a seal and as a result a large number of small patches were required during the winter and early spring. The entire section was sealed in March, 1926, with one-fifth gallon of quick-drying oil and a covering of sand. The only maintenance re-treatment required after that time was that given to the portion between stations 436 and 452+80. It was applied in June, 1928, and consisted of one-fifth gallon of cut-back asphalt and 20 pounds of chats per square yard. In 1930 the portion of the section between stations 464+50 and 512+00 was treated experimentally to eliminate slipperiness in wet weather and to provide a nonskid surface.

Several methods of applying the treatment were tried out. One consisted of the application of a quick-breaking emulsion, spreading the cover material and rolling. This method was varied by applying a tack coat, then spreading and smoothing the aggregate and spreading another application of emulsion, depending upon the second application to penetrate through the cover stone to the tack coat. This treatment was generally not successful, because of the use of an amount of bituminous material insufficient to penetrate the stone cover. The result was that the surface peeled and raveled as shown in Figure 3. By another method the stone was spread, the emulsion applied, the two mixed, and the mixture spread and rolled. This method proved successful where sufficient bituminous material was used. While a nonskid surface texture was obtained by each method, the first one seemed to serve the purpose most satisfactorily.

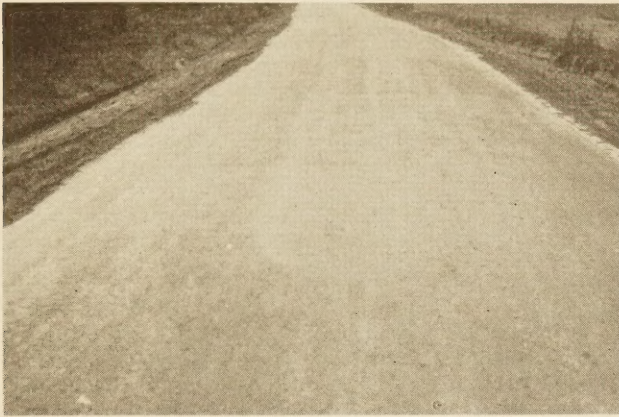
FIGURE 4.—PORTION OF SECTION 8 NEVER RE-TREATED AFTER CONSTRUCTION, PHOTOGRAPHED IN APRIL, 1930

The portion of the section between stations 452+80 and 464+50 remained in excellent condition and received no treatment after March, 1926. Its condition in April, 1930, is illustrated in Figure 4.

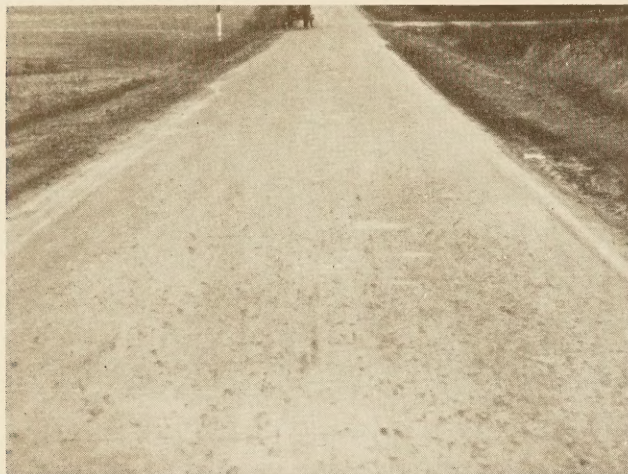
FIGURE 7.—TYPICAL CONDITION OF THE PORTION OF SECTION 10 WHICH WAS NEVER RE-TREATED

than it should have been. Had the project been continued it is believed that a light re-treatment would have been desirable on this area. The portion never re-treated showed no need of immediate re-treatment. Figure 7 is a typical view showing its excellent condition.

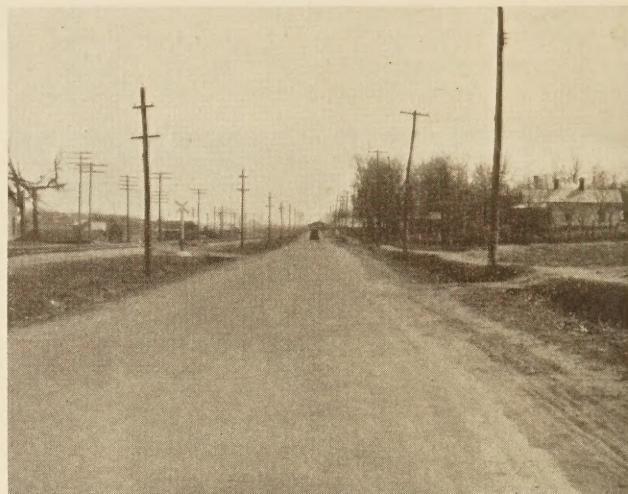
FIGURE 8.—VIEW OF THE SOUTH END OF SECTION 11, SHOWING THE EXCELLENT CONDITION OF THE PORTION NEVER RE-TREATED

The section as a whole was in better condition in July, 1931, than at any previous inspection. The portion which was never re-treated remained in excellent condition as illustrated in Figure 8. Figures 9 and 10 show other views of the section.

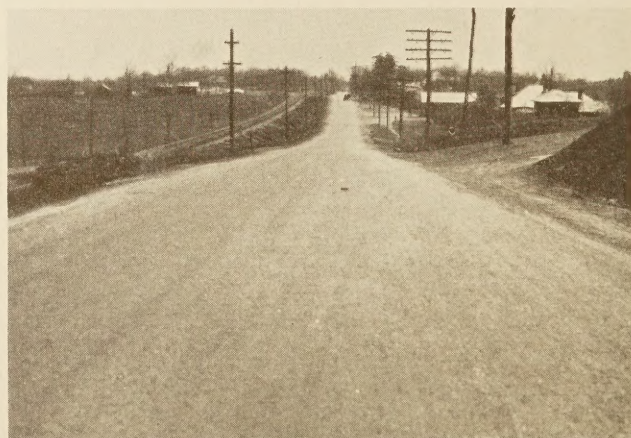
FIGURE 9.—TYPICAL APPEARANCE OF SECTION 11 AFTER APPLICATION OF THE NONSKID TREATMENT

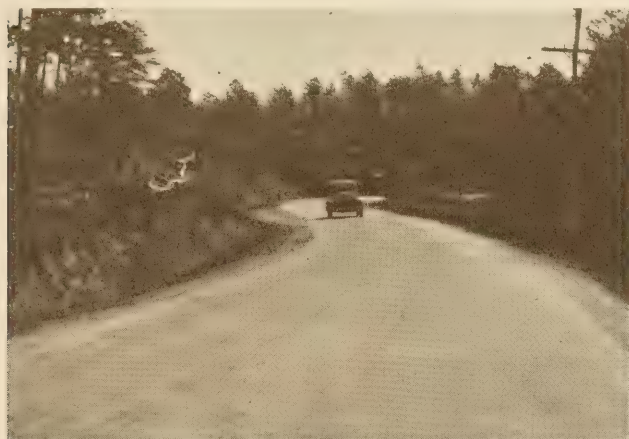
FIGURE 10.—GENERAL VIEW OF NORTH END OF PROJECT, WHICH WAS LOCATED IN FAIRLY ROUGH COUNTRY
