PUBLIC ROADS

CONSTRUCTING A STABILIZED SOIL BASE

STABILIZED BASE EXPERIMENT IN MINNESOTA

BY THE DIVISION OF PHYSICAL RESEARCH, PUBLIC ROADS ADMINISTRATION

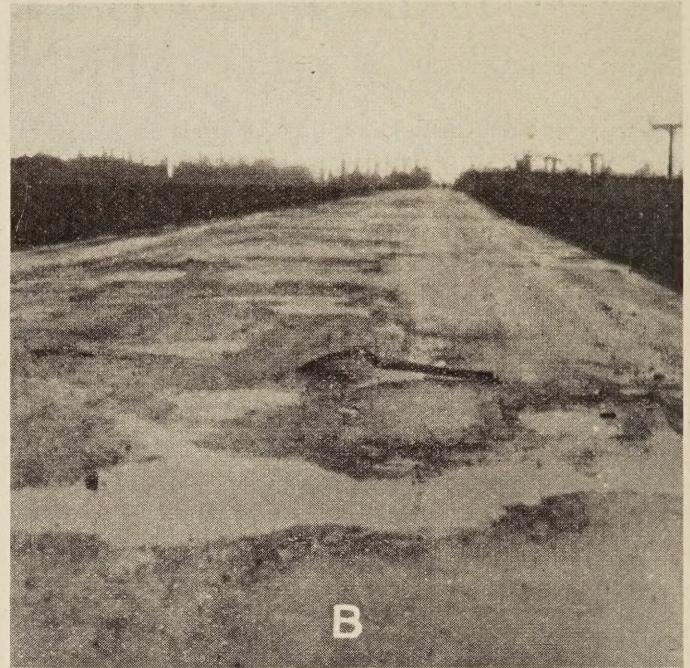
Figure 2.—CONDITION OF OLD BITUMINOUS MAT, A, TYPICAL OF BETTER PORTIONS OF THE PROJECT AND B, TYPICAL OF SECTIONS WHERE SURFACING WAS COMPLETELY DESTROYED.

In 1925 the roadway was graded to a width of 30 feet. In 1926 a blotter type bituminous surface was constructed, followed by re-treatments in 1927, 1928, 1929, 1931, and 1934. In 1936 only about 13 percent of the total length of the road was in good condition, while the remainder was rough as a result of cracking, breaking, pitting, sealing, and raveling. Typical failures are illustrated in figure 2.

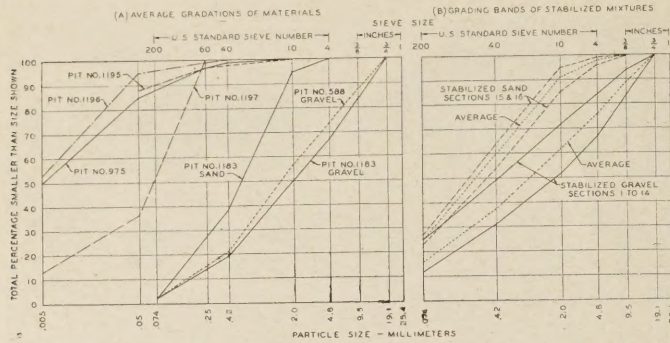
Figure 5.—GRADATIONS OF MATERIALS AND MIXTURES USED IN ORIGINAL CONSTRUCTION.

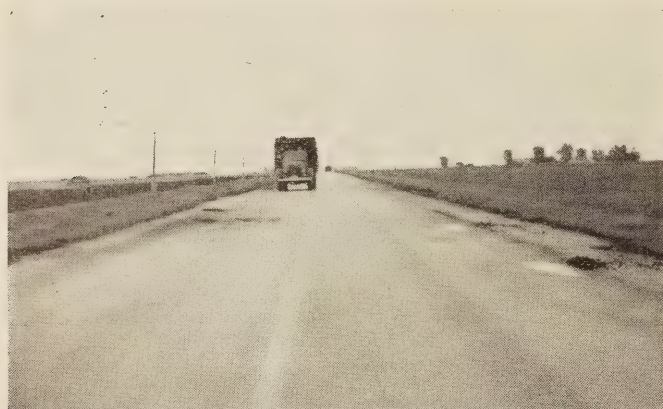
Figure 14.—A BITUMINOUS SURFACE THAT FAILED AFTER 1 YEAR OF SERVICE.

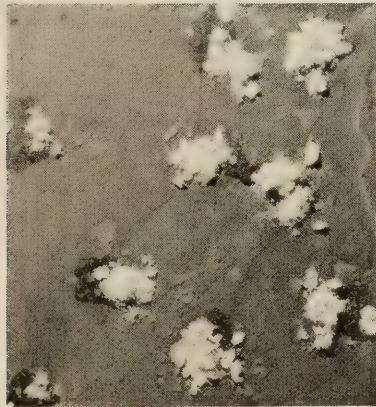
Figure 6.—REACTION OBTAINED IN 65 DAYS WITH CEMENT CONTAINING 0.92 PERCENT TOTAL ALKALIES AND ALTERED TRACHYANDESITE, AN IGNEOUS ROCK TYPE.

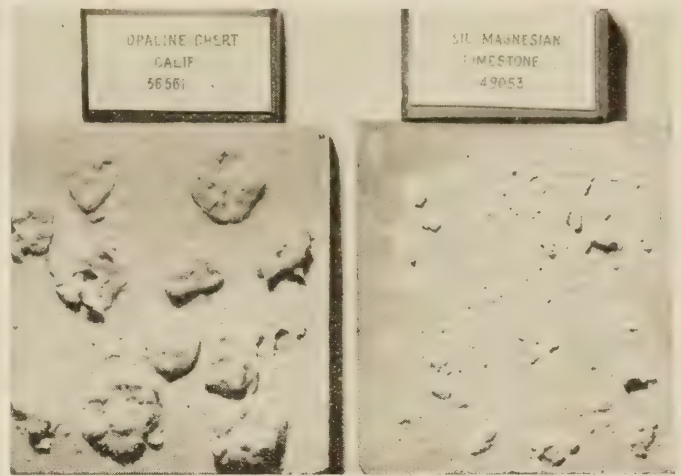
Figure 7.—REACTION OBTAINED USING OPALINE CHERT AND SILICEOUS-MAGNESIAN LIMESTONE WITH CEMENT CONTAINING 0.92 PERCENT TOTAL ALKALIES.

to be very reactive, and the data of these tests correlate with the results obtained by the California Division of Highways. Photographs of the reaction developed by these two aggregates are shown in figure 7.

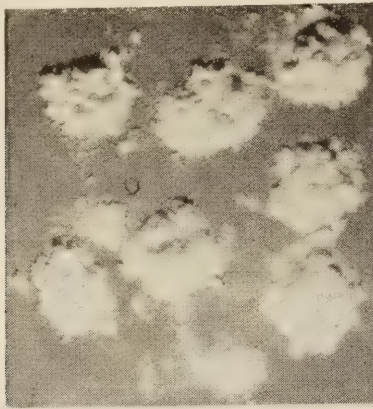
Figure 8.—EXTENT OF REACTION PRODUCT DEVELOPED BETWEEN A POROUS SANDSTONE AND CEMENT CONTAINING AN AVERAGE OF 0.92 PERCENT TOTAL ALKALIES, AFTER 9 WEEKS' STORAGE IN CAUSTIC SOLUTION.
