# PUBLIC ROADS

VOL. 24, NO. 8

# LONGITUDINAL CRACKING IN CONCRETE PAVEMENTS

A REPORT ON A STUDY OF CRACKING IN KENTUCKY, INDIANA, AND ILLINOIS

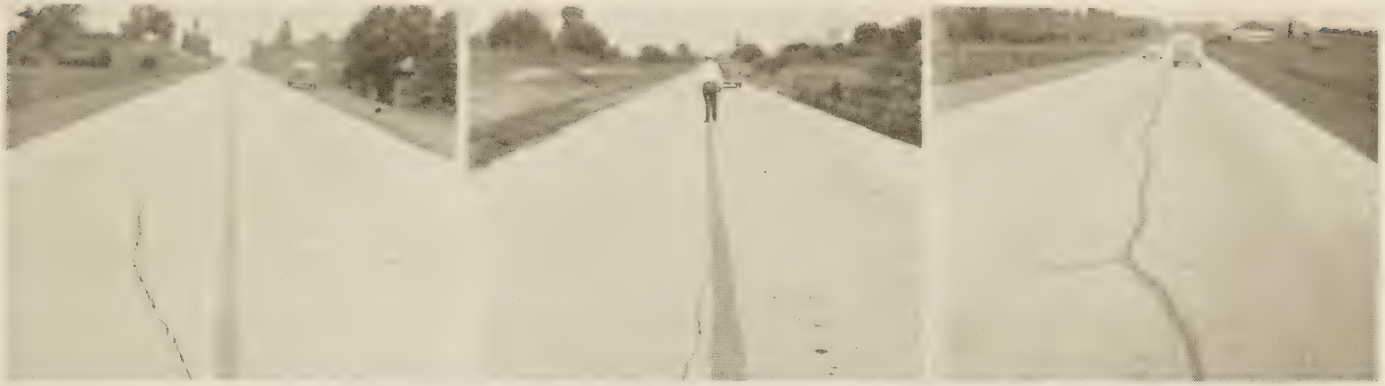
FIGURE 3.—TYPICAL LONGITUDINAL CRACKS IN THE 1942 KENTUCKY PAVEMENTS.

Many of the cracks had opened up badly because of the absence of reinforcement in the pavement and of tie bars in the longitudinal joint. Figure 3 shows several typical examples of cracking in the Kentucky pavements laid in 1942.

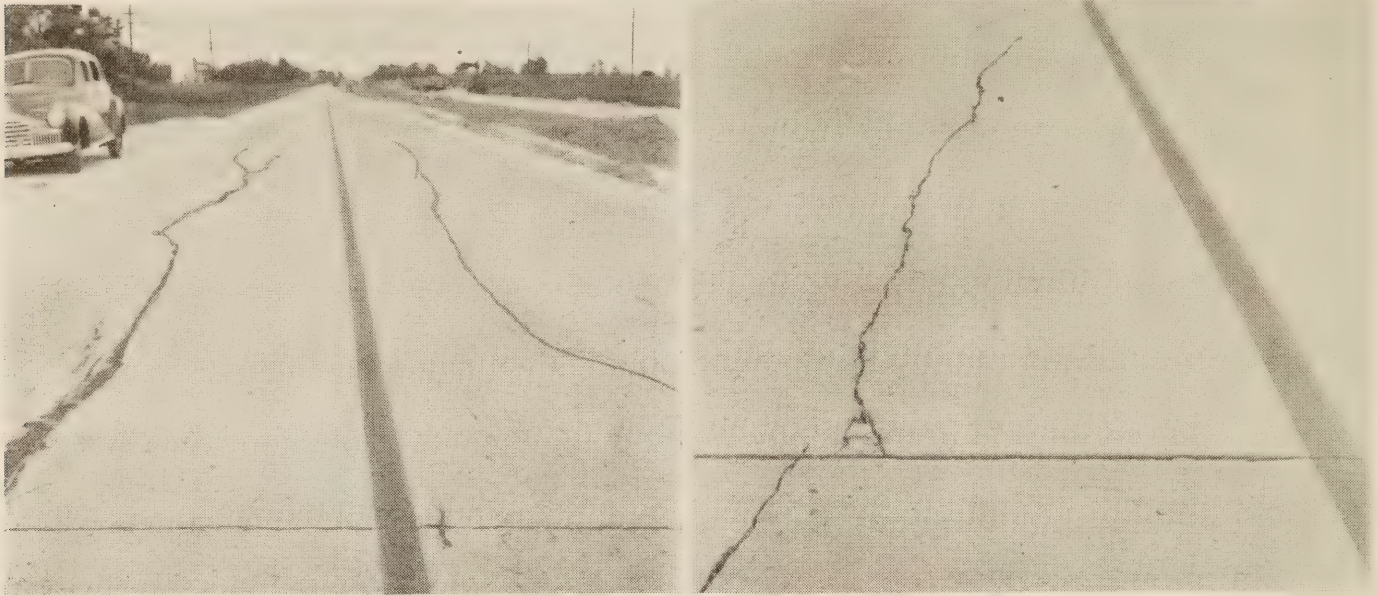
FIGURE 5.—TYPICAL LONGITUDINAL CRACKS OBSERVED IN 1943 IN INDIANA PAVEMENT SN-FA 13-B (2).

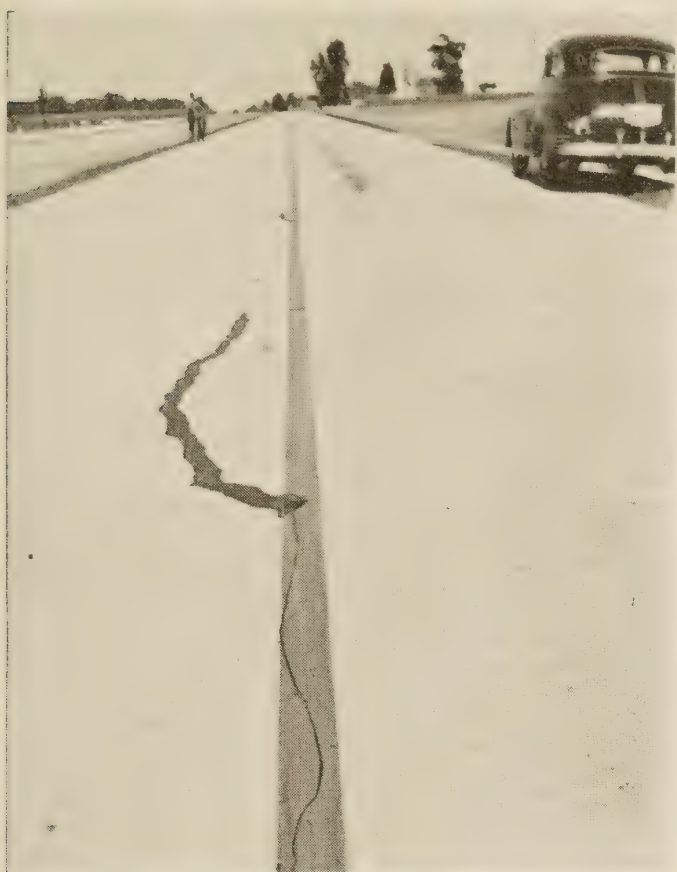
FIGURE 7.—TYPICAL LONGITUDINAL CRACKS IN INDIANA PAVEMENT SN-FA 74 A (2), A (3), B (5).

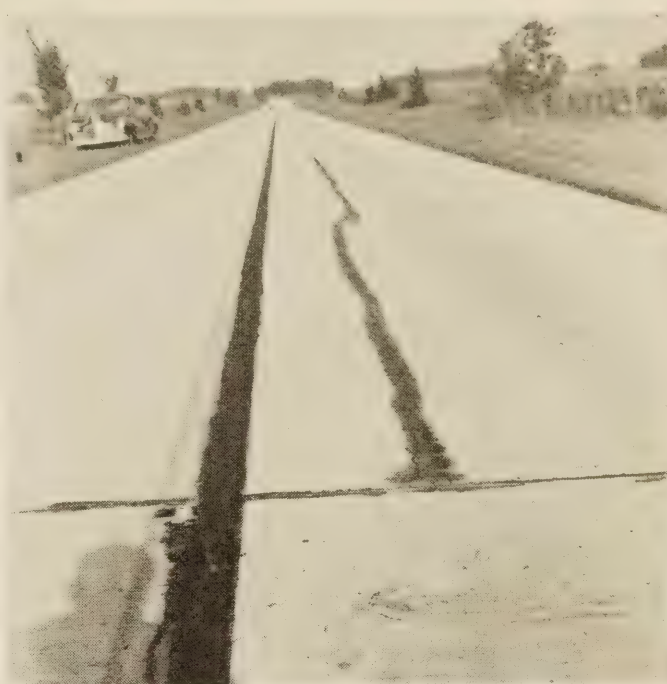
FIGURE 8.—LONGITUDINAL CRACKING IN THE OLDER REINFORCED PAVEMENTS WITH DUMMY CENTER JOINT LAID IN INDIANA IN 1937 (74-E).

It was found that a small number of longitudinal cracks have formed in these pavements. The majority of these break from the center joint at some intermediate point and continue the remaining length of the panel and, as found in the 1942 pavements, the center joint had not fractured in the panels or parts of panels where the longitudinal cracking developed. Figure 8 shows typical longitudinal cracks found in these pavements.

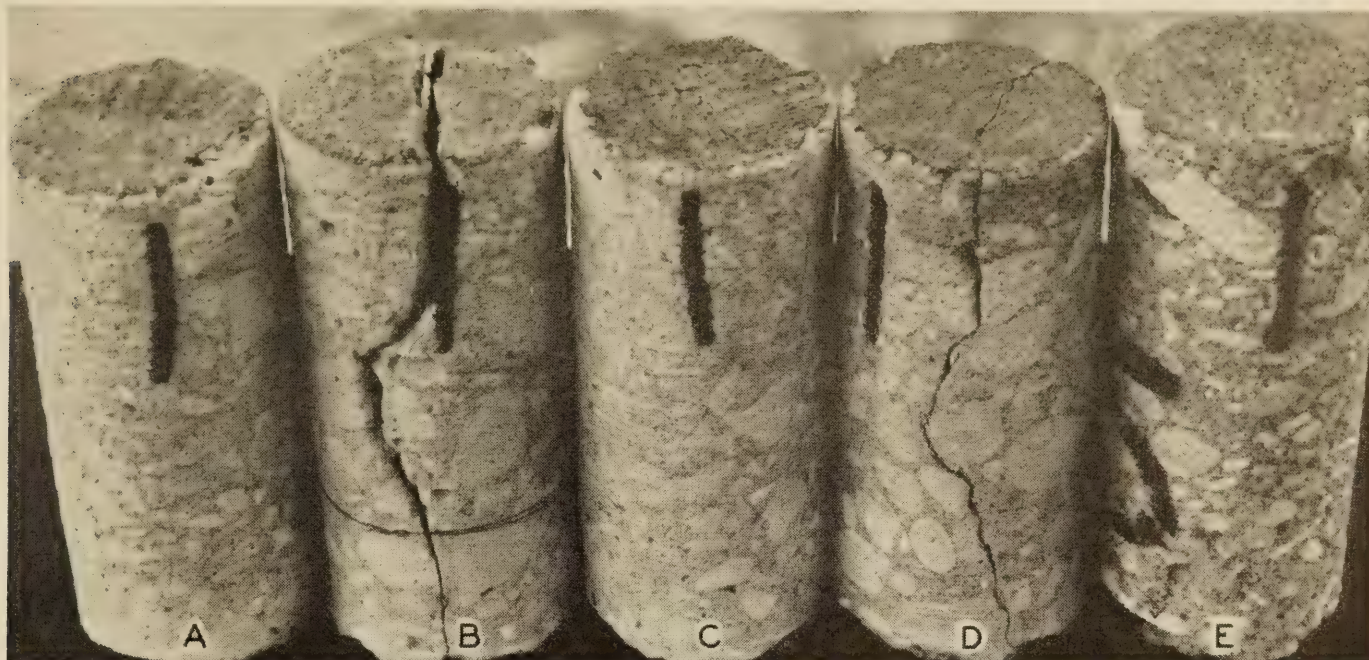
FIGURE 9.—TYPICAL CORES DRILLED AT THE LONGITUDINAL JOINT IN THE 1942 ILLINOIS PAVEMENTS.

Core A of figure 9 was taken from a panel with a full-length longitudinal crack approximately 2 feet from the center joint. The top edge of the ribbon was one-half inch below the surface and there was no crack either above or below the ribbon. There was no crack in the

panel from which core B was taken. The ribbon was seven-sixteenth inch below the surface and the center joint had fractured. The panel from which core C was taken showed a full-length longitudinal crack. The ribbon was one-fourth inch below the surface and there was no crack either above or below the ribbon. The panel from which core D was taken was cracked. The ribbon was one-half inch below the surface and there was no crack either above or below the ribbon. The panel from which core E was taken contained a full-length longitudinal crack. The ribbon was one-half inch below the surface and there was no crack above or below the ribbon.

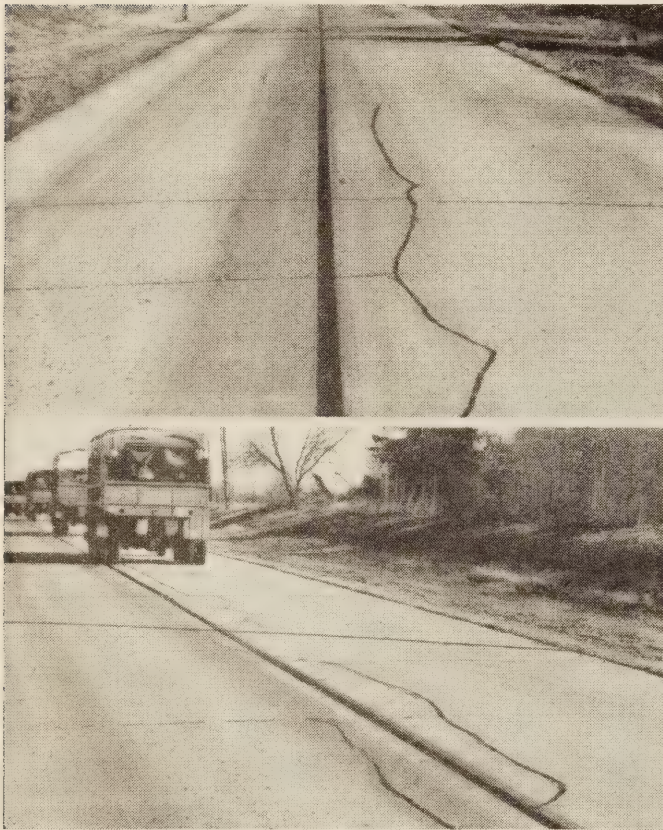
FIGURE 11.—LONGITUDINAL CRACKING IN NEBRASKA PAVEMENTS WITH DUMMY CENTER JOINT, LAID IN 1935-36.
