# Public Roads

Continuous Reinforcement in Concrete Pavement—after 15½ years . . . . .	127
New Publications:	
<i>Revisions to the Manual on Uniform Traffic Control Devices for Streets and Highways</i> . . . . .	141
<i>Construction Review</i> . . . . .	141
<i>Annual Report of the Bureau of Public Roads, Fiscal Year 1954</i> . . . . .	142
<i>Criteria for Prestressed Concrete Bridges</i> . . . . .	142
<i>Uniform Vehicle Code</i> . . . . .	142

Observation of the experimental pavement sections after 15<sup>1</sup>/<sub>2</sub> years of service indicates that, with the proper use of longitudinal reinforcement, any spacing of transverse joints within the range studied will give satisfactory performance, without failure of the steel or adverse effects on the concrete.

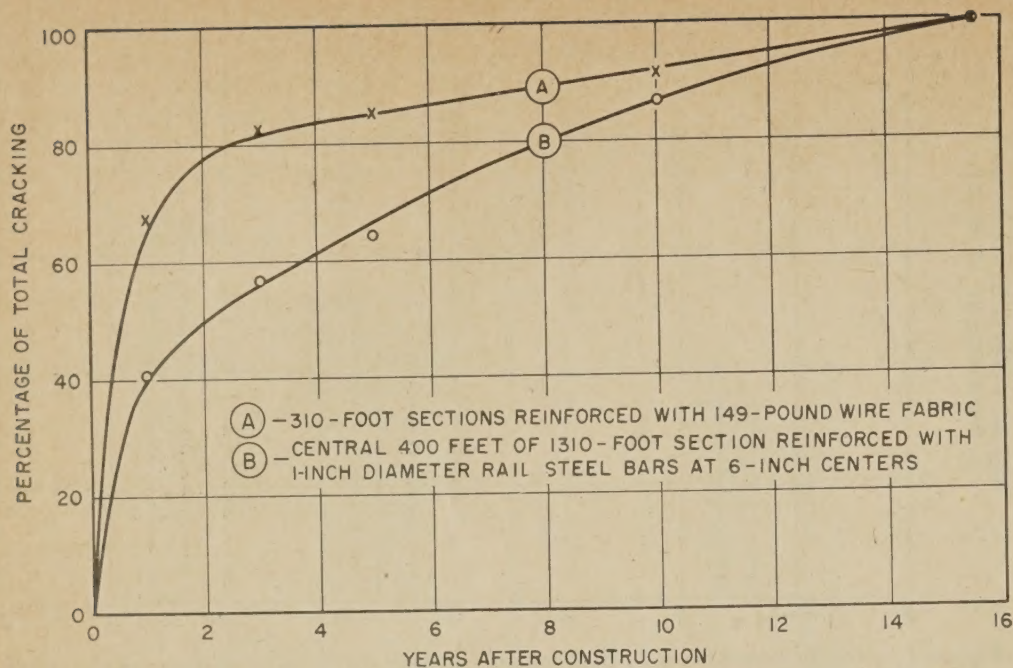
Figure 3 indicates the manner in which the fractures appeared with respect to time. As will be noted, the rate of cracking was very high during the first year following construction, after which the rate was comparatively

low, remaining rather uniform for the intermediate-length section and diminishing progressively with time in the case of the central area of the long section. Of special interest is the fact that 13 percent of the cracks now present in the central 400 feet of the 1,310-foot section formed during the last 5½ years. This suggests a continued high stress condition in the concrete in that region, with continued bond between the steel and the concrete.

Figure 3.—Rate of crack development during the first 15½ years of pavement life.

Figures 3 and 4 show the development of cracking over the 15½-year period in two selected cases, a 310-foot section and the critical central region of the 1,310-foot section. In this report, unless otherwise noted, fractures less than 5 feet long and those that occurred at the extreme ends of sections as a result of pumping at the joints are not considered in the various analyses of cracking.

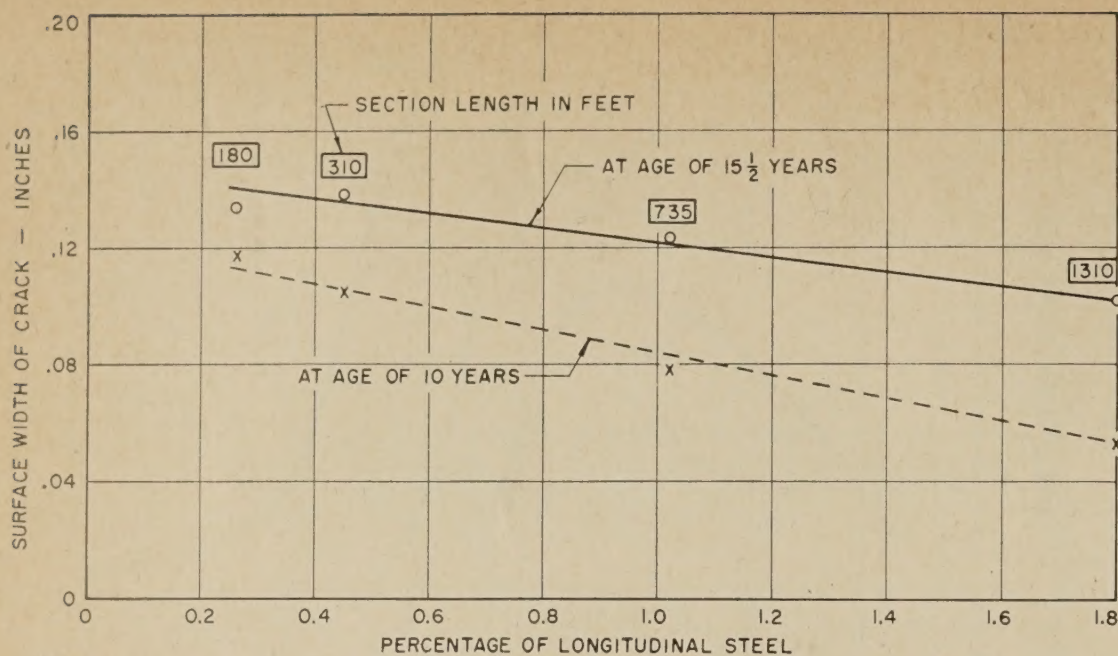
At pavement ages of 10 and 15½ years, measured values of the average surface widths of numerous cracks were obtained in the manner described. Figure 7 shows, for each of the two ages, the relation established by plotting values obtained in the heavily traveled lane against corresponding percentages of longitudinal reinforcement. Each plotted value represents an average of a number of fractures that formed at an early age in the central area of the longest section of a group of similarly reinforced sections.

Comparisons available in figure 7 indicate that the surface widths of cracks tend to decrease with an increase in the amount of longitudinal steel in spite of the fact that the heavier the reinforcement the longer the length of section. As expected, the surface widths of cracks tend to increase with pavement age. It is of interest to note, however, that during the last 5½ years the rate of surface raveling

Figure 7.—Effect of percentage of longitudinal steel and pavement age on the surface widths of cracks. The values shown are of fractures that occurred at an early age in the central portion of sections in the heavily traveled lane.

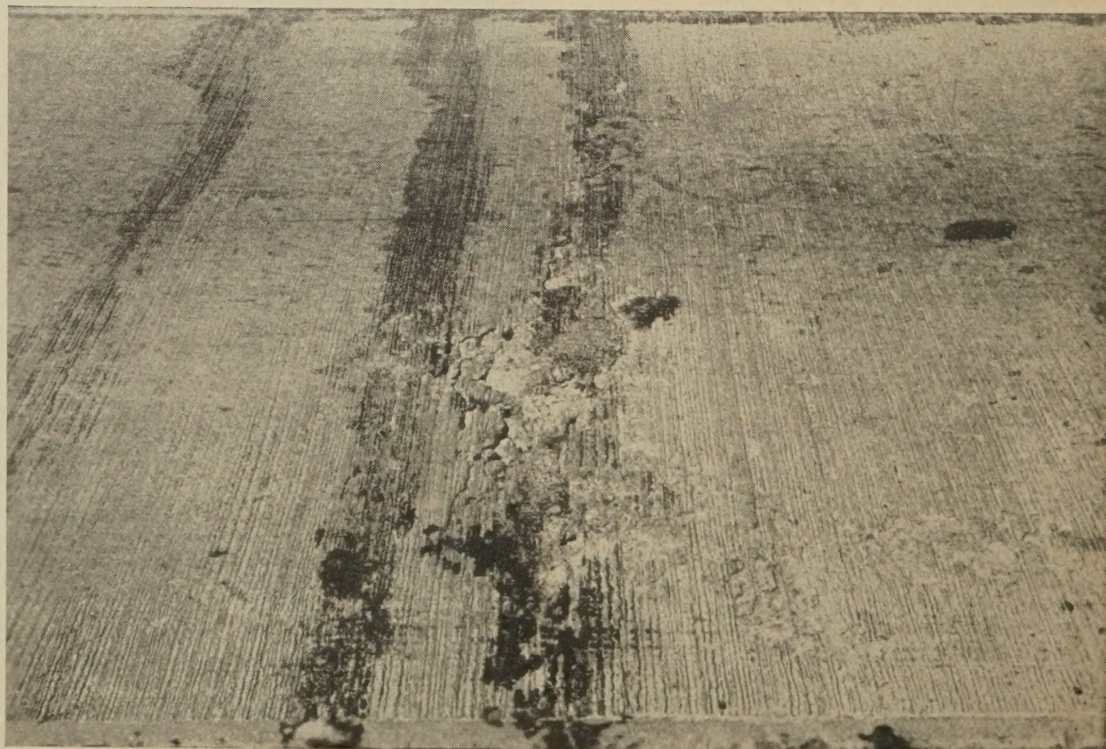
Concrete deterioration, other than the natural raveling and wearing just reported, was extremely rare at all cracks held closed by continuous reinforcement. Of the few cases of more than superficial damage observed at the cracks, the worst is pictured in figure 8. This type of damage, classified as surface spalling, was first noticed during the 15½-year performance survey.

Figure 8.—Extreme case of spalling at a crack in a section reinforced with heavy steel bars. Even minor spalling at such cracks is unusual.

With the exception of isolated cases of spalling, such as that shown in figure 8, it is the opinion of all those who have examined critically the more heavily reinforced sections that the inconsequential surface widths and the fineness of the transverse cracks themselves definitely preclude the need for bituminous maintenance. Opinion has been

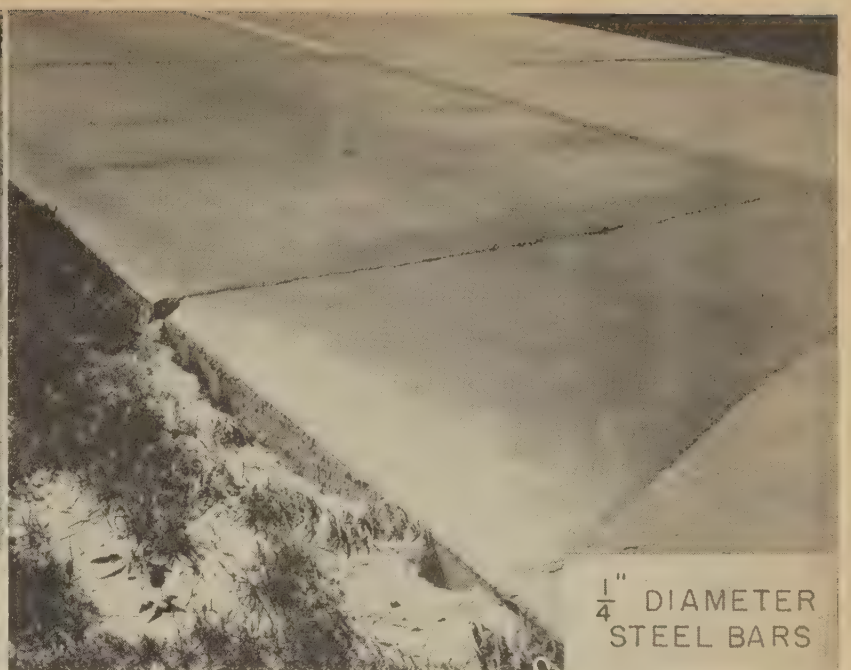
32- POUND  
WIRE FABRIC

$\frac{1}{4}$ " DIAMETER  
STEEL BARS

Figure 9.—Cracks at which the reinforcing steel failed. Steel failures in the heavily traveled lane were generally followed by pumping and faulting.

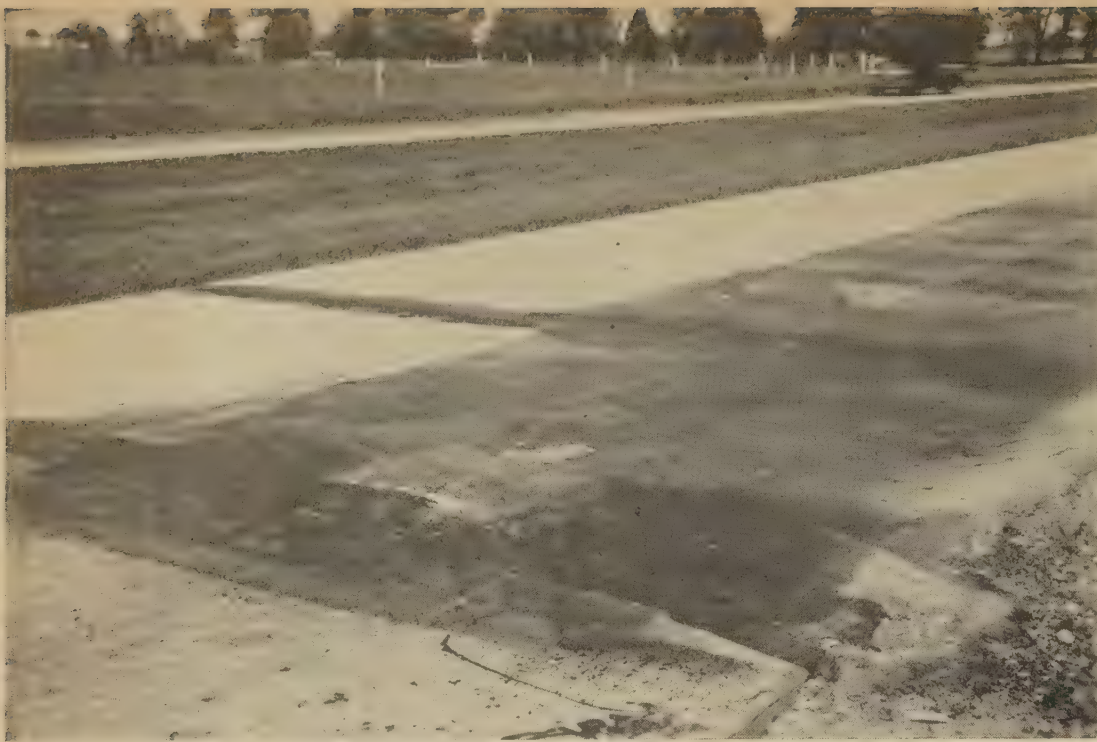
**Figure 11.**—Condition after 15½ years of a double bridge-type expansion joint, typical of the majority. Loosening of the steel cover plate, pumping, and faulting developed at an early age at most of these joints in the heavily traveled lane.

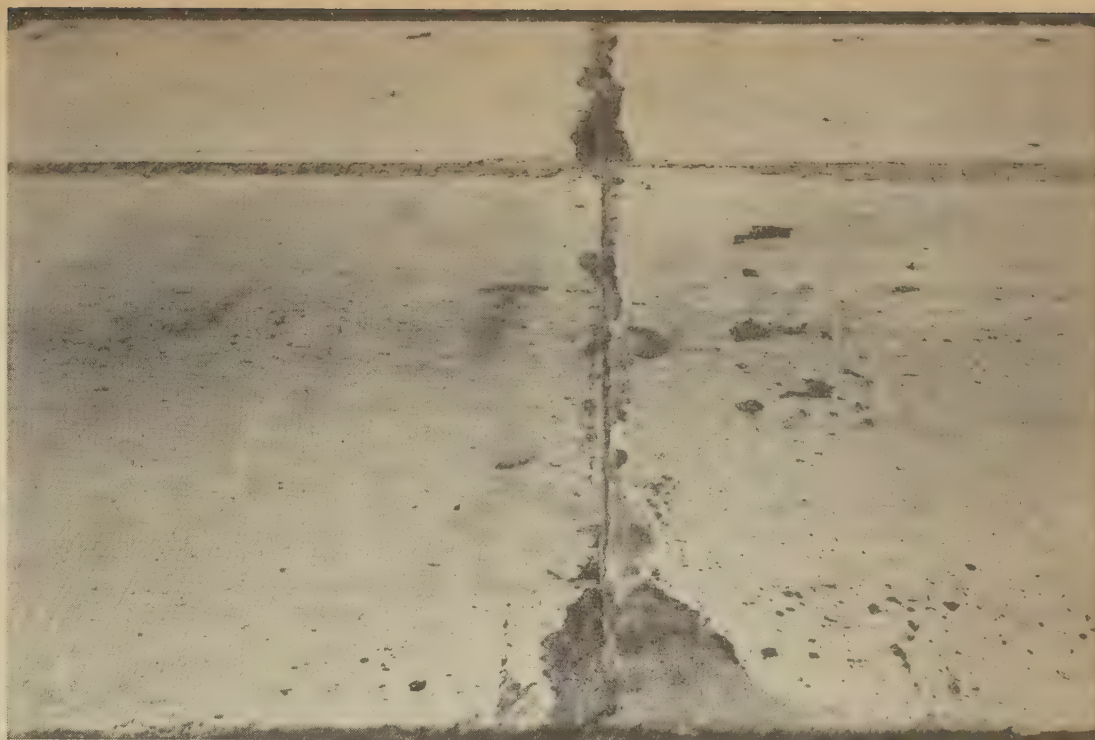
Figure 12.—Condition after 15½ years of a construction joint in sections reinforced with wire fabric. Tie bars were used to hold adjoining slabs together.

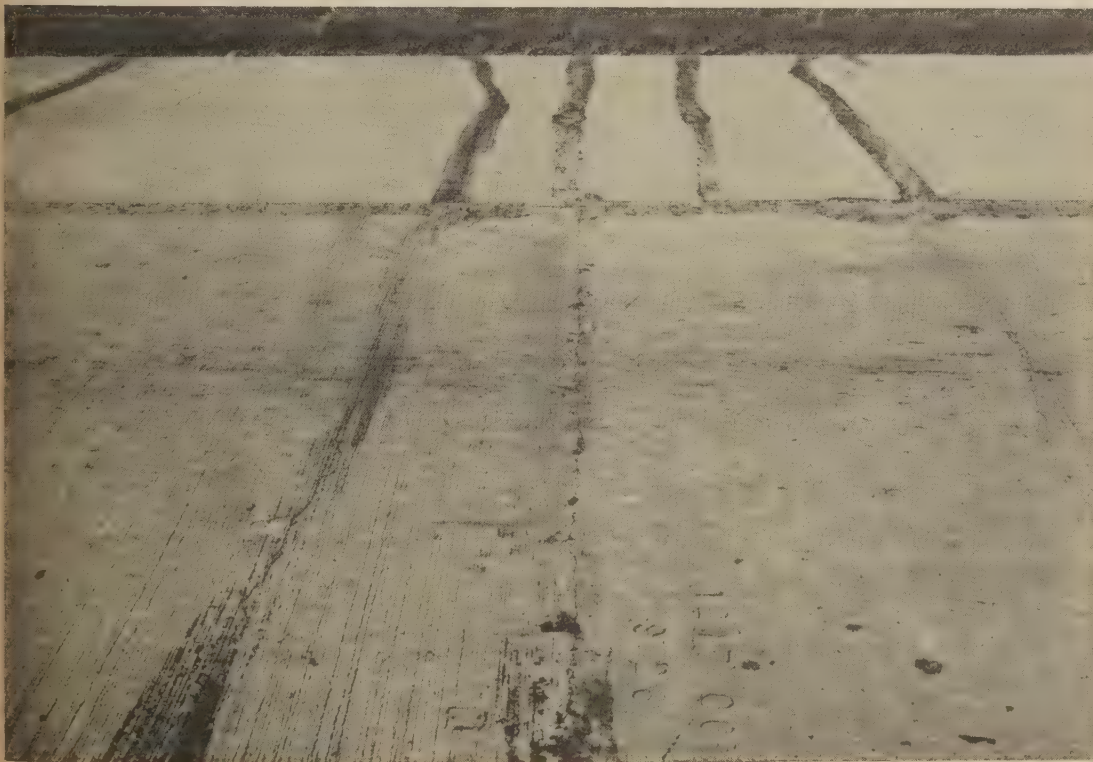
Under the same conditions 22 of the 25 construction joints of the second type—that is, those containing continuous reinforcement—were found to be structurally sound, tightly closed, and free from pumping. The condition of the pavement at one of these joints, installed in the central portion of a section reinforced with 1-inch diameter bars, is shown in figure 13.

Figure 13.—Condition after 15½ years of a construction joint in the central portion of a section reinforced with heavy steel bars. Reinforcement was continuous through the joint.

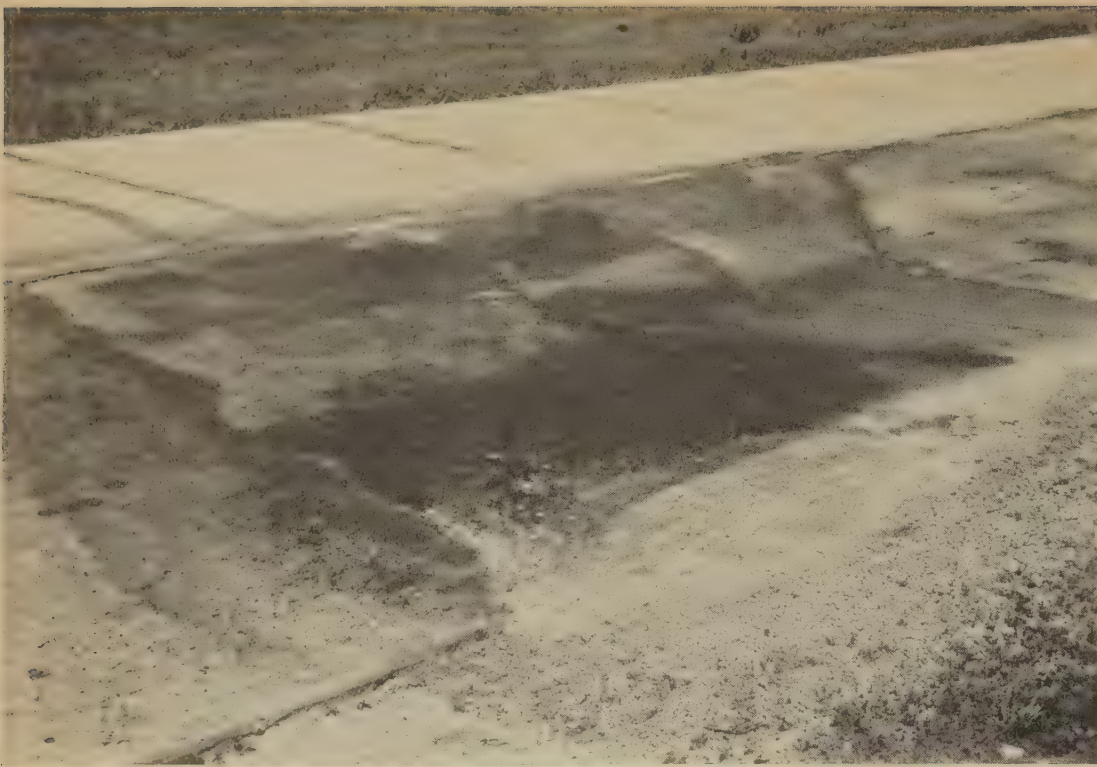
**Figure 14.**—Condition after 15½ years: Slab failure in heavily traveled lane near center of 830-foot section reinforced with 1-inch rail-steel bars. Faulting at longitudinal joint and edge pumping preceded structural breakdown.
