# public roads

March 1979

Vol. 42, No. 4

# Solving the Mysteries of Pavement Deflections With "Thumper"

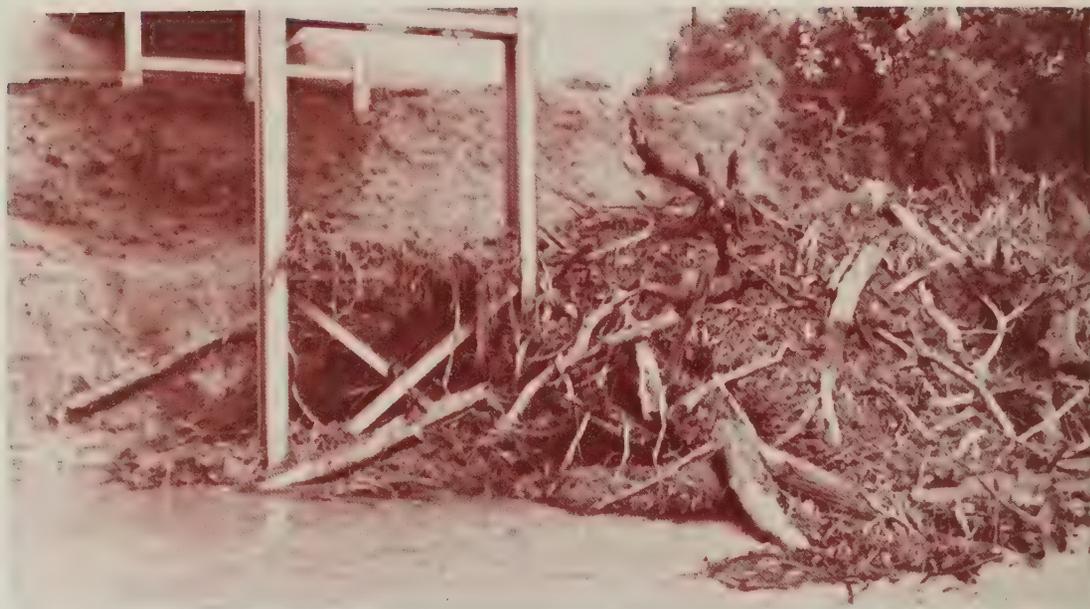
Figure 2.—Massive vegetation debris accumulation on a bridge pier.

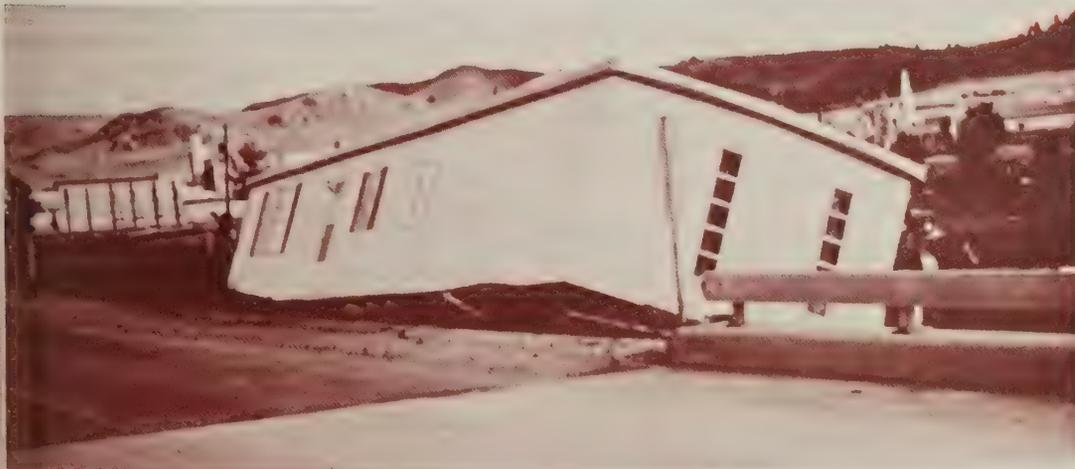
Figure 3.—Manmade structures can become a debris problem in severe floods.

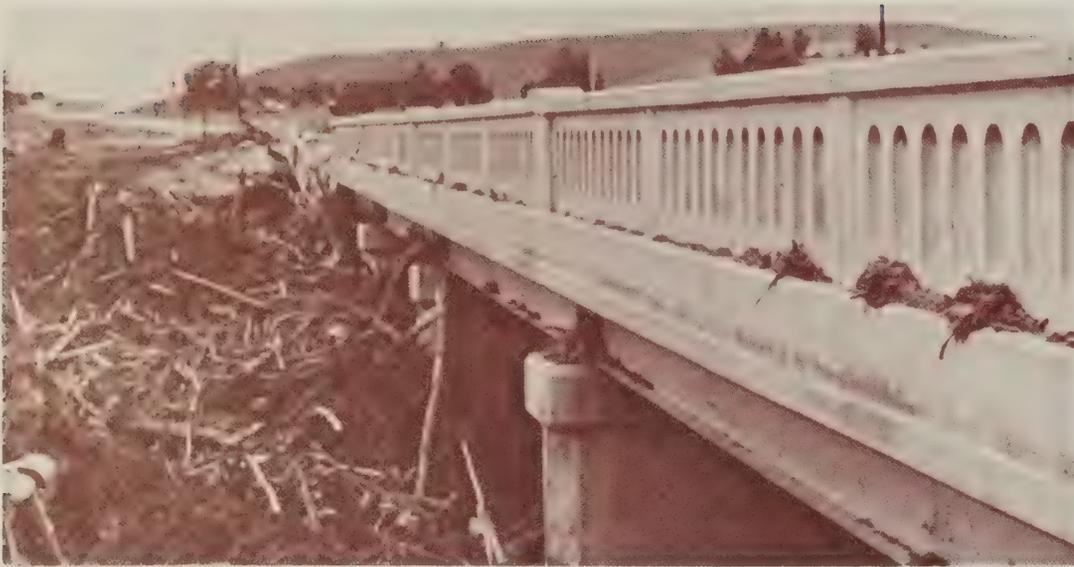
Figure 4.—Massive debris pile-ups may constrict flood flow and result in scour at the bridge pier. Note damaged deck at the far end of the bridge.

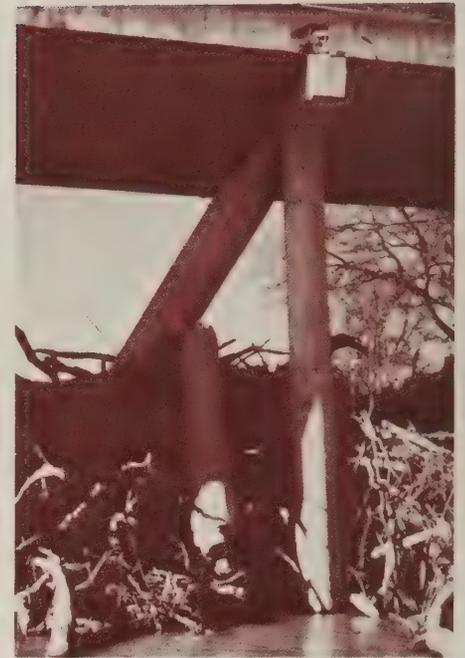
Figure 5.—The lateral forces of water against a large debris accumulation caused the destruction of this bridge pier.

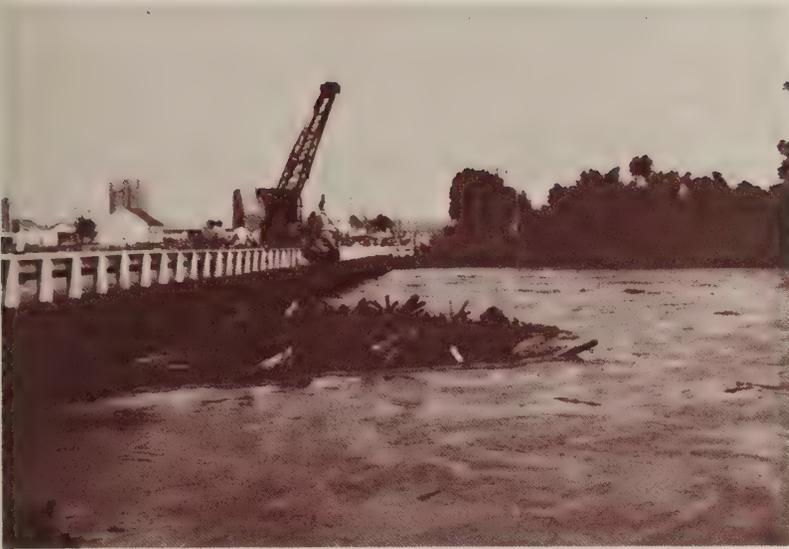
Figure 6.—Crane being used to remove hazardous debris.

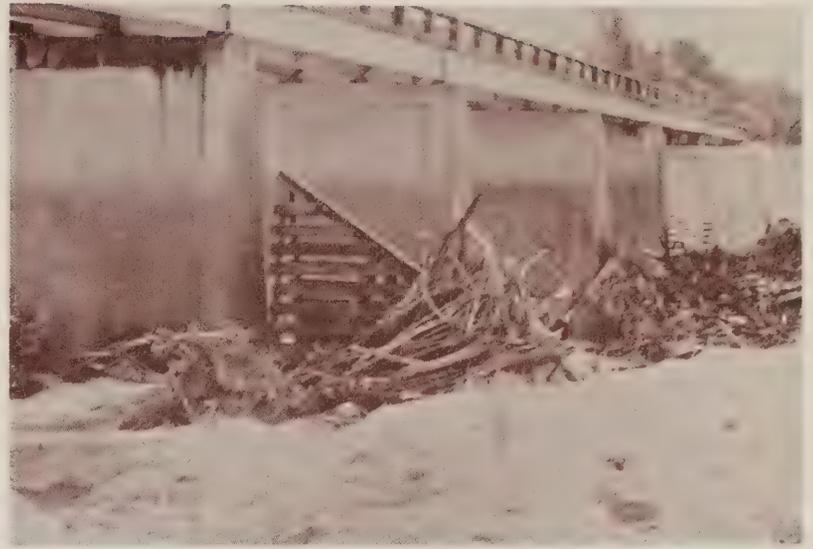
Figure 7.—A debris fin (foreground) and a debris crib (last pier).

Debris fins and cribs are similar to deflectors but are attached to the leading pier and guide debris to either side of the pier (fig. 7). A debris crib is any type of shielding that protects otherwise debris-prone parts of the structure. Cribs are commonly provided for open pile bents in streams known for their debris potential. The spacing between crib strips should be chosen carefully or the problem the strips were meant to solve could become worse. The space between the strip should be small enough to preclude branch entrapment and resulting debris accumulation. The crib should

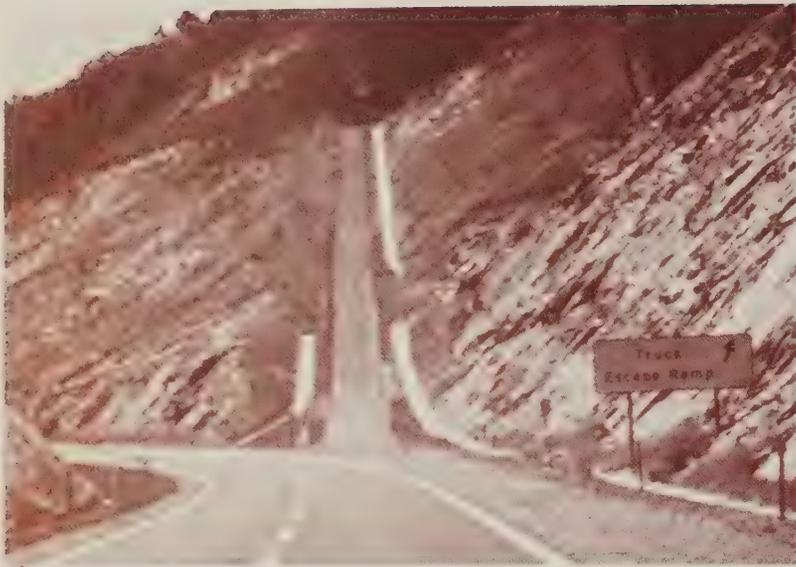
Gravity escape ramp.

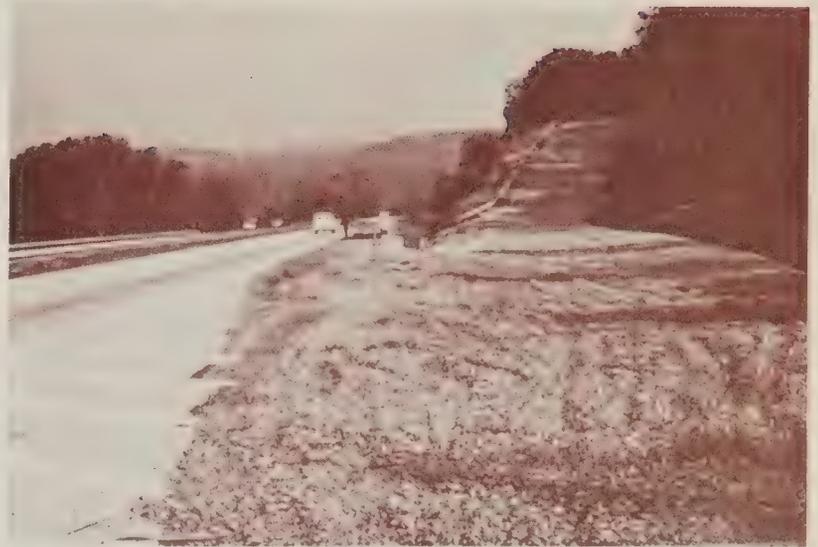
Figure 2.—Arrester bed ramp being constructed.

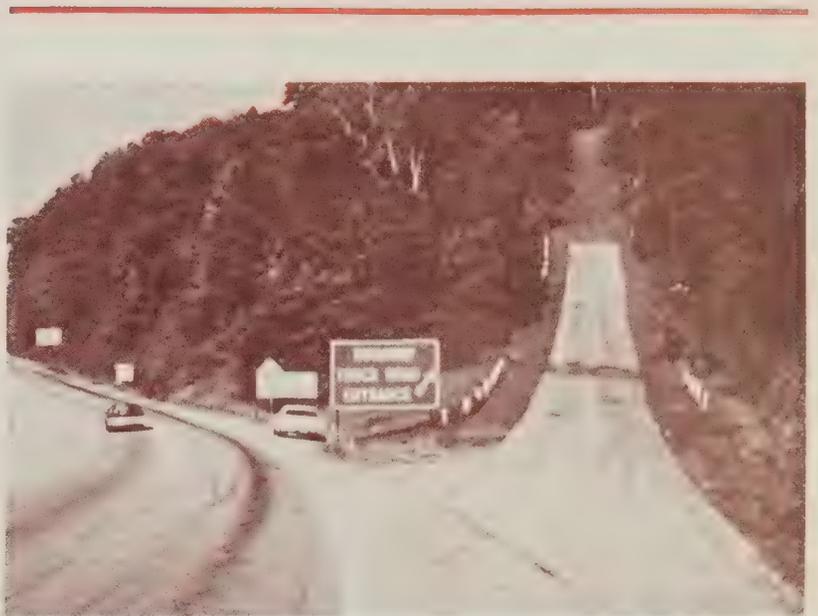
Figure 3.—Combination arrester bed and gravity ramp.

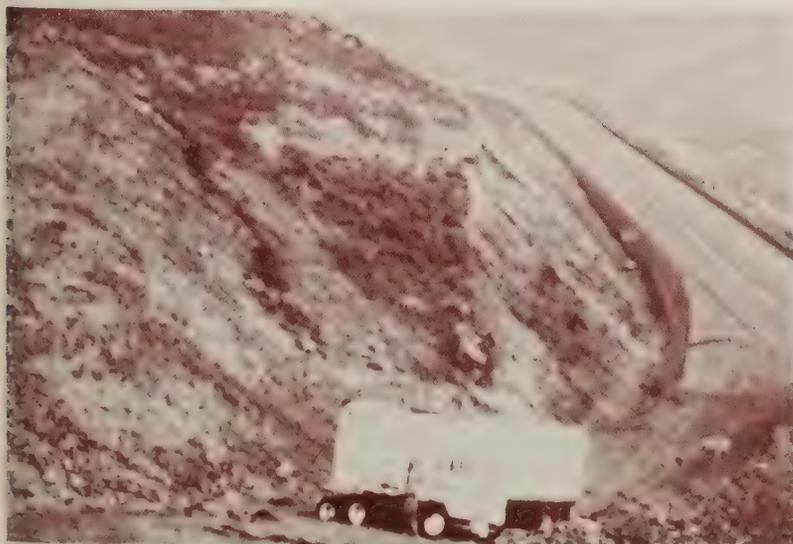
Figure 1.—Arrester bed ramp with embedded truck.

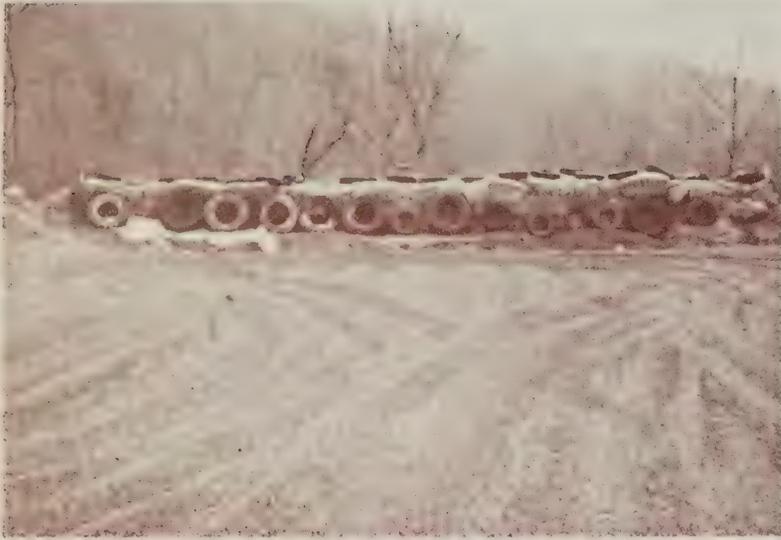
Figure 4.—Arrester bed ramp with attenuator.

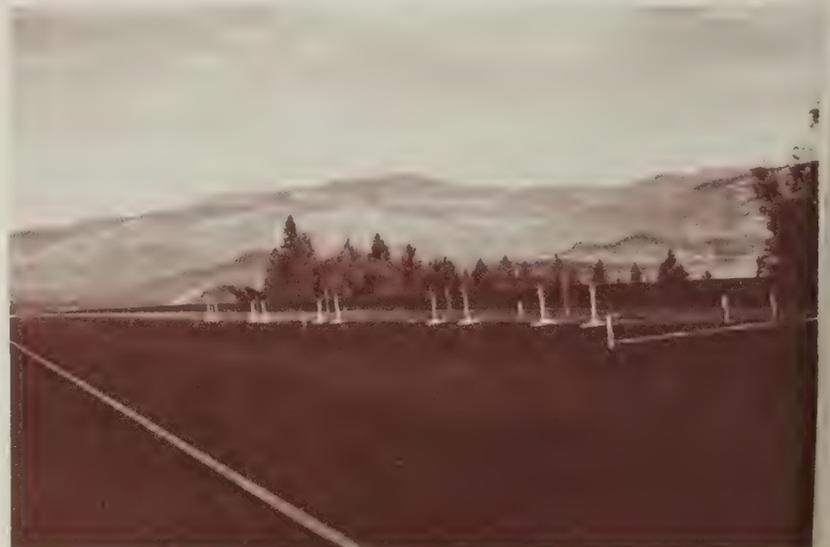
Figure 5.—Overall view of the Siskiyou Truck Escape Ramp with smooth arrester bed.

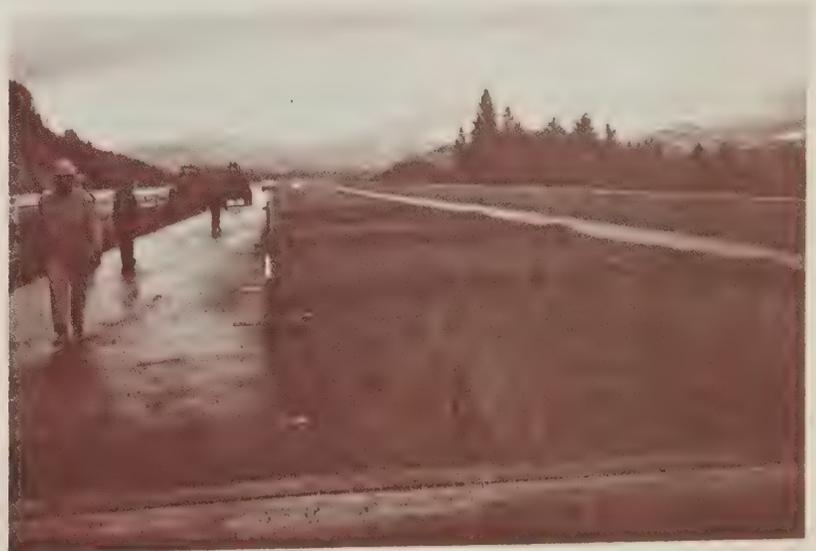
Figure 6.—Smooth bed with 0.3 m high transverse mounds, 3.7 m service lane, and oversize jersey-type barrier.

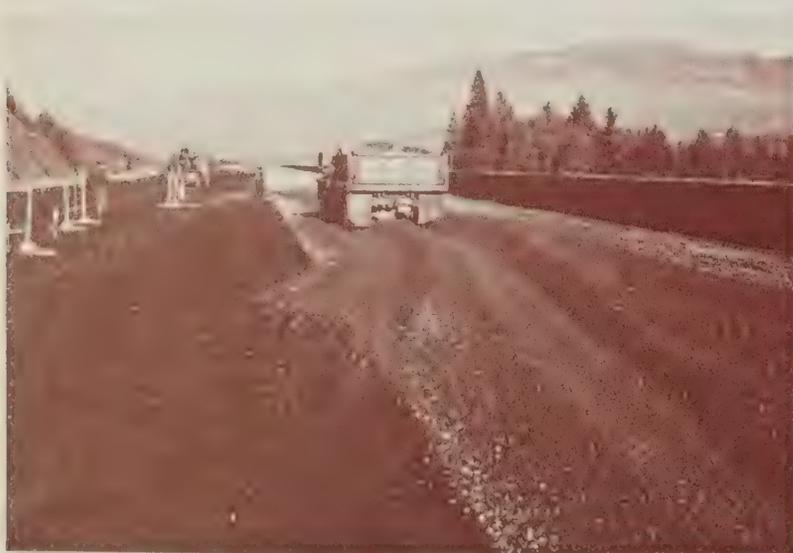
Figure 7.—Single-unit truck test at 40.2 km with right wheel entry.

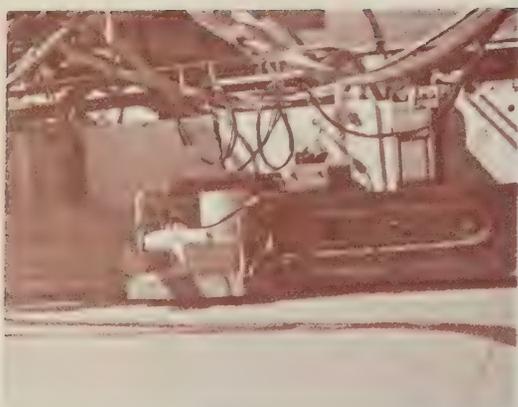
Figure 2.—Source/sensor unit and traversing mechanism.
