**VERIDIAN ON-SITE SIDE AIR BAG RELATED CHILD  
SERIOUS INJURY INVESTIGATION**

**VERIDIAN CASE NO. CA01-049**

**VEHICLE - 1997 NISSAN QUEST XE**

**CRASH DATE - MAY, 2001**

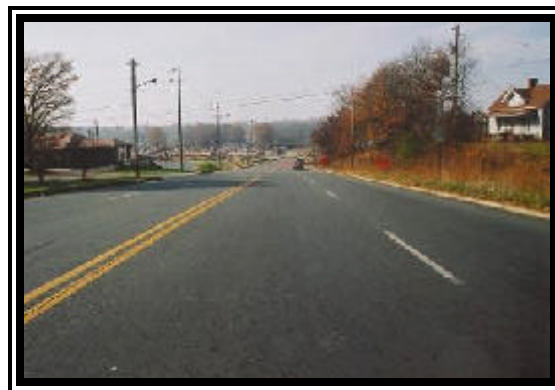
**Figure 1.** Westbound approach for the 1997 Nissan Quest.

The 30 year old female driver of the 1997 Nissan Quest XE was en-route home and operating the vehicle westbound (**Figure 1**) on the inboard lane of a four lane roadway at a (driver reported) speed of 56 km/h (35 mph). The driver became distracted by a conversation with the front right child passenger and failed to observe traffic slowing ahead for the urban connector. Upon recognition of the impending harmful event, the driver braked in avoidance and remained in the westbound inboard lane prior to the collision.

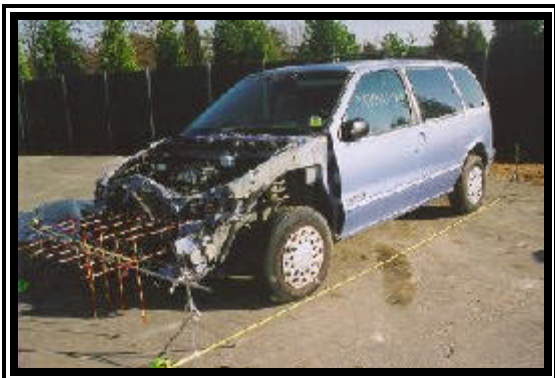
Figure 2. Front left damage to the 1997 Nissan Quest XE.

The 1997 Nissan Quest XE sustained moderate frontal damage as a result of the impact with the GMC Sonoma pickup truck (**Figures 2 & 3**). Although the vehicle was partially dismantled by insurance personnel prior to the SCI inspection, crush dimensions were accurately obtained for reconstructive purposes (*the hood, fenders and bumper assembly were removed from the vehicle and were not available for SCI inspection*). The direct contact damage began at the front left bumper corner and extended approximately 103.0 cm (40.6 in) inboard. The impact deformed the entire front end width resulting in an combined direct and induced damage length (Field L) of 101.0 cm (39.8 in). Six crush measurements were documented at the level of the bumper and 13.0 cm (5.1 in) above the level of the bumper to capture the underride damage, which resulted in an *averaged profile of*: C1= 16.0 cm (6.3 in), C2= 10.0 cm (3.9 in), C3= 11.0 cm (4.3 in), C4= 10.0 cm (3.9 in), C5= 0 cm, C6= 0 cm. The Collision Deformation Classification (CDC) for this impact to the Nissan was 12-FYEW-2 with a principal direction of force of 0 degrees. The windshield was fractured at the right lower A-pillar from exterior impact forces and the right mid-windshield area from the passenger air bag deployment. No wheelbase reduction was identified.

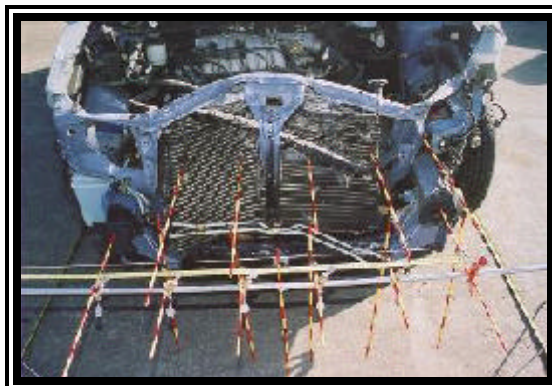
Figure 3. Gauge overview.

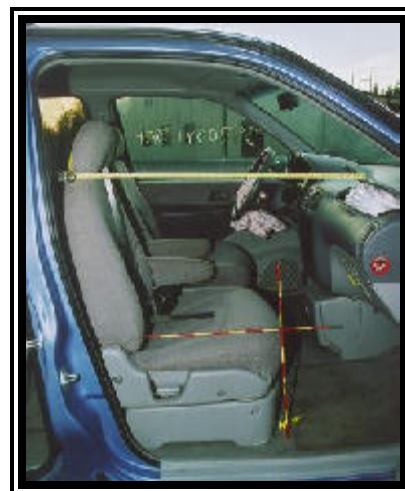
Figure 4. Interior view.

Interior damage to the Nissan was moderate and was attributed to occupant contact. Scuff marks were documented on the left knee bolster and glove compartment door with an indentation surrounding the contact site. Abrasions and small indentations were also identified on the rear aspect of the front seat backs from second row occupant loading. The second row seat back was deformed forward 13.0 cm (5.1 in) to an upright position from third row occupant loading. Occupant interaction with the expanding front right passenger air bag fractured the right mid-windshield area with a white scuff mark surrounding the fracture site (**Figure 4**). No component intrusions were found in the vehicle.

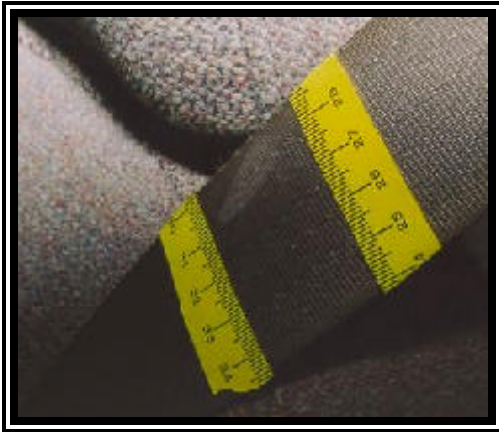
**Figure 5. Tissue transfer to the driver shoulder restraint.**

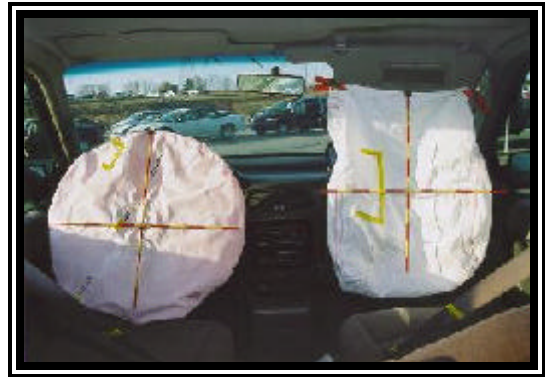
**Figure 7. 1997 Nissan Quest XE deployed frontal air bag system.**

The 1997 Nissan Quest XE was equipped with frontal air bags for the driver and front right passenger positions which deployed as a result of the crash (**Figure 7**). The driver air bag was identified by the part number: \*U1C0207J158G5\* with a bar coded lot number of: \*WMB63968050069\* and housed in the center of the steering wheel with a horizontally oriented flap tear seam (H-configuration). The flaps were nearly symmetrical in shape as the upper flap measured 19.0 cm (7.5 in) in width and 10.3

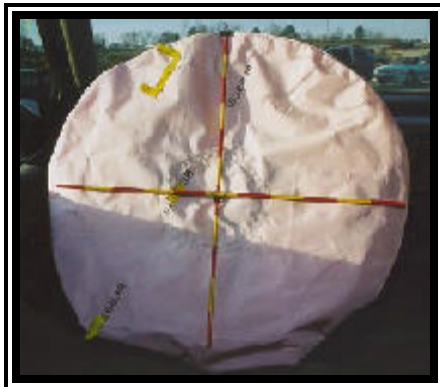
**Figure 8. 1997 Nissan Quest deployed driver air bag.**

cm (4.1 in) in height while the lower flap measured 19.0 cm (7.5 in) in width and 9.0 cm (3.5 in) in height. No contact evidence was identified on the exterior surface of the module cover flaps. The diameter of the driver air bag measured 64.0 cm (25.2 in) in its deflated state (**Figure 8**). Makeup transfers were identified at the upper left quadrant of the air bag face along with multiple black vinyl transfers to the rear aspect from expansion within the module. The bag was tethered by four internal straps and vented by two 4.5 cm (1.8 in) diameter ports located at the 10 o'clock and 2 o'clock sectors on the rear aspect of the air bag. Rearward bag excursion measured 27.0 cm (10.6 in) from the steering wheel hub.

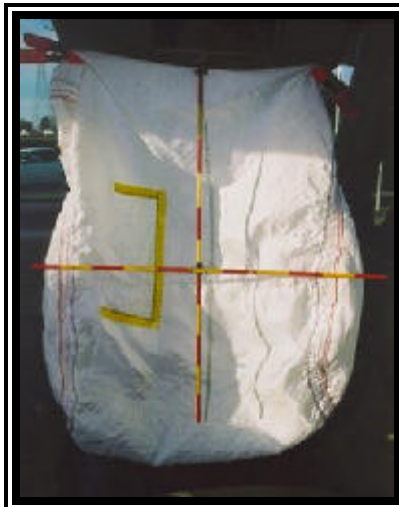
**Figure 9. 1997 Nissan Quest deployed passenger air bag.**

The front right passenger air bag deployed from the right top instrument panel area with a single cover flap design hinged at the forward aspect. The aluminum-reinforced cover flap was rectangular in shape and measured 46.3 cm (18.2 in) in width and 23.5 cm (9.3 in) in height. No contact evidence was identified on the exterior surface of the cover flap or surrounding instrument panel area. The passenger air bag measured 52.0 cm (20.5 in) in width and 73.0 cm (28.7 in) in height in its deflated state (**Figure 9**). The bag was tethered by two internal straps and vented by two 2.5 cm (1.0 in) diameter ports located at the 10 o'clock and 2 o'clock sectors on the side aspect of the air bag. Passenger interaction with the expanding air bag re-directed the proper deployment path of the membrane and produced the noted fracture and scuffs to the right mid-windshield area. The top portion of the air bag was also slightly abraded from engagement against the windshield. Contact evidence to the membrane consisted of extensive abrading along the left side aspect and upper left quadrant of the air bag face. Light deposits of skin tissue were also identified on the membrane surrounding the left vent port (**Figure 10**).

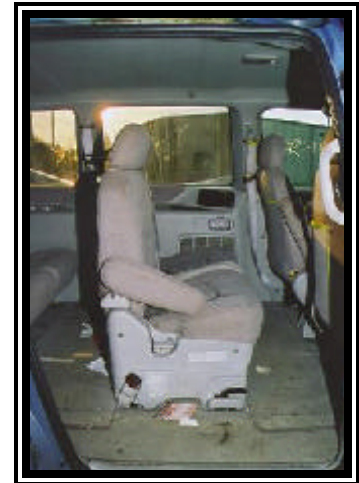
**Figure 11. Deformation to the second row seat back.**

The third row right seating position was occupied by a 9 year old female who was unrestrained (3-point manual lap and shoulder belt system available) and seated in an upright posture. The lack of restraint usage was determined by the trajectory of the child and extensive loading pattern documented to the second row seat back (**Figure 11**). At impact, she initiated a forward trajectory in response to the 12 o'clock impact force and loaded the second row seat back. She was reported by the driver as uninjured in the collision. The extensive loading pattern to the second row seat back and absence of resulting injury was also indicative of possible incorrect (reversed) seating assignments; however, driver/police statements confirmed the child's actual seat assignment at this location. Following the crash, she attended to the 3 year old male passenger as she exited the vehicle under her own power through the right rear door.
