**REMOTE ADVANCED 208-COMPLIANT VEHICLE CRASH INVESTIGATION
VERIDIAN SCI TECHNICAL SUMMARY REPORT**

NASS/SCI COMBO CASE NO. 2002-09-239J

VEHICLE – 2003 GMC YUKON

LOCATION - MARYLAND

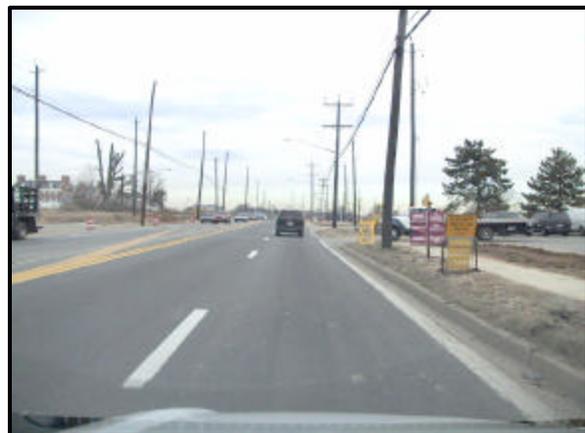
This three-vehicle crash occurred during the afternoon hours in December 2002. At the time of the crash, it was dark with street lights illuminating the area and it was raining. The road surface was wet. The crash occurred on a four-lane north/south state highway in a suburban setting. The speed limit in the area of the crash was 56 km/h (35 mph). **Figure 1** is a southbound approach view of the 2003 GMC Yukon.

Figure 1: Southbound trajectory view of the GMC.

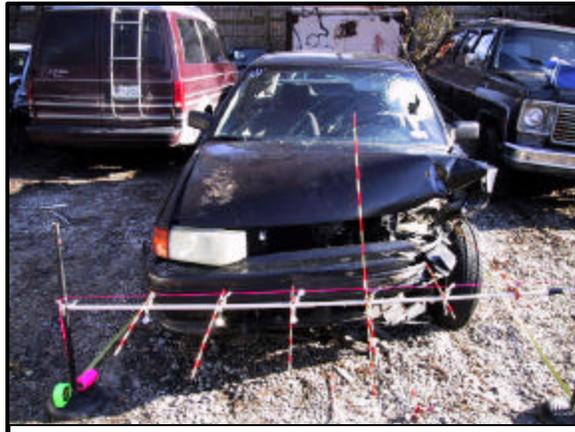
Figure 2 is a view of the frontal impact damage to the Escort. The vehicle sustained 40 cm (16 in) of direct contact damage that began 29 cm (11 in) left of center and extended to the left corner of the front bumper. The combined width of the direct and induced damage extended across the 138.0 cm (54.3 in) entire frontal end width of the vehicle. The damaged components included the front bumper, center grille, left headlamp assembly, hood, left front fender and components of the left front suspension. The left wheelbase was shortened 16.0 cm (6.3 in).

The crush profile measured along the front bumper was as follows: C1=48 cm (19 in), C2=25 cm (10 in), C3=14 cm (6 in), C4=9 cm (4 in), C5=5 cm (2 in), C6=2 cm (1 in). The delta V calculated by the Damage Algorithm of the WINSMASH model was 22 km/h (14 mph). The longitudinal and lateral components of the delta V were -22 km/h (-14 mph) and 0, respectively. The Collision Deformation Classification (CDC) was 12-FLEE-3.

Figure 2: Front view of the 1991 Ford Escort.

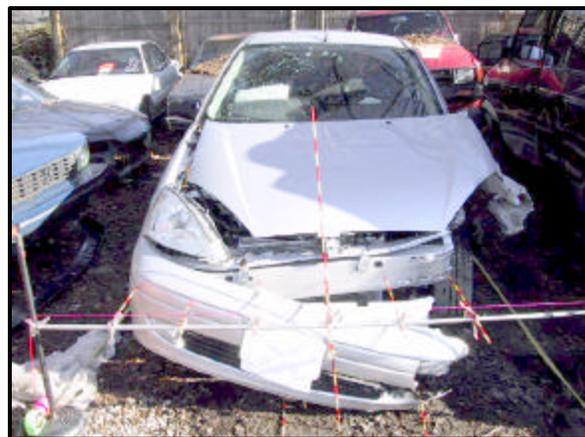
Figure 3 is a view of the frontal damage to the Focus. The vehicle sustained 34 cm (13.4 in) of direct contact damage that began 29 cm (11.4 in) left of center and extended to the left corner of the front bumper. The combined width of the direct and induced damage extended across the entire 126 cm (49.6 in) frontal end width of the vehicle. The outboard left aspect of the bumper fascia was fractured and the left end of the bumper reinforcement was deflected rearward. The primary zone of engagement appeared to have occurred immediately outboard of the left end of the reinforcement bar. The frontal contact pattern transitioned to longitudinal direct damage

Figure 3: Front view of the 2002 Ford Focus.

to the left front fender and left front suspension components. The reported frontal crush profile was as follows: C1=4 cm (2 in), C2=4 cm (2 in), C3=3 cm (1 in), C4=2 cm (1 in), C5=0 cm, C6=0 cm. The reported crush profile appeared to have underestimated the severity of the damage based on an analysis of the photographs. The reported delta V calculated by the Damage Algorithm of the WINSMASH model was 20 km/h (12 mph). The longitudinal and lateral components of the delta V were -20 km/h (-12 mph) and 3 km/h (2 mph), respectively. The Collision Deformation Classification (CDC) was 12-FLEE-3.

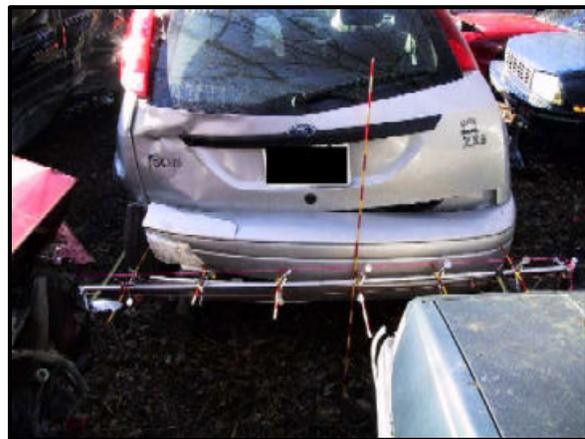
Figure 4 is a view of the Focus's back plane damage sustained as a result of the impact from the GMC. The 87 cm (34.3 in) of direct contact damage began 19 cm (7.5 in) right of center and extended to the left corner of the rear bumper. The direct damage wrapped around the left rear corner and extended onto the left rear quarterpanel panel. The direct damage pattern was indicative of the 7 o'clock direction of the impact force. The reported residual crush profile along the rear bumper was as follows: C1=15 cm (5.9 in), C2=9 cm (3.5 in), C3=2 cm (0.8 in), C4=0 cm, C5=0 cm, C6=0 cm. The reported delta V calculated by the Damage Algorithm of the WINSMASH model was 22 km/h (14 mph). The longitudinal and lateral components of the delta V were 21 km/h (13 mph) and 8 km/h (5 mph), respectively. The Collision Deformation Classification (CDC) was 07-BYAW-2.

Figure 4: Damage to the back plane of the Focus.

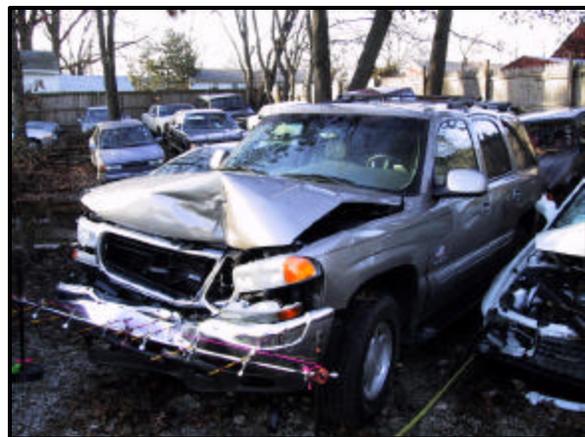
The 2003 GMC Yukon, **Figure 5**, was identified by the Vehicle Identification Number (VIN): 1GKEK13Z43J (production sequence deleted). The four wheel drive, ½ ton, sport utility vehicle was equipped with a 5.3 liter/V8 engine linked to a 4-speed automatic transmission with overdrive. The vehicle's Gross Vehicle Weight Rating (GVWR) was 3,130 kg (6,900 lb). The service brakes were hydraulic, self adjusting, power assisted front and rear disc brakes with anti-lock (ABS). The GMC was equipped for eight passenger seating (2-3-3). The manual restraint system consisted of 3-point lap and shoulder belts in Rows 1 and 2, and in the outboard positions of Row 3. The center position of Row 3 was lap belt

Figure 5: Left front view of the Yukon.

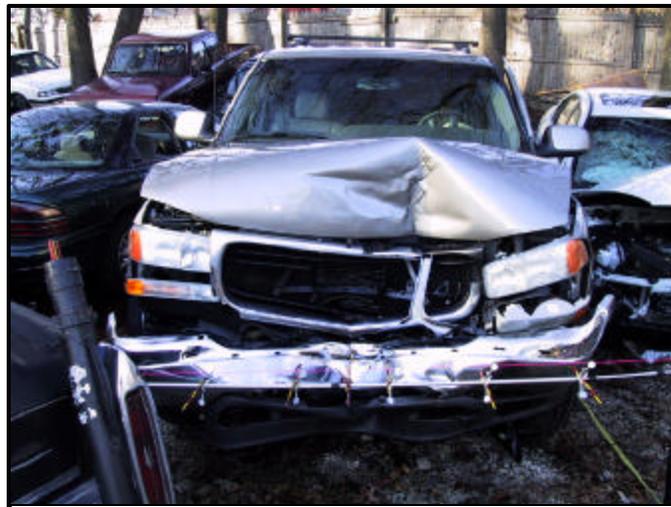
The front plane of the GMC sustained 173 cm (68 in) of direct and induced damage that extended across the entire frontal end width of the vehicle. The direct damage width measured 112 cm and began at the left front corner. The damaged components included the front bumper, center grille, left headlamp assembly, and hood. There was no change in the wheelbase dimensions. The reported residual crush profile along the front bumper was as follows: C1=0 cm, C2=0 cm, C3=18 cm (7 in), C4=14 cm (6 in), C5=1 cm (0.5in), C6=0 cm. The maximum crush was located along the vehicle's center line and measured 27 cm (10 in). The reported crush profile appeared to underestimate the overall damage sustained by the vehicle. The forward aspect of the hood sustained an estimated 30 cm (12 in) of direct contact damage during its deformation indicative of above-bumper damage not quantified in the crush profile. The Collision Deformation Classification (CDC) was 12-FZEW-1. The reported total delta V calculated by the Damage Algorithm of the WINSMASH model was 8 km/h (5 mph) and underestimated the severity of the crash. The longitudinal and lateral components of the delta V were -8 km/h (-5 mph) and +1 km/h (+0.6 mph), respectively. The estimated total delta V based on SCI experience and analysis of the photographs was approximately 16 km/h (10 mph). This estimated delta V was more consistent with the 14.9 km/h (9.3 mph) maximum delta V reported by the vehicle's EDR.

Figure 6: Frontal view of the damaged GMC.

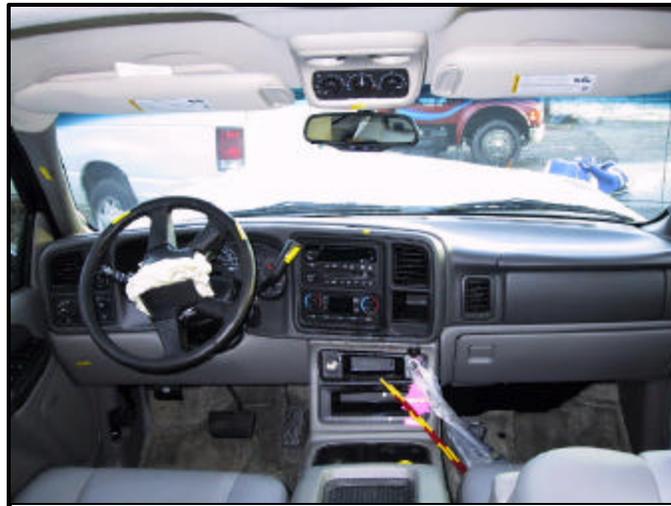
Figure 7 is an overall interior view of the front compartment in the GMC. The vehicle's interior damage consisted of minor occupant scuffing contacts attributed to the hands of the driver.

These contacts were minor in nature and did not produce any injuries. There was no intrusion into the occupant compartment attributed to the exterior crash forces.

The driver seat was located in a mid-track position. The four-spoke steering wheel rim was not deformed and there was no shear capsule displacement. The steering wheel was rotated 90 degrees counterclockwise at the time of the inspection. There was no contact evidence on the driver's knee bolster.

Figure 7: Front interior view of the GMC.

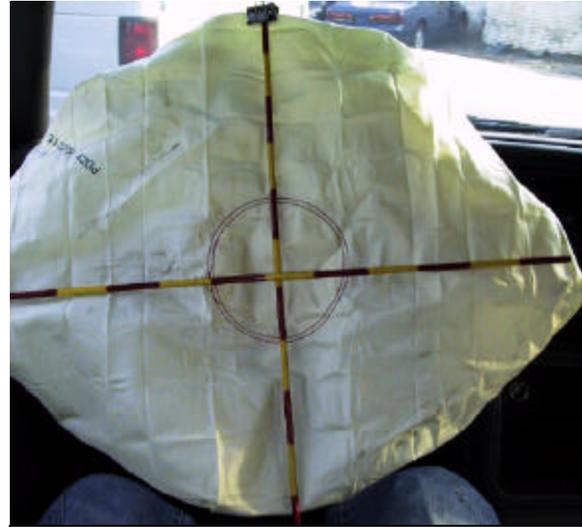
The driver air bag module was designed in the typical manner and located in the center hub of the steering wheel rim. The I-configuration module cover flaps were not damaged. The flaps were symmetrical and measured 7 cm (2.8 in) by 12 cm (4.7 in), width by height. The driver air bag measured 70 cm (27.6 in) in diameter in its deflated state. Two internal straps sewn to the face of the bag tethered the air bag. It was vented by two ports located in the 11/1 o'clock sectors on the backside of the bag. **Figure 8** is a view of the driver air bag. The 12 o'clock sector of the bag is at the left side of the photograph; the steering wheel was turned 90 degrees counterclockwise at the time of the inspection. There was no direct evidence of occupant contact to the face of the bag. The EDR reported that a Stage 2 deployment occurred.

Figure 8: Driver air bag.

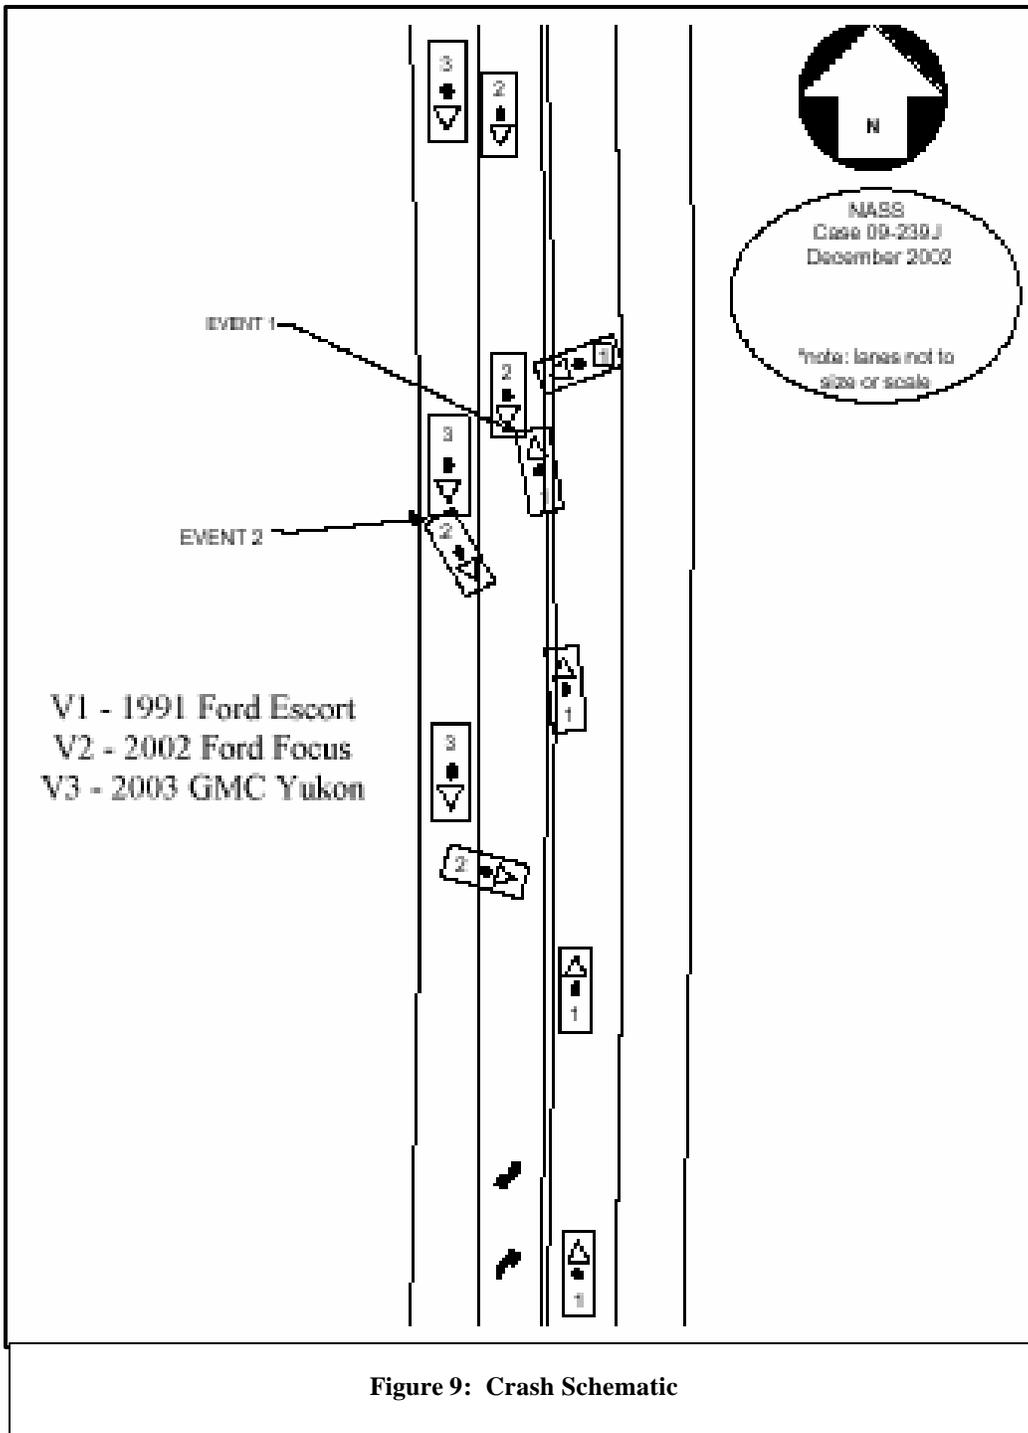
The front plane of the GMC impacted the back left aspect of the Ford Focus in a 12/7 o'clock impact configuration. The southbound momentum of the GMC displaced the Focus southward and amplified its counterclockwise rotation. The Focus reportedly came to rest facing eastward straddling the divider separating the southbound lanes. The GMC came to rest in the outboard southbound lane several meters north of the Focus. The Ford Escort came to rest (from the initial impact) in the center turn lane. The final rest locations of the vehicles were not documented by the police investigation and could not be determined during the NASS scene inspection. A generalized crash schematic developed by the NASS team is attached to the end of this report as **Figure 9**.

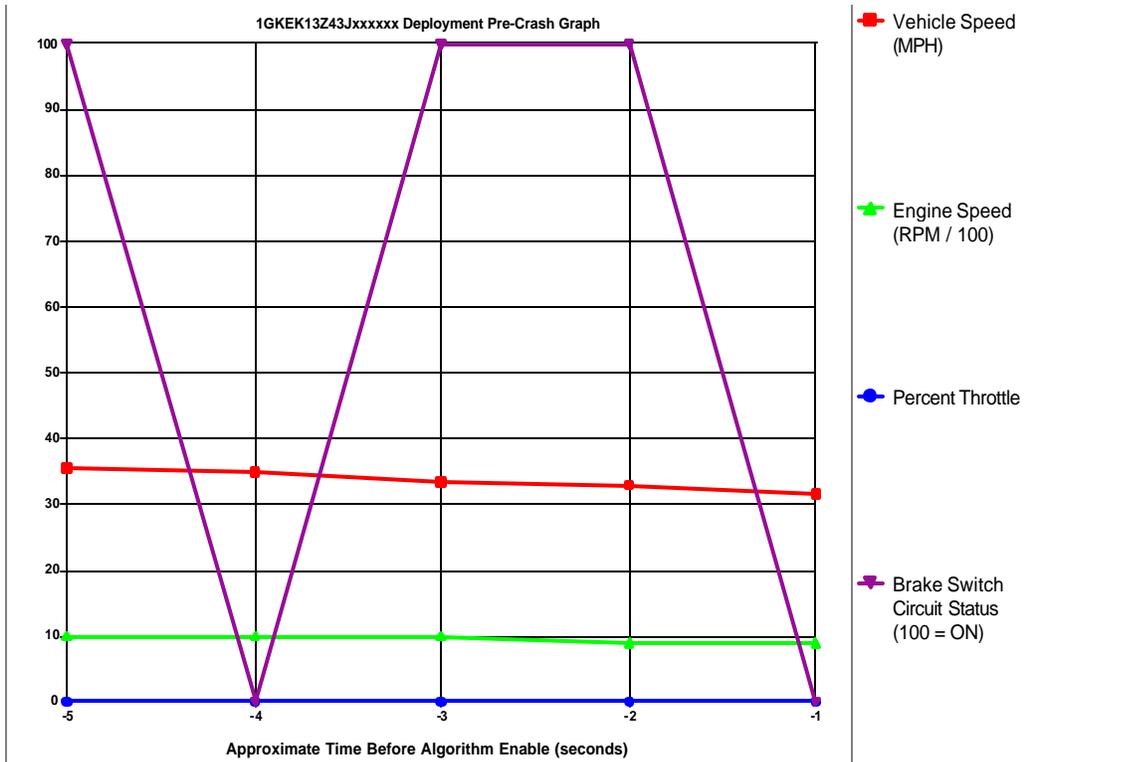
Seconds Before AE	Vehicle Speed (MPH)	Engine Speed (RPM)	Percent Throttle	Brake Switch Circuit Status
-5	35	1024	0	ON
-4	35	960	0	OFF
-3	34	960	0	ON
-2	33	896	0	ON
-1	32	896	0	OFF

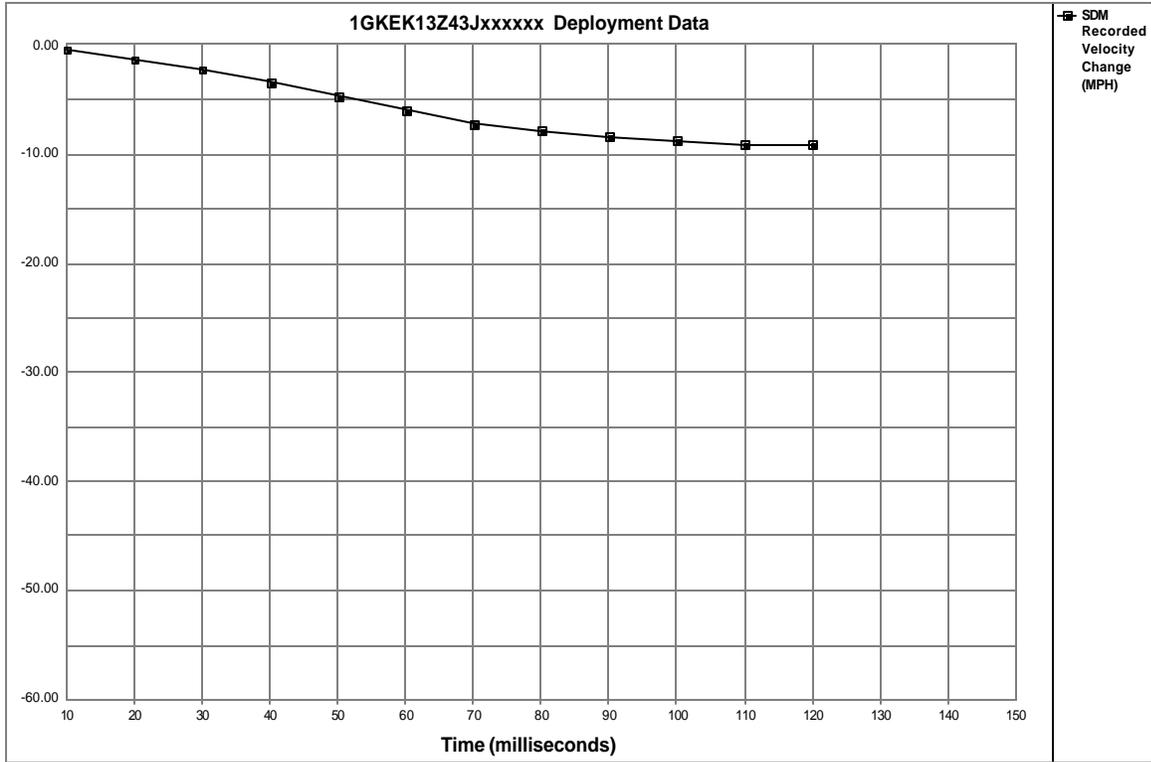
Time (milliseconds)	10	20	30	40	50	60	70	80	90	100	110	120	130	140	150
Recorded Velocity Change (MPH)	-0.31	-1.24	-2.17	-3.41	-4.65	-5.89	-7.13	-7.75	-8.37	-8.68	-8.99	-8.99	N/A	N/A	N/A
