**VERIDIAN REMOTE  
ADVANCED 208 COMPLAINT VEHICLE CRASH INVESTIGATION**

**SCI TECHNICAL SUMMARY REPORT**

**NASS/SCI COMBO CASE NO. 03-08-063F**

**VEHICLE – 2003 CHEVROLET AVALANCHE**

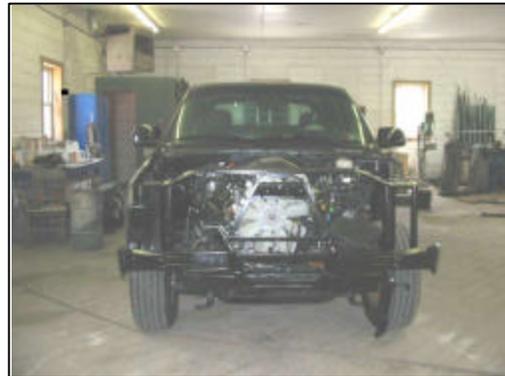
**Figure 1. 2003 Chevrolet Avalanche**

This investigation focused on the performance of the advanced 208-Compliant occupant protection system in a 2003 Chevrolet Avalanche. The system included dual stage frontal air bags, right front passenger presence detection and seat track position sensors for the front left and front right seats. The Chevrolet (**Figure1**) was involved in an intersection collision with a 1999 Oldsmobile Intrigue that resulted in the deployment of the Chevrolet's driver's air bag. The Oldsmobile was equipped with redesigned frontal air bags that deployed as a result of the impact. Both vehicles were equipped with an Electronic Data Recorder (EDR) that was downloaded as a supplement to the investigation. The Chevrolet was occupied by an unrestrained 78-year old male driver that was not injured. The Oldsmobile was occupied by a restrained 40-year old female driver that was not injured in the event and a restrained 64-year old female front right passenger. The Oldsmobile's front right passenger sustained minor injuries and was transported to a hospital for treatment and released.

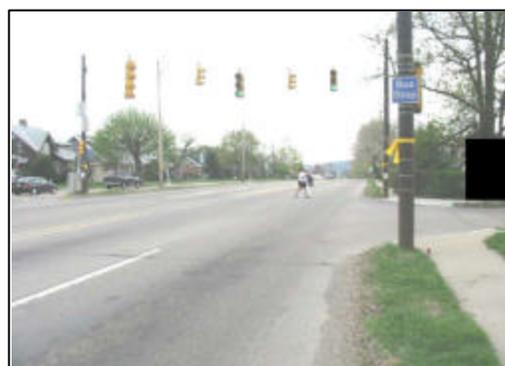
**Figure 2. Crash site from westbound approach.**

This two-vehicle crash occurred during the morning hours in April 2003. At the time of the crash, it was daylight and there were no adverse weather conditions. The road surface was dry. The crash occurred at the four-leg intersection

of a four-lane east/west county road and a two-lane north/south road (**Figure 2**). The east/west roadway was divided by yellow double-lines and was bordered with 15.0 cm (6.0”) concrete curbs. The intersection was controlled by a three-phase traffic light that was regulating the east/west traffic flow. The traffic was reported as operating properly. The speed limit in the area of the crash was 64 km/h (40 mph).

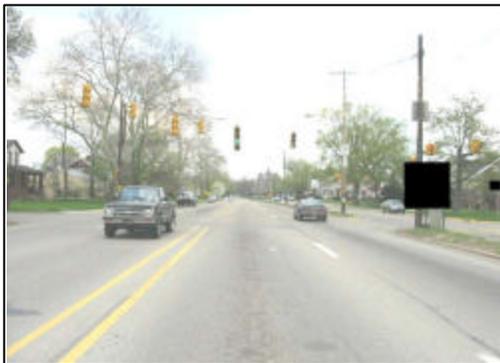
**Figure 3. Chevrolet approach to the intersection.**

The 2003 Chevrolet Avalanche was traveling eastbound in the inboard lane driven by an unrestrained 78-year old male (**Figure 3**) approaching the four-leg intersection. It was the driver’s intension to turn left at the intersection. The EDR data indicated that the Chevrolet’s travel speed was 14.9 km/h (24.0 mph) five seconds prior to the crash and the vehicle decelerated to 7.5 km/h (12.0 mph) one second before the crash. The 1999 Oldsmobile Intrigue was traveling westbound in the outboard lane driven by a 40-year old restrained female (**Figure 4**) and occupied by a restrained 64-year old female front right passenger. It was the Oldsmobile driver’s intension to travel through the intersection. The Oldsmobile’s EDR did not have the capability to record pre-crash data. The driver reported during the NASS interview that her pre-impact travel speed was approximately 24.8 km/h (40.0 mph).

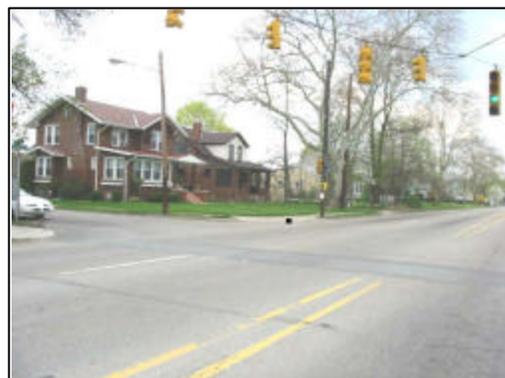
**Figure 5. Area of impact.**

As the Chevrolet entered the intersection, the driver turned left across the path of the Oldsmobile (**Figure 5**). The front left aspect of the Oldsmobile struck the front right aspect of the Chevrolet in an 11 and 2 o’clock impact configuration. The force of the impact caused the deployments of the Chevrolet’s driver air bag and both frontal air bags in the Oldsmobile. The EDR recorded a maximum longitudinal

velocity change in the crash of -17.46 km/h (-10.85 mph) for the Chevrolet and -35.31 km/h (-21.94 mph) for the Oldsmobile, respectively. The EDR data for the Chevrolet and Oldsmobile is included in this report as **Attachment A** and **B**.

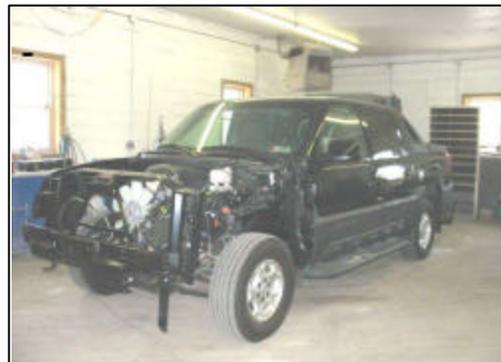
**Figure 6. Under repair Chevrolet.**

The 2003 Chevrolet Avalanche sustained minor severity damage as a result of the intersection collision. The vehicle was in a state of repair at the time of the NASS inspection and the damaged parts had been removed (**Figure 6**). Based on the repair estimate, the following components were replaced: bumper fascia, bumper reinforcement bar, bumper supports, grille, right head light assembly, and right and

left front fenders with an approximate repair cost of \$8,220. The damage appeared to be limited to components forward of the radiator support plane. There was no reported suspension repair. All glazing remained intact. The Collision Deformation Classification for this impact was 99-F999-9. A WinSmash missing vehicle algorithm was used on this crash due to the lack of crush data for the Chevrolet. The total delta V for the Chevrolet was 24.0 km/h (14.9 mph) and the longitudinal and lateral components were -20.8 km/h (-12.9 mph) and -12.0 km/h (-7.5 mph) respectively. The WinSmash calculated delta V results were consistent with the downloaded EDR data.

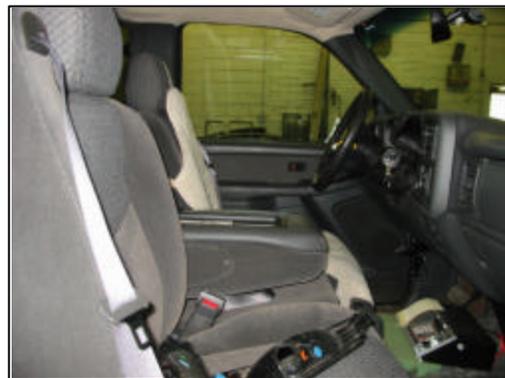
**Figure 7. Interior of Chevrolet.**

There was no identified interior damage or intrusion related to the exterior crash forces (**Figure 7**).

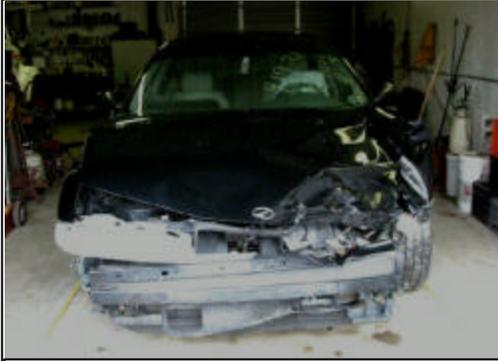
**Figure 8. Oldsmobile Intrigue**

The 1999 Oldsmobile Intrigue sustained moderate severity frontal damage as result of the impact with the Chevrolet (**Figure 8**). The damage consisted of longitudinal displacement of the bumper fascia, reinforcement bar, bumper supports, left front fender, and hood. The direct contact damage began at the centerline and extended 70.0 cm (27.5") to the front left bumper corner. The combined direct and induced damage measured 125.0 cm (49.2"). Six crush measurements were documented along the bumper (**Figure 9**): C1=23.0 cm (9.0"), C2 =35.0 cm (13.8), C3= 28.0 cm (11.0"), C4= 22.0 cm (8.7"), C5= 0.0 cm, C6= 0.0 cm. The Collision Deformation Classification for this impact was 11-FYEW-2. The WinSmash calculated total delta V for the Oldsmobile was 37.0 km/h (23.0 mph). The longitudinal and lateral components were -34.8 km/h (-21.6 mph) and 12.7 km/h (7.9 mph), respectively. The WinSmash results were consistent with the EDR data.

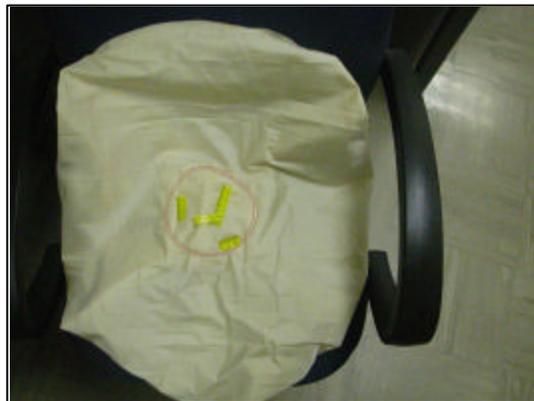
**Figure 10. Removed driver's air bag.  
Occupant contact on center of air bag.**

The front left air bag (**Figure 10**) deployed from the center of the steering wheel hub. The air bag diameter measured 55.0 cm (21.6”). The front left air bag module was configured with two symmetrical I-configuration cover flaps. The cover flaps measured 6.0 cm (2.4”) in width and 12.0 cm (4.7”) in height. The front left air bag contained two tethers and was vented by two vent ports on the rear aspect of the air bag at the 11 and 1 o’clock positions. A possible skin transfer was noted on the center of the air bag. However, this contact did not result in an injury.

The 78-year-old male driver of the 2003 Chevrolet Avalanche was seated in an upright posture and was unrestrained. The seat was in the mid-track position. At impact, the front left air bag deployed. The unrestrained driver initiated a forward and rightward trajectory in response to the 2 o’clock direction of force and possibly contacted the frontal air bag with his face. A possible skin transfer was noted on the center of the air bag. The driver was not injured in the crash and exited the vehicle under his own power.

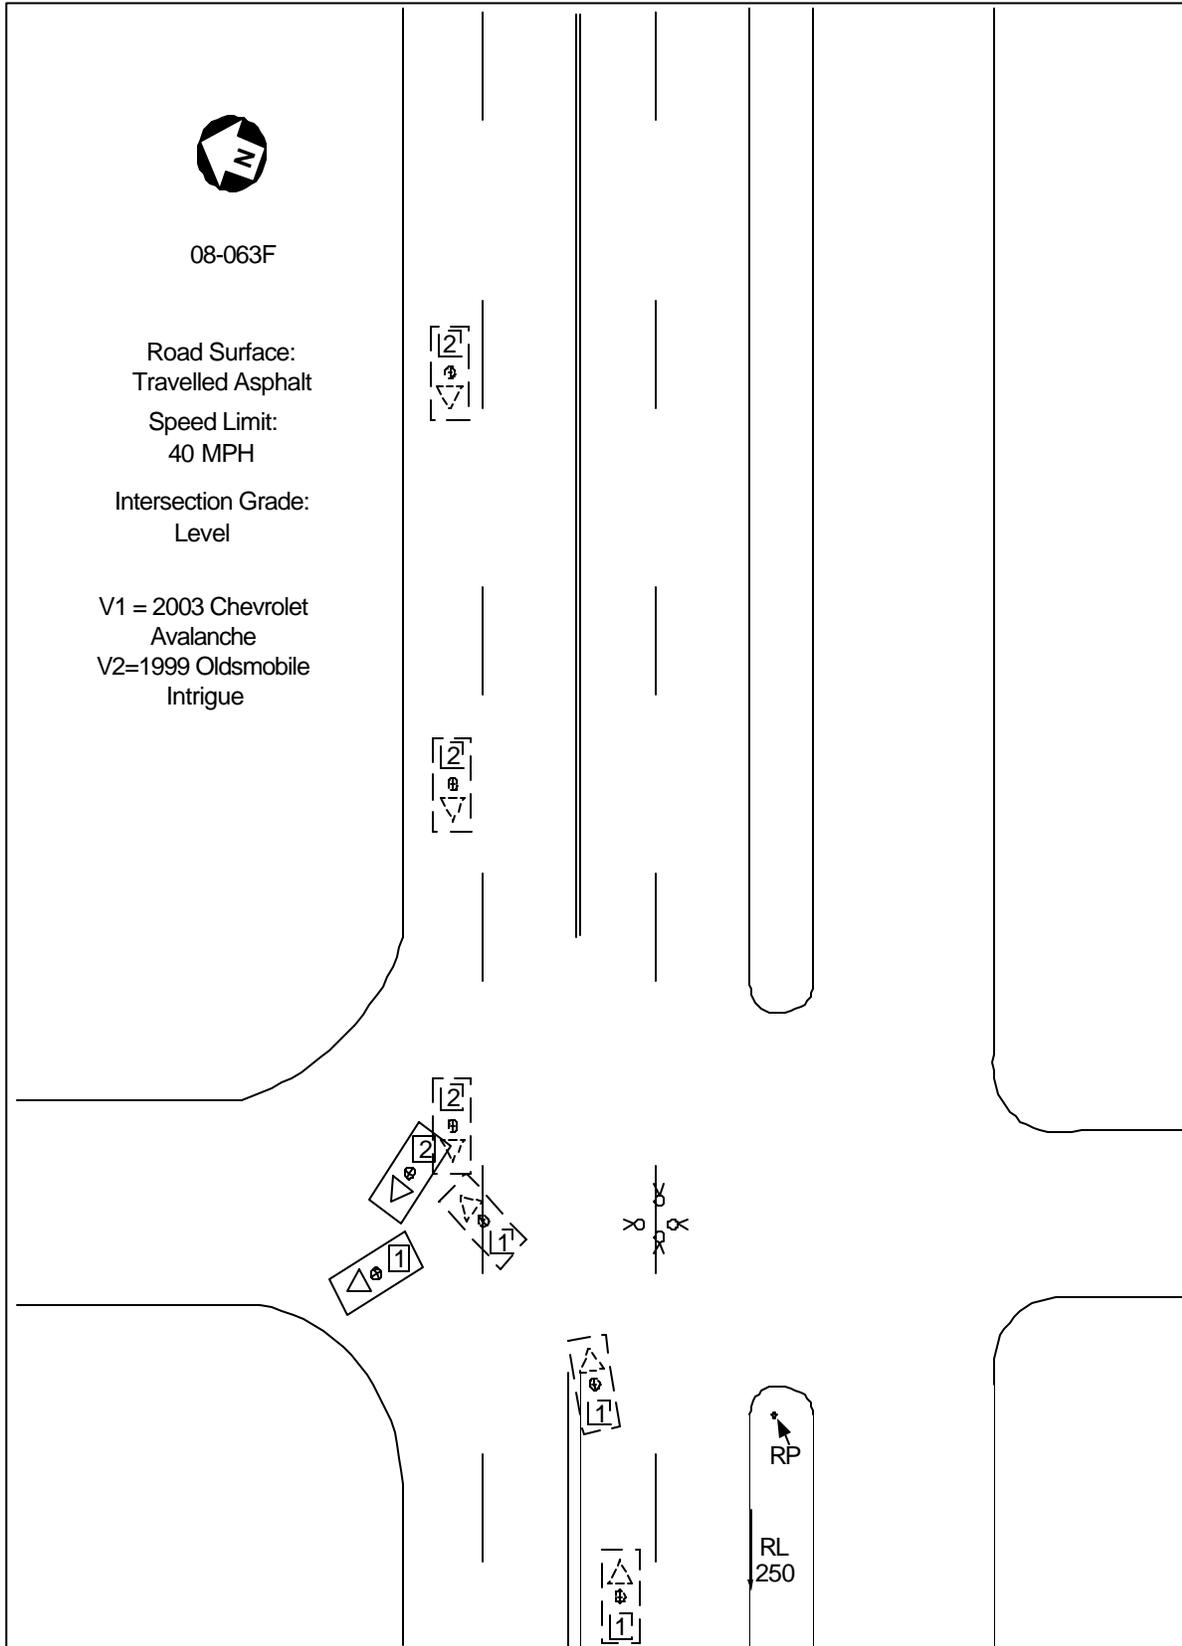
**Figure 11.** NASS Scene Schematic

The impact with the Oldsmobile forward of the Chevrolet's center of gravity caused the Chevrolet to rotate counterclockwise as it slid to rest. The angular collision redirected the Oldsmobile northward and both vehicles came to rest in the northwest quadrant of the intersection. Both vehicles sustained disabling damage and had to be towed. A schematic of the crash scene developed by the NASS researcher is attached to the end of this report, **Figure 11**.

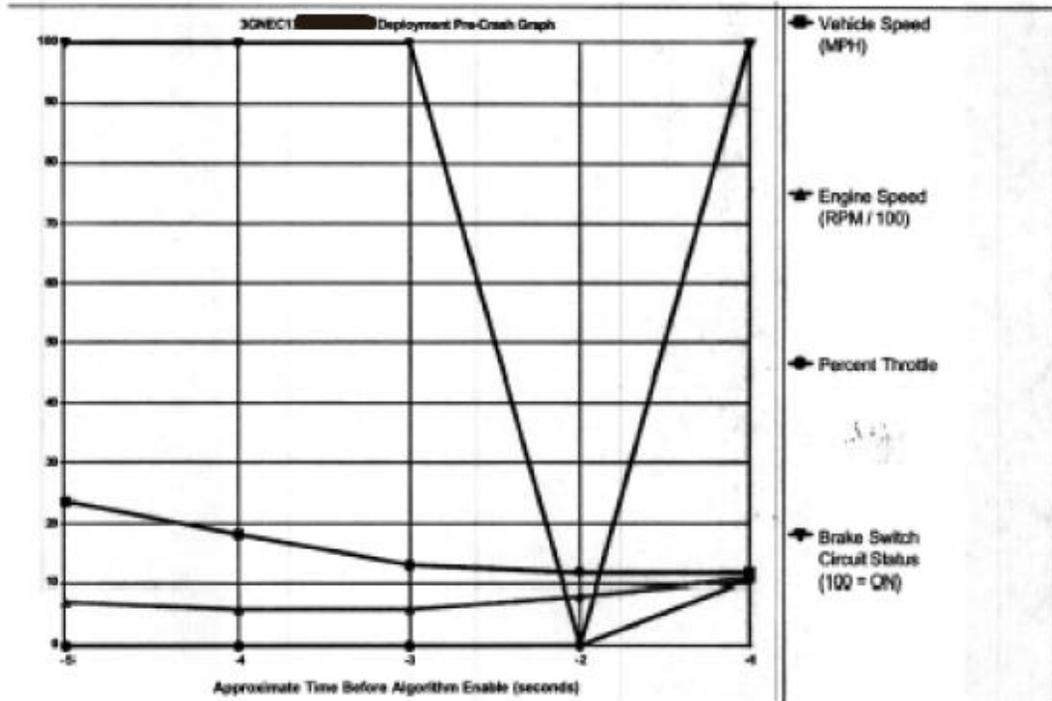
Attachment A: EDR printout page 2 2003 Chevrolet Avalanche.

Seconds Before AE	Vehicle Speed (MPH)	Engine Speed (RPM)	Percent Throttle	Brake Switch Circuit Status
-5	24	704	0	ON
-4	18	576	0	ON
-3	13	640	0	ON
-2	12	832	0	OFF
-1	12	1088	11	ON

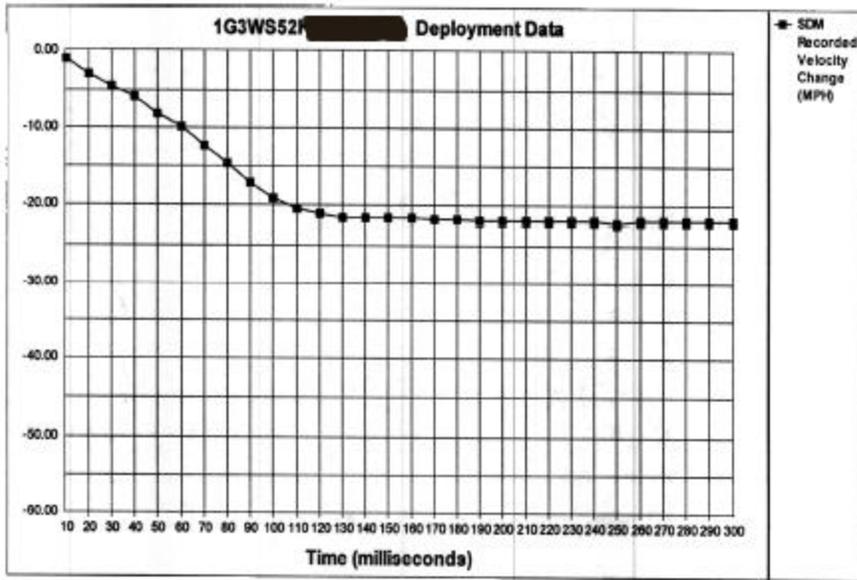
Time (milliseconds)	10	20	30	40	50	60	70	80	90	100	110	120	130	140	150
Recorded Velocity Change (MPH)	0.00	-2.86	-4.81	-5.92	-8.12	-8.87	-12.29	-14.70	-17.11	-19.04	-20.40	-21.06	-21.90	-21.50	-21.50
Time (milliseconds)	160	170	180	190	200	210	220	230	240	250	260	270	280	290	300
Recorded Velocity Change (MPH)	-21.50	-21.72	-21.72	-21.94	-21.94	-21.94	-21.64	-21.94	-21.94	-21.94	-21.94	-21.94	-21.94	-21.94	-21.94
