Certified Advanced 208 Compliant Investigation / Vehicle to Vehicle
Dynamic Science, Inc. / Case Number: DS03005
2003 Chevrolet Tahoe 4X4 SUV
Colorado
January, 2003

1. Report No. DS03005		2. Government Accession No.		3. Recipient Catalog No.	
4. Title and Subtitle Certified Advanced 208 Compliant Investigation				5. Report Date

14. Sponsoring Agency Code	
15. Supplemental Notes					
16. Abstract <p>This on-scene, in-depth investigation focused on the Certified Advanced 208 Compliant vehicle. This two vehicle crash took place in January, 2003 at 1716 hours. The weather was clear and the level bituminous/asphalt surface was dry. It was dark at the time, but the roadway was lighted by overhead luminaires. The crash occurred in lane four of a five lane, westbound, divided interstate highway. This highway consists of westbound travel lanes and eastbound travel lanes which are separated by a positive center concrete barrier. There were no traffic controls present and the speed limit is 105 km/h (65 mph).</p> <p>The case vehicle was a fleet rental 2003 Chevrolet Tahoe 4x4 full size sport utility vehicle and was being driven by a fully restrained 26 year-old female. The third row left si

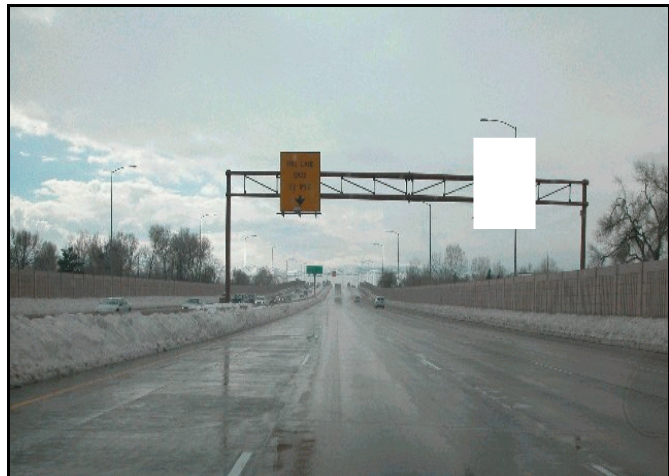
Figure 1. Westbound view showing impact location

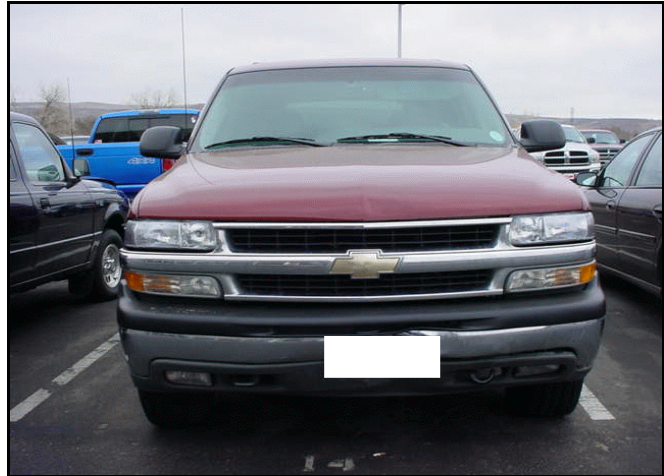
Figure 2. Full frontal view of case vehicle showing minor front bumper deformation

Damage Description:	<u>Minor/Primary Frontal Impact (Highest Delta V):</u> Slight longitudinal displacement of front bumper. Depression noted approximately 13 cm (5.1 in.) left of vehicle centerline. Minor depression noted to hood edge.	
CDC:	12FDEW1	
Delta V:	Total	7.0 km/h ¹ (4.3 mph)
	Longitudinal	-7.0 km/h (-4.3 mph)
	Latitudinal	0.0 km/h (0.0 mph)
	Energy	2446 Joules (1804 ft/lbs)

C measurement: No crush profile obtained/ Insurance photos of original damage obtained. Damage and CDC estimated from photos only.

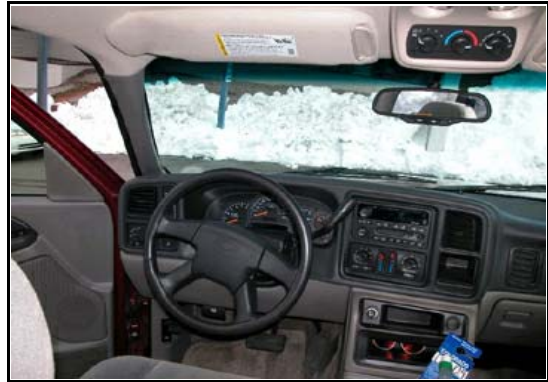
Figure 3. Not deployed driver's air bag

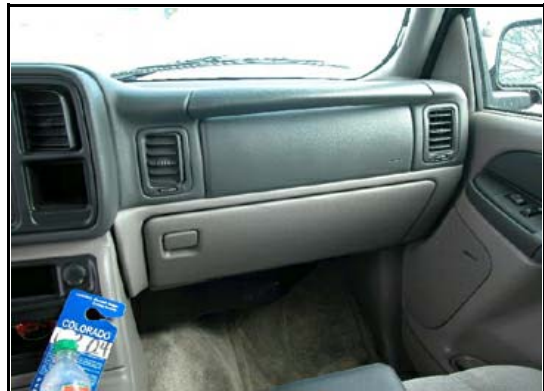
Figure 4. Not deployed front right passenger's air bag

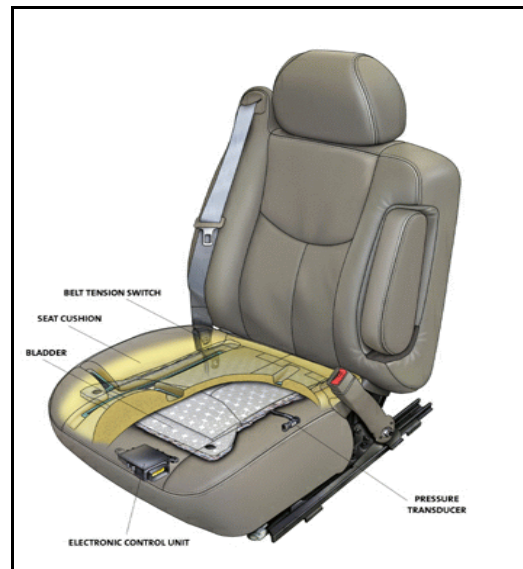
The case vehicle was equipped with frontal air bags mounted in the steering wheel and mid-mounted in the instrument panel of the front right seat position. The front right passenger air bag includes a “Passenger Sensing System”. The system is designed to automatically switch the air bag on or off based on a passenger’s weight. The system also uses a sensor in the passenger-side seat belt to measure how much tension is exerted by the seat belt when it is being cinched down, another means of determining what may be on the seat.

Figure 5. Front right Passenger Sensing System

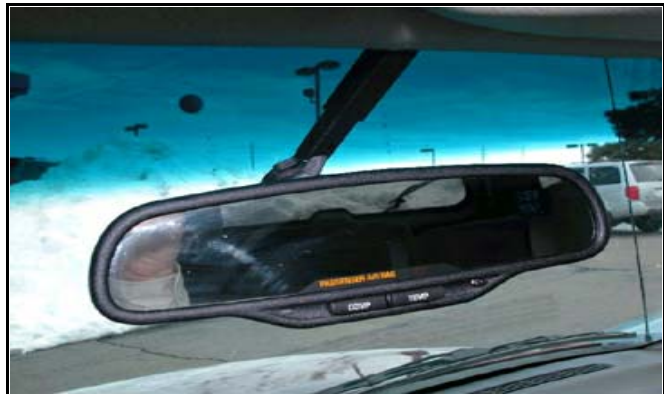
There is an indicator on the rear-view mirror that alerts vehicle occupants to the status of the system at all times. If the light reads “Passenger Air Bag ON,” the air bag is programmed to deploy in a frontal crash of sufficient severity. If it reads “Passenger Air Bag OFF,” the system has turned off the air bag because it determined either that there is no occupant on the front passenger seat, or that a rear-facing infant seat, a forward-facing child restraint, a booster seat or a smaller person, such as a child who has outgrown child restraints, is present.

Figure 6. Passenger Sensing System monitored on rear view mirror

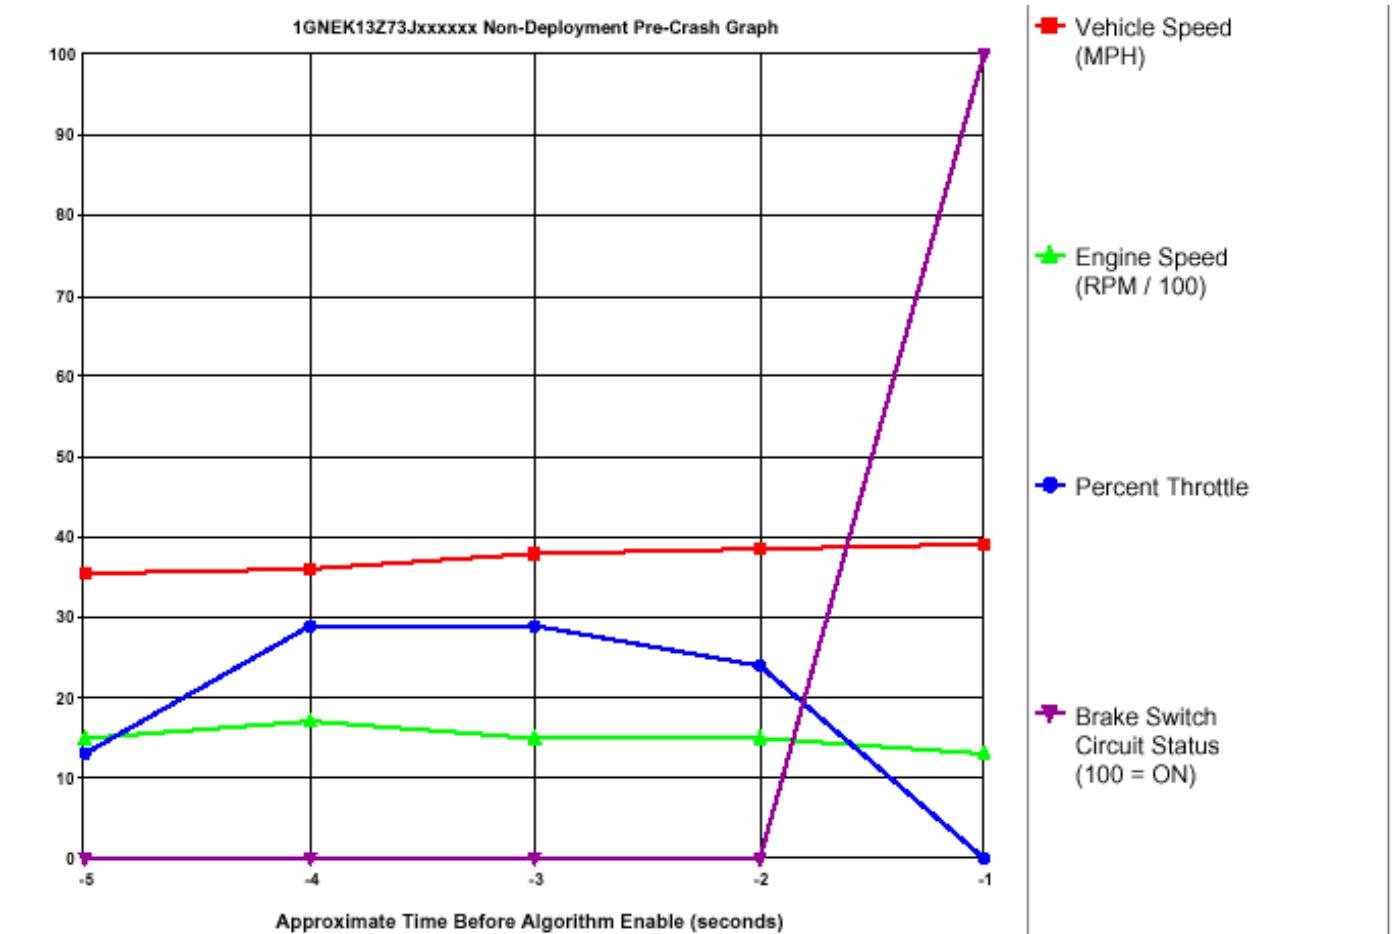
Seconds Before AE	Vehicle Speed (MPH)	Engine Speed (RPM)	Percent Throttle	Brake Switch Circuit Status
-5	35	1536	13	OFF
-4	36	1664	29	OFF
-3	38	1536	29	OFF
-2	39	1536	24	OFF
-1	39	1280	0	ON

10. The vehicle speed was 56 km/h (35 mph) five seconds before AE, accelerated to 58 km/h (36 mph) at 4 seconds before AE, 61 km/h (38 mph) at 3 seconds before AE, and 63 km/h (39 mph) at 2 and 1 seconds before AE.
11. The brake switch status was OFF from 5 through 2 seconds before AE, and was ON for 1 second before AE.

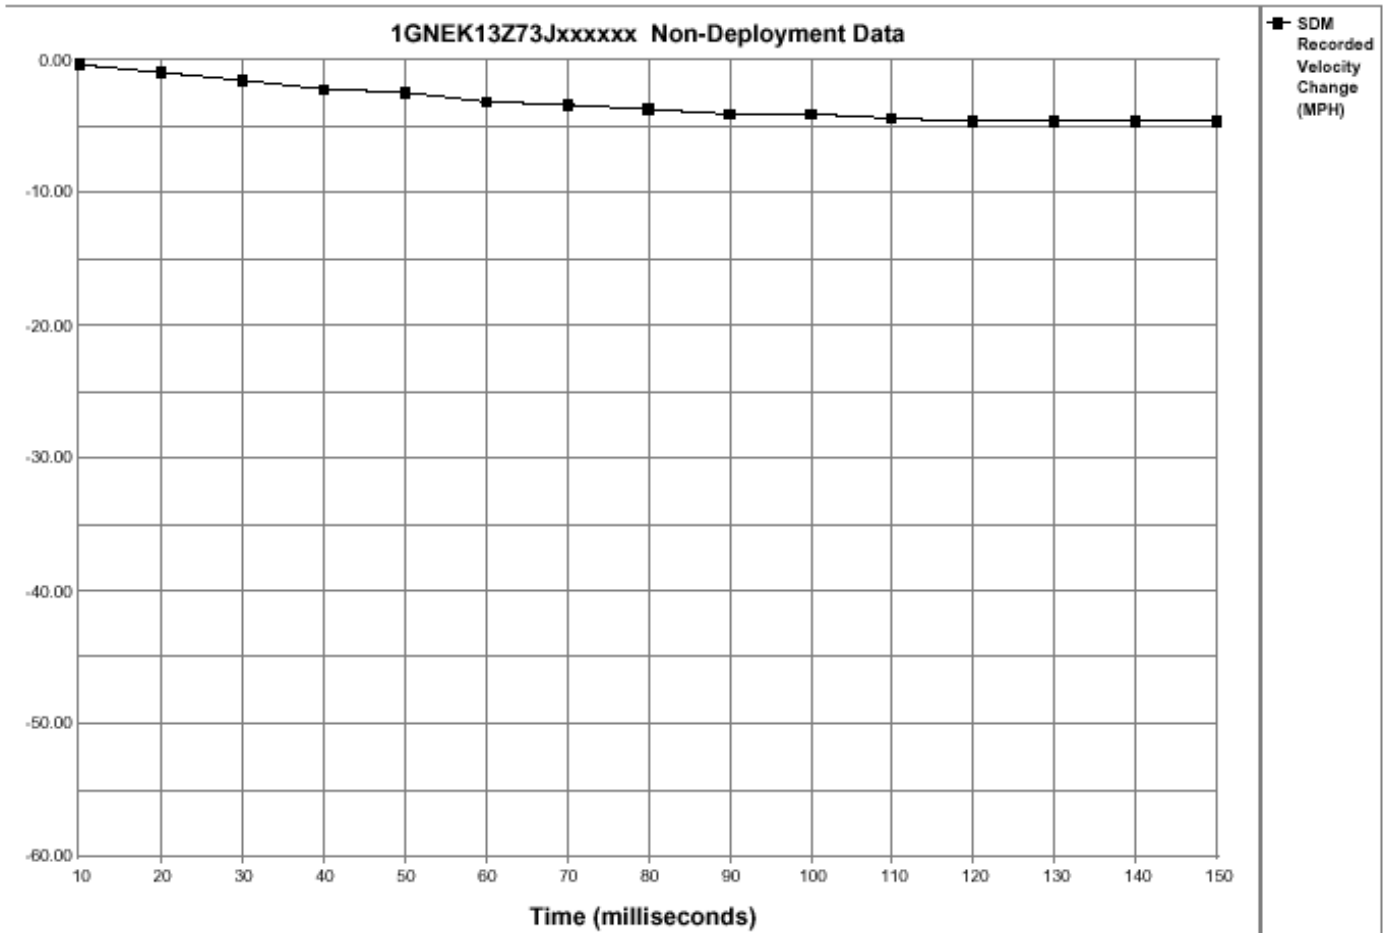
Time (milliseconds)	10	20	30	40	50	60	70	80	90	100	110	120	130	140	150
Recorded Velocity Change (MPH)	-0.31	-0.93	-1.55	-2.17	-2.48	-3.10	-3.41	-3.72	-4.03	-4.03	-4.34	-4.65	-4.65	-4.65	-4.65

The downloaded data indicates a non-deployment event was recorded. The case vehicle had a maximum recorded velocity change of -7.87 km/h (-4.89 mph) at the 122.5 ms mark.
