**ON-SITE CERTIFIED ADVANCED 208-COMPLIANT
VEHICLE CRASH INVESTIGATION**

CASE NO: CA03-040

VEHICLE: 2003 CHEVROLET C1500 SILVERADO PICK-UP TRUCK

CRASH DATE: APRIL 2003

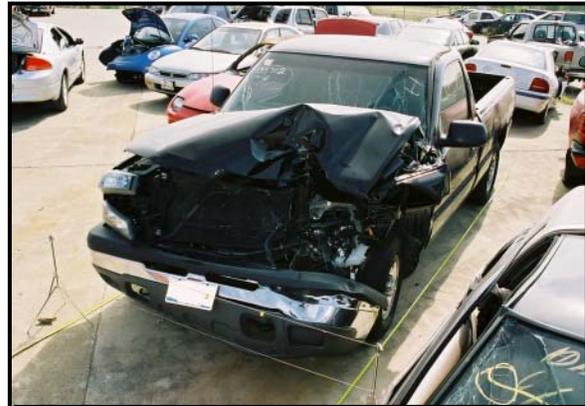
Figure 1: Left front view of the 2003 Chevrolet C1500.

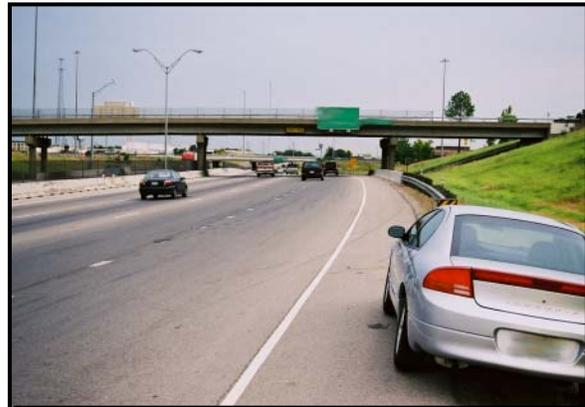
Figure 2: Southbound trajectory view.

This two-vehicle crash occurred during the morning hours in April, 2003. At the time of the crash, it was dawn. The weather was clear and was not a factor in the crash. The road surface was dry. The crash occurred in the outboard southbound lane of a four-lane divided interstate highway. The outboard southbound lane served as a continuous entrance/exit lane for traffic merging onto the interstate from a secondary roadway and/or for traffic exiting the interstate onto an intersecting state route. The three inboard lanes were for continuous southbound through traffic. The police report indicated the crash occurred approximately 91 m (300 ft) north of the exit ramp. Due to the passage of time between the date of the crash and the on-site inspection, there was no physical evidence identified at the scene related to the subject crash. **Figure 2** is a southbound trajectory view of the interstate at the crash site. The speed limit in the area of the crash was 97 km/h (60 mph). The SCI scene schematic is included as **Figure 6** at the end of this narrative report.

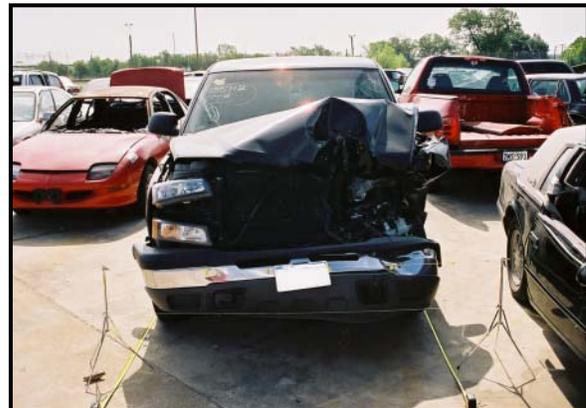
The front plane of the Chevrolet sustained 170.2 cm (67.0 in) of direct and induced damage that extended across the vehicle's front end width, **Figure 3**. The direct damage measured 64.3 cm (25.3 in). The direct damage began 20.8 cm (8.2 in) left of center and extended to the left corner. The damage profile was indicative of an under ride with the maximum deformation occurring at the elevation of the upper radiator support. The vehicle's residual crush was measured along the front bumper was as follows: C1 = 18.2 cm (7.2 in), C2 = 11.3 cm (4.4 in), C3 = 6.1 cm (2.4 in), C4 = 1.3 cm (0.5 in), C5 = 0, C6 = 0. The crush profile along the upper radiator support measured:

C1 = 52.0 cm (20.5 in), C2 = 59.6 cm (23.5 in), C3 = 52.4 cm (20.7 in), C4 = 32.9 cm (13.0 in), C5 = 17.6 cm (7.0 in), C6 = 10.9 cm (4.3 in). The left wheelbase was reduced 11.2 cm (4.4 in) and the left front tire was restricted against the aft aspect of the wheel opening. The left front door shifted rearward overlapping the left B-pillar and was jammed shut. There was evidence of

Figure 3: Front view of the Chevrolet.

cab-to-bed contact on both sides of the pick-up box. The lower aspect of the windshield was fractured from the exterior crash force.

The Collision Deformation Classification was 12-FYEW-3. The Missing Vehicle Algorithm of the WINSMASH model was used to assess the crash severity (delta V) based on an average of the above referenced profiles. The Chevrolet's calculated total delta V was 30.4 km/h (18.9 mph). The longitudinal and lateral components were -30.4 km/h (-18.9 mph) and 0, respectively. The computed delta V was in agreement with the delta V recorded by the Event Data Recorder. The recorded maximum delta V was -29.97 km/h (-18.62 mph). This maximum value was recorded 142.5 msec after algorithm enable. Refer to the EDR report attached to the end of this document.

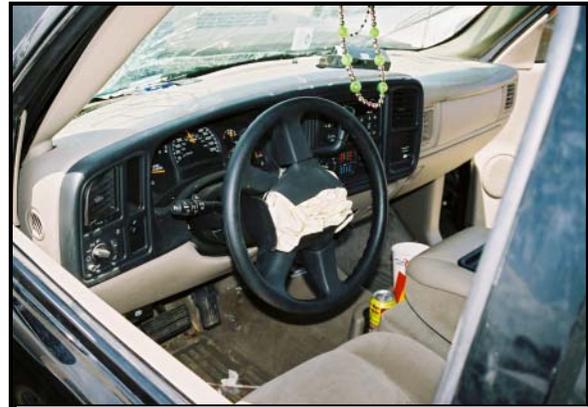
Figure 4 is an interior view of the Chevrolet. The interior damage to the Chevrolet consisted of the deployment of the driver air bag and minor occupant interior contacts. There was no intrusion related to the exterior crash forces.

Figure 4: Interior view of the Chevrolet.

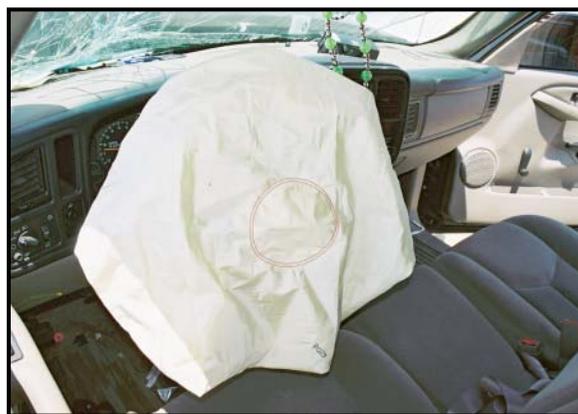
The driver air bag module was located in the center hub of the steering wheel. The symmetrical I-configuration module cover flaps measured 6.4 cm x 11.7 cm (2.5 in x 4.6 in), width by height. The deployed driver air bag, **Figure 5**, measured 61 cm (24 in) in diameter. It was tethered by two 8 cm (3 in) wide straps and vented by two ports located in the 11/1 o'clock sectors on the back side of the bag. The face of the air bag was speckled with dirt from post-crash handling. Inspection of the air bag was unremarkable. There was no evidence of driver contact identified on the deployed bag.

Figure 5: Driver air bag.
