**CALSPAN ON-SITE CHILD SAFETY SEAT / SIDE IMPACT AIR BAG
INVESTIGATION**

CALSPAN CASE NO. – CA03-060

SUBJECT VEHICLE – 2000 ACURA 3.2 TL

CRASH DATE – SEPTEMBER 2003

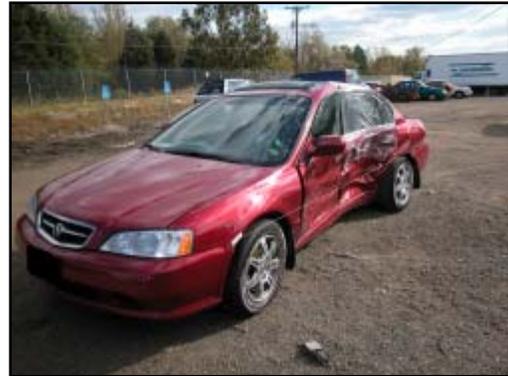
Figure 1. 2000 Acura 3.2 TL.

This on-site investigation focused on the performance of two child safety seats (CSS) in a 2000 Acura 3.2 TL (**Figure 1**) and the deployment of a side impact air bag. The Acura was involved in an intersection crash with a 1998 Pontiac Transport. The Acura was occupied by a restrained 38-year-old male driver, a restrained 37-year-old female front right passenger, a 7-year-old female seated in a belt positioning booster seat in the rear left, and a 4-year-old female seated in the rear right in a belt positioning booster seat. Both children were restrained by the vehicle's lap and shoulder belts. The Pontiac was occupied by a

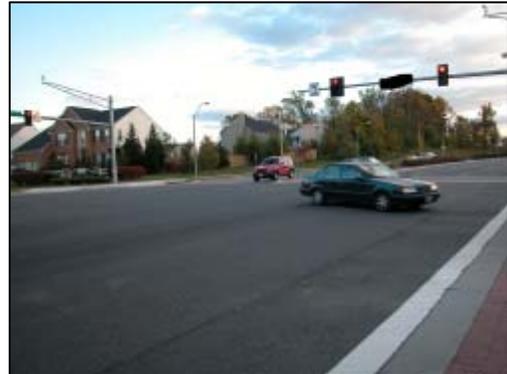
Figure 2. Crash site viewed from the northwest quadrant.

This crash occurred at a four-leg intersection (**Figure 2**) during the daytime hours of September 2003. At the time of the crash, the weather was clear with no adverse conditions. The north/southbound lanes were configured with two through traffic lanes, a right turn lane, and a left turn lane. The north/south roadway was divided by a raised concrete median that consisted of trees and grass. The east/westbound roadway consisted of four lanes. The westbound lanes were configured with one through traffic lane, a left turn lane, and a right turn lane. The eastbound lanes were configured with two through traffic lanes. The east/west roadway was divided by double yellow centerlines. Traffic flow through the intersection was controlled by overhead three-phase traffic signals. A thunder storm disabled the traffic lights and temporary stops signs were placed at the intersection to control traffic at the time of the crash. The posted speed limit for both roadways was 56 km/h (35 mph). The scene schematic is included as (**Figure 20**) of this report.

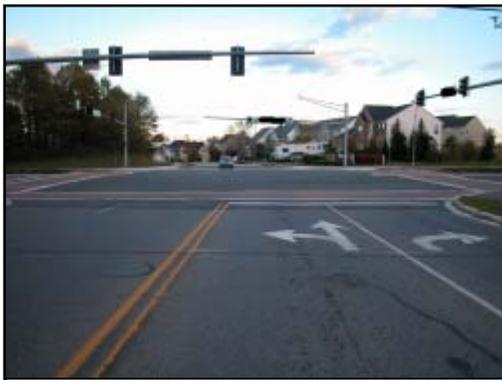
Figure 3. Acura's approach to the intersection.

The 38-year-old male restrained driver of the Acura was operating the vehicle eastbound in the left lane approaching the intersection (**Figure 3**). The 35-year-old restrained male driver of the Pontiac was traveling southbound (**Figure 4**) approaching the same intersection. The Pontiac failed to stop at the temporary stop sign and entered the intersection. The police reported that the Acura had stopped at the intersection and then proceeded into the intersection.

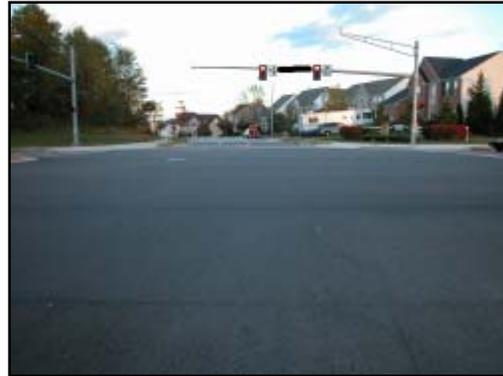
Figure 5. Area of impact from Acura's approach.

The full frontal aspect of the Pontiac impacted the left aspect of the Acura in the intersection (**Figure 5**). Three small gouges in the asphalt road surface were present in the area of the point of impact. The resultant directions of force were 10 o'clock for the Acura and 1 o'clock for the Pontiac. The damage algorithm of the WINSMASH program computed a total delta-V of 24.0 km/h (14.9 mph) for the Acura. The longitudinal and lateral components for the Acura were -12.0 km/h (-7.5 mph) and 20.8 km/h (12.9 mph), respectively. The total delta V for the Pontiac was 23.0 km/h (14.3 mph). The longitudinal and lateral components for the Pontiac were -19.9 km/h (-12.4 mph) and -11.5 km/h (-7.1 mph) respectively. As a result of the impact, the Acura's frontal air bags deployed and the driver's side impact air bag deployed. The Pontiac's frontal air bags deployed and the front safety belt pretensioners fired as a result of the crash.

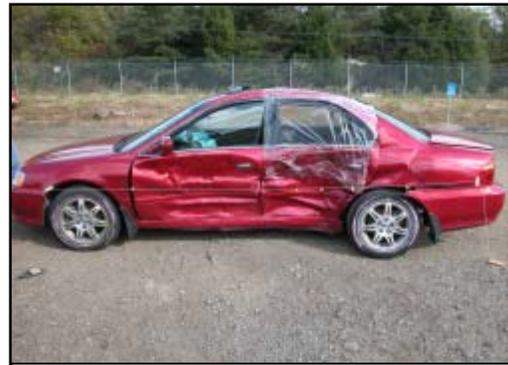
Figure 6. Damage profile of 2000 Acura 3.2 TL.

The 2000 Acura 3.2 TL sustained moderate left side damage as a result of the impact with the Pontiac (Figure 6). The maximum crush was 29.2 cm (11.5”) and was located on the left rear door. The direct contact damage began 78.7 cm (31.0”) rear of the left front axle and was 173.3 cm (68.3”) in length. The damage consisted of laterally displaced left front and left rear doors, disintegrated left rear and right front glazing and the forward aspect of the left rear quarter panel was displaced laterally. Six crush measurements were documented at the mid-door level using a combined direct and induced damaged width of 234.9 cm (92.5”) and were as follows: C1 = 0.0 cm, C2 = 17.8 cm (7.0”), C3 = 27.9 cm (11.0”), C4 = 25.4 cm (10.0”), C5 = 18.4 cm (7.3”), C6 = 1.9 cm (0.8”). The Collision Deformation Classification (CDC) for the impact was 10-LPEW-3.

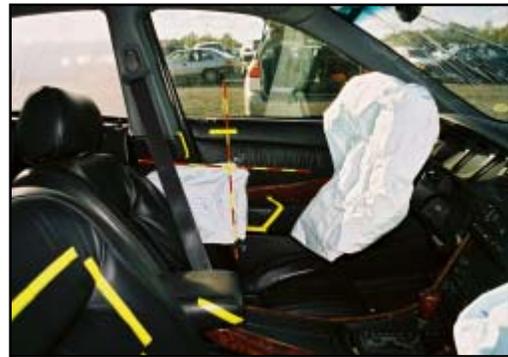
Figure 7. Interior damage to 2000 Acura 3.2 TL.

The interior damage to the 2000 Acura 3.2 TL was moderate and attributed to passenger compartment intrusion and occupant contact (Figure 7). The driver’s occupant contacts consisted of a scuff to the rear aspect of the door-mounted armrest from contact with the driver’s hip. The front right passenger’s contacts consisted of a left hip contact to the center arm rest which was deflected to the left, a fracture to the center console from contact with the occupant’s left hip, and the center console trim panel was separated from contact with the occupant’s left hip. A fabric transfer to the front right seat back was noted from contact with the right front occupants back. No occupant contacts were noted in the rear. The intrusions are listed in the table below:

Component	Intrusion	Direction
Left front roof side rail	2.5 cm (1.0”)	Lateral
Left front door	12.2 cm (4.8”)	Lateral
Left front sill	7.6 cm (3.0”)	Lateral
Left B-pillar	15.2 cm (6.0”)	Lateral

Left rear roof side rail	2.5 cm (1.0")	Lateral
Left rear door	19.1 cm (7.5")	Lateral
Left rear sill	10.8 cm (4.3")	Lateral

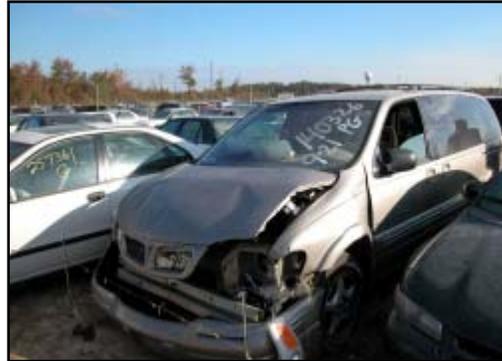
Figure 8. Damage profile of 1998 Pontiac Transport.

The 1998 Pontiac Transport sustained moderate frontal damage (**Figure 8**) as a result of the impact with the Acura. The damage consisted of a longitudinally displaced bumper beam, separated bumper fascia, and longitudinally deformed left and right fenders, hood and grille. Both headlight assemblies were disintegrated. The left and right front frame rails were shifted laterally left 16.5 cm (6.5"). The direct contact damage on the bumper fascia was 122.0 cm (48.0") and began 77.5 cm (30.5") right of the centerline to 44.5 cm (17.5") left of the centerline. Six crush measurements were documented at the bumper beam using a combined direct and induced damage width of 132.1 cm (52.0") and were as follows: C1= 0.0 cm, C2= 11.3 cm (4.5"), C3= 16.5 cm (6.5"), C4= 17.1 cm (6.7"), C5= 14.9 cm (5.9"), C6= 0.0 cm. The CDC for this impact was 81-FDEW-2 with an incremented shift value of 80.

Six crush measurements were documented at the bumper beam using a combined direct and induced damage width of 132.1 cm (52.0") and were as follows: C1= 0.0 cm, C2= 11.3 cm (4.5"), C3= 16.5 cm (6.5"), C4= 17.1 cm (6.7"), C5= 14.9 cm (5.9"), C6= 0.0 cm. The CDC for this impact was 81-FDEW-2 with an incremented shift value of 80.

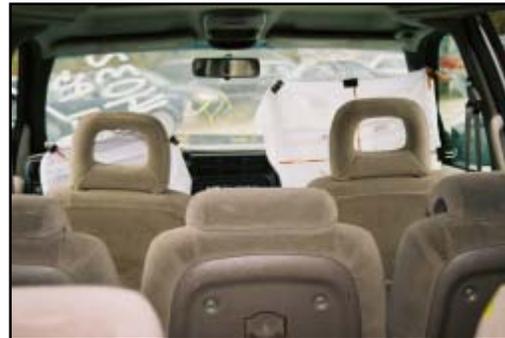
Figure 9. Interior of 1998 Pontiac from rear of vehicle.

The 1998 Pontiac Transport (**Figure 9**) sustained minor interior damage as result of occupant contacts and air bag deployment. The occupant contacts consisted of the driver loading the manual 3-point lap and shoulder belt which resulted in a D-ring transfer on the safety belt. The damage from air bag deployment consisted of the frontal passenger air bag cover flap contacting and fracturing the windshield and a vinyl transfer on the windshield. Also noted were multiple abrasions and indentations on the second and third row seat backs, cushions, and head restraints that were consistent with the frequent installation and removal of child safety seats.

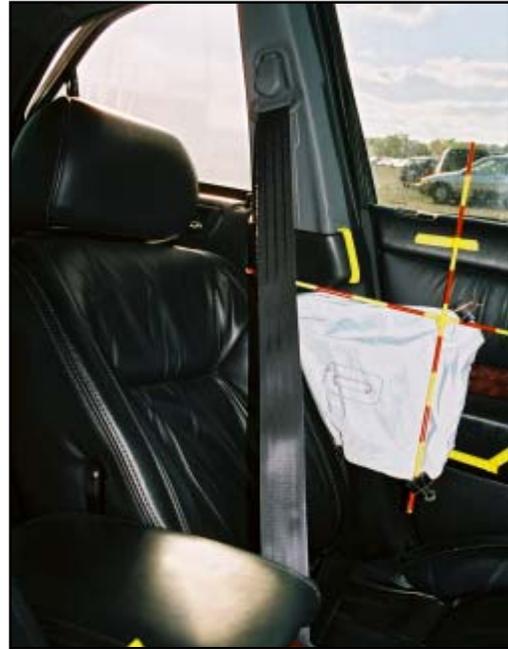
Figure 10. Deployed driver's side impact air bag.

The 2000 Acura 3.2 TL was equipped with front left and front right seatback mounted side impact air bags. The driver's side air bag deployed (**Figure 10**) as result of the impact with the Pontiac. The air bag was concealed in the left front seat back and was covered by a leather flap that was 21.1 cm (8.3") in height and 7.1 (2.8") in width. The top of the air bag extended from the seatback to 34.3 cm (13.5") forward and the bottom extended 22.9 cm (9.0") forward. The air bag was 25.4 cm (10.0") in height at the seatback and the forward edge was 19.1 cm (7.5"). The air bag contained a single tether that was stitched at the center of the air bag membrane. The tether was 8.9 cm (3.5") in width and 4.6 cm (1.8") in height. Two 2.0 cm (0.8") diameter vent ports vented the air bag at the forward edge. No occupant contact evidence was noted to the air bag.

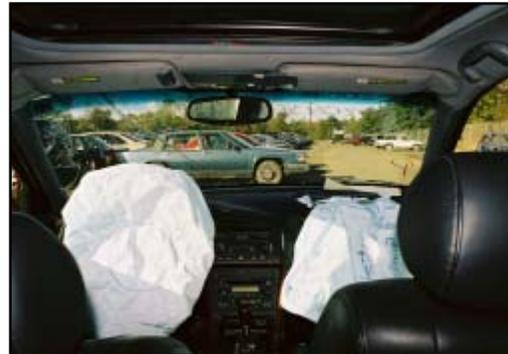
Figure 11. Deployed frontal air bags.

The 2000 Acura 3.2 TL was equipped dual-stage frontal air bags for the front left and front right positions. The air bags deployed (**Figure 11**) as result of the impact with the Pontiac. It's not known if one or both stages deployed in the crash. Two non-symmetrical cover flaps covered the front left air bag module. The top flap was 17.5 cm (6.9") at its widest point and 8.4 cm (3.3") in height. The lower flap was 13.5 cm (5.3") at its widest point and 4.6 cm (1.8") in height. The air bag was 58.4 cm (23.0") in diameter and contained two 19.1 cm (7.5") tethers on the face of the air bag at the 12 and 6 o'clock positions. Two 3.6 cm (1.4") diameter vent ports that were located on the rear of the air bag at the 10 and 2 o'clock positions vented the air bag. No occupant contact evidence was noted to the driver's frontal air bag.

The front right air bag module was located on the top right instrument panel. The air bag module was covered by a single cover flap that was hinged on the forward aspect and measured 25.6 cm (10.1") in width and 8.9 cm (3.5") in height. The air bag was 57.2 cm

(22.5”) in width and 58.4 cm (23.0”) in height. The air bag was not tethered and contained two symmetrical vent ports that were 4.6 cm (1.8”) in diameter and were located on the side panels of the air bag at the 3 and 9 o’clock positions. No occupant contact evidence was noted to the air bag.

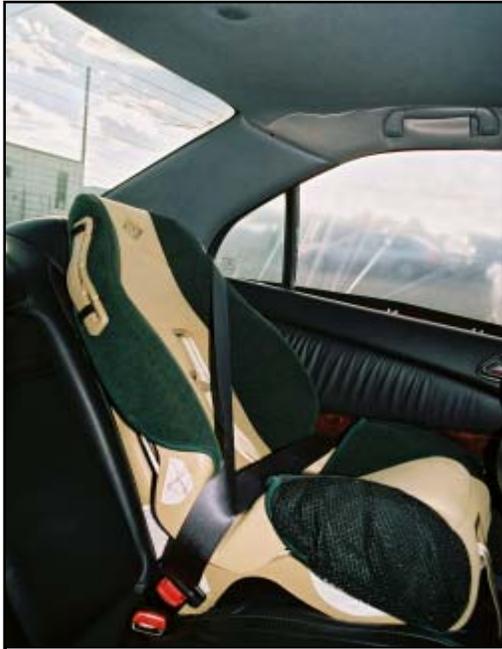
Figure 12. Cosco booster that was occupied by the 7-year-old female.

Two child safety seats were used in the rear of the Acura during the crash. The rear left seat was a Cosco Eddie Bauer Model No. 02849EBG and was manufactured on 01/2/00 (**Figure 12**). The seat was designed to be used as a forward facing CSS with the 5-point harness for children weighing 12.2-18.1 kg (22-40 lbs) or as a belt-positioning booster for children weighing 13.6-36.3 kg (30-80 lbs). The seat was used as a belt-positioning booster and was occupied by a 7-year-old female. The booster seat was equipped with a five-point harness system that was attached to the seat and positioned in the top slots at the time of the inspection. It’s unknown if the child was sitting on the harness system at the time of the crash. The plastic transfer that was noted to the rear left safety belt indicated that the child safety seat was used as a belt positioning booster seat at the time of the crash. The booster seat sustained minor damage as a result of intrusion. The rear left foot/leg at the base of the seat was deflected inward 0.3 cm (0.1”) from contact with the intruding left rear door.

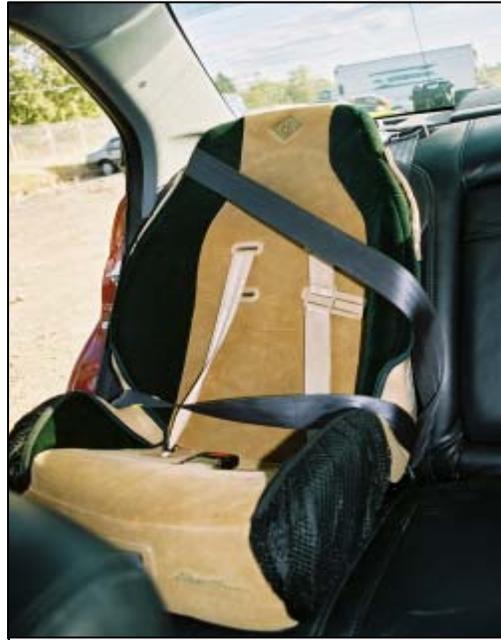
Figure 13. Cosco booster seat that was occupied by the 4-year-old female.

The rear right CSS was a Cosco Eddie Bauer Model No. 02849EBG and was manufactured on 7/10/00 (**Figure 13**). A 4-year-old female occupied the CSS. The CSS was designed to be used as a forward facing CSS with the 5-point harness for children weighing 12.2-18.1 kg (22-40 lbs) or as a belt-positioning booster for children weighing 13.6-36.3 kg (30-80 lbs). The seat was used as a belt positioning booster seat in the subject crash. The 5-point harness was still attached to the booster seat. The harness straps were positioned on the top slots at the time of the inspection. It was unknown where the internal harness system was stored in relation to the child at the time of the crash. The booster seat sustained minor damage as result of the crash. The damage consisted of abrasions to the CSS from the vehicle’s lap and shoulder belt. The abrasions were noted to the right side outboard belt path from the lap belt portion of vehicle’s safety belt. The abrasion measured 4.6 cm (1.8”) in height and 1.0 cm (0.4”) wide. An abrasion from loading was noted to the left apex of the left side inboard belt path and was measured as 2.3 cm (0.9”) in height by 1.0 cm (0.4”) width.

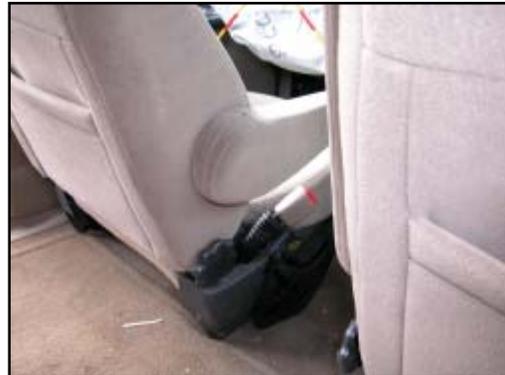
Figure 14. Fired driver's buckle pretensioner.

The 1998 Pontiac Transport was equipped manual 3-point lap and shoulder belts for the six outboard seating positions. The second row center was equipped with a manual 2-point lap belt. The front left safety belt was configured with a sliding latch plate, belt sensitive Emergency Locking Retractor (ELR), and a buckle pretensioner. The pretensioner fired as a result of the crash with the Acura (**Figure 14**). The stroke of the fired driver's pretensioner was measured 0.5 cm (0.2"). The driver utilized the lap and shoulder belt in this crash. This was evidenced by a D-ring transfer to the safety belt. The front right safety belt was configured with a sliding latch plate, switchable ELR/Automatic Locking Retractor (ALR), and a buckle pretensioner. The stroke of the unoccupied front right seat pretensioner measured 4.3 cm (1.7").

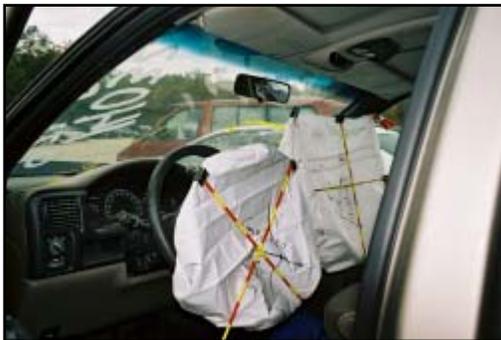
Figure 15. Deployed driver's frontal air bag.

The 1998 Pontiac Transport was equipped redesigned frontal air bags that deployed as a result of the impact with the Acura. The Pontiac was equipped with a Sensing and Diagnostic Module (SDM) that had EDR capabilities. The EDR could only be downloaded from this vehicle through the Diagnostic Link Connector (DLC) with a 12-volt power source and the ignition key. The ignition key was not present with the vehicle; therefore the EDR could not be downloaded. The driver's air bag was located in the center of the steering wheel hub (**Figure 15**) and was covered by "I" configuration cover flaps that measured 8.9 cm (3.5") in height and 10.9 cm (4.3") in width. The air bag was 67.3 cm (26.5") in diameter. The air bag was not tethered and was vented by two 2.5 cm (1.0") diameter vent ports on the rear aspect of the air bag at the 3 and 9 o'clock positions. No occupant contact evidence was noted to the air bag; however, expansion marks were noted on the face of the air bag at the 6 o'clock position.

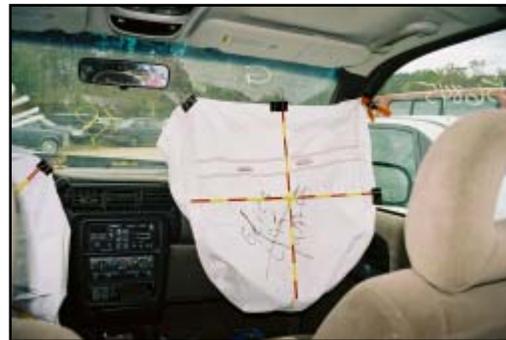
Figure 16. Deployed front right frontal air bag.

The front right air bag was located on the top right instrument panel (**Figure 16**). The air bag contained a single cover flap. The air bag was 52.1 cm (20.5") in height and 55.6 cm (22.0) in width. The air bag contained four tethers and was vented by two 2.5 cm (1.0") vent ports on the on the side panels at the 3 and 9 o'clock positions. No occupant contact evidence was noted to the air bag.

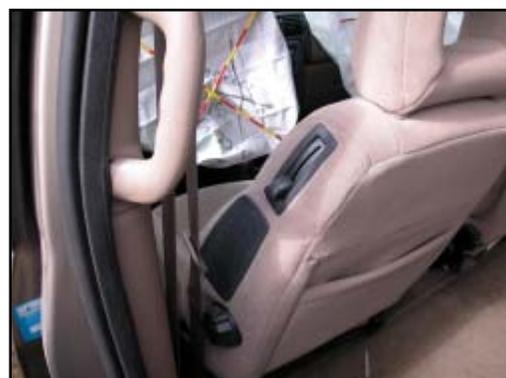
Figure 17. Non-deployed driver's side impact air bag.

The 1998 Pontiac Transport was equipped with seatback mounted side impact air bags for the front (**Figure 17**) seating positions. The Pontiac did not sustain a side impact, therefore the side impact air bags did not deploy in this crash.

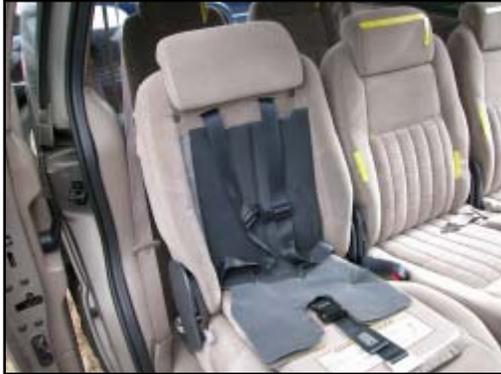
Figure 18. Integrated child safety seat in the second row right of the 1998 Pontiac Transport.

The 1998 Pontiac Transport was equipped with an integrated child safety seat in the second row right seating position (**Figure 18**). The

integrated safety seat was designed to be used for children that weigh between 9.9-18.1 kg (22.0-40.0 lbs) and between 85.1-101.6 cm (33.5-40.0”) in length as specified on the warning label (**Figure 19**). The integrated safety seat was configured with a five-point harness system. The harness system exhibited evidence of frequent use. The police reported that the 5-year-old male occupied this seat during the crash. No evidence of loading or failures were noted to the seat.
