**GENERAL DYNAMICS ON-SITE SIDE IMPACT INFLATABLE OCCUPANT
PROTECTION INVESTIGATION**

SCI CASE NO. – CA04-010

SUBJECT VEHICLE – 2003 FORD EXPLORER

CRASH DATE – MARCH 2004

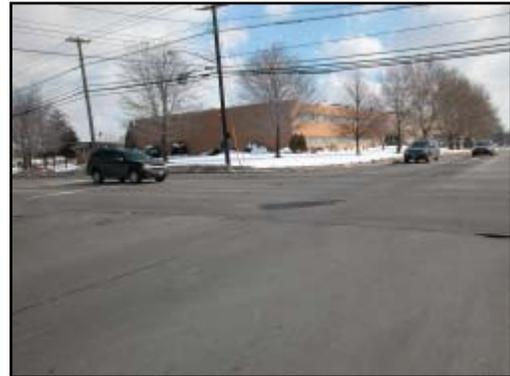
Figure 2. Northeast view of the intersection.

This intersection crash occurred during the morning hours of March 2004. At the time of the crash, the weather was clear with no adverse conditions. The crash occurred at a four-leg intersection of two local roadways (**Figure 2**). The north/southbound roadway was configured with two travel lanes in each direction and a designated left turn lane. A double-yellow centerline and appropriate lane lines delineated the north/south roadway. The east/westbound roadway was configured with two travel lanes in each direction and a designated left turn lane. The east/west roadway was separated by a double-yellow centerline and had a slight uphill grade for eastbound travel. The four-leg roadway was bordered with mountable concrete curbs.

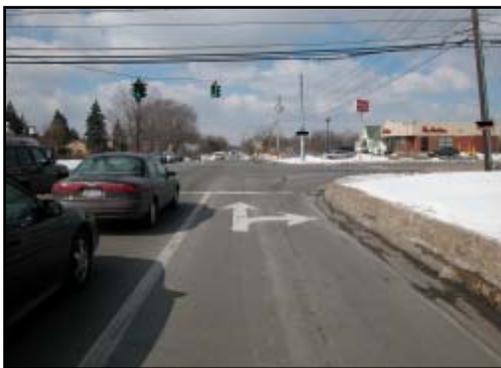
Figure 3. Ford's westbound approach to the intersection.

The restrained 45-year-old female driver of the Ford was operating the vehicle westbound (**Figure 3**) on the outboard lane, approaching the four-leg intersection. The 47-year-old male driver of the Chevrolet was traveling southbound (**Figure 4**) on the inboard lane approaching the intersection. The 62-year-old female driver of the Dodge was stopped in the left though lane at the intersection facing an easterly direction. The traffic signal was in the red phase for east/westbound travel and green for the north/southbound travel. The driver of the Ford failed to stop for the red traffic signal and entered the intersection crossing the path of the Chevrolet, which had a green signal phase.

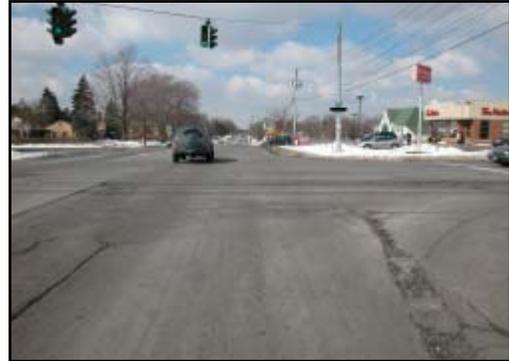
Figure 5. Area of impact between the Ford and Chevrolet from westbound approach.

The frontal aspect of the Chevrolet impacted the right passenger compartment area of the Ford in the intersection (**Figure 5**). The resultant directions of force were with the 11 o'clock sector for the Chevrolet and the 2 o'clock sector for the Ford. The WINSMASH program was used to compute a delta-V for this crash. The total calculated delta-V for the Ford was 18.0 km/h (11.2 mph). The longitudinal and lateral components for the Ford were -9.0 km/h (-5.6 mph) and -15.6 km/h (-9.7 mph), respectively. The total calculated delta-V for the Chevrolet was 16.0 km/h (9.9 mph). The longitudinal and lateral components for the Chevrolet were -15.0 km/h (-9.3 mph) and 5.8 km/h (3.4 mph), respectively. The frontal air bags deployed in the Chevrolet as a result of the crash. The Chevrolet was equipped with an Event Data Recorder (EDR) that was downloaded at the time of the SCI inspection. The data contained two files, Deployment and Deployment Level events. Both events yielded a maximum-recorded delta-V of -5.1 km/h (-3.18) mph at 52.5 milliseconds from Algorithm Enable.

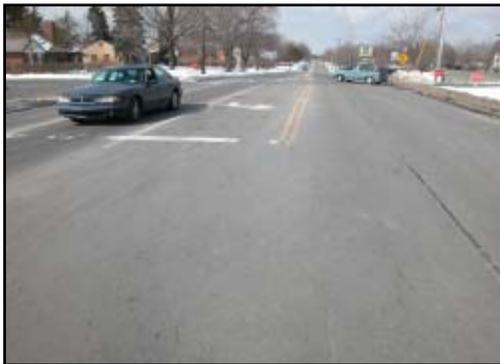
Figure 6. Area of rollover.

The Ford was deflected laterally left and initiated a clockwise yaw as its center of gravity continued in a southwesterly direction. A left rear tire scuffmark that measured 5.7 m (18.7') evidenced the vehicle's trajectory. The lateral forces exerted on the left side tires in combination with the vehicle's high center of gravity resulted in a un-tripped turn-over as the Ford rolled one-quarter turn onto its left side (**Figure 6**). The Ford's RCM measured the roll rate at 75.4 degrees per second and at an rollover angle of 42.7 degrees, the safety canopy system deployed 20 milliseconds following algorithm wake-up. The Explorer slid on its left side across the eastbound travel lanes. In this attitude, the roof of the Explorer contacted the upper surface of the left front fender of the Dodge Caravan (**Figure 7**). This impact resulted in minor damage to the Caravan and no discernable damage was evident on the Explorer.

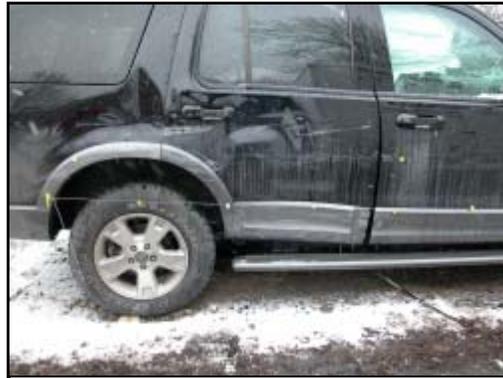
Figure 8. Damage from the impact with the Chevrolet.

The 2003 Ford Explorer sustained minor damage as a result of the impact with the Chevrolet (**Figure 8**). The direct contact damage for the initial impact with the Chevrolet measured 155.5 cm (61.25”) in length and began 9.6 cm (3.8”) forward of the rear edge of the right front door extending rearward. The damage consisted of lateral displacement of the right front door, right rear door and right rear fender. Maximum crush was located 44.7 cm (18.0”) aft of the rear edge of the front right door and measured 10.2 cm (4.0”). Six crush measurements were documented at the mid-door level using a combined direct and induced damage width of 213.4 cm (84.0”) and were as follows: C1 = 0, C2 = 1.3 cm (0.5”), C3 = 7.7 cm (3.1”), C4 = 1.3 cm (0.5”), C5 = 1.9 cm (0.8”), C6 = 0. The Collision Deformation Classification (CDC) for this impact was 02-RZEW-1.

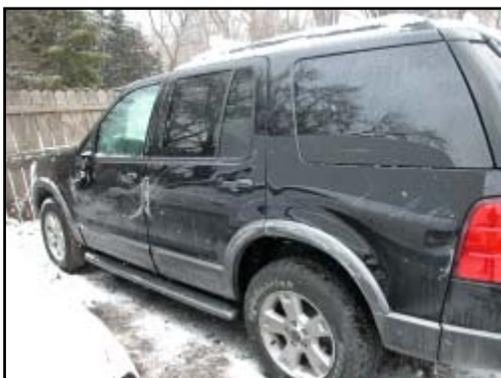
Figure 9. Rollover damage to the left side of the Ford.

The Ford sustained minor damage as a result of the rollover event. The damage consisted of superficial abrasions to the left plane (**Figure 9**). The abrasive damage was isolated to the side sheet metal and did not involve the greenhouse area of the Ford. The direct damage measured 391.8 cm (154.25”) and began 88.9 cm (35.0”) forward of the forward edge of the front left door and extended rearward. The CDC for this impact was 00-LDEO-1.

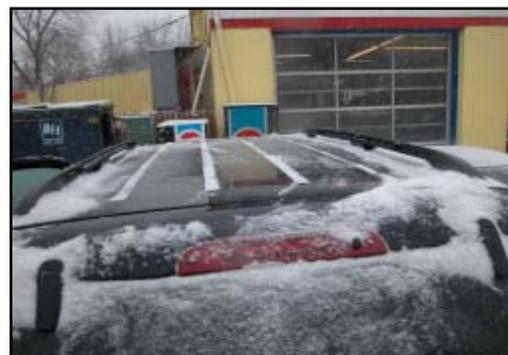
Figure 10. Rear roof aspect of the Explorer. Note no damage from the impact with the Dodge.

There was no residual damage from the impact with the Dodge (**Figure 10**). Based on the final rest positions of both vehicles, the impact area would have involved the rear aspect of the roof of the Ford. The CDC for this impact was 00-TBYU-1.

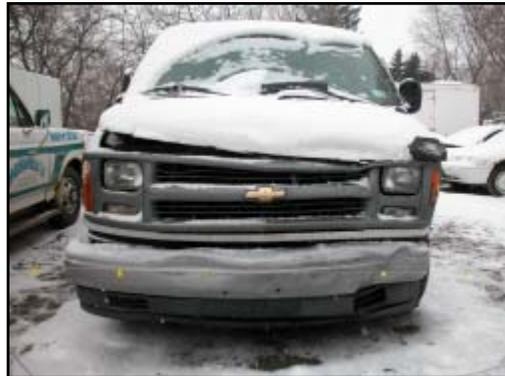
Figure 11. Damaged 2001 Chevrolet Express cargo van.

The 2001 Chevrolet Express sustained minor damage as a result of the impact with the Ford (**Figure 11**). The direct damage measured 134.4 cm (52.9") and began 83.1 cm (32.75") left of the centerline and extended to 51.3 cm (21.2") right of the centerline. The damage involved the bumper, grille, and hood. Six crush measurements were documented along the front bumper using a combined direct and induced damage with of 185.4 cm (73.0") and were as follows: C1 = 15.0 cm (5.9"), C2 = 16.5 cm (6.5"), C3 = 13.2 cm (5.2"), C4 = 13.9 cm (5.5"), C5 = 12.1 cm (4.8"), C6 = 11.0 cm (4.3"). The CDC for the impact with the Ford was 11-FDEW-1.

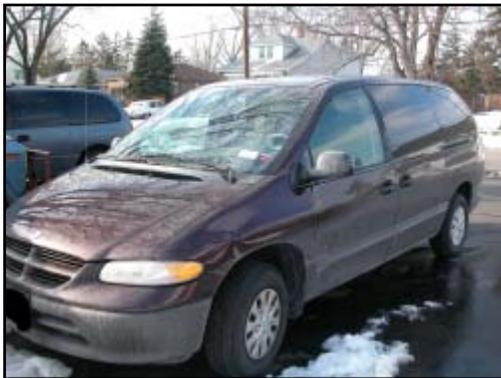
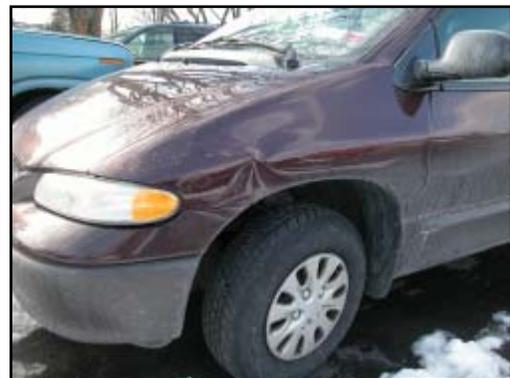
Figure 13. Damage sustained from the impact with the Ford.

The 1996 Dodge Grand Caravan sustained minor damage as a result of the impact with the Ford (**Figures 12 and 13**). The damage consisted of a dent and a lateral black scuffmark on the front left fender. The direct damage measured 25.0 cm (9.8") and began 18.0 cm (7.1") forward of the left front axle. No crush measurements were documented for this impact. The CDC for this impact was 09-LFMN-1.

Figure 12. 1996 Dodge Grand Caravan.

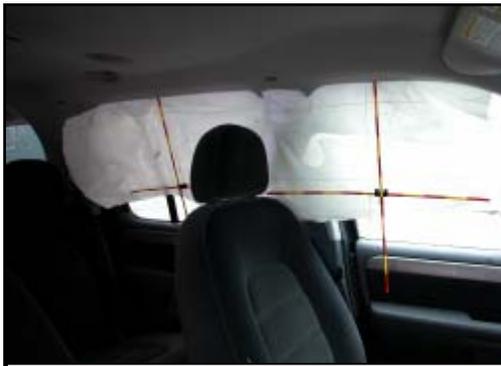
Figure 14. Deployed left side safety canopy air bag.

The 2003 Ford Explorer was equipped with safety canopy air bags for the left and right outboard seating positions. The system consisted of curtain-type air bags that deployed from the roof side rails. The canopy air bags were designed to deploy in the event of a side impact or rollover crash. The air bags were designed to remain inflated for a period of six seconds following deployment. In the subject crash, the left and right canopy air bags deployed (**Figures 14 and 15**) simultaneously and the driver's safety belt pretensioner fired as result of the rollover event. The left and right canopy air bags were rectangular in shape and measured 40.6 cm (16.0") vertically from the roof side rail and 147.3 cm (58.0") in length. The air bags were tethered at the A- and C-pillars. The tethers were a rope-type tether and measured 43.2 cm (17.0") in length at the A-pillar and 7.6 cm (3.0") in length at the C-pillar. No occupant contacts were noted to the canopy air bags; however, the left canopy air bag contained spilled coffee and candy residue. Also present on the left air bag were dirt marks from post-crash handling by tow personnel.

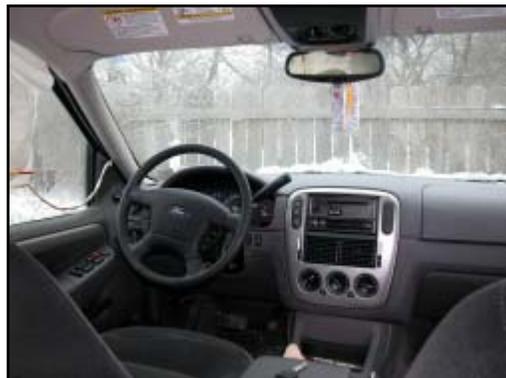
Figure 16. Ford's instrument panel, no frontal air bag deployment.

The 2003 Ford Explorer was equipped with dual-stage frontal air bags that did not deploy in this crash (**Figure 16**). The driver's frontal air bag was located in the center of the steering wheel hub. The front right air bag was mid-mounted on the front right instrument panel.

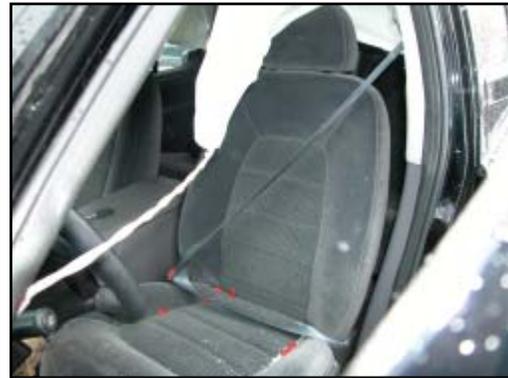
Figure 17. Driver's safety belt.

The 2003 Ford Explorer was equipped with manual 3-point lap and shoulder safety belts for all seven seating positions. The second row center seat was an integrated lap and shoulder safety belt. The driver's safety belt was configured with a sliding latch plate, Emergency Locking Retractor (ELR), buckle mounted pretensioner which fired during the crash, and a height adjustable D-ring that was adjusted to the full-up position. Historical usage evidence was noted to the latch plate, which consisted of minor scratches. The investigating police officer noted that the driver utilized the safety belt in this crash (**Figure 17**), however, no crash related evidence (e.g. stretching, transfers etc.) were present on the safety belt. The front right safety

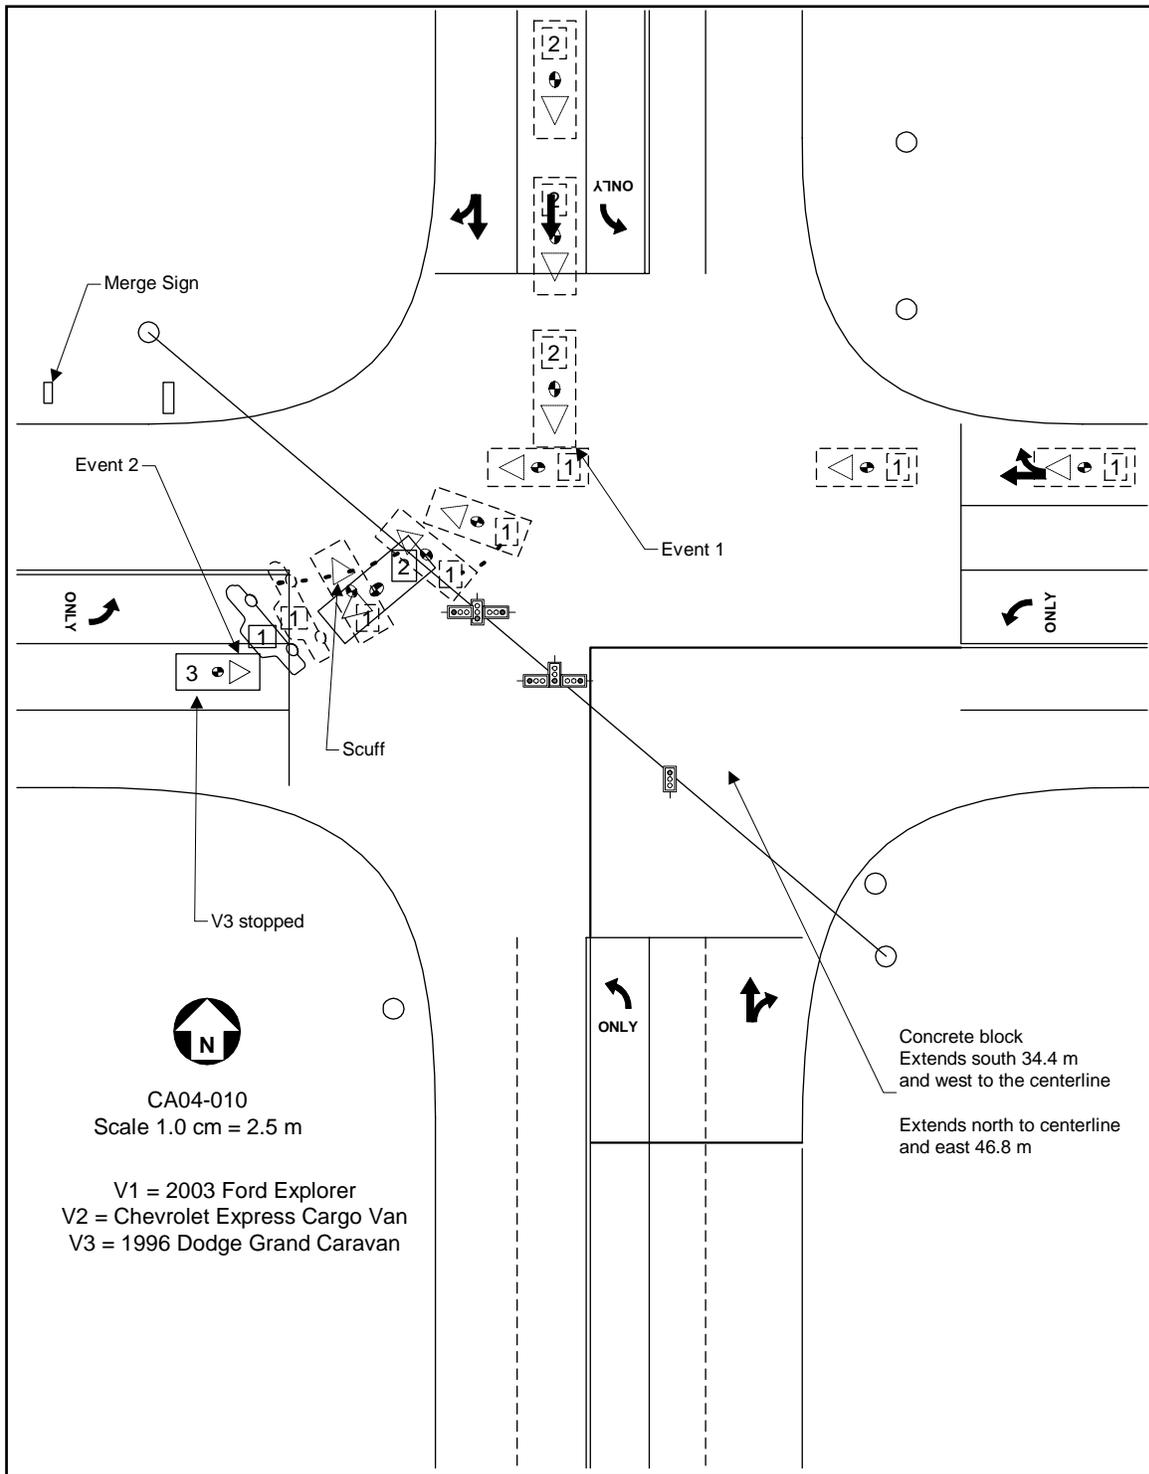
Figure 18. Scene schematic

Traffic through the intersection was controlled by overhead three-phase traffic signals. The posted speed limit for the north/south roadway was 48 km/h (30 mph). The posted speed limit for the east/west roadway was 56 km/h (35 mph). The scene schematic is included as (**Figure 18**) of this report.

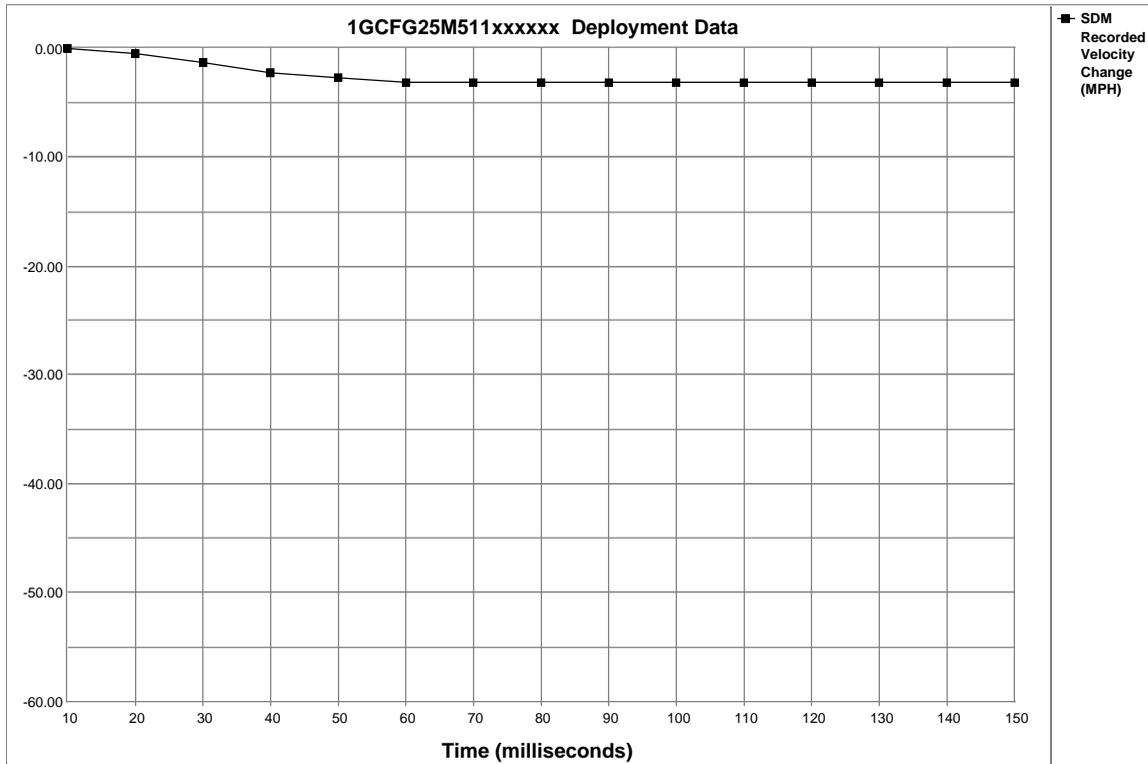
SIR Warning Lamp Status	OFF
Driver's Belt Switch Circuit Status	UNBUCKLED
Passenger Front Air Bag Suppression Switch Circuit Status	Air Bag Not Suppressed
Ignition Cycles At Deployment	8835
Ignition Cycles At Investigation	8843
Maximum SDM Algorithm Forward Velocity Change (MPH)	-3.18
Algorithm Enable to Maximum SDM Recorded Velocity Change (msec)	52.5
Time Between Non-Deployment And Deployment Events (sec)	N/A
Time From Algorithm Enable to Deployment Command Criteria Met (msec)	42.5

Time (milliseconds)	10	20	30	40	50	60	70	80	90	100	110	120	130	140	150
SDM Recorded Velocity Change	0.00	-0.44	-1.32	-2.19	-2.63	-3.07	-3.07	-3.07	-3.07	-3.07	-3.07	-3.07	-3.07	-3.07	-3.07

The 2001 Chevrolet Express was equipped with an Event Data Recorder (EDR). The EDR was downloaded during the SCI inspection and the printout is included as **Attachment A** of this report. The downloaded data consisted of two events, a Deployment and Deployment Level event. The maximum-recorded delta-V for both events was -5.1 km/h (-3.18 mph) at 52.5 milliseconds from Algorithm Enable. The EDR also indicated that the driver's safety belt was not buckled at the time of the crash and the passenger air bag was not suppressed. Although the EDR recorded Deployment and Deployment Level events, the recorded data was the same which

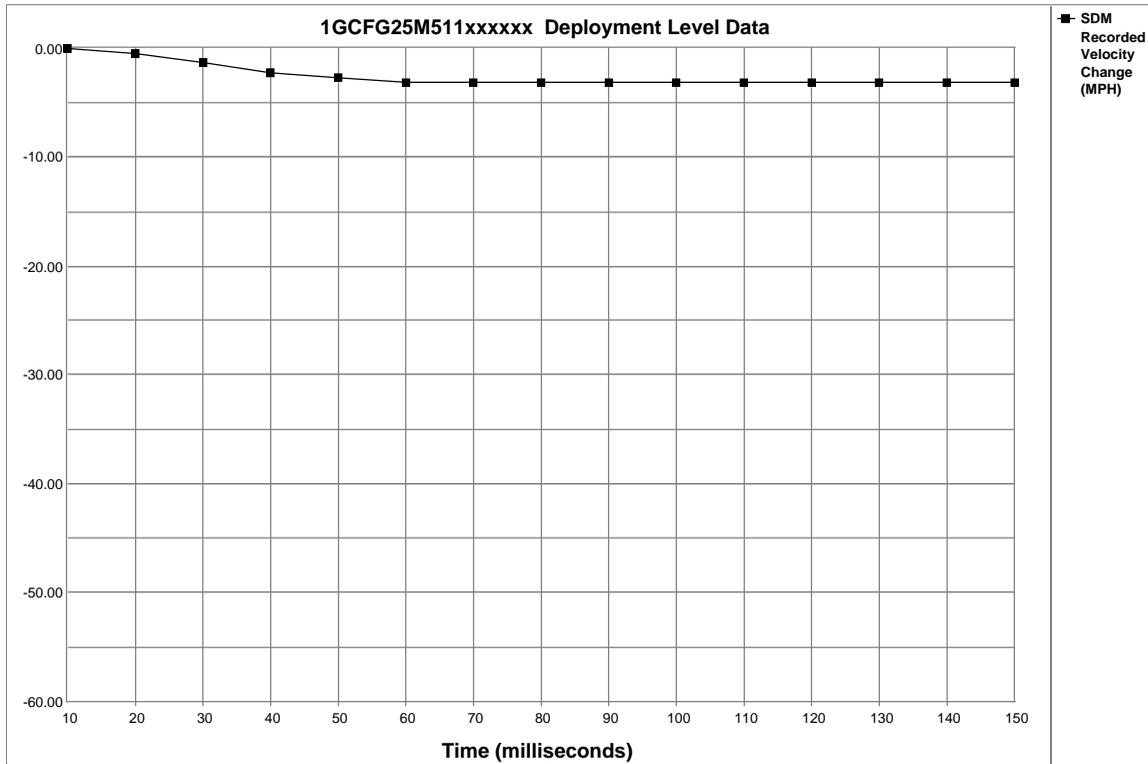
SIR Warning Lamp Status	OFF
Driver's Belt Switch Circuit Status	UNBUCKLED
Passenger Front Air Bag Suppression Switch Circuit Status	Air Bag Not Suppressed
Ignition Cycles At Deployment Level	8835
Ignition Cycles At Investigation	8843
Maximum SDM Algorithm Forward Velocity Change (MPH)	-3.18
Algorithm Enable to Maximum SDM Recorded Velocity Change (msec)	52.5
Time From Algorithm Enable to Deployment Command Criteria Met (msec)	42.5
Time Between Deployment And Deployment Level Events (sec)	N/A

Time (milliseconds)	10	20	30	40	50	60	70	80	90	100	110	120	130	140	150
SDM Recorded Velocity Change	0.00	-0.44	-1.32	-2.19	-2.63	-3.07	-3.07	-3.07	-3.07	-3.07	-3.07	-3.07	-3.07	-3.07	-3.07
