**CALSPAN REMOTE SIDE IMPACT INFLATABLE OCCUPANT PROTECTION
INVESTIGATION
VEHICLE CRASH INVESTIGATION**

CASE NO: CA04-032

VEHICLE: 2003 JAGUAR S-TYPE

CRASH DATE: JUNE 2004

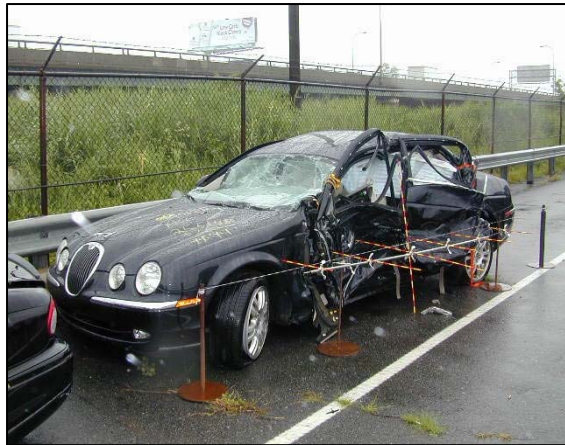
Figure 1 - Damaged 2003 Jaguar S-Type.

This remote investigative effort focused on the performance of the side impact occupant protection system that was present in a 2003 Jaguar S-Type four-door sedan. The Jaguar (**Figure 1**) was involved in an intersection crash with a 1998 Jeep Cherokee that was sufficient to deploy the Jaguar's side Inflatable Curtain (IC), the driver's seat back air bag, and fire all four outboard seatbelt retractor pretensioners. Five adult passengers occupied the 2003 Jaguar. The vehicle was occupied by a restrained 36-year-old male driver, a restrained 24-year-old female seated in the front right position, a restrained 35-year-old male seated in the

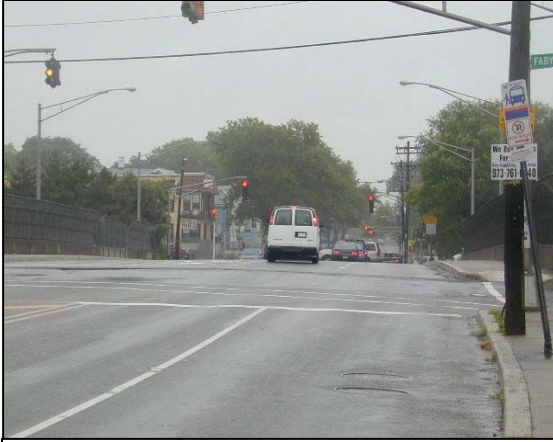
Figure 2 - Eastbound approach for the Jaguar S-Type

The 35-year-old male driver of the Jaguar S-Type entered his vehicle into an intersection with a flashing amber traffic signal (**Figure 2**). The driver of the Jeep Cherokee entered the intersection against a red flashing traffic signal (**Figure 3**). The Jaguar was traveling in the outboard eastbound lane. The lane in which the Jeep was traveling was unknown. It is not known whether either driver attempted any avoidance actions prior to the impact.

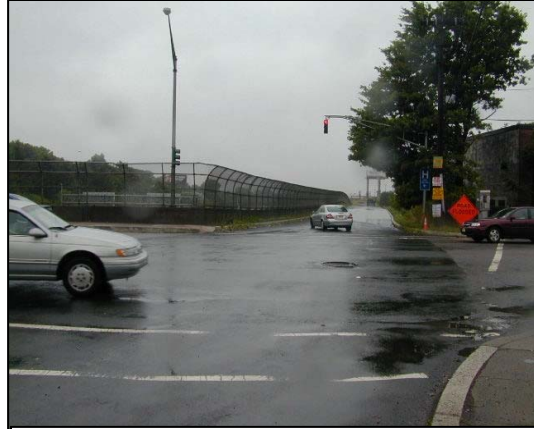
Figure 3 - The southbound approach of the 1998 Jeep Cherokee

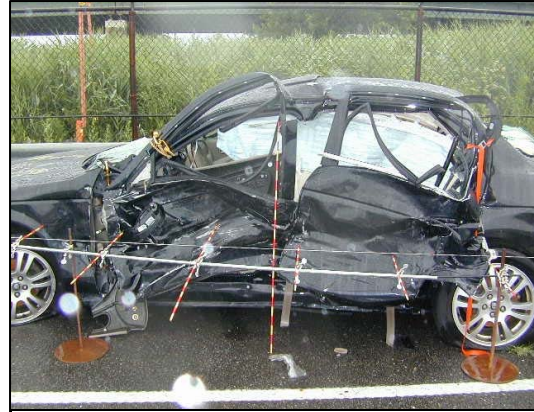
The 2003 Jaguar S-Type sustained moderate left side damage (**Figure 4**) as a result of the impact with the 1998 Jeep Cherokee. The direct damage began 20.0 cm (7.9") aft of the front left axle and extended rearward 250.0 cm (98.4"). The direct damage extended vertically above the beltline. The maximum crush was located 120.0 cm (47.2") aft of the front left axle and measured 36.0 cm (14.2"). The combined direct and induced damage measured 250.0 cm (98.4") and began 20.0 cm (7.9") aft of the front left axle and

ending 12.0 cm (4.7") forward of the left rear axle. Both left side doors were crushed laterally and jammed shut. Induced buckling was present on the front left fender, along the roof, and on the right side doors. The front left and rear left side glazing, and the backlight glazing was shattered due to impact forces. The windshield sustained stress cracking extending across the entire width. The left side window frames were displaced approximately 5.0 cm (2.0") vertically above the roofline. Six crush measurements were documented at the mid-door and were as follows: C1 = 3.0 cm (1.2"), C2 = 12.0 cm (4.7"), C3 = 24.0 cm (9.4"), C4 = 36.0 cm (14.2"), C5 = 10.0 cm (3.9"), C6 = 7.0 cm (2.8"). The Collision Deformation Classification (CDC) for the impact with the 1998 Jeep Cherokee was 10-LYAW-3.

Figure 4 - Damaged left side of the 2003 Jaguar S-Type

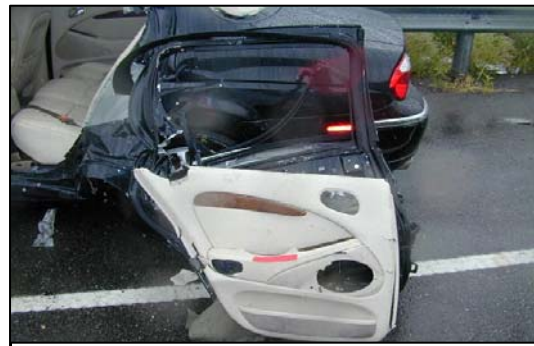
The 2003 Jaguar S-Type sustained moderate interior damage as a result of lateral passenger compartment intrusion (**Figure 5**). A contact point was present on the armrest of the back left door. As the back left occupant loaded the door panel, it sustained a crack on the plastic trim. Both left side occupants loaded the side air bags and safety belts; however, no discernable contact evidence was present on these components. The front left and rear left doors were jammed shut. Lateral intrusion into the driver's seating position included the front left door, left A- and B- pillars, and the left sill. The front left seat was compressed slightly by the intrusion of the driver's door. Lateral intrusion into the back left passenger's seating position included the back left door, back left sill, the back left roof-side-rail, and the C- pillar. The back left seat was compressed slightly due to the lateral intrusion of the left door panel. The extent of the intrusion of these components is documented in the table that follows:

Figure 5 - Interior rear left intruded door

Seating Position	Intruded Component	Magnitude	Direction
Front Left	Door Panel	8.0 cm (3.2")	Lateral
Front Left	Floor Pan	11.0 cm (4.3")	Lateral
Front Left	A Pillar	4.0 cm (1.6")	Lateral
Front Left	B-Pillar	5.0 cm (2.0")	Lateral
Front Left	Roof Side Rail	6.0 cm (2.4")	Lateral
Rear Left	Floor Pan	4.0 cm (1.6")	Lateral

Seating Position	Intruded Component	Magnitude	Direction
Rear Left	Door Panel	4.0 cm (1.6")	Lateral
Rear Left	Roof Side Rail	7.0 cm (2.8")	Lateral
Rear Left	C-Pillar	5.0 cm (2.0")	Lateral

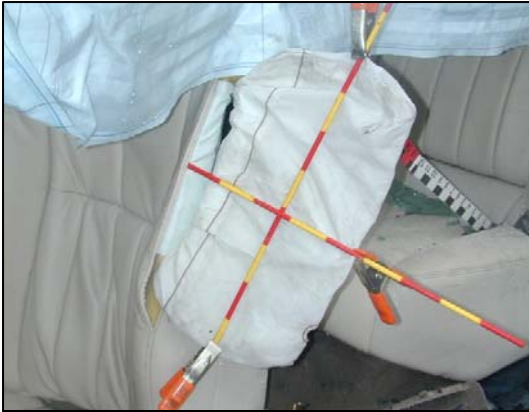
The driver’s side seat back-mounted and IC air bags deployed as a result of the left side impact with the 1998 Jeep Cherokee. The seat back air bag (**Figure 6**) deployed through a tear seam along the outboard edge of the seat back that measured 39.0 cm (15.4”) in length. The air bag was rectangular in shape and measured 40.0 cm (15.7”) in height and 20.0 cm (7.9”) in width. The seat back air bag was not tethered and was vented by one vent port located in the 8 o’clock position on the lower left inboard aspect of the deployed air bag.

Figure 6 - Driver's seat back air bag.

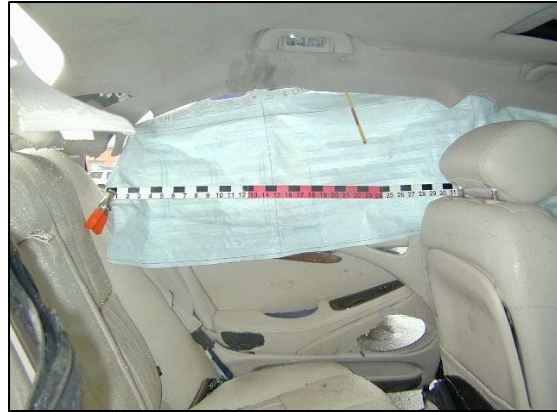
The left side IC air bag also deployed as a result of the left side impact with the 1998 Jeep Cherokee. The IC (**Figure 7**) deployed through the headliner seam at the inboard aspect of the left side roof side rail that measured 135.0 cm (53.1”) in width. The air bag was rectangular in shape, extended from the A-pillar to the C-pillar, and measured 27.0 cm (10.6”) in height and 132.0 cm (52.0”) in width. The IC was not internally tethered nor was it configured with vent ports

Figure 7 - Rear left Inflatable Curtain (IC)

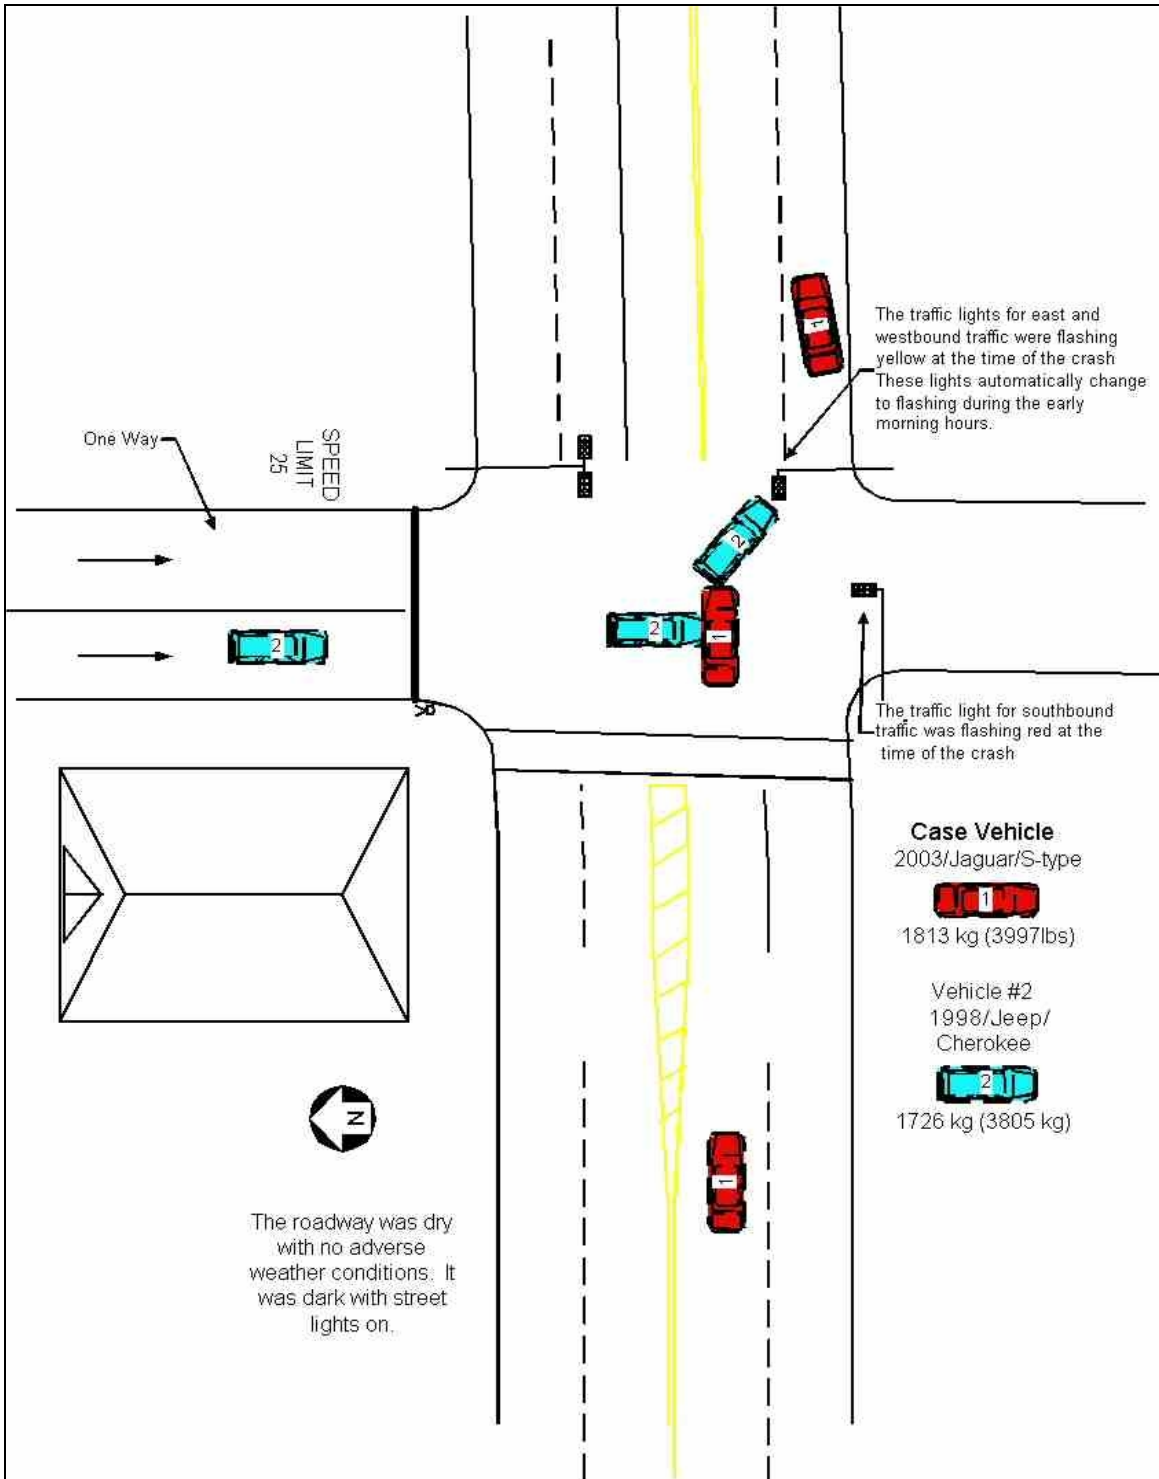
Figure 8 – Scene Schematic from CIREN Case: NJ7967-340

This two-vehicle crash occurred during the early morning hours under dark but lighted conditions in June 2004 in the state of New Jersey. At the time of the crash, the weather was clear and the asphalt roadway surface was dry. The crash occurred on the south side of a four-lane east/west roadway in the outboard lane of a four-leg intersection. The east/west roadway consisted of four lanes separated by a painted yellow divider approximately 3.0 meters (9.8') in width and designed to divide the sides of the roadways in each direction. The roadway exhibited a slight positive grade in both east/west directions and was slightly curved left from the eastbound perspective. Concrete sidewalks and commercial buildings bordered the roadway. The north-leg of the north/south roadway consisted of two lanes and was designated a one-way roadway. The southbound leg of this intersection was a one-way access road connecting to an expressway. Two-phase flashing traffic signals controlled each leg of the intersection and were reported to be functional at the time of the crash. The posted speed limit for the east/west roadway was 64 km/h (40 mph) and 40 km/h (25 mph) for the north/south roadway. A conceptual scene schematic is included as **Figure 8** of this narrative report.
