**CALSPAN ON-SITE CHILD AIR BAG RELATED FATALITY
CRASH INVESTIGATION**

CASE NO: CA05-048

VEHICLE: 1996 FORD CONTOUR GL

CRASH DATE: AUGUST 2005

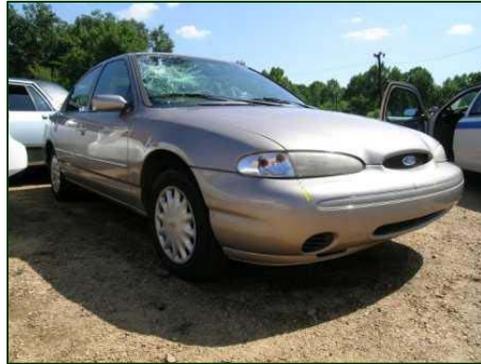
Figure 1- Damaged 1996 Ford Contour

This on-site investigation focused on the severity of the crash and the injury source that contributed to the death of an unrestrained 6-year-old female child seated in the front right position of a 1996 Ford Contour. The Ford Contour (**Figure 1**) was equipped with first generation frontal air bags for the driver and front right positions that deployed as a result of a minor severity front-to-rear crash with a 1991 Cadillac Sedan DeVille. The Contour was also occupied by a 38-year old female driver, a 14-year old female seated in the rear right, and a 7-month old child held on the lap of the rear right passenger. The driver of the Contour was traveling southbound behind the DeVille, which stopped prior to a T-intersection for a non-contact vehicle that was turning left at the intersecting roadway. The driver of the Contour braked in an attempt to avoid the impact. The unrestrained 6-year old child passenger, who was reportedly kneeling on the front right seat, was displaced forward by the pre-crash braking. The front right area of the Contour struck the back left area of the Cadillac resulting in minor damage to the Contour. The deceleration forces were sufficient to deploy the vehicle's frontal air bag system. The 6-year-old child was struck under the chin by the front right air bag module cover flap. The flap contact and subsequent air bag expansion accelerated her vertically into the windshield. The continued expansion of the air bag propelled her rearward into the windshield header and the headliner, evidenced by strands of hair. Based on the low delta-V of this crash and the child's interaction with the cover flap and expanding air bag, the cover flap was determined to be the source of the cervical spine injury. The child passenger came to rest on the rear left aspect of the rear seat with her lower extremities positioned between the front seats. The child was removed from the vehicle by the driver and was placed on the ground adjacent to the crash site. She expired at the scene due to injuries related to a cervical spine fracture identified by the Coroner. No autopsy was performed and no further injury information was available. The other three occupants of the Contour were not injured.

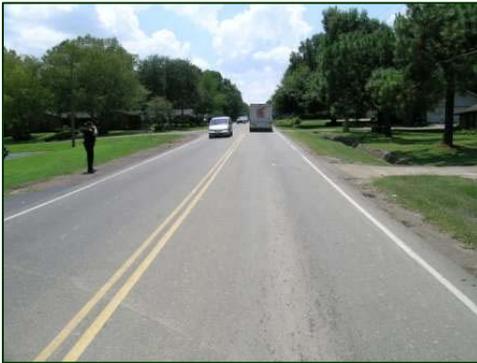
Figure 2 - Southbound approach for both vehicles

The 38-year old female driver of the Contour was operating the vehicle in a southbound direction on the two-lane roadway (**Figure 2**). Her pre-impact speed was unknown, but was below the speed limit according to a witness. A 54-year old female driver of the Cadillac was operating the vehicle in a southbound direction, traveling ahead of the Contour. Both vehicles were approaching a T-intersection. The driver of the Cadillac slowed to a stop approximately 13 meters (43 ft) north of the intersection behind a non-contact vehicle that was waiting to initiate a left turn onto the intersecting roadway. The driver of the Contour failed to detect the Cadillac in sufficient time as she braked in an attempt to avoid the impending crash. The driver of a non-contact sport utility vehicle that was following the Contour steered right onto the shoulder and roadside to avoid possible impact with the Contour. There was no pre-crash physical evidence at the scene.

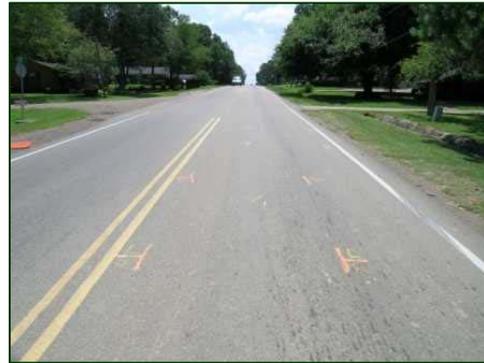
Figure 3 - Impact and final rest positions for both vehicles

The front right area of the Ford Contour struck the back left aspect of the Cadillac DeVille in the southbound travel lane (**Figure 3**). The resultant directions of force were 12 o’clock for the Contour and 6 o’clock for the struck Cadillac. The impact resulted in minor residual crush to the rear bumper of the Cadillac. The Contour did not sustain

residual damage to the frontal structure. The damage was limited to abrasions and paint transfers to the bumper fascia and an isolated area of roof deformation above the right B-pillar. The damage algorithm of the WinSMASH program computed a total delta-V of 15.0 km/h (9.3 mph) for the Contour and 12.0 km/h (7.5 mph) for the Cadillac, based on crush analysis of both vehicles. The longitudinal and lateral components of the delta Vs were -15 km/h (-9.3 mph) and 0 km/h for the Contour and 12 km/h (7.5 mph) and 0 km/h for the struck Cadillac. The impact resulted in a sufficient longitudinal deceleration to deploy the frontal driver and passenger air bags in the Contour. Both vehicles came to final rest forward of the point of impact.

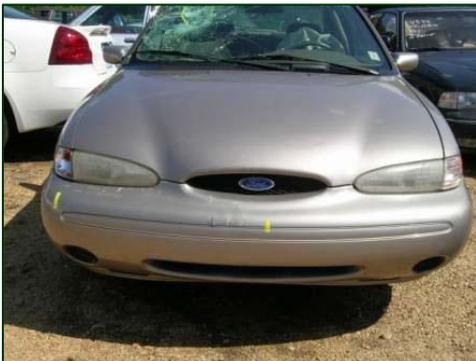
Figure 4 –Front right direct contact damage to the 1996 Ford Contour.

The 1996 Ford Contour (**Figure 4**) sustained no structural damage as a result of the frontal impact with the 1991 Cadillac Sedan DeVille. The direct contact damage on the front bumper fascia began 3 cm (1.1”) left of the centerline and extended 72 cm (28.4”) to the right, ending 5 cm (1.9”) inboard of the front right corner. No measurable frontal crush was identified. The front right turn signal lens was fractured. The bumper fascia, grille, headlamp assembly, front fenders, and hood remained in alignment post-crash (**Figure 5**). No crush measurements were taken due to the absence of crush on the frontal plane. An isolated dent (induced buckling) was present 10 cm (4”) rear of the right B-pillar on the roof, and 10 cm (4”) inboard of the right roof side rail. The Collision Deformation Classification (CDC) for this impact event was 12-FZEW-1.

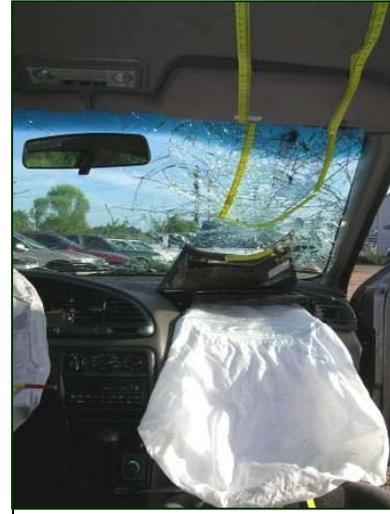
Figure 6 – Child passenger contact evidence on windshield, header, sun visor, and headliner.

The interior of the Ford Contour sustained minor severity damage that resulted from the air bag deployment and contact from the front right child passenger (**Figure 6**). There was no passenger compartment intrusion in the Contour. The deploying front right passenger air bag displaced the child passenger vertically into the windshield. Her head impacted and fractured the windshield directly above the front right air bag module. Strands of hair were embedded in the glass. The hair transfers began 28 cm (11”) right of the vehicle centerline and extended 13 cm (5”) to the right. Vertically, the hair transfers began 4 cm (1.5”) below the windshield header and extended 33 cm (13”) in length. Hair strands continued onto the right sun visor and headliner of the vehicle as the front right passenger was propelled rearward by the expanding air bag. The hair pattern along the headliner crossed the visor and continued 74 cm (29”) rearward. The hair transfers were 13 cm (5”) in width and were located 28 – 41 cm (11-16”) right of the vehicle’s centerline and extended rearward deflecting to the left, ending 10-23 cm (4-9”) right of the centerline. The front right air bag module cover flap was deformed by contact with the child passenger. This damage is addressed in the section entitled, “Frontal Air Bag System.”

The child’s head struck the windshield directly above the air bag module. This contact was evidenced by the outward bowing fracture of the windshield and a large collection of hair embedded into the fractures of the laminated glazing.

The rearward expansion of the air bag membrane struck the child in the chest region and displaced the child rearward. Her head contacted the right sun visor and headliner, evidenced by a trail of hair in the fabric of these components. The hair extended to the mid point of the headliner as the child began to fall to rest.

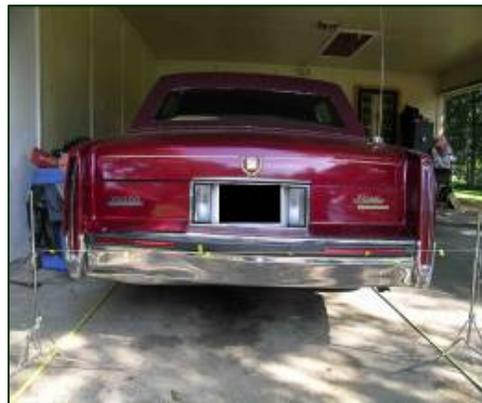
Figure 7 – Back left damage to the Cadillac DeVille.

The 1991 Cadillac DeVille sustained minor rear left damage as a result of the impact with the 1996 Ford Contour (**Figure 7**). The direct contact damage began 21 cm (8.3”) left of the centerline and extended 60 cm (23.8”) to the left. Maximum crush was 10 cm (4.1”) located at the left rear bumper corner. The rear left quarter panel sustained minor induced buckling. Six crush measurements were documented across the rear bumper as follows: C1 = 10 cm (4.1”), C2 = 8 cm (3”), C3 = 6.4 cm (3”), C4 = 5 cm (1.5”), C5 = 0 cm, C6 = 0 cm. The Collision Deformation Classification (CDC) for this impact was 06-BYEW-1.

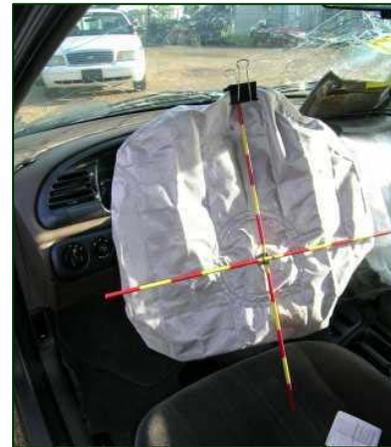
Figure 8 – Deployed driver's air bag

The 1996 Ford Contour was equipped with frontal air bags for the driver and front right passenger positions. The driver's air bag deployed through asymmetrical H-configuration module cover flaps. The upper flap measured 19 cm (7.5") in width at the horizontal tear seam and 9 cm (3.5") in height. The lower flap measured 19 cm (7.5") in width and 8 cm (3") in height. The driver's air bag (**Figure 8**) measured 56 cm (22") in diameter in its deflated state. Two circular ports that measured 2 cm (0.8") in diameter vented the air bag. The vent ports were spaced on 15 cm (6.0") centers, and located 6 cm (2.5") inboard of the peripheral seam. Four internal straps tethered the bag at the 12, 3, 6, and 9 o'clock positions. The tether stitching on the face of the driver's air bag was 17 cm (6.8") in diameter. There was no discernable contact evidence on the driver's air bag or cover flap.

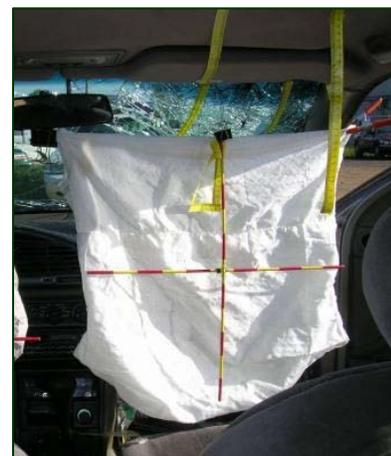
Figure 9 - Front right air bag

The front right passenger's air bag (**Figure 9**) deployed through a top-mount module with a rectangular cover flap hinged at the forward aspect. The cover flap measured 33 (13") in width and 19 cm (7.5") in height. The top aspect of the cover flap was contoured to the curvature of the top aspect of the instrument panel. At the time of deployment, the front right passenger's head was positioned above the rectangular cover flap. The flap contacted the anterior surface of the child passenger's chin, deforming the steel reinforced flap to a U-shaped pattern (**Figure 10**). The interaction between the child and the cover flap resulted in an 8 cm (3.1") deflection of the cover flap. Although the cover flap was

severely deformed by contact with the child passenger, there were no tissue or fabric transfers on the face or leading edge of the cover flap.

The front right passenger's air bag measured 70 cm (27.5") in width and 47 cm (18.5") in height. The air bag was vented internally and was not tethered. A tissue transfer was present on the upper right quadrant of the air bag. The transfer began at the top surface of the bag and extended 11 cm (4.5") downward and was centered on the vertical centerline. Several loose strands of hair were noted to the top aspect on the passenger's air bag.

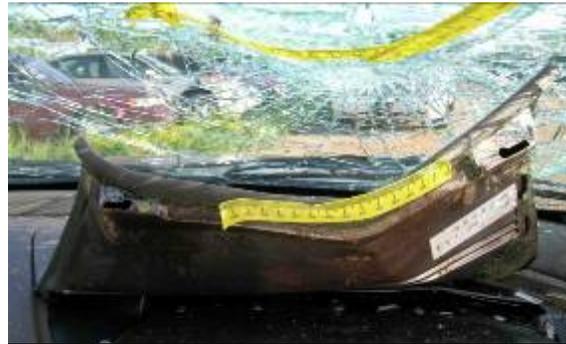
Figure 10 - Contact evidence to front right air bag tear flap

At deployment, the front right air bag module cover flap opened at the designated tear seams in an upward and forward direction. The leading edge of the flap struck the child passenger under the chin and accelerated the child in an upward direction as the air bag membrane began to expand from within the module. As a result of the interaction with the child, the cover flap deformed to a U-contour as evidenced in **Figure 10**.
