Rollover Investigation / Vehicle rollover
Dynamic Science, Inc. / Case Number: 2006-78-069A
2005 Cadillac SRX
Arizona
July 2006

1. Report No. 2006-78-069A	2. Government Accession No.		3. Recipient Catalog No.	
4. Title and Subtitle Rollover Investigation (Remote)		5. Report Date December 18, 2006

Dynamic Science, Inc.
Crash Investigation
Case Number: 2006-78-069A

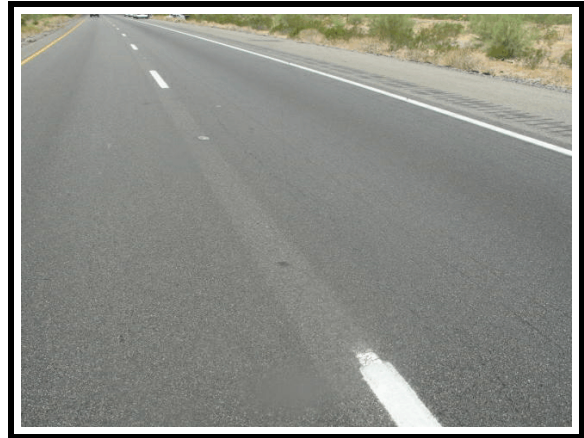
The Cadillac was traveling westbound at an EDR reported speed of 137 km/h (85 mph). The driver was likely using the cruise control¹. The driver was suffering from depression. He was taking Zoloft² for the depression. Apparently his wife and brother had recently died. According to the police supplemental report, his wife's remains were in a green bag in the vehicle. For unknown reasons, the case vehicle drifted off the left side of the roadway onto the dirt shoulder. The Cadillac continued traveling westbound on the dirt shoulder for approximately 61 m (199 ft). The driver then began braking and steering right back onto the roadway. The DSI calculated speed at the beginning of braking was 132 km/h (82.0 mph)—see Attachment 3. The EDR report indicated that the driver began braking four seconds before algorithm enable. The vehicle began a clockwise yaw. The vehicle re-entered the roadway while continuing the clockwise yaw. The vehicle crossed both westbound travel lanes and then the northern shoulder. According to the police, the driver had applied the brakes, activating the ABS system (indicated by ghost³ skid marks crossing the white fog line). It appears that the driver over-corrected by steering sharply back to the left. It appears that the front end of the Cadillac struck a reflective delineator with its front end. The vehicle went into a counterclockwise yaw while on the roadside.

Figure 3. Path of vehicle as it crosses roadway

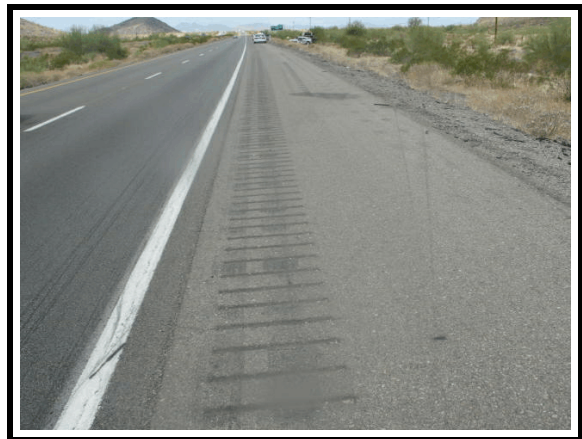
Figure 4. Vehicle path as it departs roadway toward trip point

³Light skid marks that are barely discernible due to ABS operation

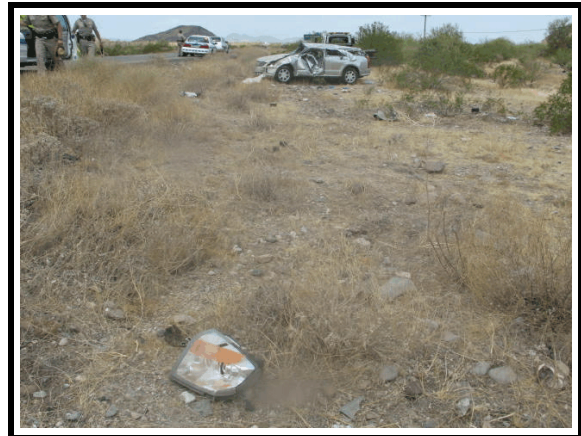
The Cadillac came to rest off road on the north side of the roadway on its wheel facing south. The driver's door had come open during the rollover. The first responder, a law enforcement officer, found the driver sitting upright in the driver's seat still wearing the manual lap and shoulder belt. The driver was non responsive. Efforts to locate a pulse were not successful. An ambulance was dispatched at 0756 hours and arrived on scene at 0810 hours. The first responder entered the right door and noted that the driver had a 12.7 cm (5.0 in) long by 7.6 cm (3.0 in) gash across the top right of the driver's head, exposing the skull. Medical staff removed the driver from the vehicle and attempted to revive him. At approximately 0823 hours a paramedic pronounced the driver dead. No autopsy was conducted, only a death certificate. The ambulance was cleared from the scene at 0851 hours.

Figure 5. Vehicle final rest

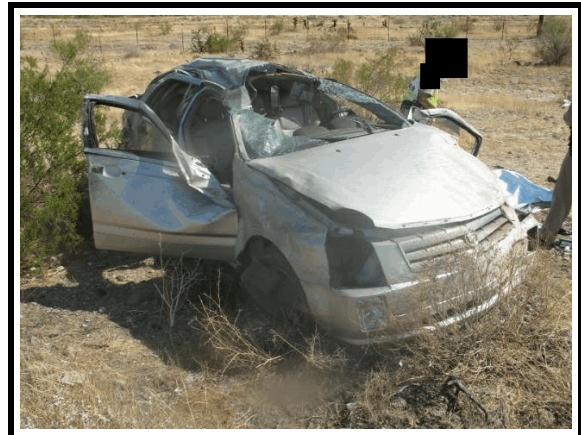
Figure 6. Vehicle final rest

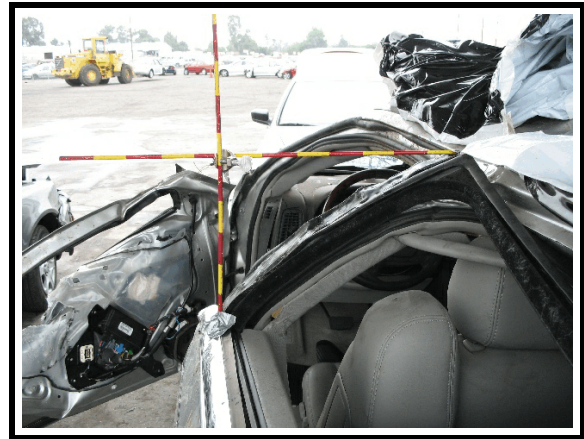
Left	Right
A	16.0 cm (6.3 in)	17.0 cm (6.7 in)
B	14.0 cm (5.5 in)	7.0 cm (2.8 in)
C	17.0 cm (6.7 in)	11.0 cm (4.3 in)
D	20.0 cm (7.9 in)	35.0 cm (13.8 in)

The maximum crush (forward of the C pillar) was located at the left B pillar and measured 17.0 cm (6.7 in) vertically and 7.0 cm (2.8 in).

Figure 8. Crush at left B pillar

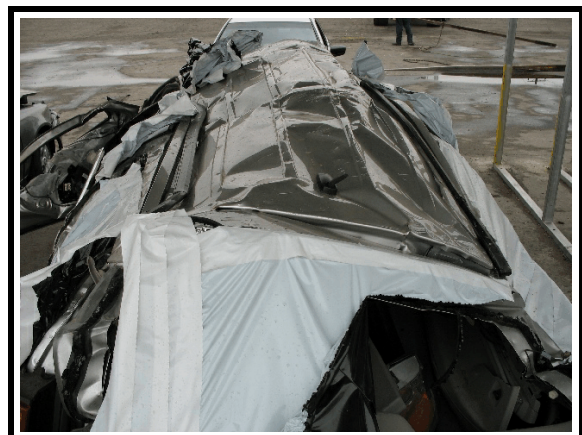
The 2005 Cadillac SRX sustained moderate rollover damage to the top, right and left side planes. Measurements were taken at each pillar location and referenced to a ground measurement. The following table lists the crush at each pillar location:

There was 98.0 cm (38.6 in) of lateral direct damage to the hood. The direct damage extended 123.0 cm (48.4 in) longitudinally along the hood, then into the windshield, and then extended rearward 230.0 cm (90.5 in) to the rear of the vehicle. The Collision Deformation Classification (CDC) for the rollover event was 00-TDDO-3.

Figure 9. Overview of roof damage

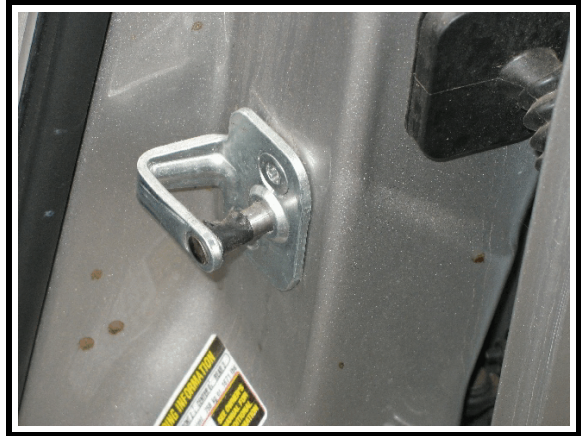
There was blood found along the left side B pillar; blood and hair were found along the interior portion of the driver's side roof rail. The left front door latch striker plate sustained minor loading damage to the inner side of the post.

Figure 10. Door latch striker plate

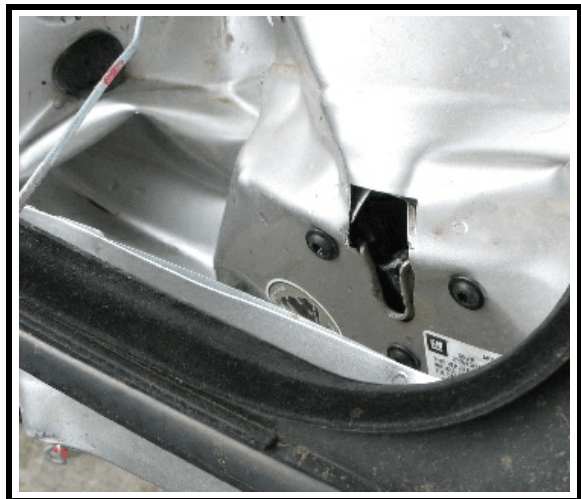
The driver's door came open during the crash sequence. It was further damaged as the open door came into contact with the ground during the rollover. According to on-scene investigators, the front right door also came open during the crash sequence. Both rear doors were jammed shut. The tail gate was also jammed shut. All the tempered glazing at all locations disintegrated during the rollover. The windshield was cracked and holed. Both right side tires were deboned and flat.

Figure 11. Door latch

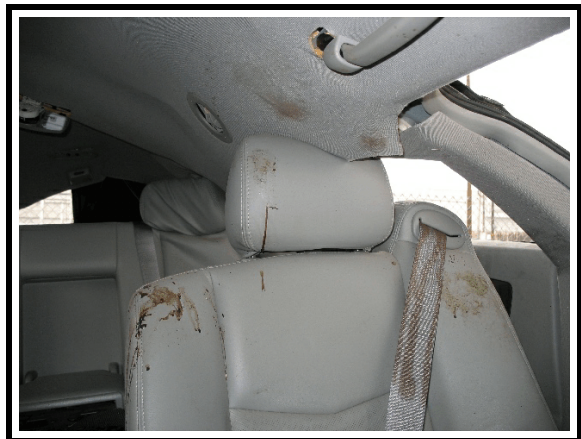
The 2005 Cadillac sustained moderate interior damage as a result of passenger compartment intrusion and occupant contacts. The right and left pillars and roof rails sustained vertical intrusion. The driver's seat headrest was deformed from contact with the left roof rail. There was blood on the headrest, on the left seat back and on the right seat back. Both sides of the driver's seat belt were blood covered.

Figure 12. Driver's seat back/head restraint

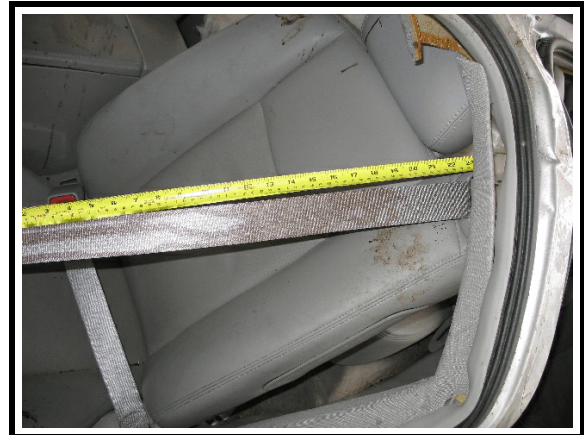
The driver's safety belt was configured with a sliding latch plate and an Emergency Locking Retractor (ELR). The driver's belt showed evidence of historical usage and loading. There was blood found on both sides of the belt indicating that the belt was in use at the time of crash. The blood was located 37.0 cm (14.6 in) from the stop button and measured 53.0 cm (20.9 in) in length.

Figure 13. Driver's seat belt

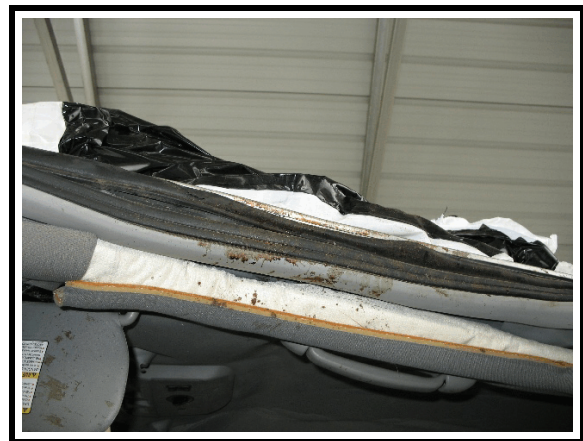
<u>Injury</u>	<u>OIC Code</u>	<u>Injury Mechanism</u>	<u>Confidence Level</u>
Closed head injury (died without further evaluation; no autopsy)	115099.7,0	Left side rail	Possible
The first responder noted that the driver had a 12.7 cm (5.0 in) long by 7.6 cm (3.0 in) gash across the top right of the driver's head, exposing the skull.	Not codeable

Figure 14. Left front roof rail contact

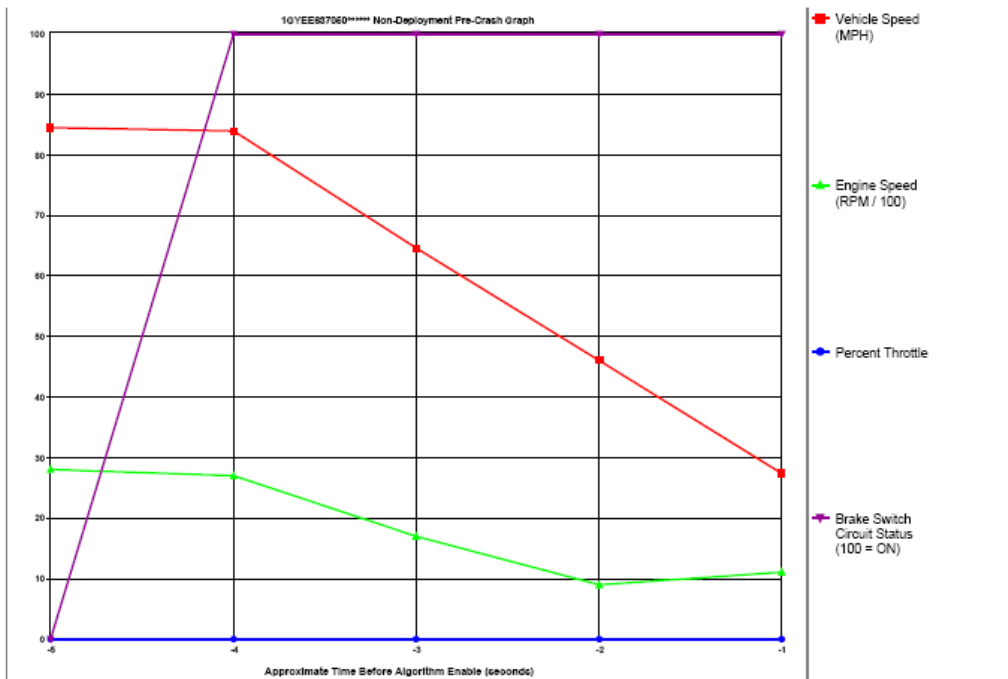
Seconds Before AE	Vehicle Speed (MPH)	Engine Speed (RPM)	Percent Throttle	Brake Switch Circuit Status
-5	85	2752	0	OFF
-4	84	2688	0	ON
-3	65	1664	0	ON
-2	46	896	0	ON
-1	27	1088	0	ON

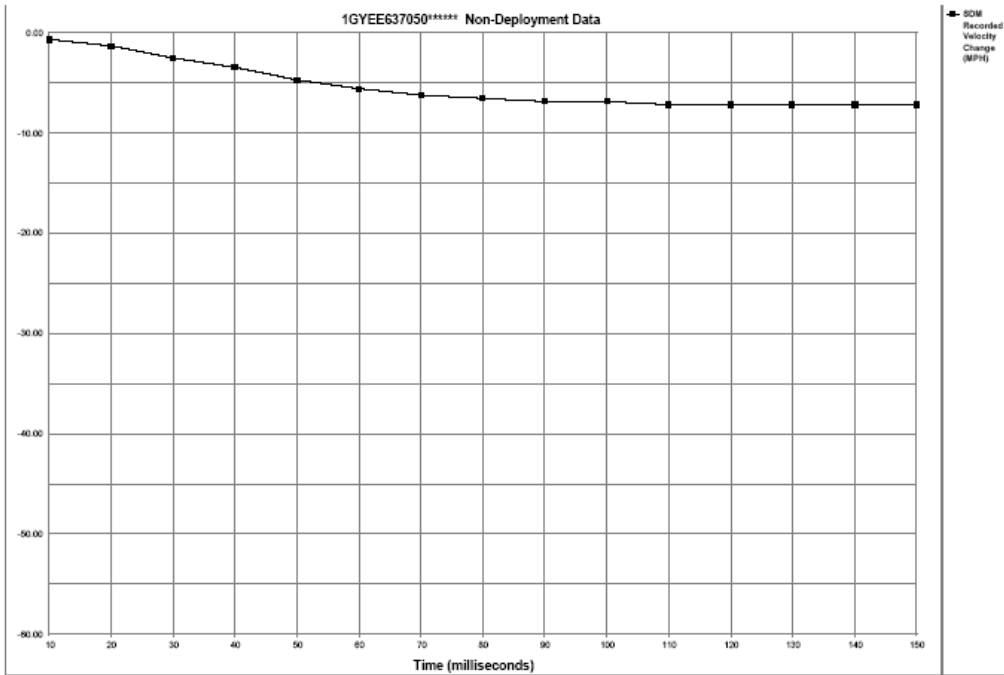
Time (milliseconds)	10	20	30	40	50	60	70	80	90	100	110	120	130	140	150
Recorded Velocity Change (MPH)	-0.62	-1.24	-2.48	-3.41	-4.65	-5.58	-6.20	-6.51	-6.82	-6.82	-7.13	-7.13	-7.13	-7.13	-7.13
