Child Safety Seat Fatality Investigation / Vehicle to Vehicle
Dynamic Science, Inc. / Case Number: DS06004
2000 Toyota Camry
California
January 2006

1. Report No. DS06004		2. Government Accession No.		3. Recipient Catalog No.	
4. Title and Subtitle Child Safety Seat Fatality Investigation				5. Report Date June 26, 2006

Dynamic Science, Inc.
Crash Investigation
Case Number: DS06004

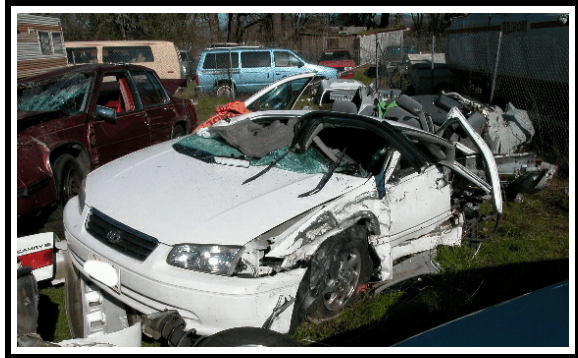
Figure 1. 2000 Toyota Camry

The focus of this on site investigation was on two child safety seats installed in the rear seat of a 2000 Toyota Camry (see Figure 1). The Camry was occupied by a 35-year-old male driver, a 33-year-old female front right seat passenger, a 3-year-old male second row left passenger who was seated in a forward facing child safety seat, and a 6-month-old second row female right passenger who was seated in a rear facing infant safety seat. Both child seats were anchored to the vehicle using the manual 3-point lap and shoulder belts. The

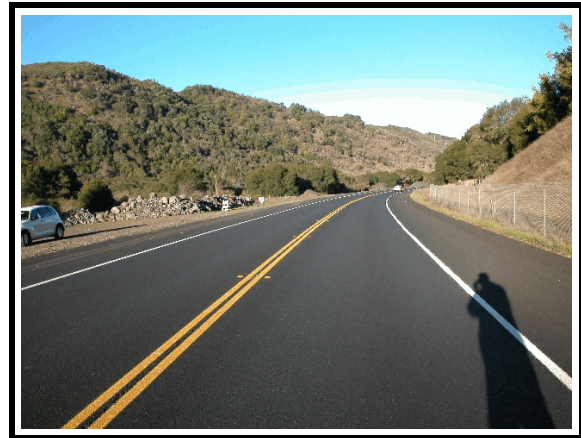
Figure 3. Path of other vehicle, westbound

The 1997 Ford pickup was traveling on the straight portion of the roadway and had begun to enter the right hand curve area. The Ford pickup drifted across the center line of the highway and struck the driver's side of the Toyota in a sideswiping type motion. The Ford's left bumper continued to engage the left side of the Toyota until penetrating the left rear door area and snagging the left rear wheel assembly. The front air bags in both vehicles deployed at impact. After impact, the Toyota began a counterclockwise rotation and left the roadway on the south side. The Toyota traveled approximately 10.9 m (36.0 ft) and came to rest facing west. The Ford also began a counterclockwise rotation and left the roadway on the south side. The Ford traveled approximately 17.9 m (59.0 ft) and came to rest facing east. Debris from the impact between the Toyota and Ford struck the front of the Chrysler causing some minor damage.

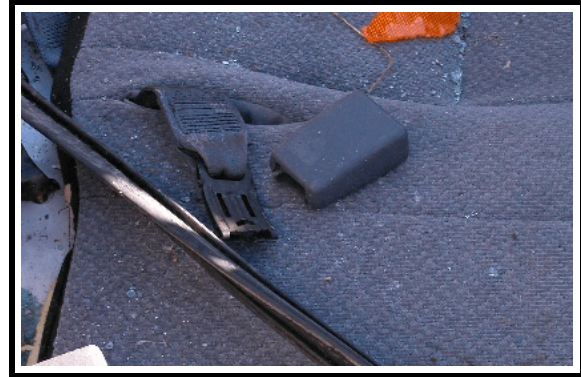
Figure 5. Second row, left seat belt buckle

The 2000 Toyota Camry sustained substantial interior damage as a result of passenger compartment intrusion. There was lateral intrusion to the driver's seated area from the left front door and the B pillar. There was an unknown amount of lateral intrusion to the second row left seat position from the door. There was also, according to police, vertical intrusion to the second row left seat position from the roof/roof side rail. The seat back for the second row left seat position failed and separated from the rest of the seat. The left rear door remained attached at the hinges, but the locking mechanism at the C pillar was torn away.

The second row left safety belt was used to secure a forward facing child safety seat. The seat belt failed at two points during the crash sequence. First, the buckle failed and the sliding latch came out of the buckle. Second, the supporting structure that secured the seat belt retractor was pulled from the vehicle. The failures do not appear to be related to any loading from the child safety seat. It appears more likely that as the rear structures of the vehicle were being torn away by the Ford pickup, the retractor support was torn away and began to pull on the seat belt. This movement caused over tension on the belt and the buckle gave way.

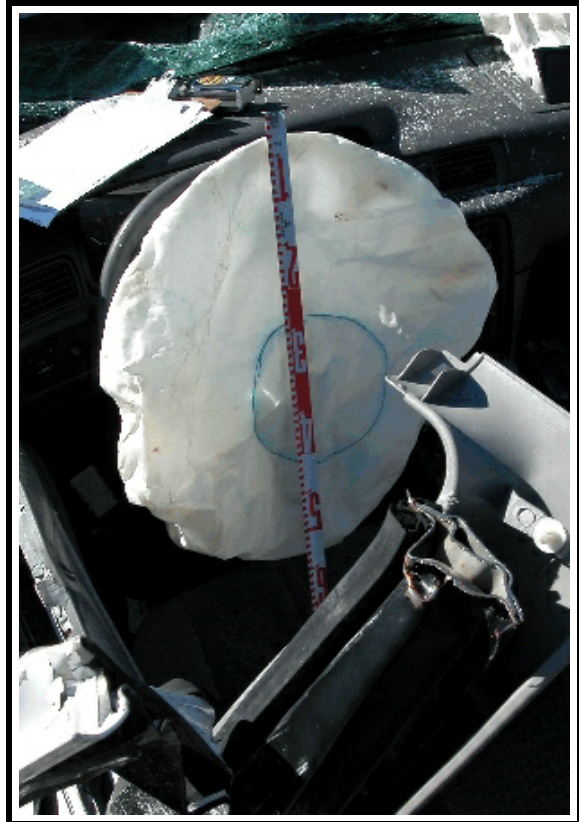
Figure 9. Driver's air bag

The driver's air bag deployed from the center of the steering wheel hub through symmetrical H-configuration module cover flaps (see Figure 9). Each flap measured 4.0 cm (1.6 in) in height and 16.0 cm (6.3 in) in width. The deployed driver's air bag measured 62.0 cm (24.4 in) in diameter in its deflated state. There was a single internal tether and two circular vent ports. The vent ports were located at the 11 and 1 o'clock positions.

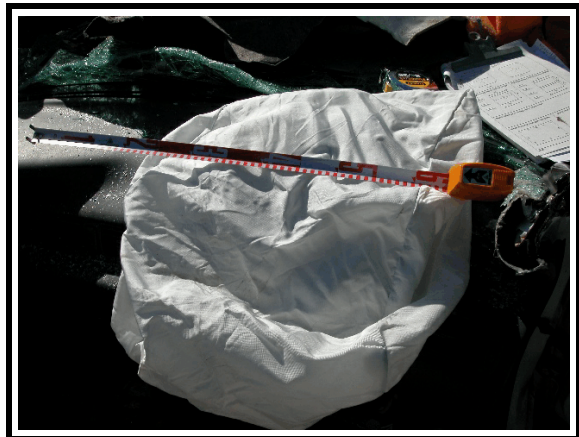
Figure 10. Front right passenger's air bag

The front right passenger's air bag deployed through top mount H-configuration module cover flaps (see Figure 10). Each flap measured 22.0 cm (8.7 in) in width and 7.0 cm (2.8 in) in height. The deployed front right passenger's air bag measured 39.0 cm (15.3 in) seam to seam in its deflated state. There were circular vent ports at the 9 and 3 o'clock positions.

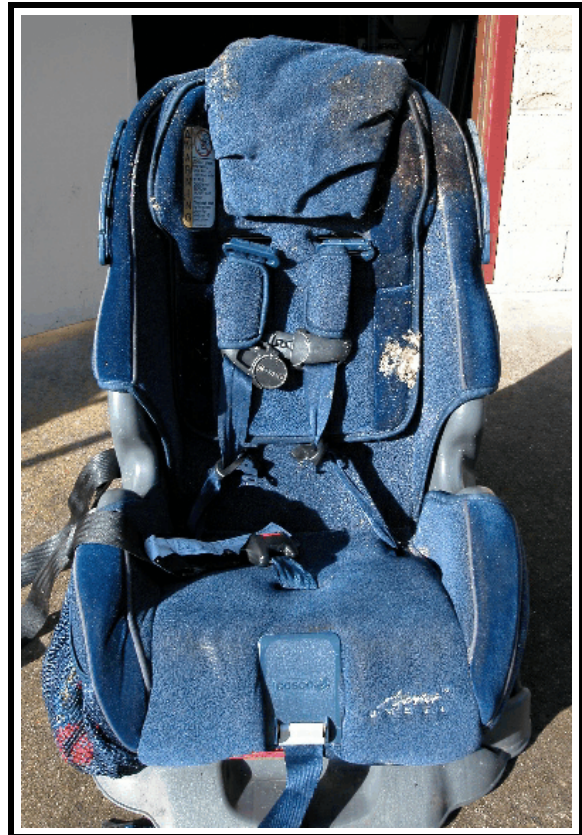
Figure 11. Cosco Alpha Omega child safety seat

The Cosco Alpha Omega child safety seat was positioned in the second row left seat of the Toyota Camry. The seat can be used with an internal harness system to secure a child up to 40 pounds and then, with the removal of the internal harness, is used as a high back belt positioning booster (BPB) seat. The model number was 22-269 CRK. The date of manufacture is not known. This car seat was configured with a five-point harness system and a two-piece, locking harness retainer clip. The manufacturer recommends that the seat be used in a forward facing fashion. When used with the harness, the seat is designed to be used for children weighing 10-18 kg (20-40 lbs). When used without the harness, the seat is designed to be used for children weighing 13.6-36.3 kg (30-80 lbs) and up to 132 cm (52 in) in height.

The seat was being used with the harness. The child's weight (approximately 21 kg/47 lbs) exceeded the manufacturer's recommended weight.

At the time of the child seat inspection, the harness straps were routed through the top set of harness slots.

The child safety seat was installed in a forward facing orientation and was anchored to the vehicle using the manual 3-point lap and shoulder belt. The belt was routed through the forward facing belt path. It is unknown if the switchable retractor was engaged. The vehicle was equipped with three tether anchors on the rear deck. The child seat was configured with a tether strap and lower anchor attachments that were not in used during the crash.

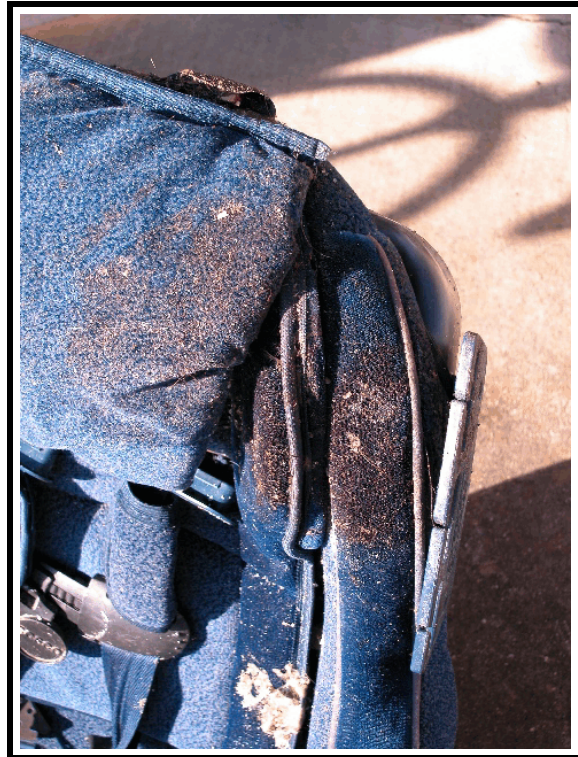
Figure 12. Close up of blood/tissue found on left side of child seat back

The child safety seat sustained minor damage as a result of the crash. There were loading and door panel transfers to the left arm of the child seat. There was blood/hair/tissue found on the left upper portion of the seat back (see Figure 12). The upper harness guides were pulled forward. There were indications of loading along the vehicle belt path, particularly on the right side (see Figure 13). The child seat shell remained intact.

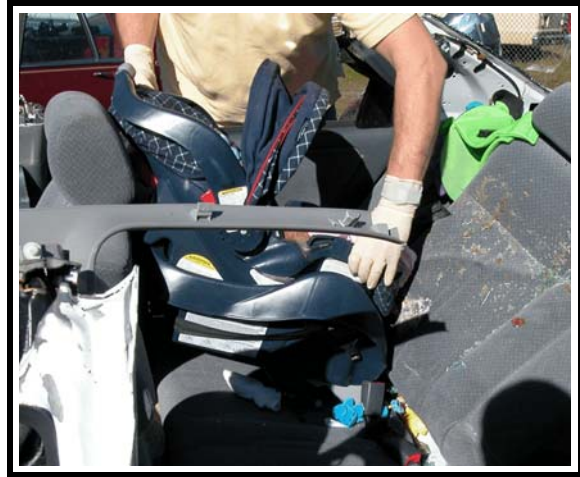
Figure 14. Graco SnugRide as found in vehicle

A rear-facing Graco SnugRide infant safety seat was positioned in the second row right seat of the Toyota Camry (see Figure 14). The model number was 8652 NPB2. The manufacture date was April 15, 2005. The infant seat was configured with a stay in vehicle base, an adjustable canopy, and a five-point harness system. The manufacturer recommends that the SnugRide infant car seat be used rear-facing only and for infants who weigh 2-10 kg (5-22 lbs) and who are less than 74.0 cm (29.0 in) tall. The child in this seat location met both the height and weight recommendations.

The infant seat was installed in a rear facing orientation and was anchored to the vehicle using the manual 3-point lap and shoulder belt. The seat was connected to the stay in vehicle base. The vehicle seat belt was routed through the rear facing belt path in the stay in vehicle base. The switchable retractor was not engaged. The seat was not tightly anchored. At the time of the inspection, the seat was able to be moved both forward and to the side. The seat was found tilted slightly to the left at the time of the inspection. The vehicle was equipped with three tether anchors on the rear deck. A child seat tether was attached to the vehicle tether anchor, but the tether was not connected to the infant seat. The infant seat was configured with LATCH belts that were not in use at the time of the crash.

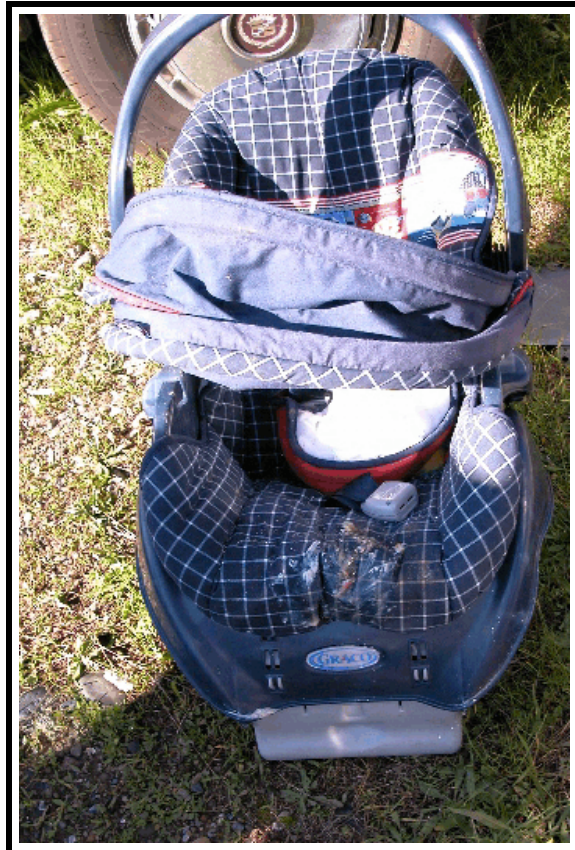
Figure 15. Graco SnugRide infant safety seat

The infant seat did not sustain any damage. Brain tissue from the left rear seat occupant was found just below the crotch strap and on the front of the seat (see Figure 15).

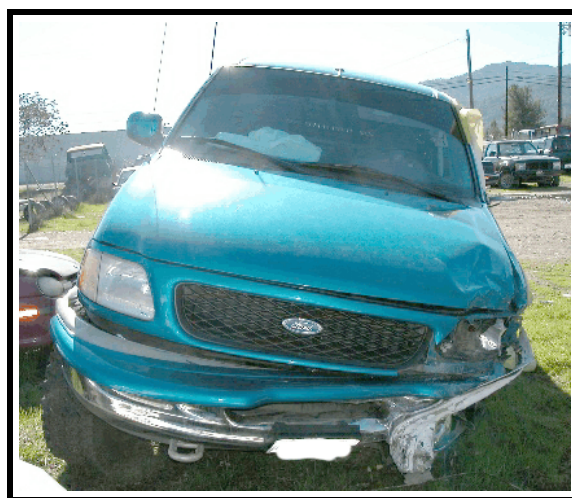
Figure 16. Front, 1997 Ford F150 pickup

The 1997 Ford F150 pickup sustained moderate frontal damage from the impact with the Toyota Camry. The vehicle was partially inspected (pictures, limited measurements) due to time constraints for the investigating police officers. The direct damage began at the left front bumper corner and extended 62.0 cm (24.4 in) across the front bumper. The maximum crush was at C1 and measured approximately 87.0 cm (34.3 in). A section of sheet metal from the Toyota's door/left rear quarter panel was embedded in the bumper. The left wheelbase was shortened by 28.0 cm (11.0 in). The left front tire was holed.

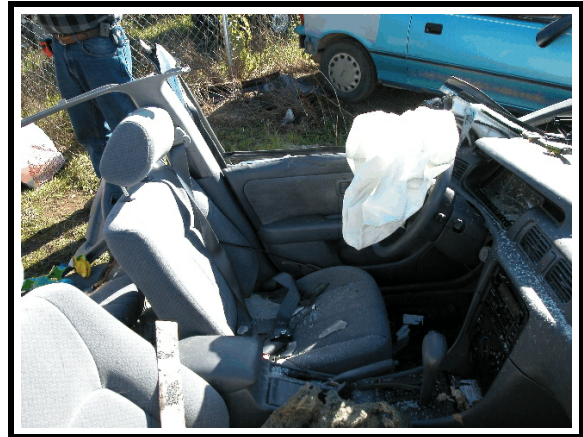
Figure 17. Overview, driver seated position

The 35-year-old male driver of the Toyota Camry was seated in a upright posture and was restrained by the manual 3-point lap and shoulder belt. The shoulder belt anchorage was adjusted to the mid position. The fabric covered bucket seat was adjusted to the rear most track position. He was wearing prescription glasses. At impact, this occupant initiated a forward and slightly left trajectory in response to the 11 o'clock direction of force. As the impact continued, the exterior of the Ford pickup penetrated and over-rode the left side of the Camry and struck the left side of the driver's face, causing the facial fractures and brain injury. The driver was unconscious immediately
