**CALSPAN ON-SITE CHILD SAFETY SEAT
CRASH INVESTIGATION**

CASE NO: CA06-026

VEHICLE: 2000 PONTIAC GRAND PRIX

CRASH DATE: OCTOBER 2006

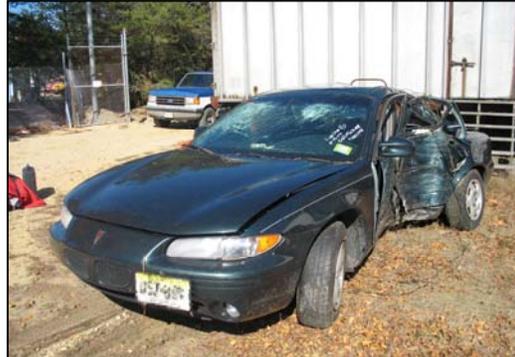
Figure 1- Damaged 2000 Pontiac Grand Prix.

This on-site investigation focused on the performance of a high back booster Child Safety Seat (CSS) that was installed in a 2000 Pontiac Grand Prix four-door sedan (**Figure 1**). The vehicle was occupied by an unrestrained 25-year old driver, an unrestrained 27-year old male seated in the front right position, and a 3-year old male seated in the booster seat in the right rear position. The 3-year old male was restrained by the manual lap and shoulder belt within the CSS. The CSS was positioned on the right side of the second row seat. The Pontiac was equipped with frontal air bags for the driver and front right passenger positions, which deployed during the impact. The Pontiac was involved in moderate left side and right side impacts with two hardwood trees. The 25-year old driver of the 2000 Pontiac Grand Prix was operating the vehicle in a westbound direction on a two-lane roadway and was negotiating a right curve. She was traveling above the posted 64 km/h (40 mph) speed limit and was engaged in an argument with the front right passenger about a domestic issue. The vehicle began to drift to the left across the roadway's centerline and the driver initiated a corrective counter steer to the right. The vehicle began to rotate clockwise, traveled across the westbound lane, and then departed the right side of the roadway. The left side of the vehicle struck a hardwood tree behind the center of gravity resulting in moderate damage. The initial impact induced a rapid counterclockwise (CCW) rotation and the right rear door area impacted a second hardwood tree where it came to final rest. The vehicle contained an Event Data Recorder (EDR); however, due to less than ideal cooperation with the tow facility, the data could not be downloaded. The driver sustained bilateral lung contusions, multiple left side rib fractures, internal lacerations, a closed head injury, and multiple soft-tissue injuries. The 3-year old child sustained an open skull fracture, a cerebral contusion, a subarachnoid hemorrhage, and lacerations to his left index finger and forehead. The driver and the 3-year old child passenger were transported via helicopter to a regional trauma center where they were admitted for 7 and 10 days, respectively. The 27-year old front right passenger sustained soft tissue injuries and was transported and released from a local hospital.

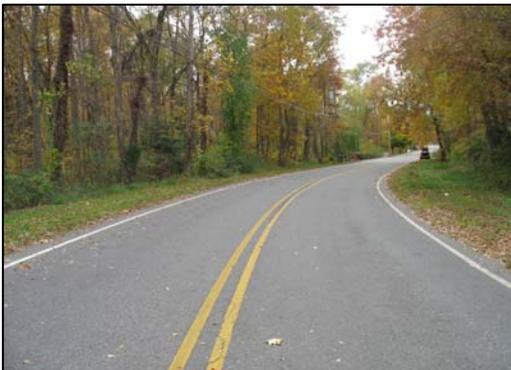
Figure 2 - Path of travel - 2000 Pontiac Grand Prix.

The 25-year old female driver of the 2000 Pontiac Grand Prix was traveling in a westerly direction on a two-lane roadway and was negotiating a right curve (**Figure 2**). The driver stated that she was engaged in an argument with the front right passenger that diverted her attention off of her driving tasks momentarily. She realized that she had drifted into the eastbound lane and initiated corrective measures in the form of steering to the right. The vehicle rotated clockwise due to a combination of the corrective action, wet roadways, and the poor conditions of the tires. The vehicle departed the roadway onto a grassy north roadside where it continued traveling toward a tree line. The vehicle rotated approximately 45 degrees as it departed the roadside, and in an attempt to regain control, the driver applied the vehicle's brakes. Physical evidence in the form of four distinct furrow marks was identified on the north roadside during the on-site investigation (**Figure 3**). The furrows were attributed to the Pontiac's four tires as the vehicle initiated a clockwise broadside yaw to the point of impact. The furrow from the right front wheel measured 28 m (91') in length and began at the north road edge and extended outboard the same a distance of 14 m (44'). The furrow from the left front tire measured 21 m (68') in length and began 1 m (3.3') outboard the north road edge and extended outboard of the same a distance of 5 m (17'). The furrow from the left rear tire measured 14 m in length and began 1.5 m outboard of the north road edge and extended outboard of the same a distance of 2.5 m (8.2'). The furrow from the right rear tire measured 4 m (12.8') in length and began 2 m (6.2') outboard the north road edge and extended outboard of the same a distance of 2.5 m (8.2'). The physical evidence in represented in the scaled crash schematic included as **Figure 11** at the end of this narrative report.

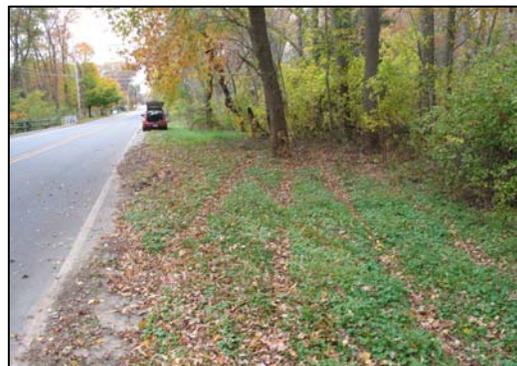
Figure 3 - Furrow marks leading to point of impact.

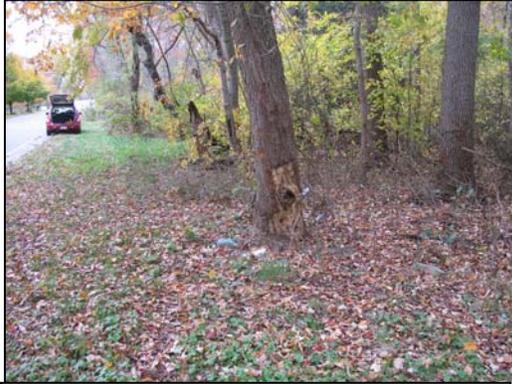
Figure 4 - Impacted tree (1st event).

The left side of the Pontiac impacted the first hardwood tree with its left side while at an angle of approximately 60 degrees (**Figure 4**). The Principal Direction of Force (PDOF) for this impact was 310 degrees which resulted in a significant longitudinal delta-V component. The impact was sufficient to deploy the frontal air bags in the vehicle. The damage algorithm of the WinSMASH program computed a total delta-V of 29 km/h (18 mph) based on the crush profile. The specific longitudinal and lateral components were -19 km/h (-11.8 mph) and 22 km/h (13.7 mph), respectively.

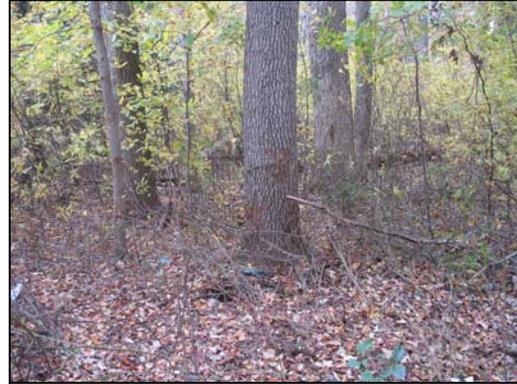
Figure 5 - Impacted tree (2nd event).

After the initial impact, the Pontiac rotated counterclockwise 240 degrees responding to the previous narrow impact behind the vehicle's center of gravity. As the vehicle rotated, the left rear door area contacted a 28 cm (11") diameter hardwood tree (**Figure 5**). For the second impact, the damage algorithm of the WinSMASH program computed a total delta-V of 11 km/h (6.8 mph) based on the crush profile. The specific longitudinal and lateral components were 4 km/h (2.5 mph) and -10 km/h (-6.2 mph), respectively. The vehicle came to final rest against the 28 cm (11") diameter tree.

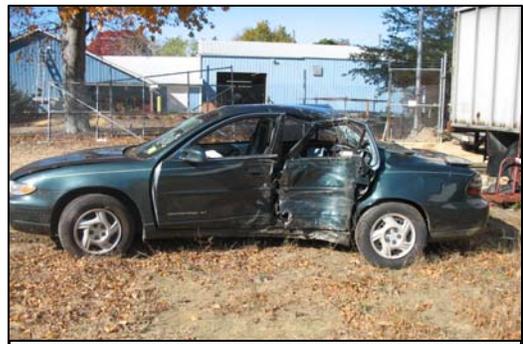
The 2000 Pontiac Grand Prix sustained moderate damage as a result of the left and right side impacts with the hardwood trees (**Figures 6 and 7**). The direct contact damage for the first impact began 36 cm (14") forward of the left rear axle and extended forward another 94 cm (37"). The Field L measurement was taken from deflection point to deflection point due to minor bowing present on the vehicle. It began 6 cm (2.5") aft of the left rear axle and extended forward 216 cm (85") to the left A-pillar. The maximum crush

Figure 6 - Damaged left side of 2000 Pontiac Grand Prix.

was located 108 cm (42.5") forward of the left rear axle and measured 46 (18.3") in depth. The crush profile consisted of six equidistant crush measurements taken along the level of the mid-door and was as follows: C1 = 0 cm, C2 = 34 cm (13.4"), C3 = 43 cm (17"), C4 = 30 cm (11.8"), C5 = 13 cm (5.1") and C6 = 0 cm. The Collision Deformation Classification (CDC) for this impact was incremented to account for the shift to the left. The change in the 10 o'clock direction of force resulted in a CDC of 90-LPAW-4.

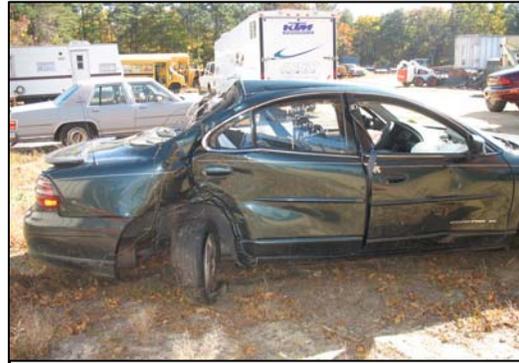
The direct contact damage for the second impact began 112 cm (44") aft of the front right axle and extended rearward 41 cm (16"). The combined direct and induced damage began 185 cm aft of the front right axle and extended rearward 150 cm (59"). The maximum crush was located 142 cm aft of the vehicle's side centerline and measured 21 cm (8.3") in depth. The crush profile consisted of six equidistant crush measurements taken along the level of the mid-door and was as follows: C1 = 4 cm (1.6"), C2 = 14 cm (5.5"), C3 = 12 cm (4.7"), C4 = 4 cm (1.6"), C5 = 0 cm and C6 = 0 cm. The CDC for this impact was 04-RZAN-2.

Figure 7 - Damaged right side of 2000 Pontiac Grand Prix.

The secondary impact originated from forward of the rear axle and contacted and damaged the right rear wheel. The damaged wheel was rotated counterclockwise approximately 80 degrees post-crash.

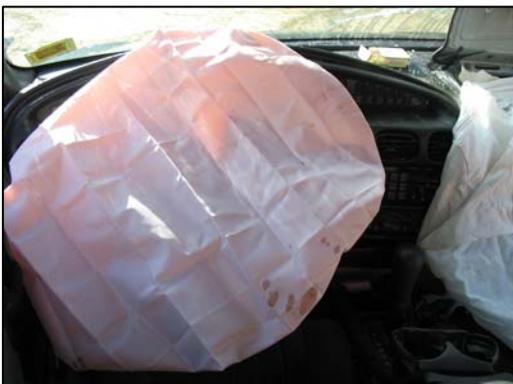
The 2000 Pontiac Grand Prix was equipped with frontal air bags for the driver and front right passenger positions. The driver’s air bag (**Figure 8**) was housed in the center of the

steering wheel hub and deployed from symmetrical I-configuration cover flaps. The cover flaps measured 11 cm (4.5”) horizontally and 8 cm (3”) vertically. The driver’s air bag measured 67 cm (26.5”) in its deflated state and had a 50 cm (20”) excursion. The air bag was vented by two circular ports located in the 10 and 2 o’clock sectors on the back of the bag. The air bag was not tethered. There was no discernable contact evidence to the air bag; however, horizontal vinyl striations were present in a linear pattern 11 cm (4.5”) above and below the air bag’s centerline. These striations resulted from the out of position driver loading the steering assembly and impeding the initial deployment of the air bag. A splattering of body fluids was also present on the back left aspect of the air bag. These fluids likely resulted from the soft tissue injuries incurred by the front right passenger. The following nomenclature was stamped on the back of the air bag:

Figure 8 - Deployed driver's air bag.

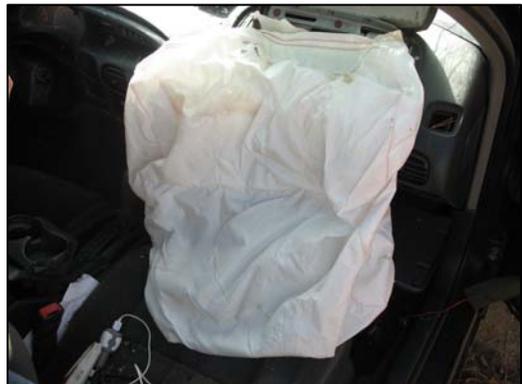
The front right passenger’s air bag (**Figure 9**) deployed from a top-mount module configured with a single rectangular vinyl cover flap hinged at the top aspect. The cover flap measured 32 cm (12.5”) in width and 15 cm (5.75”) in height. The air bag measured 47 cm (18.5”) in width and 56 cm (22”) in height in its deflated state and had an excursion of 64 cm (25”). The air bag was vented by two circular ports located in the 10 and 2 o’clock sectors. The air bag was not tethered. There were significant amounts of body fluid on the air bag mostly concentrated on the left edge. The front right occupant sustained multiple facial lacerations and is the probable source of this fluid transfer. The following nomenclature was stamped on the back of the air bag:

Figure 9 - Deployed front right air bag.

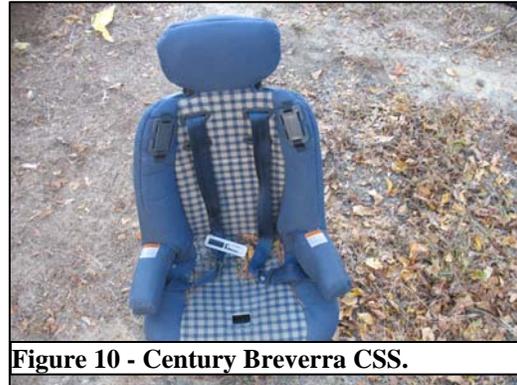
A forward facing Century Breverra Transit CSS (**Figure 10**) was installed in the second row right position of the 2000 Pontiac Grand Prix. The CSS was in its original position inside the vehicle at the time of the SCI inspection. The model number was 44845DRB and the date of manufacture was 03/28/2003. The CSS was configured with a 5-point internal harness and a two-piece retainer clip. The internal harness was not used to secure the child. The dual-purpose CSS was rated separately for use with the internal harness and without using the system. For usage with the harness the CSS was designed for children weighing between 14 – 18 kg (30 – 40 lb) and between 89 – 110 cm (35 – 43”) in height. For usage as a belt positioning booster seat, the CSS was designed for children weighing between 14 – 36 kg (30 – 80 lb) and between 89 – 127 cm (35 – 50”) in height. The CSS was used as a belt positioning booster seat by the driver who routed the shoulder belt through the belt positioning clip over the child’s right shoulder. According to the driver, the lap belt was positioned under the arm rests and snug against the child’s abdominal region. There were no discernable stress marks on the seat or shell of the CSS.

Figure 10 - Century Breverra CSS.

The CSS was equipped with the Lower Anchors and Tethers for Children (LATCH) system; however, the vehicle was not equipped with lower anchors or a top tether hook. The CSS was placed on the seat and the child was secured with the manual lap and shoulder belt; it was removed and reinstalled frequently by the owner.
