Remote Not In Traffic Surveillance Hyperthermia Investigation
Dynamic Science, Inc. / Case Number: DS07022
1998 Nissan Maxima
Hawaii
March 2007

1. Report No. DS07022	2. Government Accession No.		3. Recipient Catalog No.	
4. Title and Subtitle Remote Not In Traffic Surveillance Hyperthermia Investigation			5. Report Date April 15, 2008

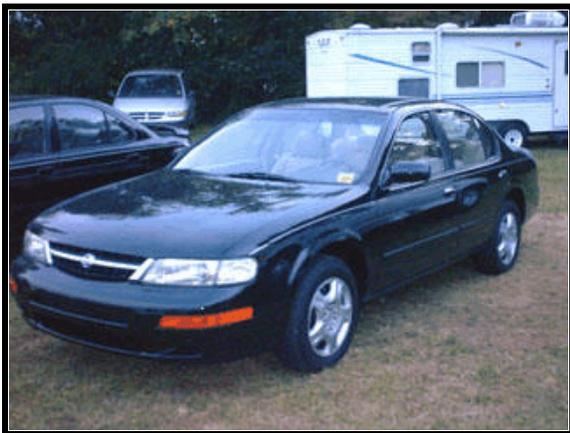
Figure 1. Exemplar view of 1998 Nissan Maxima (left front)

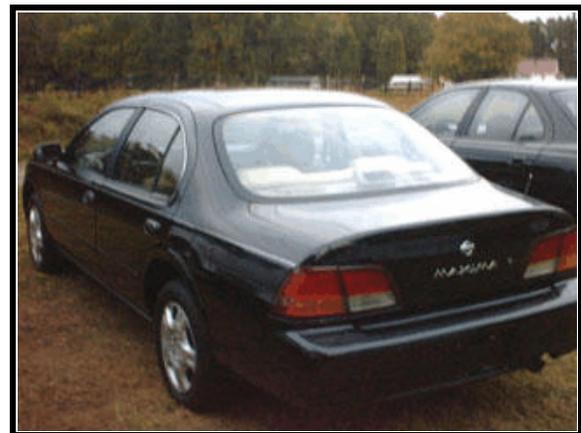
Figure 2. Exemplar view of 1998 Nissan Maxima (left rear)

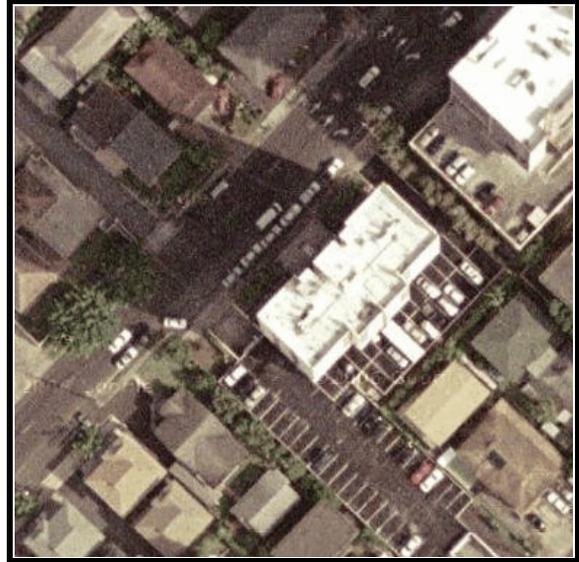
This hyperthermia related death occurred in March, 2007 between 1200 and 1340 hours. The scene was the parking lot of an apartment complex (**Figure 3**). There does not appear to be any shaded areas or area covered by foliage.

Figure 3. Case vehicle parked in apartment parking lot

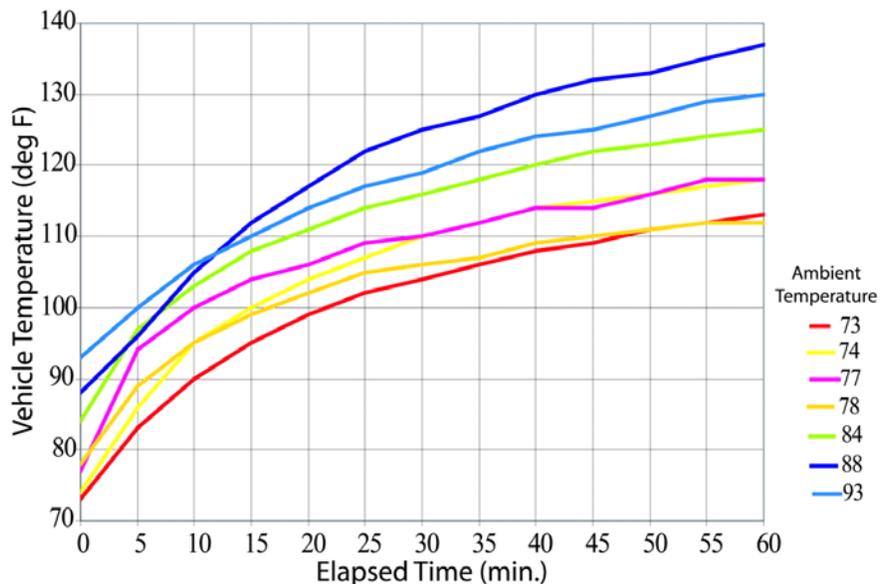
Representative vehicle temperature rise over time

In an observational study, McLaren, C. et al, noted that the internal temperature of a vehicle with the windows closed increased 3.2 degrees F per 5-minute interval, with 80% of the temperature rise occurring during the first 30 minutes. The study also reported the final temperature depended on the starting ambient temperature but even at the coolest ambient temperatures, the internal temperature reached 47.2 degrees C (117 degrees F). Given the starting ambient temperature of 25.6 degrees C (78 degrees F) in this case, the internal temperature would have reached approximately 40.6 C (105 degrees F) in 30 minutes.

At approximately 1340 hours, the driver returned to the vehicle and found the child unconscious and unresponsive. According to one weather expert quoted in an on line news article "with a high temperature of 81 degrees, the temperature inside the vehicle would have reached about 115 degrees after 30 minutes and more than 130 degrees after an hour."
