Remote Not In Transport Surveillance Back Over Investigation
Dynamic Science, Inc. (DSI), Case Number (DS07024)
1997 Chrysler Town and Country Van
Hawaii

1. Report No. DS07024	2. Government Accession No.	3. Recipient Catalog No.	
4. Title and Subtitle Remote Not In Traffic Surveillance Back Over Investigation		5. Report Date April 1, 2008

**Dynamic Science, Inc.
Crash Investigation
Case Number: DS07024**

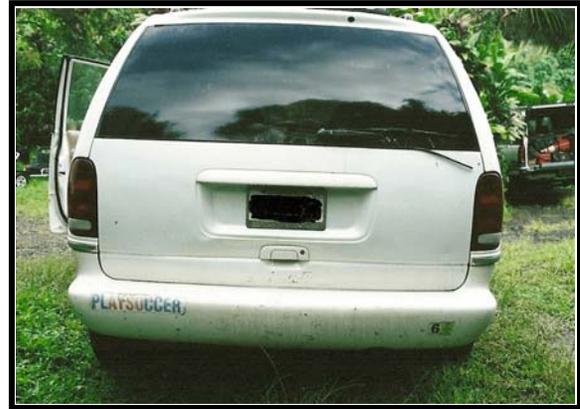
Figure 1. Rear, 1997 Chrysler Town and Country

This single vehicle crash occurred in December 2006 at 0815 hours. The case vehicle is a 1997 Chrysler Town and Country van (**Figure 1**). The incident took place in the unimproved driveway of a private residence. The area was overgrown with tall grass and fruit trees. The case vehicle was initially parked facing southwest. After eating breakfast with his family, the 30-year-old male driver walked out of the house and headed for his van, which was parked approximately 9.1 m (30.0 ft) from the home. He got into the van from the left side. After getting in the van, he saw his wife going into the home. He last recalled seeing their 1-year-old child standing by the stairs, close to the door of the home. The child appears to have walked in an easterly direction to a position behind the van and in the driver's blind spot. The driver began to back in a northeast to south direction. He was attempting to complete a two-point turn so that he could travel forward in a northwest direction. As the driver began backing, he heard what he described as a "pop" sound. He continued backing the van until it was facing north. It appears that the child was run over by the right rear tire. When the driver stopped, in preparation to go forward, he saw the child. He called for his wife. He picked up the child and put him in a second vehicle. He stated that he began administering CPR and called 911, in hopes of having an ambulance meet them. The call was dropped so they took the child directly to a local hospital. The child was pronounced dead at 0909 hours. The cause of death was: "blunt force injuries of the head, due to, or as a consequence of result of run over by a motor vehicle". The injuries included the following: multiple abrasions and contusions, multiple skull fractures, diffuse subcapular hemorrhage, diffuse subdural and subarachnoid hemorrhages, and a laceration of the brain.

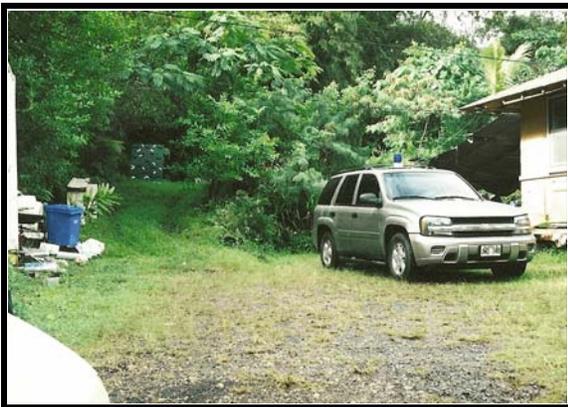
Figure 2. Initial parked area. House is to the right, container to the left. Looking southwest.

The Chrysler was initially parked facing southwest (**Figure 2**). After eating breakfast with his family, the 30-year-old male driver walked out of the house and headed for his van, which was parked approximately 9.1 m (30.0 ft) from the home. He got into the van from the left side. After getting in the van, he saw his wife going into the home. He last recalled seeing the male 1-year-old child (76 cm/30 in, 11 kg/24 lbs) standing by the stairs, close to the door of the home. The child appears to have walked in an easterly direction to a position behind the van and in the driver's blind spot. The distance between the door and the area of impact is approximately 12.1 m (40.0 ft). Given an average child walking speed of 1.1 mps (3.7 fps), it would have taken the child approximately 10-11 seconds to travel from the door to the area of impact.

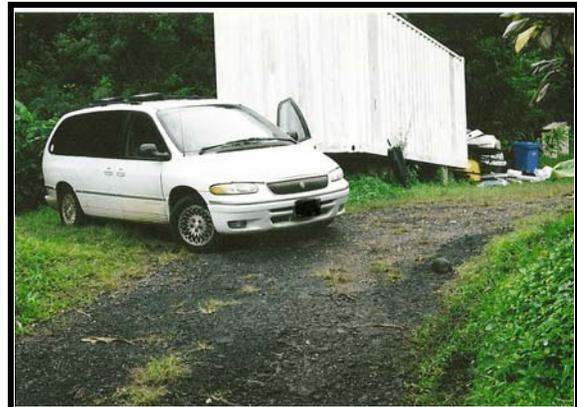
Figure 3. 1997 Chrysler Town and Country at final rest

As he began backing, he heard what he described as a “pop” sound. The van had traveled rearward approximately 2.7 m (9.0 ft). Given an acceleration rate of 4.8 ft/sec², the vehicle would have been going no faster than 10.1 km/h (6.3 mph) at impact. It appears that the child was knocked down by the bumper and then run over by the right rear tire. The driver continued backing the van until it was facing north (**Figure 3**).

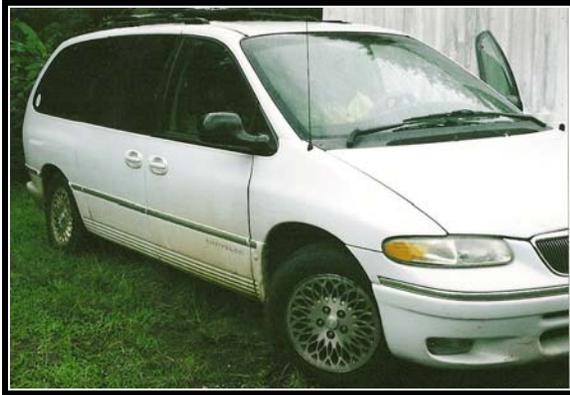
There was no exterior or interior damage to the 1997 Chrysler Town and Country (**Figures 4-5**). The police indicated the presence of what appeared to be a small blood stain on the right rear tire and on the right rear fender well. The stain was not visible in any of the police vehicle photographs.

Figure 4. Front right, Chrysler

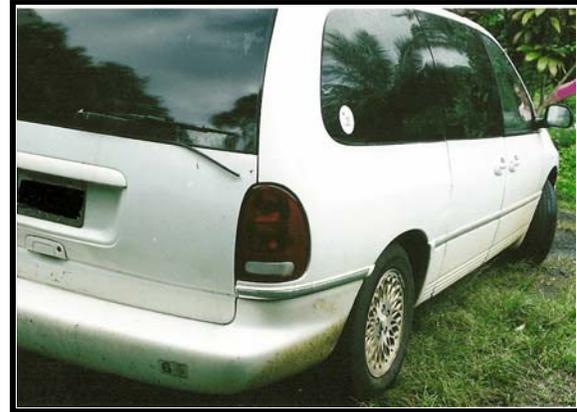
Figure 5. Right bumper and right rear tire

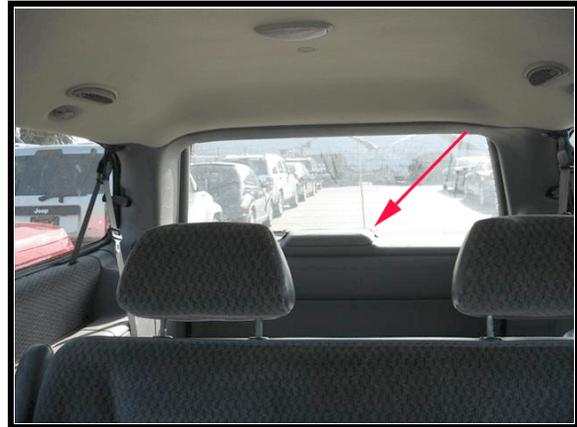
The initial set of measurements were taken as if the driver were looking over his right shoulder through the backlight (**Figure 6**). The target was moved rearward from the back bumper along the vehicle's centerline until it became visible to the investigator. The point at which the target became visible to the investigator measured 3.96 m (12.99 ft) rearward of the rear bumper. This measurement was used as the point of origin for two sets of lateral measurements which were then taken. Measurements taken laterally to the left and right resulted in a visibility zone that could be viewed through the backlight. Two sets of lateral measurements were taken due to the presence of second row head restraints which blocked the investigator's rearward vision. The first set of lateral measurements were taken from the vehicle's center line to the far left and right sides of the backlight. The second set of lateral measurements were taken from the vehicle's center line to the left and right head restraints. The point at which the roadway surface became visible to the investigator measured 10.33 m (33.89 ft) rearward of the rear bumper.

Figure 6. View over shoulder with reference highlighted by arrow (exemplar vehicle)

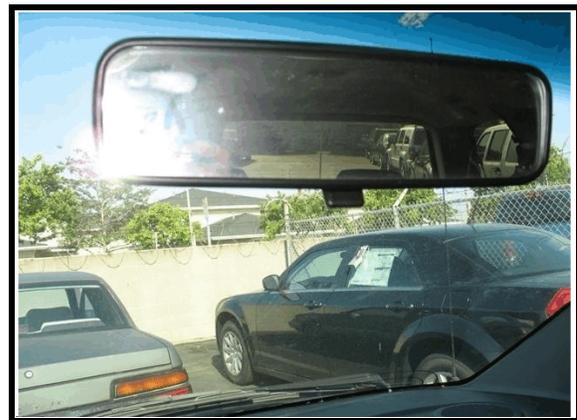
Another set of measurements were taken to simulate the driver using the rear view mirror to look through the backlight. The target was moved rearward from the rear bumper along the vehicle's centerline until it became visible to the investigator. The point at which the target became visible

Figure 7. View through rear view mirror (exemplar vehicle)

to the investigator measured 4.03 m (13.22 ft) rearward of the rear bumper. This measurement was used as the point of origin for a set of lateral measurements which were then taken. Measurements taken laterally to the left and right resulted in a visibility zone that could be viewed through the backlight.

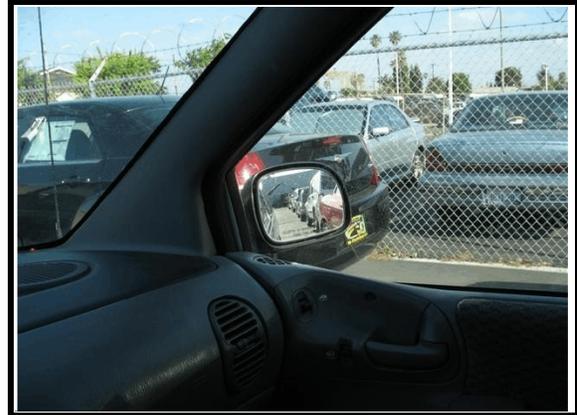
Since the SCI investigator was using an exemplar vehicle, he adjusted the side mirrors appropriately for the driver's seated eye height. With the SCI investigator seated, the side views were examined. The target was placed at the right side of the rear bumper. The target was moved from the side of the vehicle laterally to the right until the target became visible through the right side view mirror. The target was then moved laterally to the right to the point where the target was no longer visible. These measurements resulted in a visibility zone which could be viewed through the side view mirror. This process was repeated on the left side of the vehicle. The area between the left and right visibility zones resulted in a blind zone. Directly behind the rear bumper, the blind zone measured 1.98 m (6.50 ft) in width. The overall width of the vehicle was 1.92 m (6.30 ft). The target was then placed at 3.96 m (12.99 ft) rearward of the rear bumper. Lateral measurements were taken to the left and right at the points at which the investigator could view the target through the side view mirrors. The area between the two visible points resulted in a blind zone. At 3.96 m (12.99 ft) rearward of the rear bumper, the blind zone was approximately 1.82 m (5.97 ft) in width. The target was then moved further to the left and right until it could no longer be viewed through the rear view mirrors. The areas to the left and right in which the target could be viewed resulted in side view visibility zones.

Figure 8. View showing right outside mirror (exemplar vehicle)

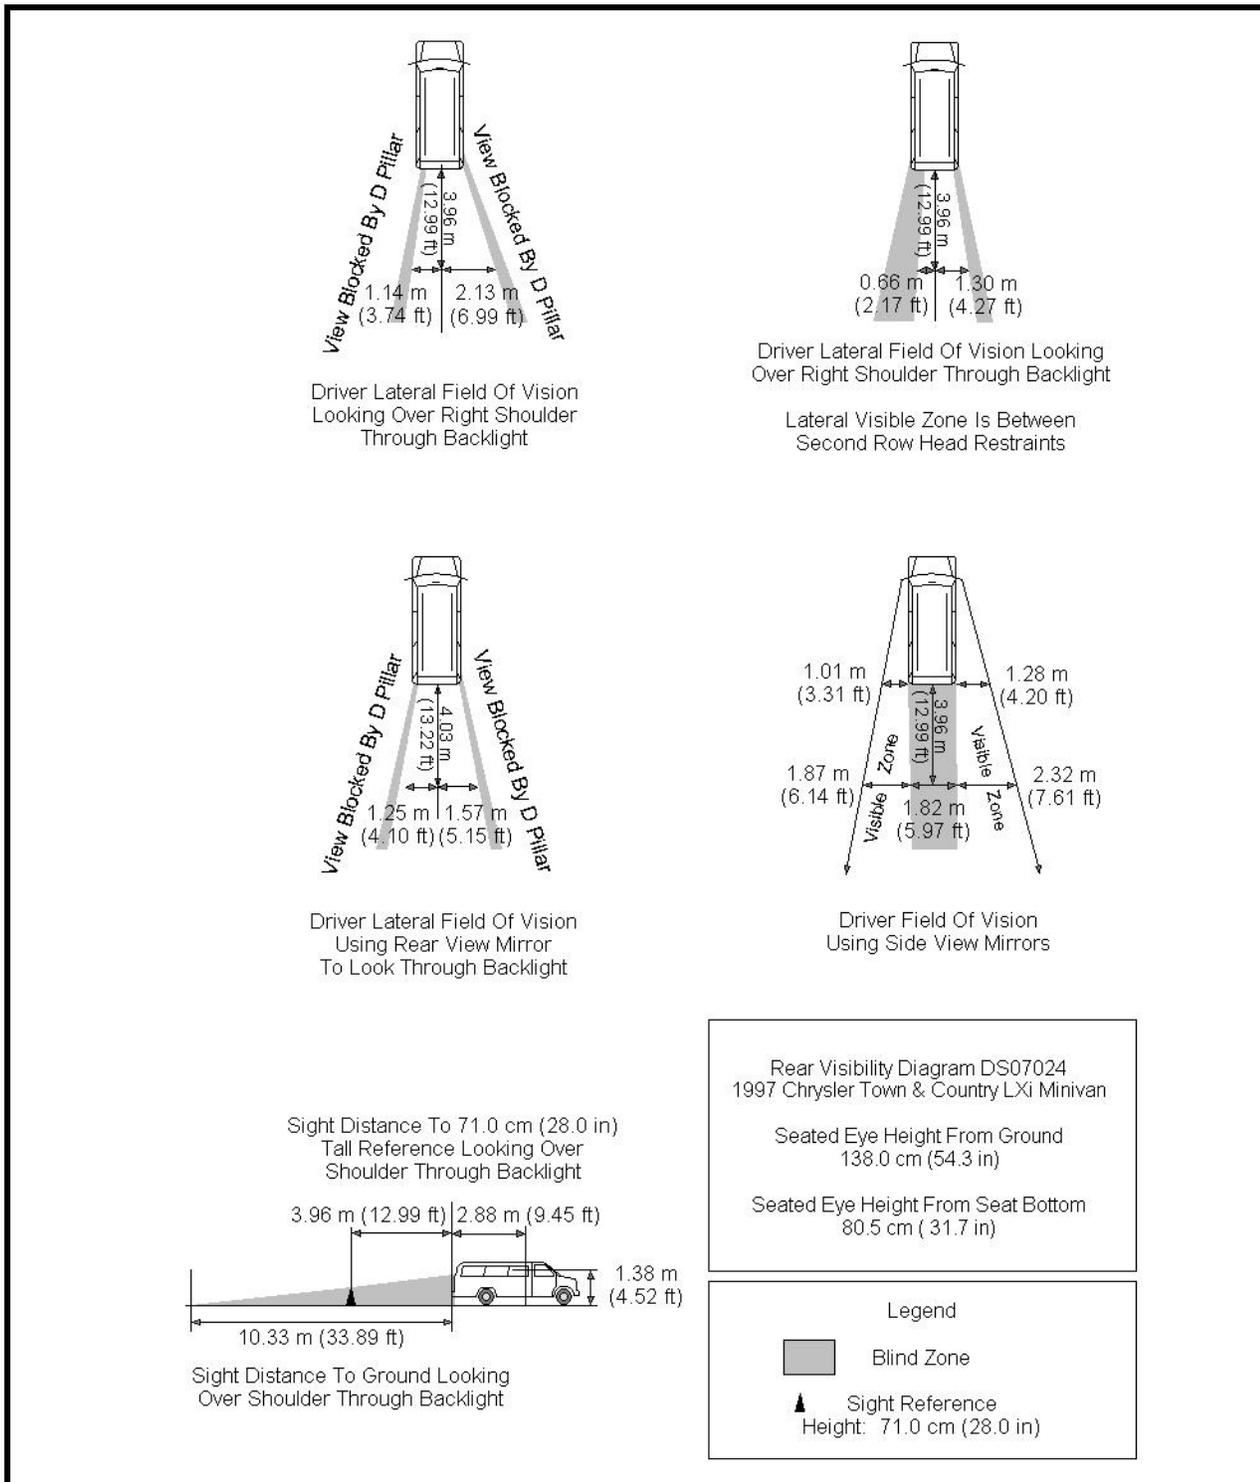
A visibility study was conducted in order to determine the nominal blind zone behind the vehicle as well as the nominal blind zone of both side view mirrors. Measurements were taken using an exemplar vehicle. The standard 71.0 cm (28.0 in) high target was used to obtain the measurements. The measurements were taken on a paved level surface.

Figure 9. Nominal Visibility Diagram
