Rollover Investigation / Vehicle to Object
Dynamic Science, Inc. / Case Number: DS07026
2006 Toyota RAV4
Washington
May 2007

1. Report No. DS07026	2. Government Accession No.	3. Recipient Catalog No.	
4. Title and Subtitle Rollover Investigation		5. Report Date March 27, 2008

14. Sponsoring Agency Code	
15. Supplemental Notes			
16. Abstract This on site investigation focused on a 2006 Toyota RAV4 that was involved in a rollover crash. This single vehicle crash occurred in May 2007 at 2244 hours. The crash occurred on an undivided city street in the state of Washington. The case vehicle was being driven by a restrained 43-year-old male. The Toyota RAV4 was traveling northbound at an unknown speed. The driver of the Toyota lost control and the left front of the vehicle struck a parked vehicle. It appears that the Toyota rotated in a counterclockwise direction and then overturned onto its roof. The driver of the Toyota was arrested for driving while intoxicated. There were no reported injuries. The Toyota was towed due to damage and was later declared a total loss by the insurance company.

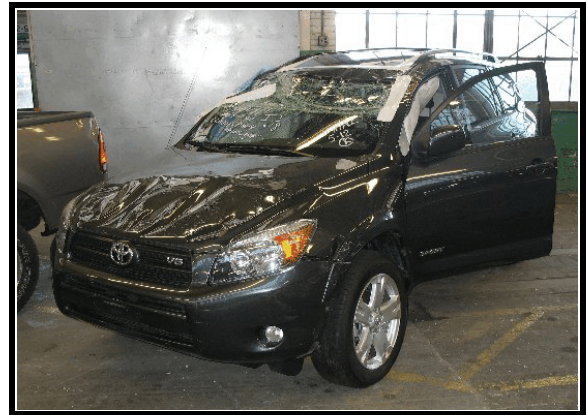
Figure 1. 2006 Toyota RAV4

This on site investigation focused on a 2006 Toyota RAV4 that was involved in a rollover crash (**Figure 1**). This single vehicle crash occurred in May 2007 at 2244 hours. The crash occurred on an undivided city street in the state of Washington. The Toyota was being driven by a restrained 43-year-old male. The Toyota was traveling northbound at an unknown speed. The driver of the Toyota lost control and the left front of the vehicle struck a parked vehicle. It appears that the Toyota rotated in a counterclockwise direction and then overturned onto its roof. The driver of the Toyota was arrested for driving while intoxicated. There were no reported injuries. The Toyota was towed due to damage and was later declared a total loss by the insurance company.

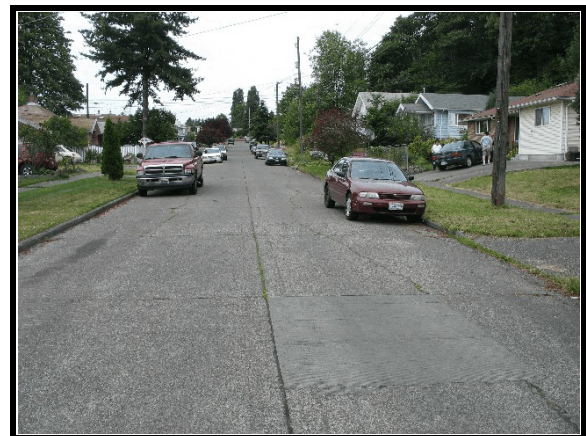
Figure 2. Approach to area of impact (north)

This single vehicle crash occurred on a two-lane, two-way urban street in May 2007 (**Figure 2**). At the time of the crash, there were no adverse weather conditions and the concrete roadway surface was dry. There is a 2% uphill grade for northbound travel. It was dark at the time of the crash and the streetlights were on. Parking is allowed on both sides of the street and vehicles were parked facing both north and south on both sides of the street. The roadway is narrow. When there are vehicles parked on both sides of the street there is only enough room for a single vehicle to travel north/south. A 2001 Jaguar S-type four-door sedan (**Figure 3**, exemplar view) was parked on the west side of the roadway facing south. The speed limit at this location is 40 km/h (25 mph).

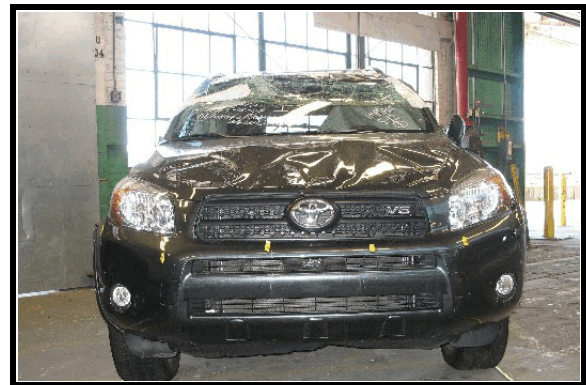
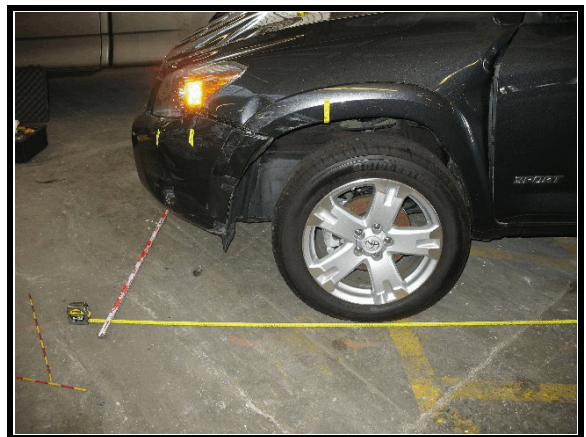
The 2006 Toyota RAV4 sustained minor front end damage as a result of the impact with the parked Jaguar. The direct damage began at the front left bumper corner and extended laterally 15.0 cm (5.9 in) to the right along the front plane (**Figures 4-5**). The maximum crush along the bumper was at C1 and measured 3 cm (1.2 in). The direct contact extended down the side plane for 45 cm (17.7 in). The direct contact extended into the left front wheel. The wheel was displaced rearward and was restricted. The left wheelbase was reduced by 9 cm (3.5 in). Six crush measurements were documented at the bumper level as follows: C1= 3 cm (1.2 in), C2 = 3 cm (1.2 in), C3 = 0 cm, C4 = 0 cm, C5 = 0 cm, C6 = 0 cm. The Collision Deformation Classification (CDC) for the impact with the parked vehicle was 12FLEE3.

Figure 4. 2006 Toyota RAV4

Figure 5. Left front damage

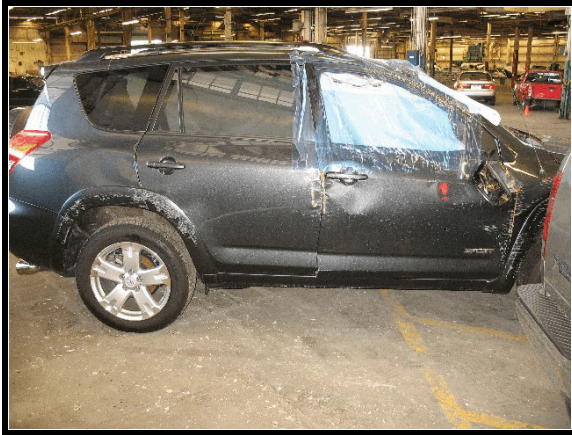
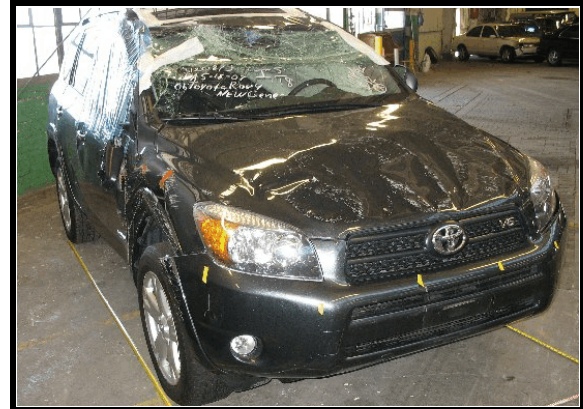
The RAV4 sustained moderate top and left side damage as a result of the rollover (**Figures 6-7**). The damage on the right side began near the right front bumper corner and extended rearward 377 cm (184.4 in). The damage on the top began at the hood line. It was 157 cm (61.8 in) wide and extended down the hood for 67 cm (26.4 in). The direct damage began again 42 cm (16.5 in) forward of windshield header and extended rearward 98 cm (38.6 in) onto the roof and cargo carrier. The maximum crush was located at the right A pillar (**Figure 8**) and measured 2.5 cm (1.0 in). The CDC for the rollover was 00TYDO2.

All the doors remained closed and operational. The windshield was damaged during the rollover. The right front side glass disintegrated during the rollover.

Figure 6. Right side rollover damage

Figure 7. Overview of right side and roof rollover damage

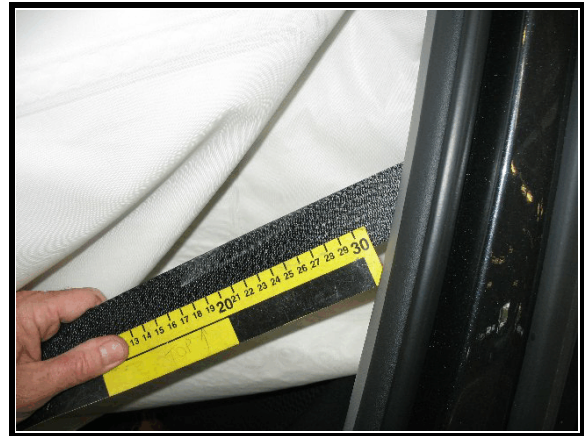
Figure 9. Load marks to driver's seat belt webbing

The 2006 Toyota RAV4 was configured with 3-point manual lap and shoulder belts for each seating position. Both front seat safety belts were equipped with retractor pretensioners and adjustable D rings. The driver's adjustable D ring was in the full up position, the front right passenger's was in the mid position. The driver's safety belt was configured with a sliding latch plate and an Emergency Locking Retractor (ELR). At the time of the vehicle inspection, the driver's retractor was restricted in the used position as a result of pretensioner actuation. The driver's belt showed evidence of loading (**Figure 9**).

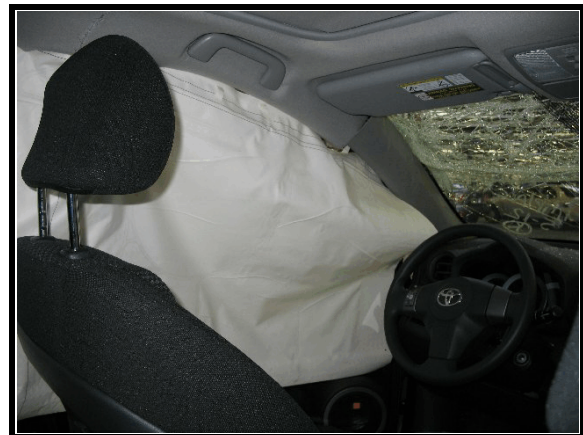
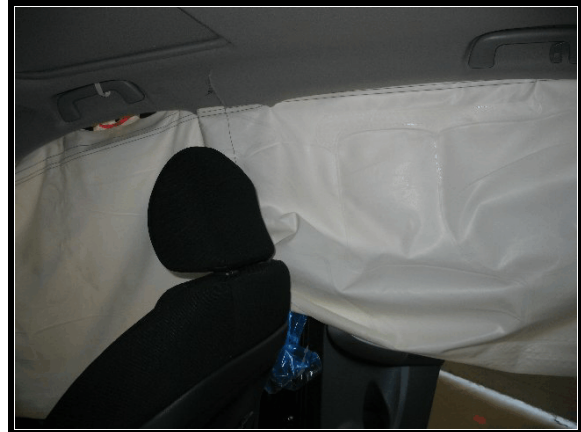
Figure 10. Driver's side curtain

The left and right side curtain air bags deployed from the roof cladding during the rollover event (**Figures 10-11**). The side curtains each measured 195 cm (75.8 in) wide by 59 cm (23.2 in) high. The curtain extends 24 cm (9.4 in) below the side glass frame and extended 27 cm (10.6 in) beyond the C pillar. The curtain was tethered to the A pillar by a 12 cm (4.7 in) strap and to the D pillar by a 20 cm (7.9 in) strap. There was no damage to the side curtains and no indications of occupant contact.

Figure 11. Front right passenger side air curtain
