Remote Not In Traffic Surveillance Back Over Investigation
Dynamic Science, Inc. / Case Number: DS07030
2006 Chevrolet Trailblazer
Hawaii
March 2007

1. Report No. DS07030	2. Government Accession No.		3. Recipient Catalog No.	
4. Title and Subtitle Remote Not In Traffic Surveillance Back Over Investigation			5. Report Date February 5, 2008

**Dynamic Science, Inc.
Crash Investigation
Case Number: DS07030**

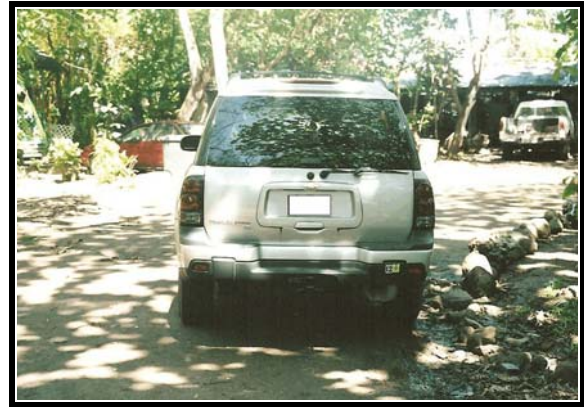
Figure 1. 2006 Chevrolet Trailblazer

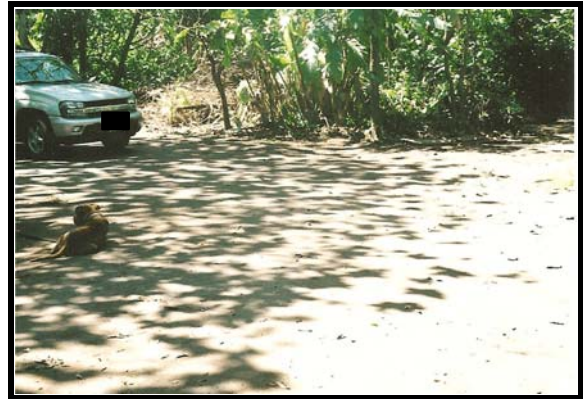
Figure 2. View of backing travel path and final rest (southeast)

This incident took place in a long private driveway/parking area. The driveway was comprised of three sections. There is a north/south section that was approximately 5.8 m (19.0 ft) wide. The residence is to the right (east) of this section of the driveway. This section leads into a parking area that is generally oriented northeast to southwest. The parking area is in the southwest section. There was a parked vehicle in the southern section of the parking area facing southwest. There was a 5.1 m (16.7 ft) wide driveway to the northeast of the parking area. There was a parked vehicle in this driveway facing northeast. The residence would be to the left (west) of the smaller driveway. The parking area was connected to a 3.0 m (10 ft) wide section that travels approximately 34.4 m (112.9 ft) to the street entrance. The weather was clear and calm at the time of the crash. The driveway surface in the area of impact was wet and muddy.

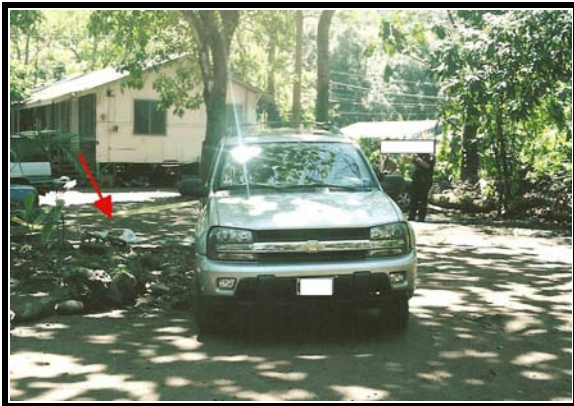
Figure 3. Case vehicle at final rest (arrow shows location of bicycle). Looking southeast.

It appears that as the driver began backing, the children and bicycle fell over and were no longer visible to the driver. The driver continued backing and felt a bump. The Trailblazer contacted both children and then backed over the 2-year-old with the right rear tire. The 4-year-old appears to have been outboard of the right rear tire. The driver heard a neighbor yell. She panicked and moved the Trailblazer forward and ran over the 2-year-old a second time. The police report indicated that the driver ran over both children, but this appears to be unlikely due to the relatively minor injuries to the 4-year-old.

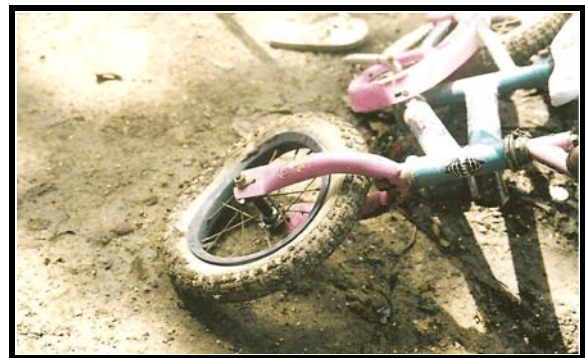
Figure 4. Close up of damaged bicycle

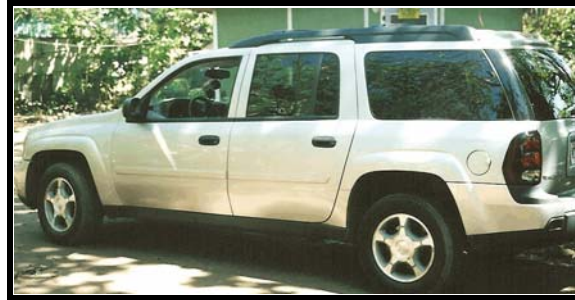
Figure 5. Left side, 2006 Chevrolet Trailblazer

The 2006 Chevrolet Trailblazer was identified by the Vehicle Identification Number (VIN): 1GNET16SX66xxxxxx. The Trailblazer was a four-door, four-wheel drive sport utility vehicle that was equipped with a 4.2 liter, six-cylinder engine, an automatic transmission, and disc brakes. The Trailblazer was configured with Continental ContiTrac P245/55R17 tires. The police report indicated that all the tires had good tread and were inflated.

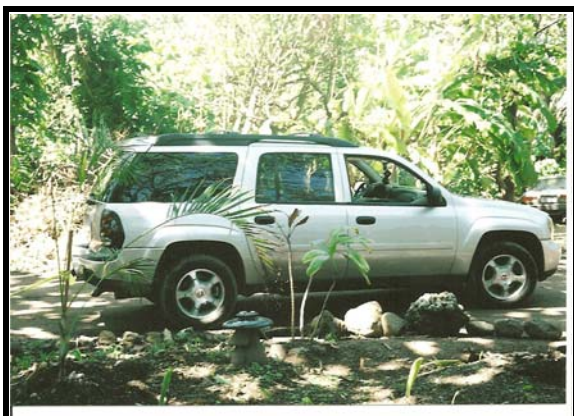
Figure 6. Right side view of 2006 Chevrolet Trailblazer

There was no damage to the Chevrolet and no reports of any contact evidence. Two no residual damage Collision Deformation Classifications (CDCs) were assigned to the two non-motorist impacts.

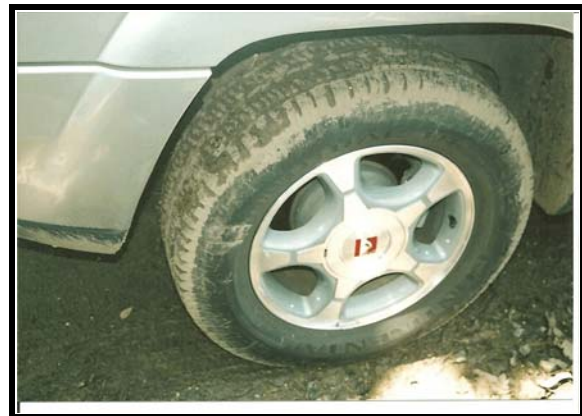
Figure 7. View of right rear tire

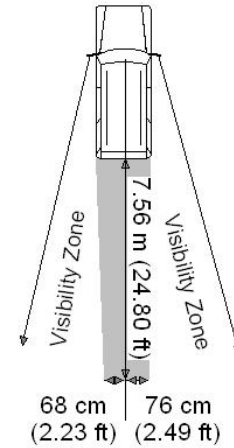
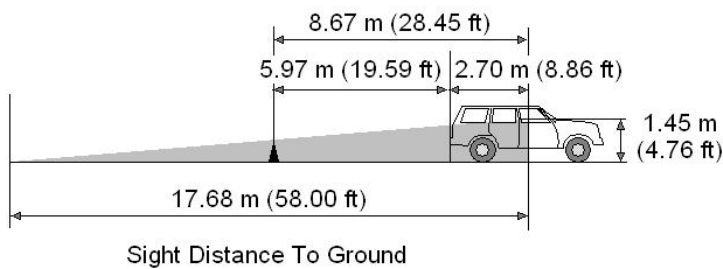
Figure 8. Nominal Visibility Diagram

Sight Distance To 71.0 cm (28.0 in) Tall Reference
Using Rear View Mirror Through Backlight
Over Top Of Center High Mounted Stop Lamp

Driver Field Of Vision
Using Side View Mirrors

Sight Distance To 71.0 cm (28.0 in) Tall Reference
Looking Over Right Shoulder Through Backlight
Over Top Of Center High Mounted Stop Lamp

Sight Distance To 71.0 cm (28.0 in) Tall Reference
Looking Over Right Shoulder Through Backlight
To Side Of Center High Mounted Stop Lamp

Rear Visibility Diagram DS07030

Seated Eye Height From Ground
145.0 cm (57.1 in)

Seated Eye Height From Seat Bottom
74.0 cm (29.1 in)

Sight Reference
Height: 71.0 cm (28.0 in)

The initial set of observations were made with the surrogate driver looking over the right shoulder out of the backlight over the top of the center high mounted stop lamp on the rear deck. The target was moved rearward from the back bumper along the Trailblazer's centerline until it came into the driver's view. The target had to be moved 7.47 m (24.5 ft) before the top of the target came into the driver's view (see Nominal Visibility Diagram in Figure 8).

A second set of observations were made with the surrogate driver looking through the rear view mirror over the top of the center high mounted stop lamp on the rear deck. The target was again moved rearward along the center line until it came into the driver's view. The target was moved 7.56 m (30.1 ft) rearward from the rear bumper.

A third set of observations were made with the surrogate driver looking over the right shoulder out the backlight to the side of the center high mounted stop lamp. The target was moved rearward from the back bumper along the Trailblazer's centerline until it came into the driver's view. The target had to be moved 17.65 m (57.9 ft) before the top of the target came into the driver's view.

A fourth set of observations were made with the driver looking through the left and right side mirrors. The target was placed at the center line 7.56 m (24.8 ft) rear of the vehicle. The target was moved laterally until it became visible to the driver. For the right, the target became visible 68.0 cm (26.7 in) from the center line. For the left, the target became visible 76.0 cm (29.9 in) from the center line.

Based on these observations, it was not possible for the driver to have seen the children by looking backwards. It is possible that she could have observed them through the right mirror.
