## ON-SITE NOT IN TRAFFIC SURVEILLANCE BACK OVER INVESTIGATION

CASE NUMBER - IN-07-031

LOCATION - TEXAS

VEHICLE - 2003 FORD FOCUS SE

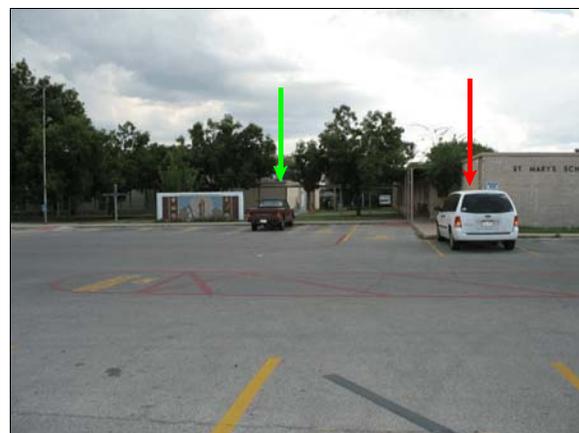
**Figure 1:** Overview of incident scene, red arrow shows location where Ford was parked, green arrow shows school gymnasium

**Crash Environment:** The case vehicle was parked in a church/school parking lot (**Figure 1**). The parking spaces were oriented north-south. Each parking space was approximately 2.7 meters (~9 feet) in width. The Ford Focus was parked in a parking space facing south toward the school directly in front of the southeast corner of the school building and a sidewalk (**Figure 1**). A

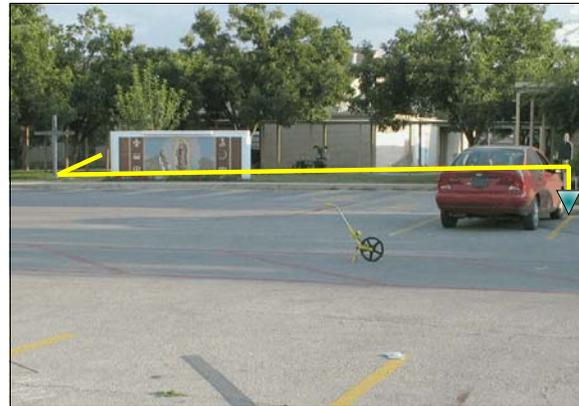
**Figure 2:** Line shows path of driver and her daughter along sidewalk from gymnasium toward Ford's right rear door, Ford is parked in same location as at time of incident

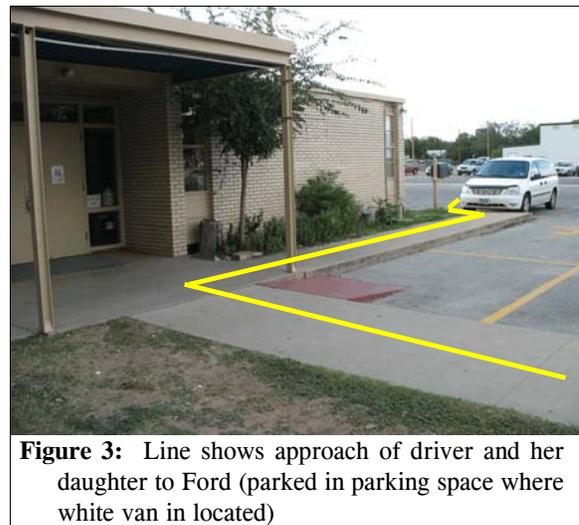
**Figure 3:** Line shows approach of driver and her daughter to Ford (parked in parking space where white van is located)

**Pre-Crash:** The Ford's driver and her daughter exited the gymnasium together and followed the sidewalk's zig-zag path the approximate 58 meters (~190 feet) to the Ford, (**Figure 2**). Their approach to the Ford was directly from the front (**Figure 3**). They first went to the Ford's passenger side rear door, where the driver secured her daughter in a child safety seat in the back right seat position. The driver then walked from the passenger side rear door around the front of the Ford and entered the driver's door. Once in the vehicle, the driver stated she adjusted the radio, attended to her daughter and put on her own safety belt. The driver stated she looked at both side view mirrors and the rearview mirror, then turned and looked over her right shoulder prior to starting her backing maneuver. The driver estimated the elapsed time between entering the Ford and beginning the backing maneuver was one minute. The available information indicated that as the driver was preparing to back up, the pedestrian was somewhere behind the Ford. However, it could not be determined if the pedestrian had approached the Ford directly from the back of the vehicle or from the driver side or passenger side. The driver stated it was her understanding that the pedestrian was with his sister and had gotten away from her just prior

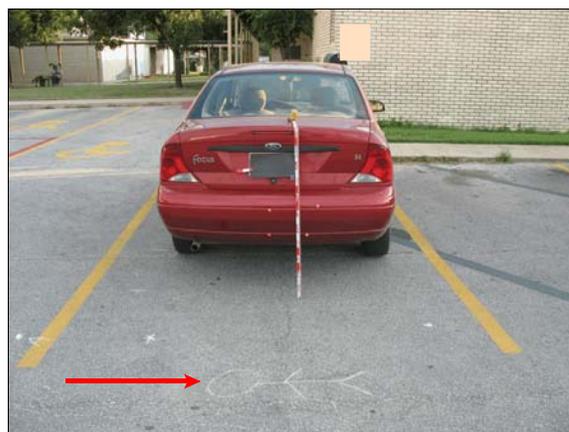
**Figure 4:** Arrow shows figure representing Ford driver's reported final rest position of pedestrian, dots on Ford's back bumper show area of pedestrian contact, scale in tenths of meter

**Post-Crash:** The Ford's driver got out of her vehicle and saw the pedestrian laying face down on the parking lot behind her parking space with his legs toward the west (**Figure 4**). The pedestrian was transported by ambulance to a hospital and was held overnight for observation. The pedestrian's injuries are not known. There was no specific injury information contained in the police crash report, and this contractor was unable to contact the pedestrian's parents.

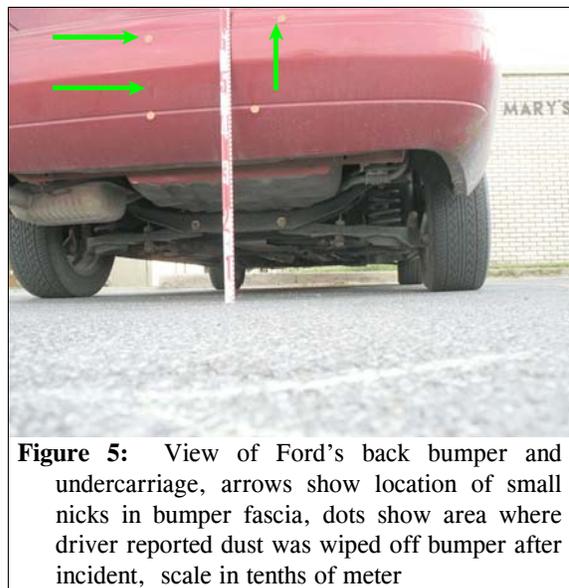
**Figure 5:** View of Ford's back bumper and undercarriage, arrows show location of small nicks in bumper fascia, dots show area where driver reported dust was wiped off bumper after incident, scale in tenths of meter

The vehicle inspection revealed three small nicks in the Ford's back bumper fascia (**Figure 5**). According to the driver, they were not there before the incident. Also in the same area, the driver stated that the dust was wiped off of the bumper fascia following the incident. The beginning of the contacted area began 51 centimeters (20.1 inches) left of the back right bumper corner. The area of contact was 31 centimeters (12.2 inches) wide. Based on the vehicle inspection and the description of the damage, a Collision Deformation Classification was determined to be: **06-BCLN-1 (180 degrees)**. The case vehicle was driven from the scene.

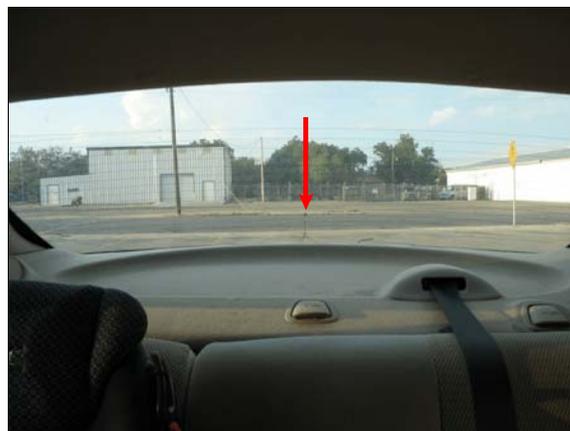
**Figure 6:** View out of Ford's backlight from driver's seat, arrow shows location of target where driver said she could first see it as she looked over her right shoulder

The initial set of observations was made with the driver looking over her right shoulder out of the backlight as she did at the time of the incident. The target was moved rearward from the back bumper along the Ford's approximate centerline until it came into the driver's view. The target had to be moved rearward from the back bumper 13.1 meters (43.0 feet) before the top of target came into the driver's view (**Figures 6 and 7** below). The target was then moved 7.2 meters (23.6 feet) to the right of the approximate centerline where it became obstructed by the right C-pillar. When moved an additional 4.3 meters (14.1 feet) further to the right, the target

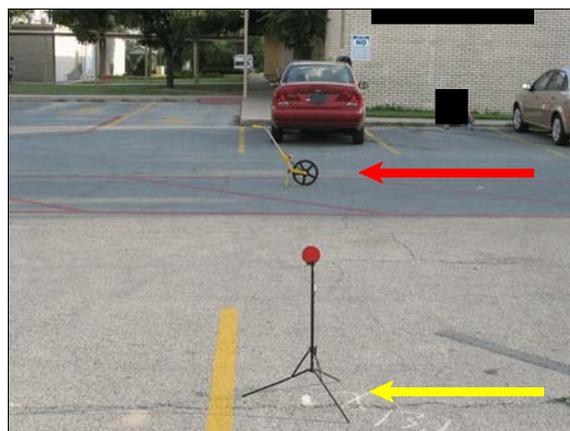
**Figure 7:** Points at which targets became visible to driver looking over shoulder (yellow arrow) and through rearview mirror (red arrow, target location indicated by measuring wheel), Ford parked in same location as at time of incident

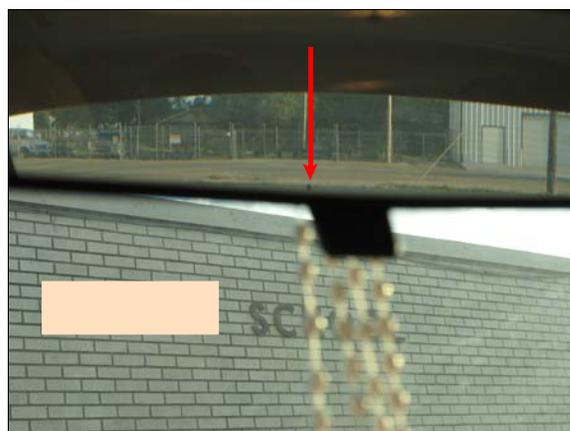
**Figure 8:** Close view through Ford's rearview mirror from driver's seat, arrow shows target in location where Ford's driver said she could first see it

The Ford's driver was then asked to view behind the vehicle through the rearview mirror, which she indicated she had adjusted the day before this contractor's on-site investigation. The adjusted position was normal for her and was approximately the same adjustment at the time of the incident. The target was moved rearward from the back bumper as the driver viewed through the rearview mirror. The target did not become visible to the driver until it was moved rearward 5.2 meters (17.1 feet, **Figures 7 and 8**). The target was then moved 2.1 meters (6.9 feet) to the right from the approximate centerline where it became obstructed by the right "C"-pillar. The target did not become visible again when moved further to the right because it went out of the rearview mirror's field of view. The target was returned to the initial location at the approximate centerline and moved left 1.6 meters (5.2 feet) where it became obstructed by the driver's head restraint and was not visible again when moved further to the left.

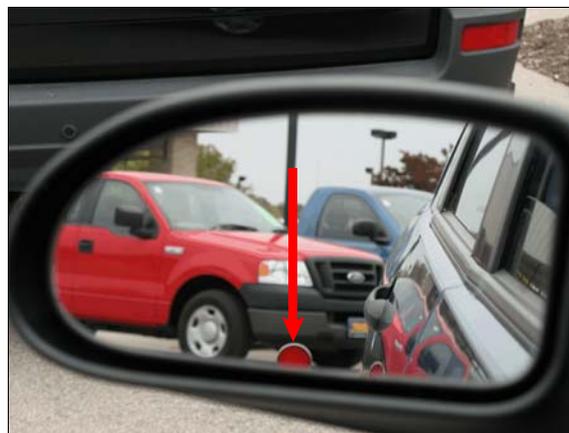
**Figure 9:** Close view from driver's seat of exemplar Ford Focus through left side view mirror, arrow shows target in location where driver said she could first see it

mirror (**Figure 9**<sup>1</sup>). The target was then moved left 0.7 meter (2.3 feet) where it went out of the mirror's field of view and the driver could no longer see it. The target was then positioned at the back right bumper corner and the same process was repeated for the right side view mirror. It was necessary to move the target rearward from the back bumper 0.4 meter (1.3 feet) before the driver could see it in the right side view mirror (**Figure 10**<sup>1</sup>). The target was then moved to the right 0.8 meter (2.6 feet) where it went out of the right side view mirror's field of view and the driver could no longer see it.

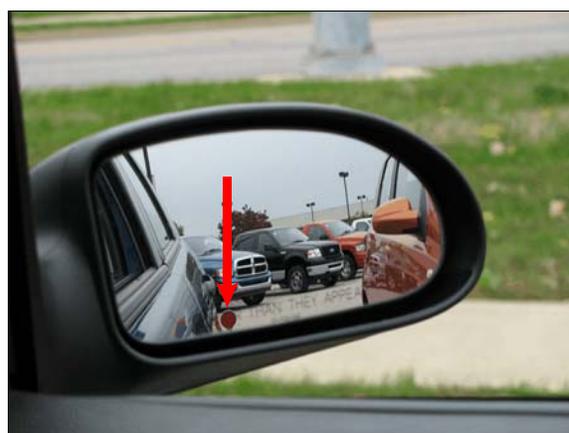
**Figure 10:** Close view from driver's seat of exemplar Ford Focus through right side view mirror; arrow shows target in location where driver said she could first see it
